# **2008 Annual Inspection and Status Report for the Hallam, Nebraska, Decommissioned Reactor Site**

The former Hallam Nuclear Power Facility (HNPF) was inspected on April 30, 2008.

This report presents the findings of the annual U.S. Department of Energy (DOE) inspection of the Hallam, Nebraska, Decommissioned Reactor Site.

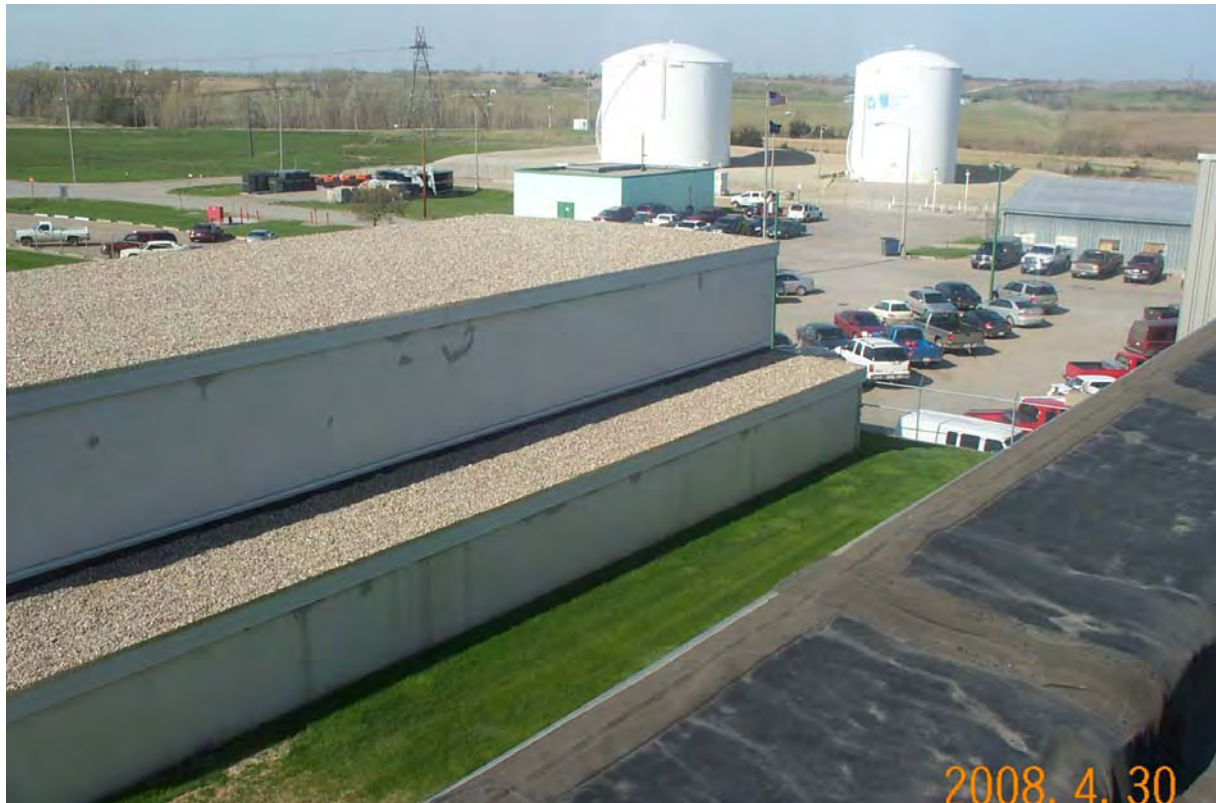
The roof of the IHX is in excellent condition (PL-1 and PL-2). The roof was replaced in 2007 and cornices noted as being in need of repair during last year's inspection were all repaired. The sides of the structure are scheduled to be re-painted in 2008.

HAL 4/2008. PL-2. Roof of IHX Building.

2. The sides of the IHX structure need to be repainted (page 2).

**Recommendation:** The sides of the IHX structure are scheduled to be re-painted in 2008.

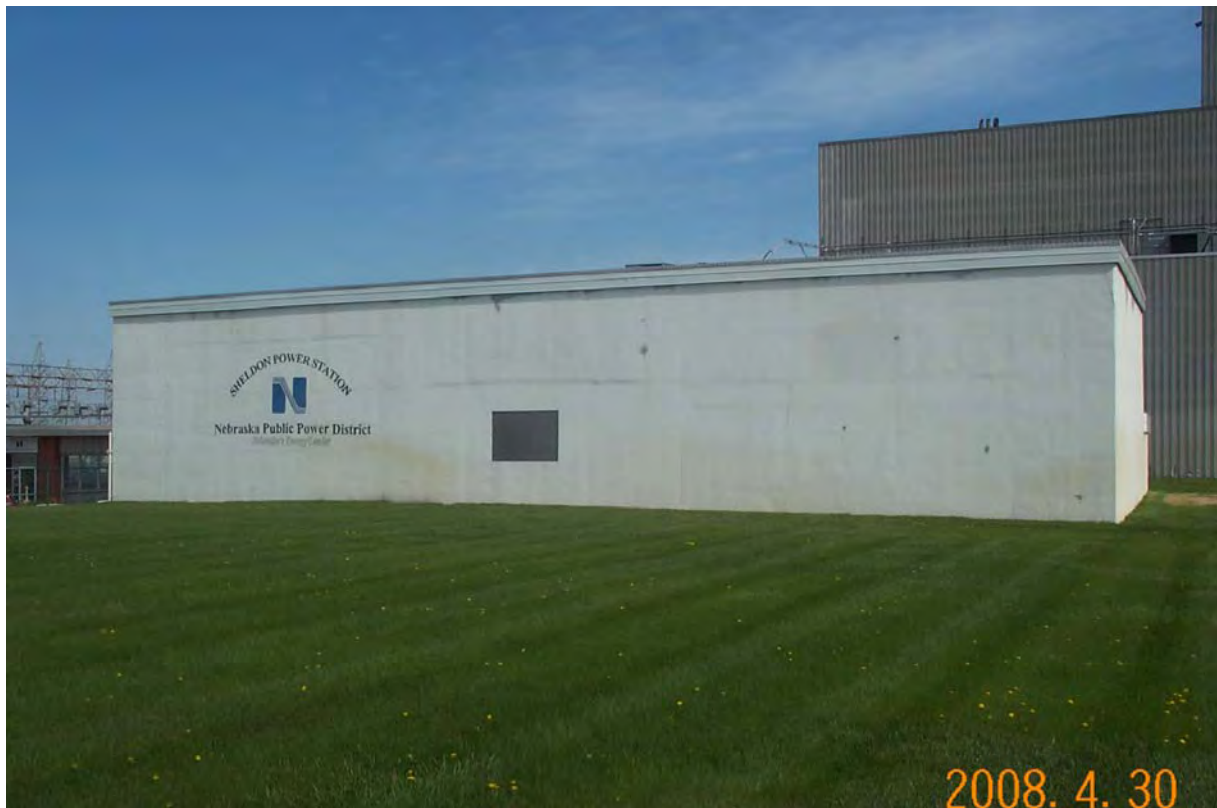
The grass is well established, and is in good condition on the grass-covered mound, with the exception of the east edge (PL-3). The east edge of the grass-covered mound, just beyond the toe of the slope, is bare of grass due to waterline work that was conducted in 2007 (PL-4). This work also left sprinkler heads exposed (PL-5). Re-seeding of the area is planned for this year.

HAL 4/2008. PL-3. South side of IHX Building.

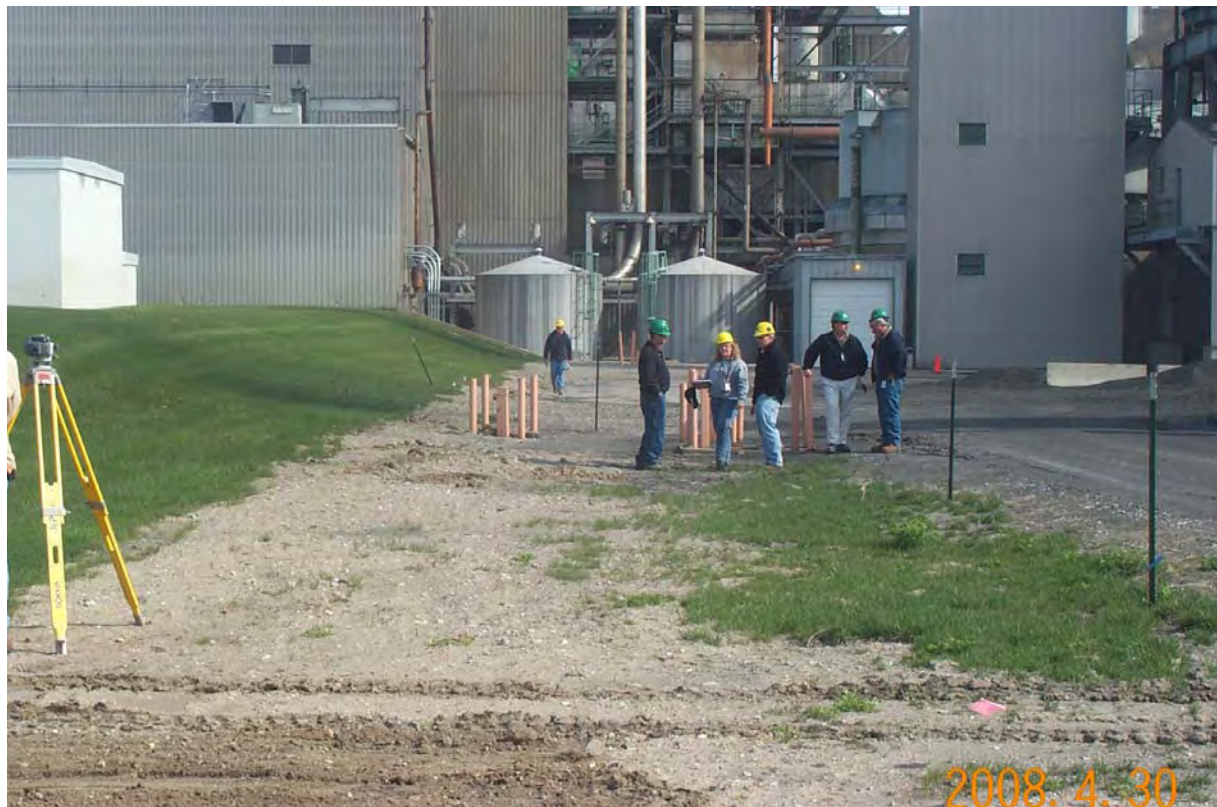
HAL 4/2008. PL-4. Looking north along east side of grass-covered mound.

3. The east edge of the grass-covered mound, just beyond the toe of the slope, is bare of grass due to waterline work that was conducted in 2007 (page 2).

**Recommendation:** Re-seeding of the area is planned for 2008.

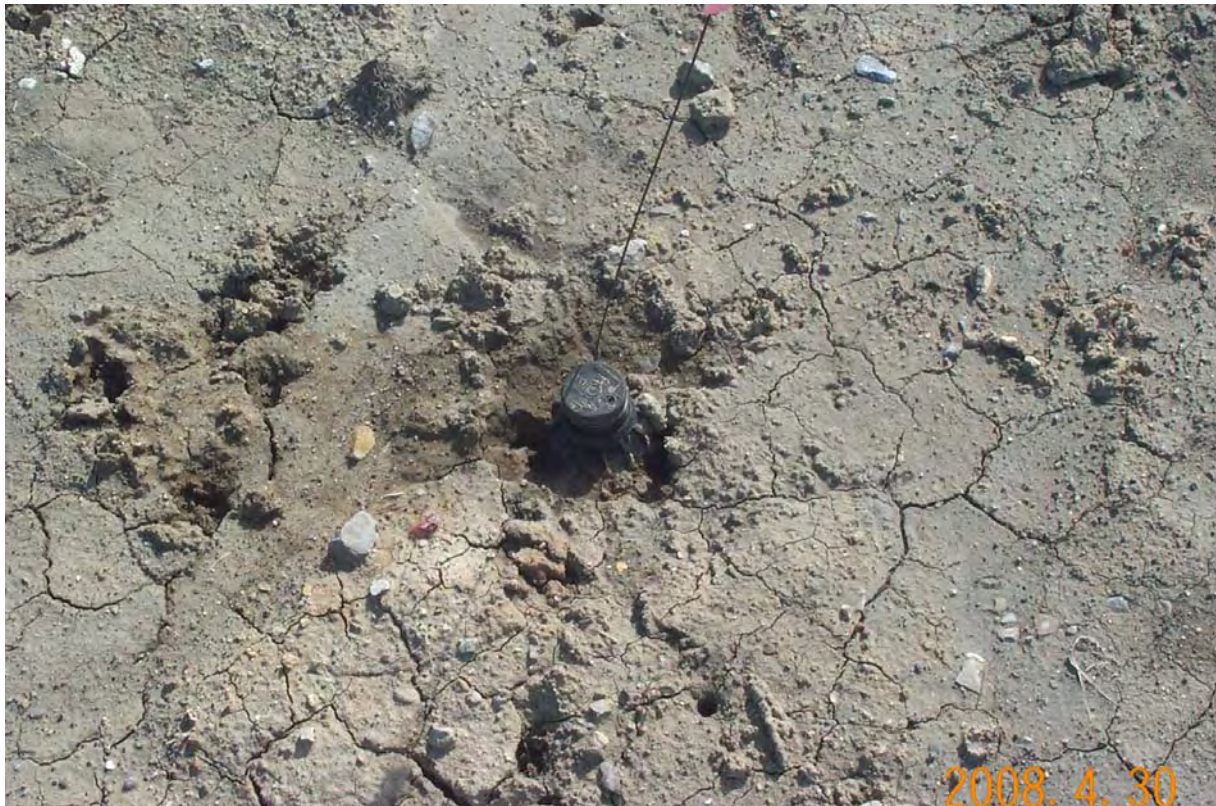
HAL 4/2008. PL-5. Exposed sprinkler head.

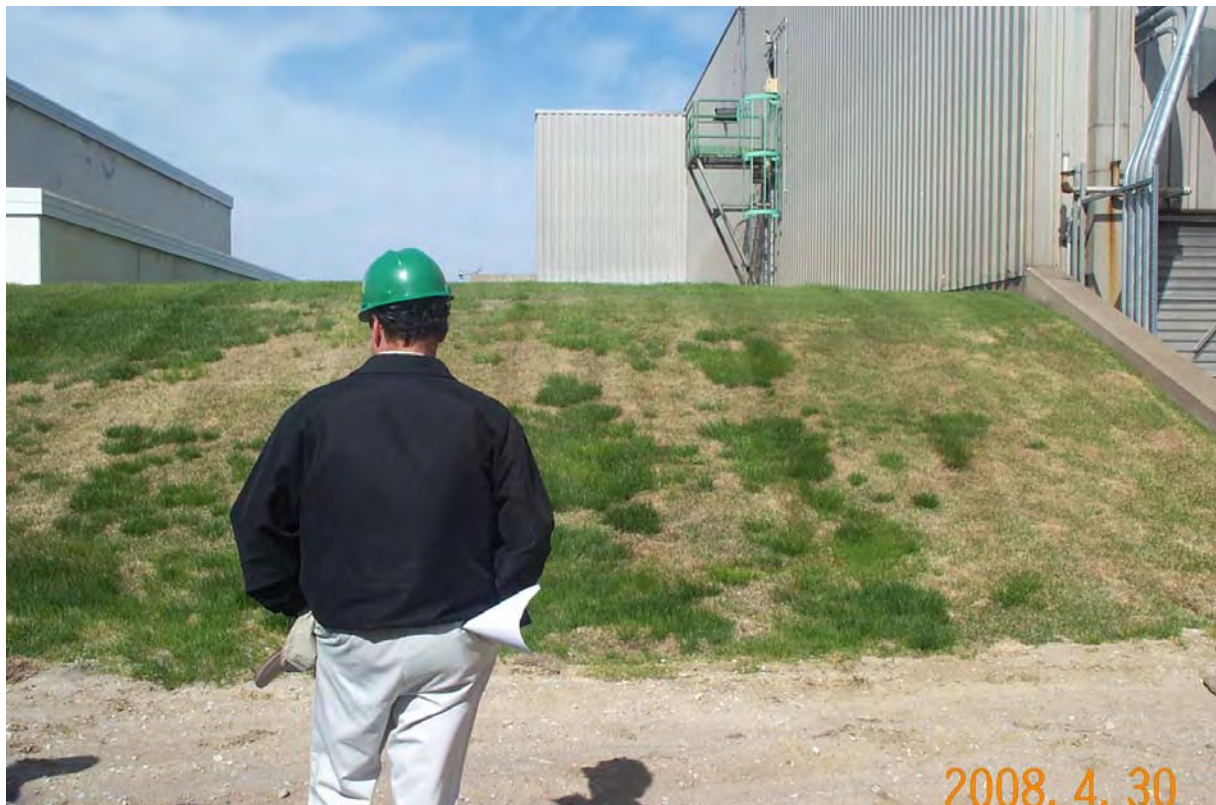
No evidence of new erosion was observed on the grass covered mound, but grass has not completely filled in an area just northeast of the IHX structure, where some work had disturbed the grass cover in prior years (PL-6).

HAL 4/2008. PL-6. Bare grass areas in northeast corner of grass covered mound.

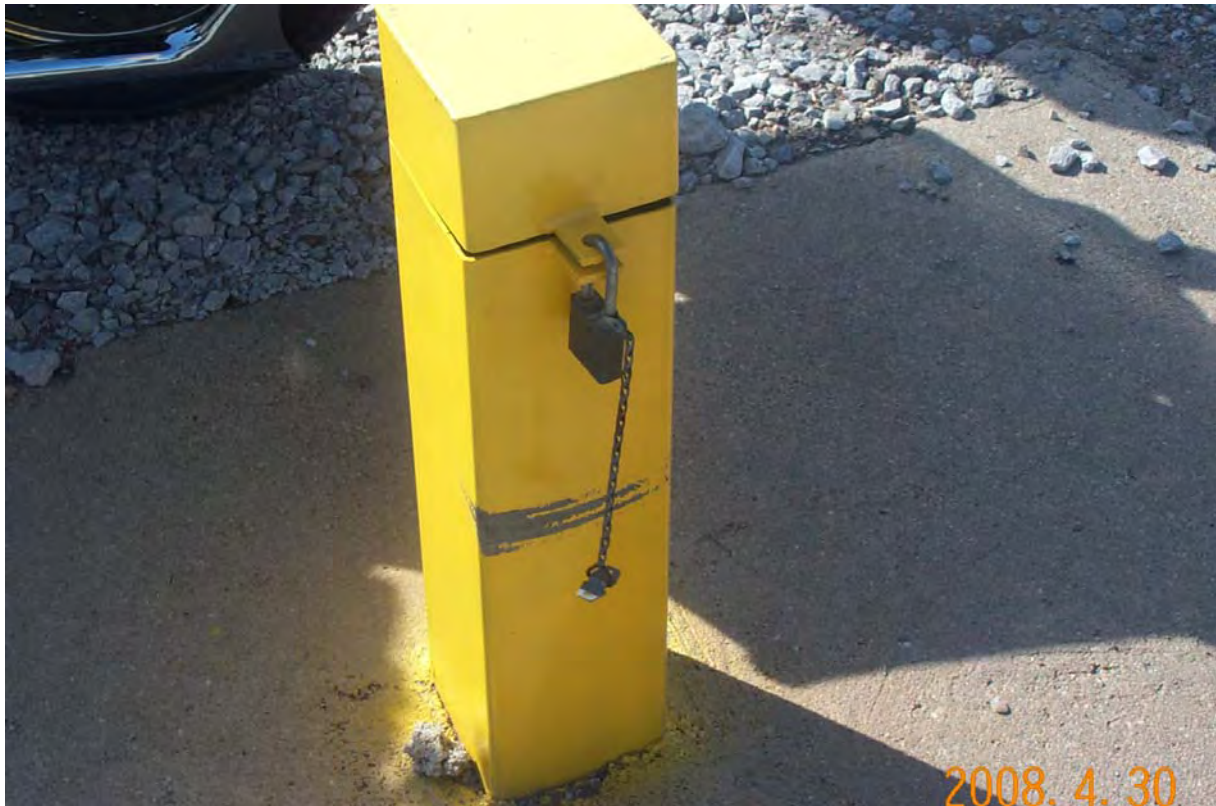
6. An un-used chain is attached to each well lock. When blown in the wind, this chain rubs against the paint on the protective casing (page 3).

HAL 4/2008. PL-7. Monitor Well OBS-4, free hanging chain on lock.

**Recommendation:** This un-used chain will be removed from each lock during the June 2008 sampling event.

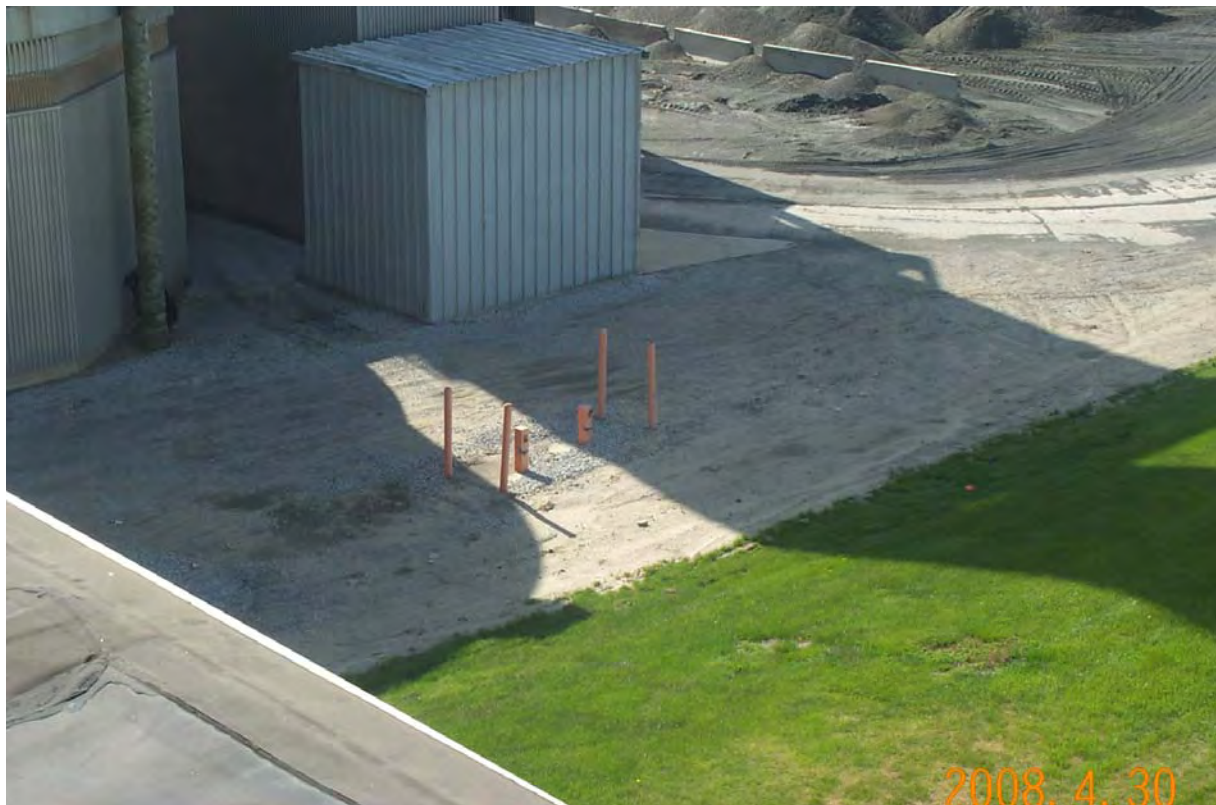
Wells OBS1A and OBS1B are located in a high traffic area (PL-8). These wells are installed in a large concrete pad and surrounded by four bollards (PL-9). A statement of work is being prepared to change these two wells to flush mount wells. A heavy-duty vault type design is planned. In Nebraska, a licensed well installer must perform this work.

HAL 4/2008. PL-8. Monitor Wells OBS1A and OBS1B.

7. Monitor wells OBS1A and OBS1B are located in high traffic areas. These wells need to be redesigned into flush mounts (page 3).

**Recommendation:** A SOW is being prepared to re-configure these wells in 2008.

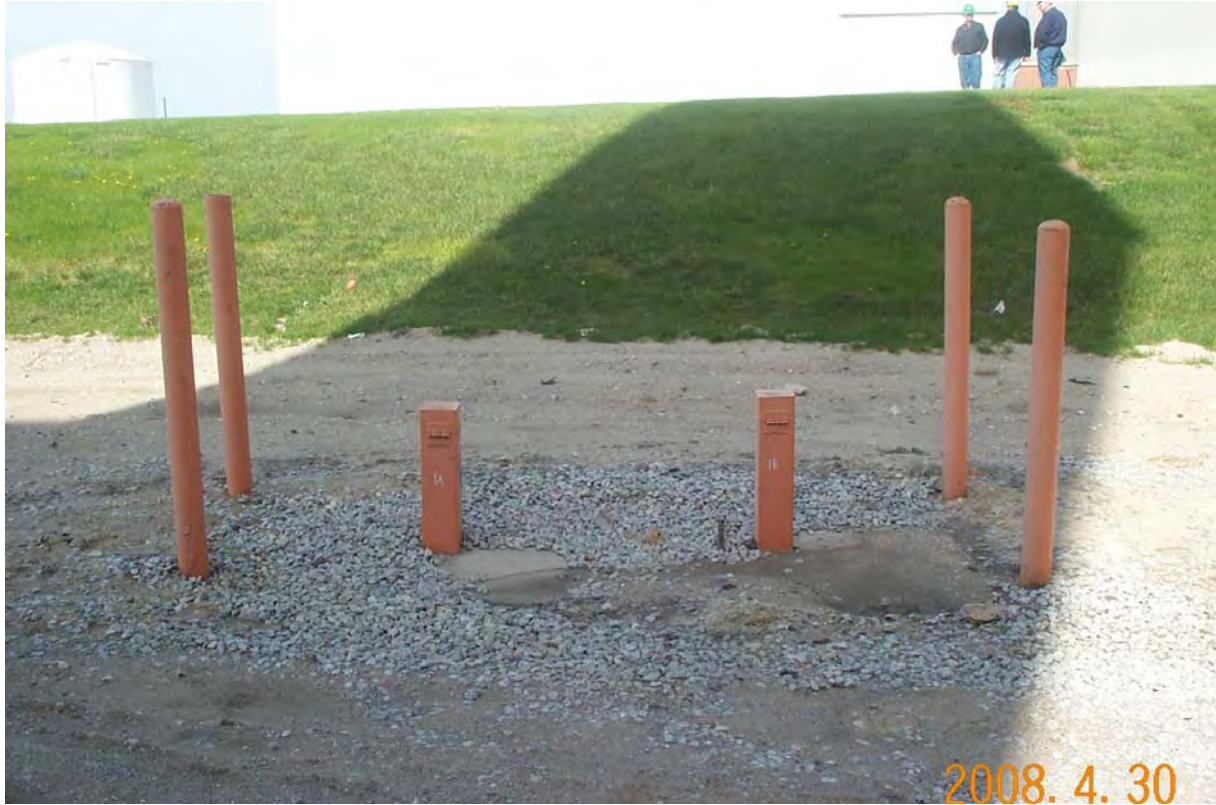
HAL 4/2008. PL-9. Monitor Wells OBS1A and OBS1B.

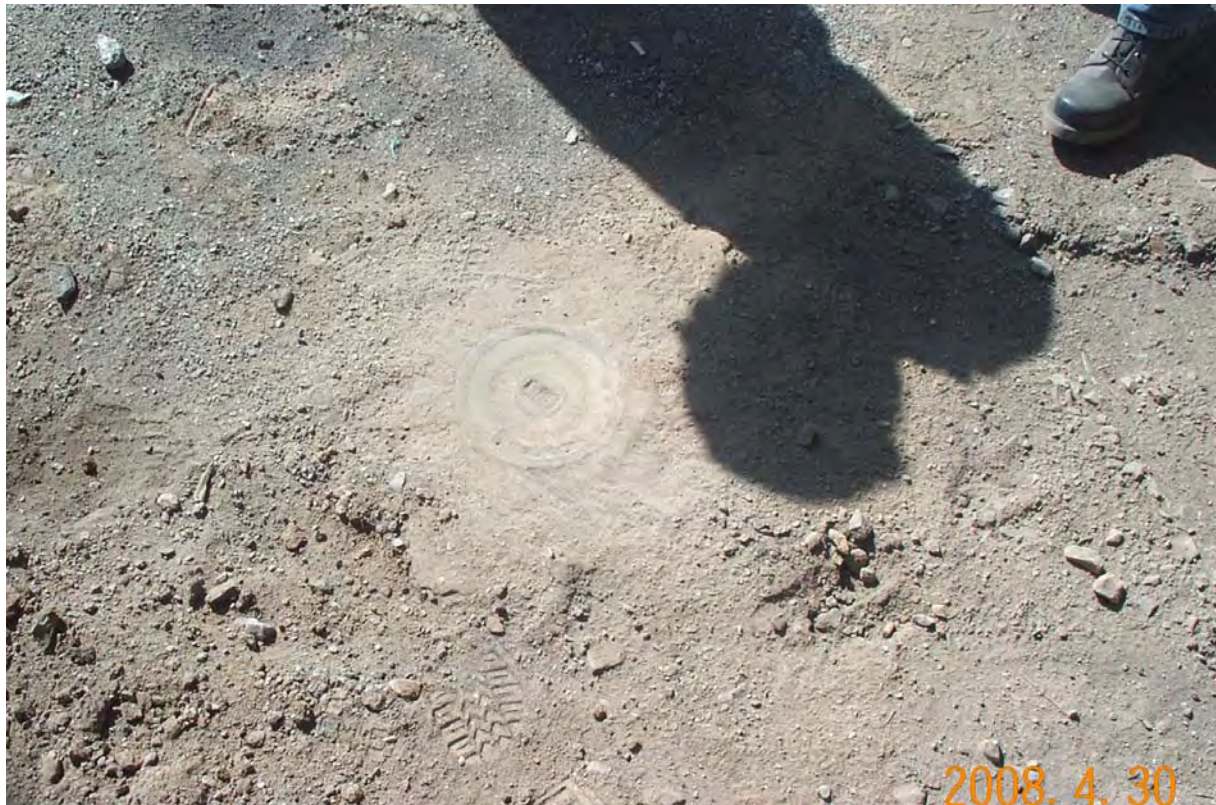
Wells OBS6A and OBS6B are flush mounted wells. The wells are usually covered with gravel and difficult to locate. The covers on these wells were not removed from 2002 through 2004 because they are cracked and wedged tight with coal dust. Since 2005, water-sampling personnel have been successful in removing the covers without damaging them. Previous attempts to find replacement covers were unsuccessful. Only one of the wells could be located during the inspection and because the wells are not labeled on the outside it was not known if the well that was found was OBS6A or OBS6B (PL-10). A statement of work is currently being prepared to re-configure these flush mounts to a more substantial design (e.g., vault type design) so they can be located and opened more easily. In Nebraska, a licensed well installer must perform this work. It is recommended that a magnetometer should accompany well samplers during their sampling visit in June 2008 to locate this well.

HAL 4/2008. PL-10. Monitor Well at OBS6 location.

9. Monitor wells OBS6A and OBS6C are flush mount wells that are easily buried with coal dust and are hard to open because the covers are usually wedged tight with coal dust (page 3).

**Recommendation:** A SOW is being prepared to re-configure these wells with a stronger vault design in 2008. Well samplers should carry a magnetometer with them during the June 2008 sampling event to help locate these wells.

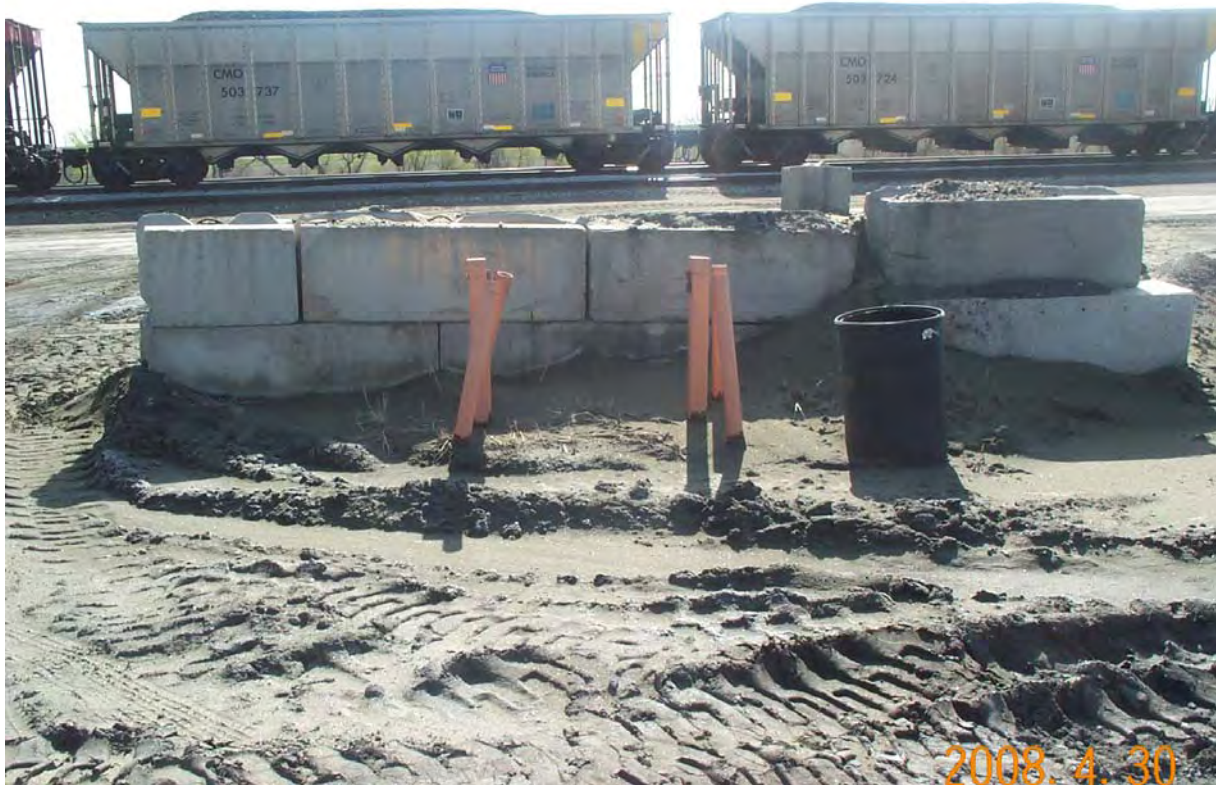
Wells OBS7B and OBS7C are located in a high traffic area and are protected by bollards (PL-11). The well pad at this location is buried and the bollards protecting the pad are bent due to being hit by heavy equipment operating in the area. There is little that can be done at this location to improve the protection of the wells. Therefore, before repairs are made to this well cluster, DOE will review data collected from this location and make a determination as to whether the data supports keeping or abandoning the monitoring location. If the decision is made to keep the monitoring location, the bollards will need to be re-enforced, perhaps with some jersey barriers, to provide additional protection against the operation of heavy equipment in the area.

HAL 4/2008. PL-11. Monitor Wells OBS7B and OBS7C.

10. Monitor Wells OBS7B and OBS7C are located in a high traffic area and are protected by bollards. There is little that can be done at this location to better protect these wells (page 3)

**Recommendation:** DOE will review the data collected from this location and make a determination as to whether the data supports keeping the monitoring location. Bollards should be placed around the location for added protection.

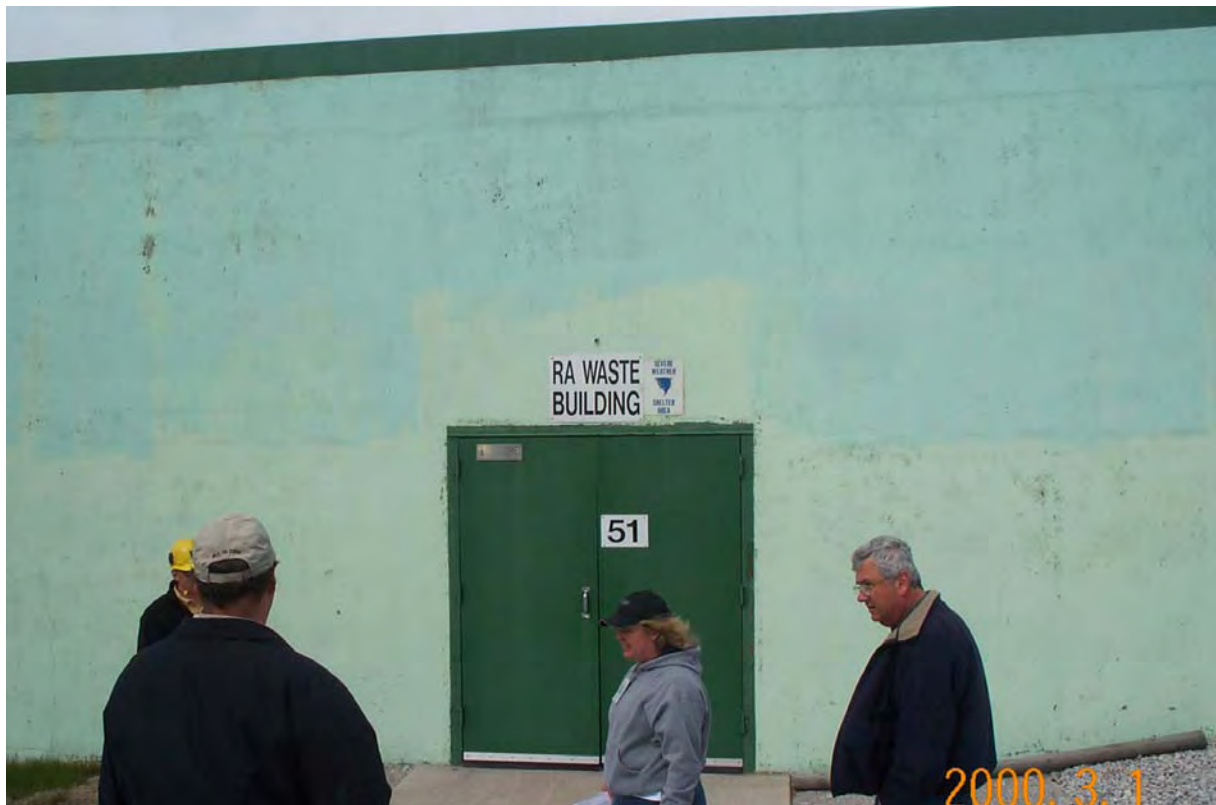
In 2007 inspectors walked through the former Radioactive Waste Building across the entrance drive from the burial mound. The basement was sealed to prevent access. This building was reported to have been surveyed for contamination and released. Stoller recommended to NPPD that the sign reading "RA Waste Building" be removed from the building. NPPD does not want to change the name of the building, as it is what the building has always been called; therefore the sign remains (PL-11).

HAL 4/2008. PL-12. Entrance to RA Building.
