Chapter 6:

Existing Conditions 2002

DRAWING 14: OVERALL EXISTING CONDITIONS PLAN

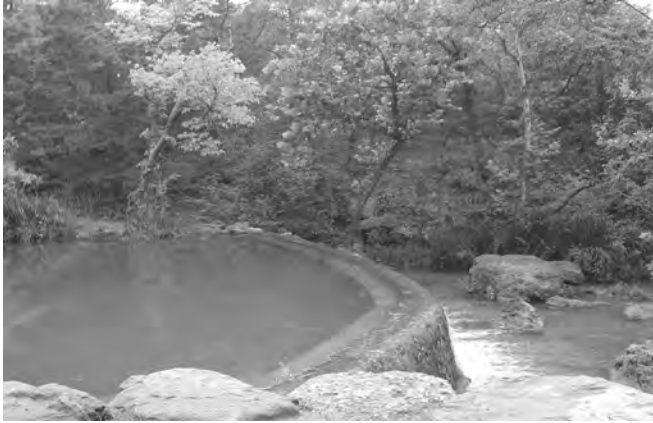
Figure 6-5. Panther Falls 2001.

The Panther Falls dam and swimming hole, located between Cold Springs and Central Campground, is the oldest in the park (Figure 6-5). This five-foot high, curved concrete wall is in good condition, though the adjacent picnic area is heavily used, with compacted bare soil instead of turf. The south bank of the swimming hole is very steep and swimmers often jump from a ledge into the pool below.

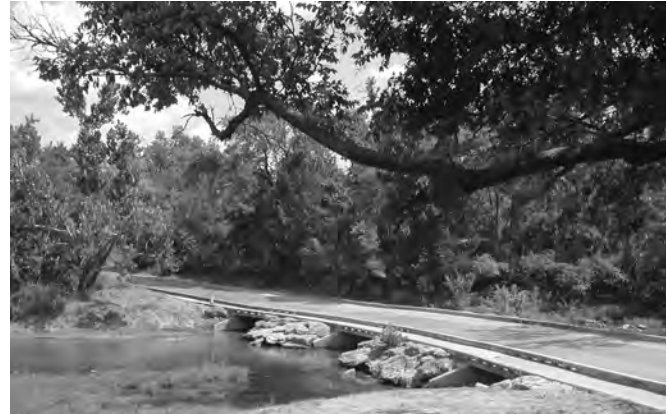
Figure 6-11. Black Sulphur Springs Causeway, 2002.

The Black Sulphur Springs Causeway crosses Rock Creek just west of Flower Park (Figure 6-11). Floods since 1950 repeatedly damaged the causeway, and it was reconstructed and widened with a pedestrian walkway constructed on the deck's north side. As a result of these changes, it is a non-contributing structure. Channel hydrology continues to impact the structure's foundation, which shows signs of erosion and undermining.

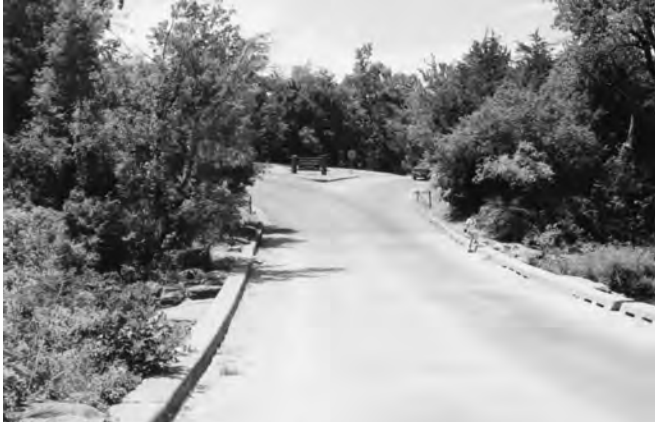
Figure 6-12. Rock Creek Causeway, 2001

West of the Bromide area is Rock Creek Causeway, located along the perimeter road (Figure 6-12). Some wear has occurred on the bridge, in particular, on the curbing. Its essential design and coursed stone piers remains the same, though periodic flooding has prompted minor reconstruction.

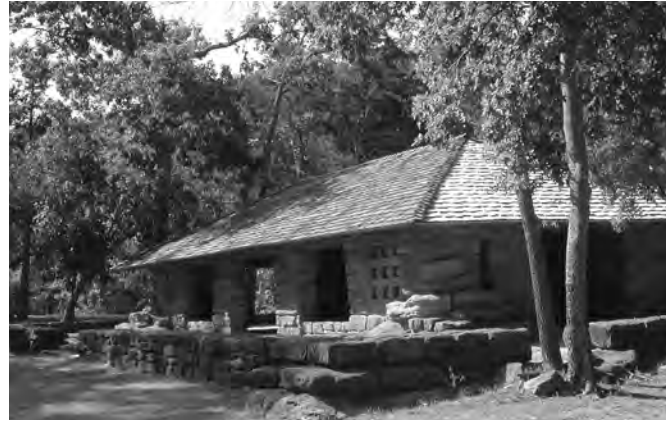
Figure 6-20. Bromide Pavilion, 2001.

Bromide Springs Pavilion (1938), located along the banks of Rock Creek, is in relatively good condition, though missing some features (Figure 6-20). These include its mineral springs, wells and its original semi-circular wood bench. However, at least six stone piers for the bench are extant along the lower wall of the Pavilion Terrace and in the woods adjacent to the Pavilion. Trees located in the terrace show signs of stress and their loss appears likely in the future. The west wall terrace has a small gap, possibly

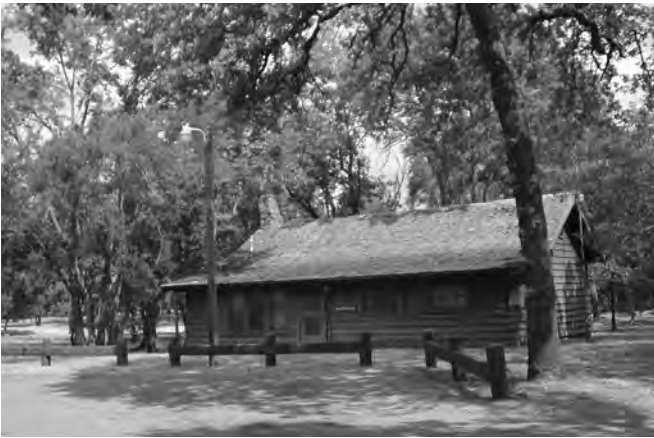
Figure 6-21. Travertine Ranger Station, 2001. Wood guardrail in front of the structure is not historic.

Located in the eastern portion of the picnic area, the Travertine Ranger Station (presently used as Resource Management Office) is a wood frame building with a concrete foundation and a small porch on its south side (Figure 6-21). Lead abatement was underway on building in the summer of 2002. Today it is painted NPS brown and is used as ranger offices.

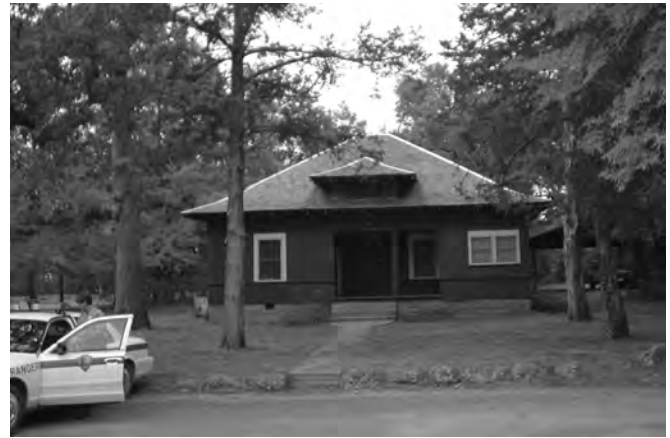
Figure 6-22. Bromide Ranger Station, 2001. Note carport on the right.

The Bromide Ranger Station, located west of the pavilion, is of wood frame construction with a limestone-faced foundation (Figure 6-22). It has been altered and its current windows are non-historic.

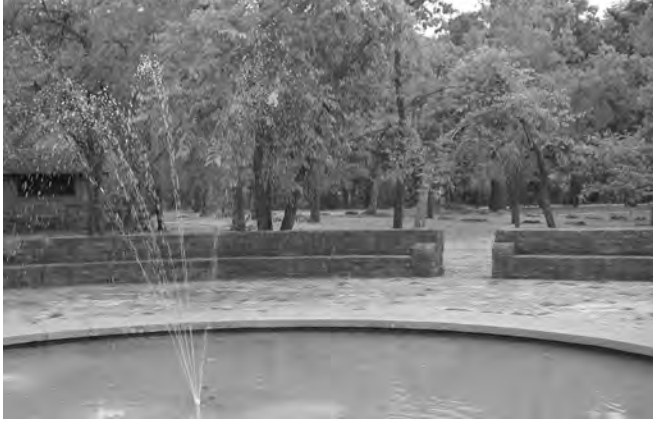
Figure 6-23. Twelfth Street fountain, 2001.

The large, circular 12th Street fountain (Figure 6-23) is constructed of limestone masonry, and has seen some changes over the years. The plaza's flagstone paving today has mortar joints; weeds growing in joints are killed with herbicide. A concrete coping sometime replaced flagstone

coping around half of the pool. The pool's shower head-like central jet is currently supplied by a city water line and does not have the same volume, pressure, and form created by the original artesian supply from the Jack Diamond well. Drinking fountains located at the ends of the fountain's encircling walls are also no longer extant. Though its condition is generally good, the fountain could benefit from increased maintenance, including more regular sweeping, pool cleaning, and masonry repair.

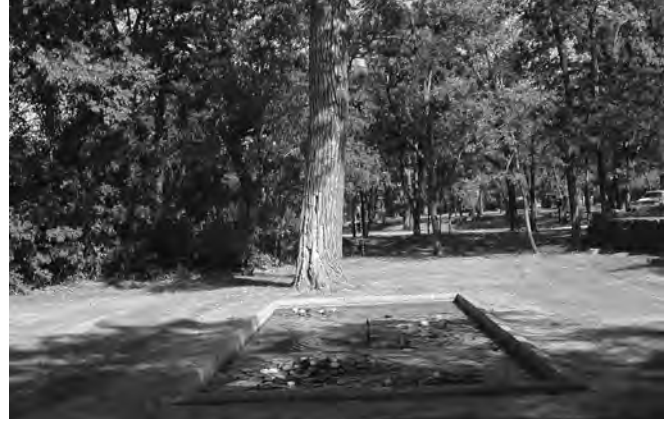
Figure 6-24. Bromide Pavilion Lily Pond, 2001.

The rectangular Bromide Pavilion Lily Pond (Figure 6-24), in fair condition, has recently been filled with sand to reduce its depth to about two feet. A concrete curb has also been added around the lily pond itself. A reconstructed fountain, a central jet spurting from the center of the pool is fed by city water on a line connected to the 12th Street fountain. A leak in the pool drains it at the approximate rate of water flowing into the pool, keeping the water level constant. The pool is filled with water lilies, planted in pots.

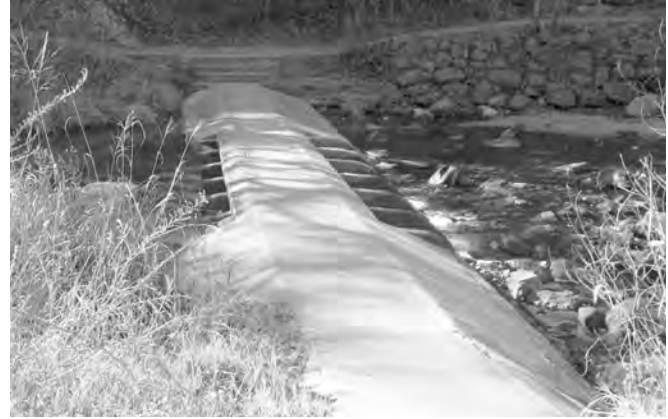
The Bromide Hill Trail (#1) is connected to the Bromide Springs area by the Bromide Pedestrian Causeway (Figure 6-26) located at the base of Bromide Hill. This three-foot-wide crossing is concrete and is accessed via a set of stone masonry steps leading from the parking area near the RV dumping station. The steps are non-historic. Though the causeway appears to be in good condition, erosion is beginning to undermine the stone steps and carve a diagonal channel down the adjacent bank.

Figure 6-26. Causeway leading to Bromide Trail, 2002.

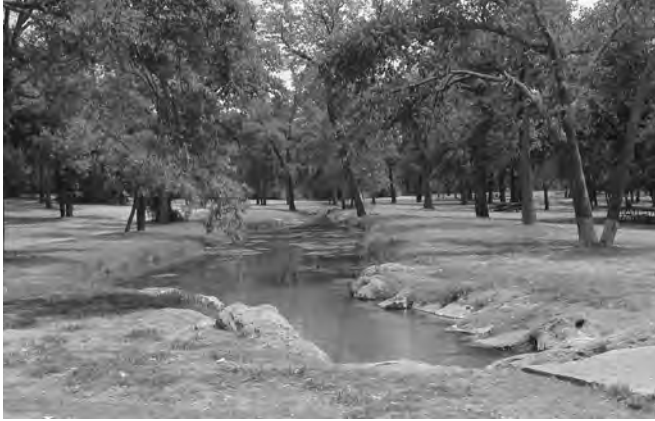
Figure 6-40. Upper pool and stream in Flower Park, 2001. Note rafts of algae present during summer months.

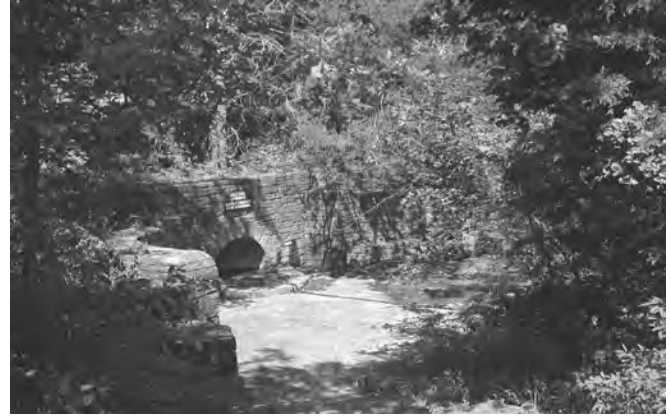
Figure 6-51. Vegetation encroaching Hillside Springs, 2001.

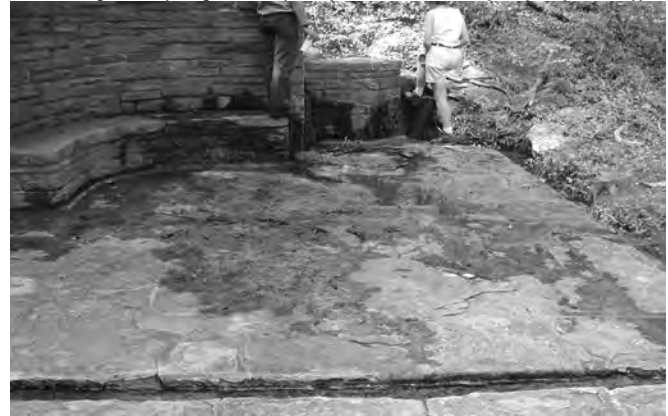
Figure 6-53. Runnel and seepage at Hillside Springs terrace, 2002.
