AVE Electronics Design Note No. 411-195B-104
EMC Group

Date: 16 February 1968

ELECTROMAGNETIC COMPATIBILITY REVIEW
OF THE
NASA GEMINI PROJECT

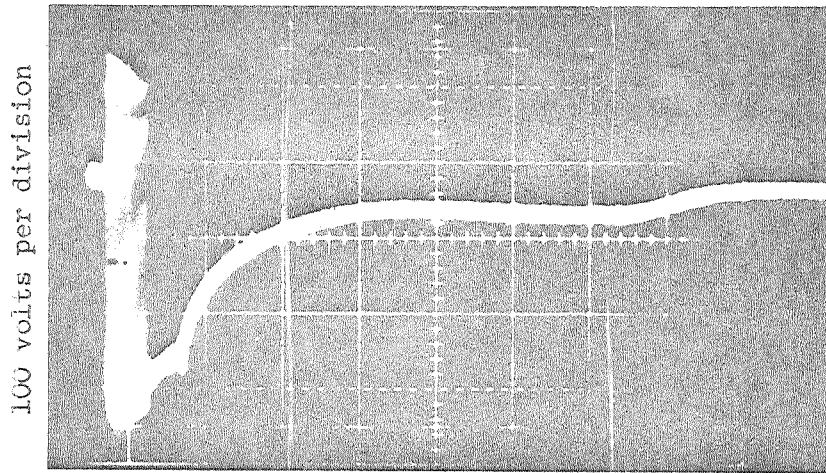
UNSUPPRESSED TRANSIENT (500V)

3.2.9.1 Investigation - It was found that the coolant-valve solenoids generated transients, 300 to 500 volts in amplitude and of short (millisecond) duration, whenever the valves were actuated.

3.2.9.2 Corrective Action - The problem was solved by adding suppression devices to the solenoids. It should be noted that the coolant system was not alone in its ability to initiate a reset of the multiplexer. Some of the other spacecraft switching functions that have been known to cause multiplexer resets during the NASA Gemini program are:

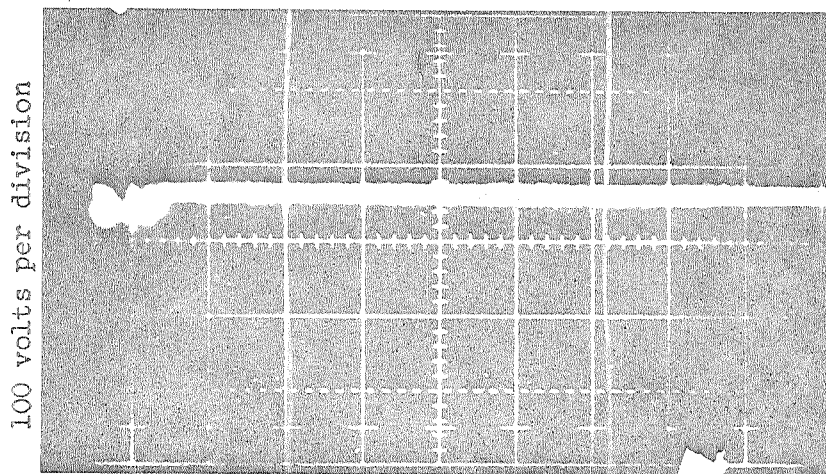
DIODE SUPPRESSED TRANSIENT (25V)

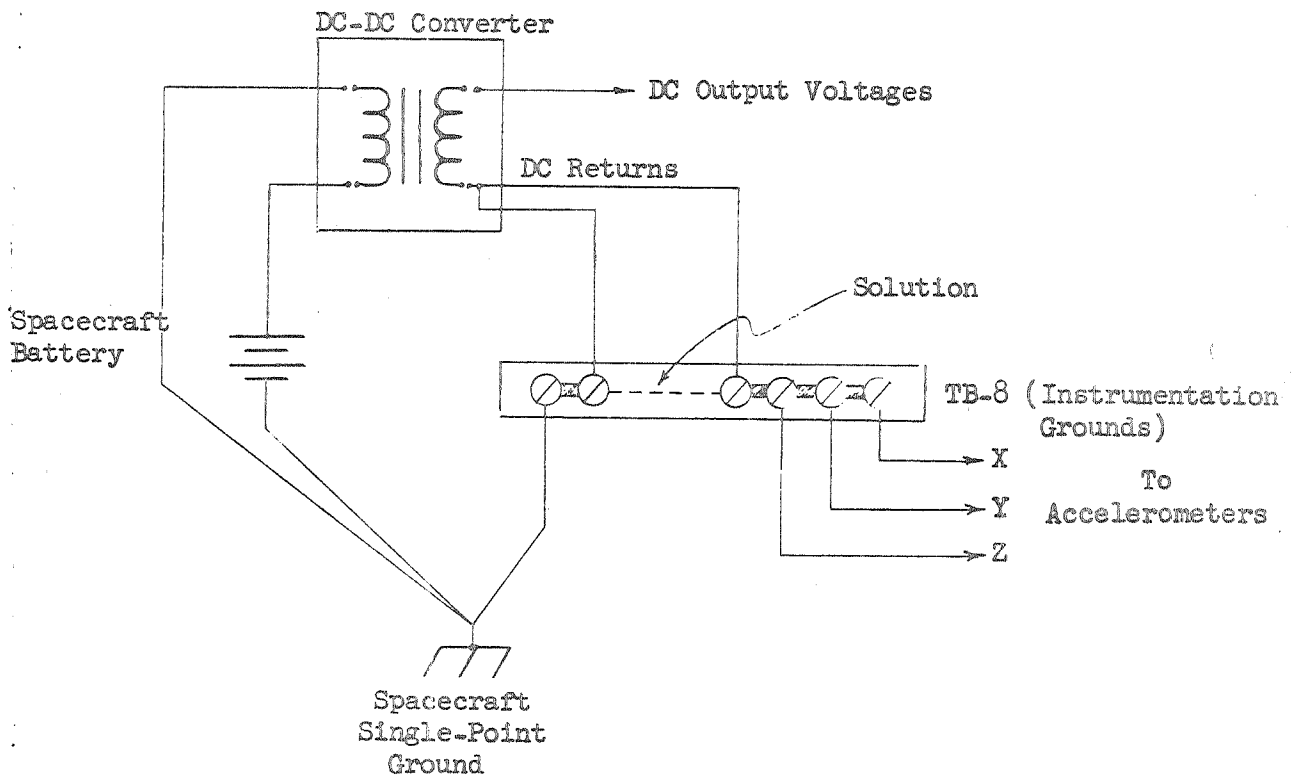
Figure 3-3. Accelerometer Grounding Configurations

3.2.11 Common Impedance Grounding System Caused Noisy Accelerometer Outputs - The ground test station telemetry readouts of the X, Y, and Z accelerometer outputs were unacceptably noisy. (Ref. S/C 6 DR#50 vs J435-6, Cape.)

3.2.11.3 Gemini B Status - A separate ground path for the accelerometer returns will be provided on the Gemini F.
