# Five-Year Review Report

First Five-Year Review Report  
For  
Riverbank Army Ammunition Plant  
City of Riverbank  
Stanislaus County, California

February 2001

PREPARED BY:  
Department of the Army  
Riverbank Army Ammunition Plant

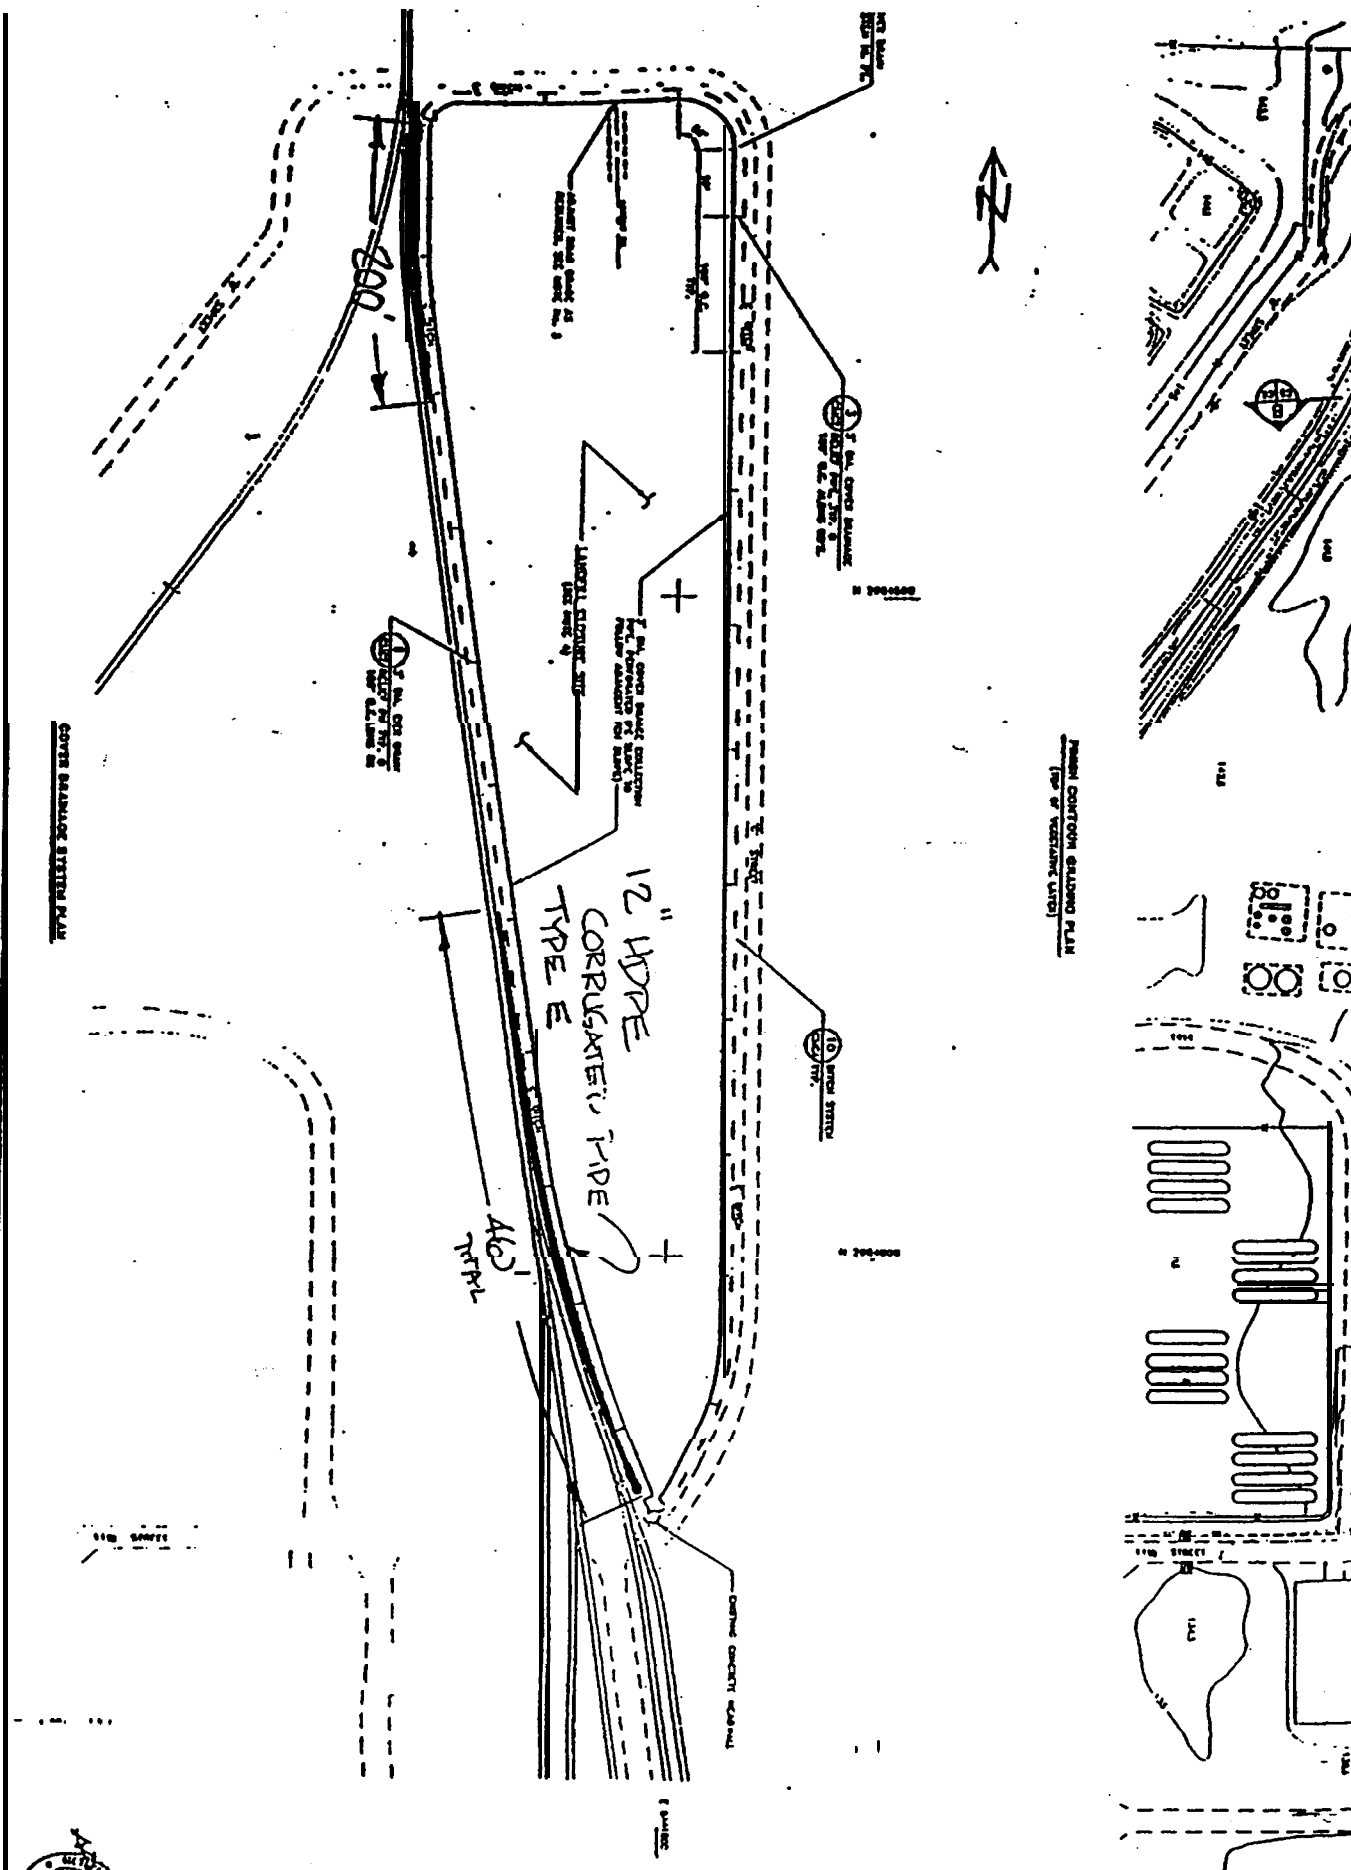
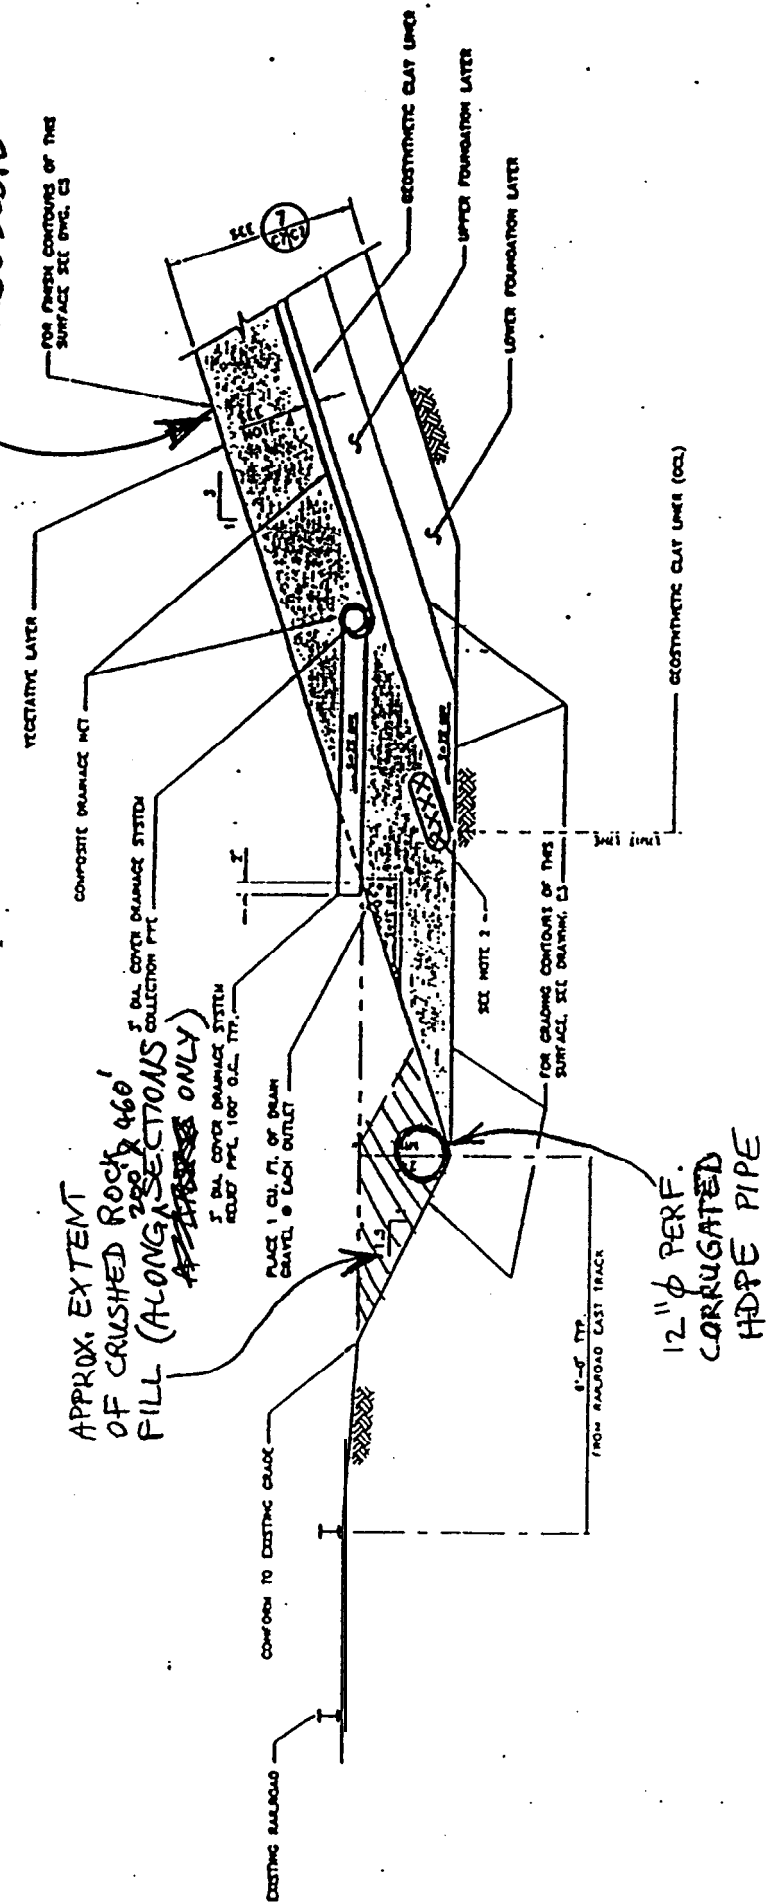
FIGURE 1  
 SITE MAP OF DRAINAGE MDD.  
 RIVERBANK LANDFILL

- The current **subgrade** condition in the scraped-off areas consists of loose silty and sandy soil with **organics** (scraped-off grass).
- The cover drainage system relief pipes, which daylight near the toe of the western **3:1** slope at approximately every 100 feet, were crushed, apparently in the process of pushing the crushed rock in place. While most of the relief pipes were visible during our site visit, approximately five pipes could not be located (one at the northern end and four near the southern end of the western side slope). These outlet pipes could not be readily located because of loose soil conditions along the toe of slope.
- The geosynthetic clay liner (GCL) and composite drainage net (CDN) did not appear to be impacted.

The approximate extent of vegetative cover damage is shown on Figure 1. The approximate extent of damage shown on this figure is not to scale, and field survey measurements should be performed to determine the exact aerial extent of vegetative cover damage. A typical section showing the perforated drainage pipe with approximate extent of additional crushed rock placed along portions of the toe of the western slope is shown on Figure 2. As indicated on this figure, the additional ballast material and drainage pipe result in a modification to the western landfill perimeter drainage system.

- Remove all remaining crushed rock, loose soil, and organic debris from the landfill cap surface.
- In areas where significant soft soil is present, carefully remove all soft soil and confirm that the CDN and/or GCL was not damaged.
- Re-compact additional soil as needed to fill in areas where soft soil has been removed.
- Repair all 3-inch-diameter subdrainage system relief pipes by replacing the crushed sections (i.e., removing crushed portions and splicing on new sections) and installing new rodent screens. Re-compact soil as needed around all repaired outlet pipes to restore the western slope to its original **3:1** grade.
- Replace gravel drain at each outlet (see Figure 2).
- Scarify and re-hydroseed all cap surface areas where vegetative cover has been removed and/or significantly damaged.
- Irrigate newly hydroseeded areas until a satisfactory stand of grass has taken root.

- Locate all drainage outlet pipes along the western side slope, including the five relief pipes that could not be readily located during our site visit.
- Provide adequate construction oversight to ensure that all repair work is adequately performed and that repair activities are appropriately recorded.
- Place additional crushed rock and/or an erosion mat upstream from the new **12-inch** perforated HDPE pipe and between the two perforated HDPE pipe sections, to reduce the potential for ditch erosion and excessive siltation of the pipe.

The above repair work should be performed immediately to provide adequate erosion protection to the landfill cap prior to the rainy season. As an interim emergency measure, hay bales could be used to prevent erosion damage to the landfill cover.

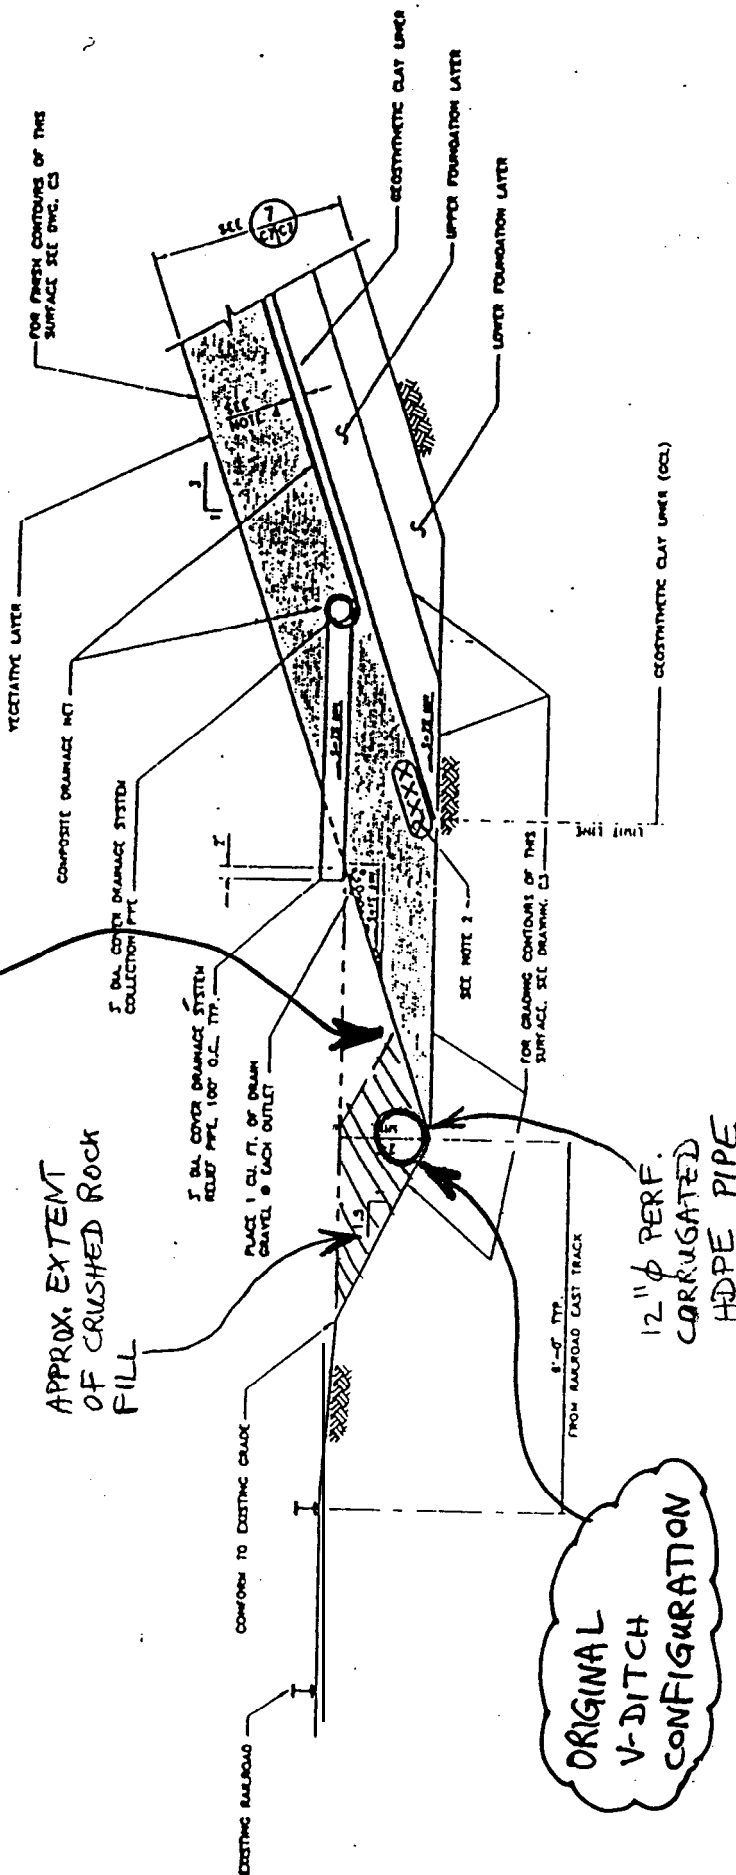
DET. OF DRAIN AND V-DITCH ADJACENT TO RAILROAD

If the pipe segments are left in place (Option 1 above), long-term maintenance issues will need to be addressed as part of the landfill's post-closure maintenance requirements. Silt is likely to accumulate not only inside the pipes and within the crushed rock around the pipes, but also at the inlet of each pipe segment. Periodic silt removal near the pipe inlets and clean-out of the pipe interiors using high-pressure flows will therefore be required. Long-term clogging of the crushed rock will result in flows being conveyed along the "newly created" **V-ditch** along the pipe segments.

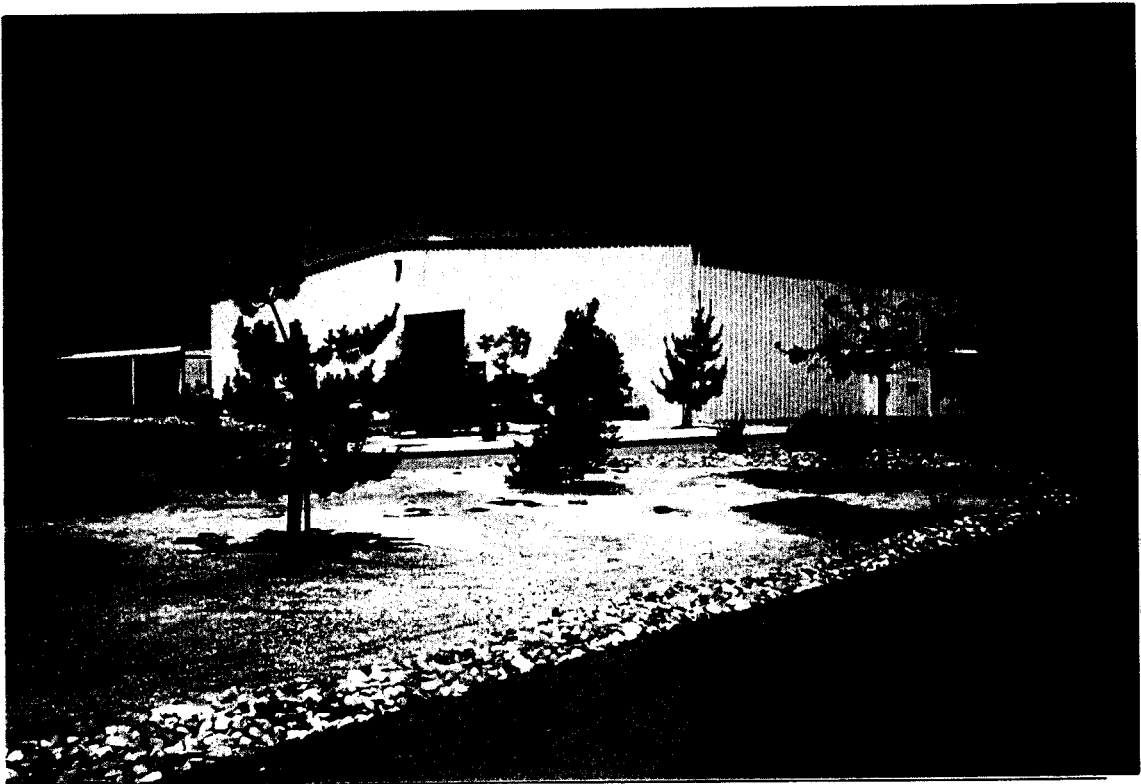
The groundwater treatment plant (consisting of the GWTS and the IGWTS) was found to be operating and functioning properly. No operational problems were observed. The current operating mode, which uses ion exchange only, results in very straightforward operation procedures. The primary operator activity is to regenerate the resin in the ion exchange columns when it is spent. Currently, each ion exchange column is regenerated approximately every two weeks. The as-built drawings and O&M manual have not yet

**Photo 1: Groundwater Treatment Plant Building**

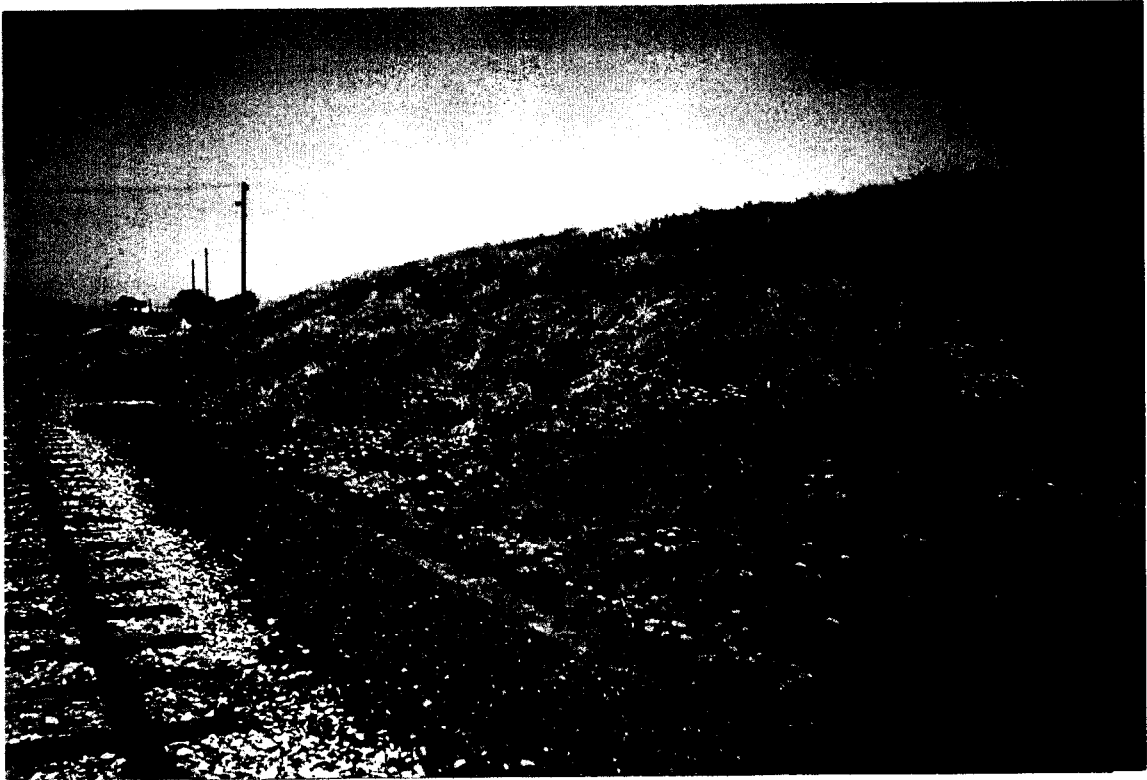
NI Industries, Inc. quarterly landfill maintenance reports have not noted any substantial issues with ponding, cracking or other landfill cap problems. There are no remaining indications of the landfill cover damage caused in 1997 by a contractor doing work on the adjoining railroad tracks (Attachment 2 includes technical memoranda documenting the damage and recommended repairs). Minor erosion was observed along some of the landfill side slopes.

**Photo 7: Western Landfill Slope and Adjacent Railroad Tracks**

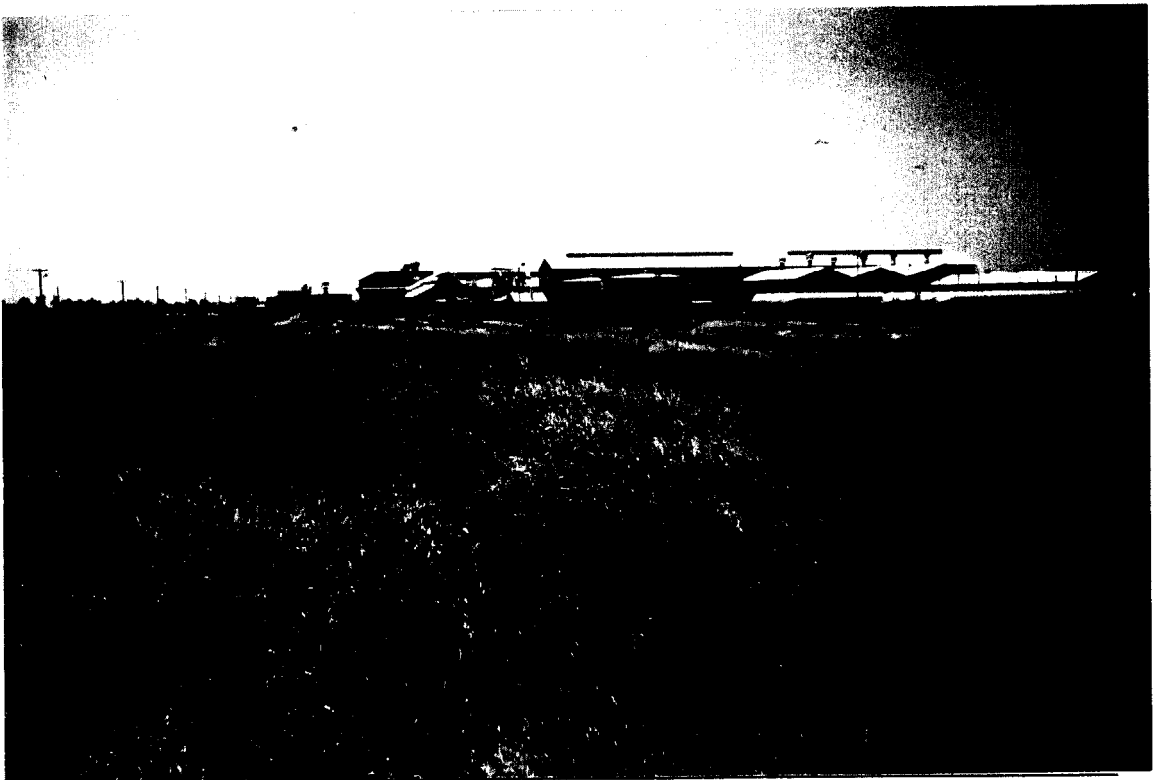
The vegetation on the landfill had not been mowed recently making it somewhat difficult to observe the condition of the landfill cap. The landfill cap appeared to be in good condition. The vegetative cover was generally thorough with no distressed areas. A star thistle weed has invaded the cover. NI Industries, Inc. is trying to mitigate this problem with the application of herbicide. The most recent application occurred in March 2000 additional applications are planned each spring as necessary.

No landfill cap damage was observed. There was evidence of small rodent burrows across much of the cap. NI Industries, Inc. has initiated a squirrel abatement program at RBAAP to address the problem. In Spring 2000, a basewide application of fumigant (aluminum phosphide) was performed in all burrows, including those at the landfill. The fumigant

**Photo 8: Landfill Top Deck- Looking South**
