U.S. Fire Administration/Technical Report Series

\$12 Million Dollar Fire at Dogwood Elementary School

Reston, Virginia

USFA-TR-135/November 2000

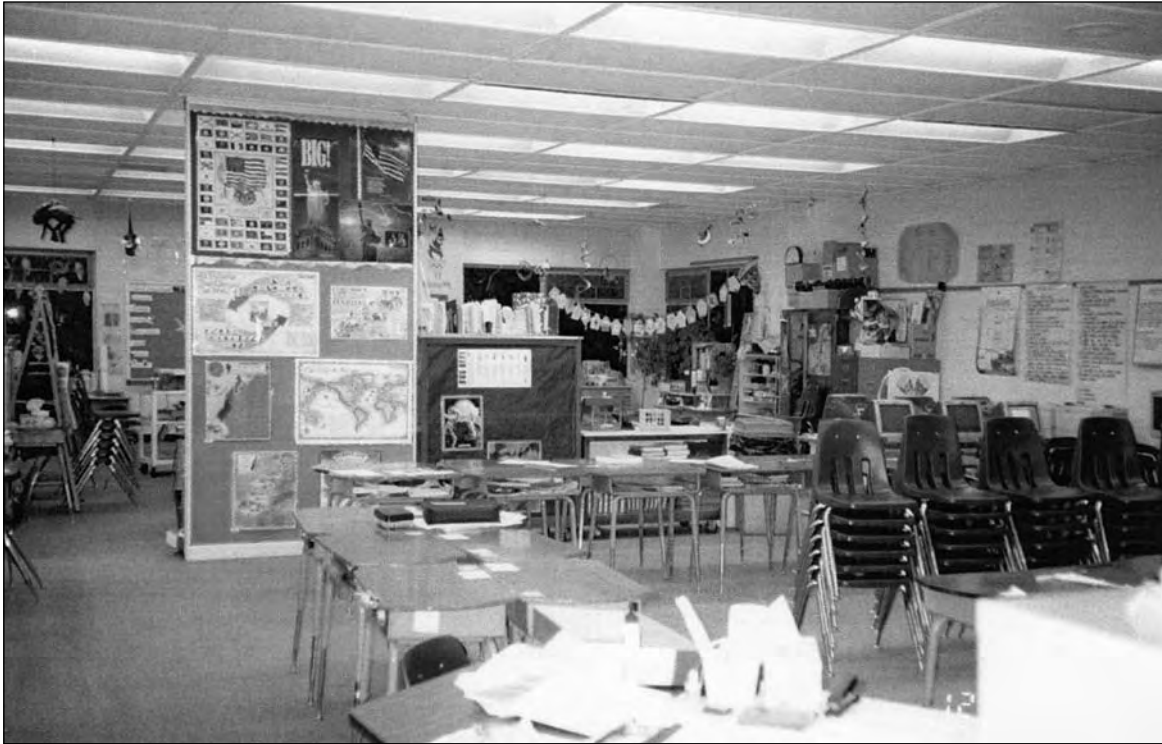
The interior of Dogwood Elementary School was arranged in an “open classroom” design: basically a warehouse with a demountable (extruded aluminum frame) partition system for internal “walls” (Appendix C, Figures 1 and 2). Thirteen other schools in the county were constructed during the 1970’s with the same design. The USFA team observed one of the schools nearby and noted that typically six to eight “classrooms” could be viewed from each hallway “wall” opening (Appendix C, Figures 3 and 4). Boundaries between classrooms consisted mostly of four-foot high bookcases, shelving, and counters and/or “soft” partitions. Boundaries between groups of classrooms were created by using demountable partitions. Additionally, the team observed that fluorescent light diffusers were stored in the plenum above the plenum access ladder at the school they visited.

Figure 1. View of three classrooms characteristic of the “open classroom forum” design.

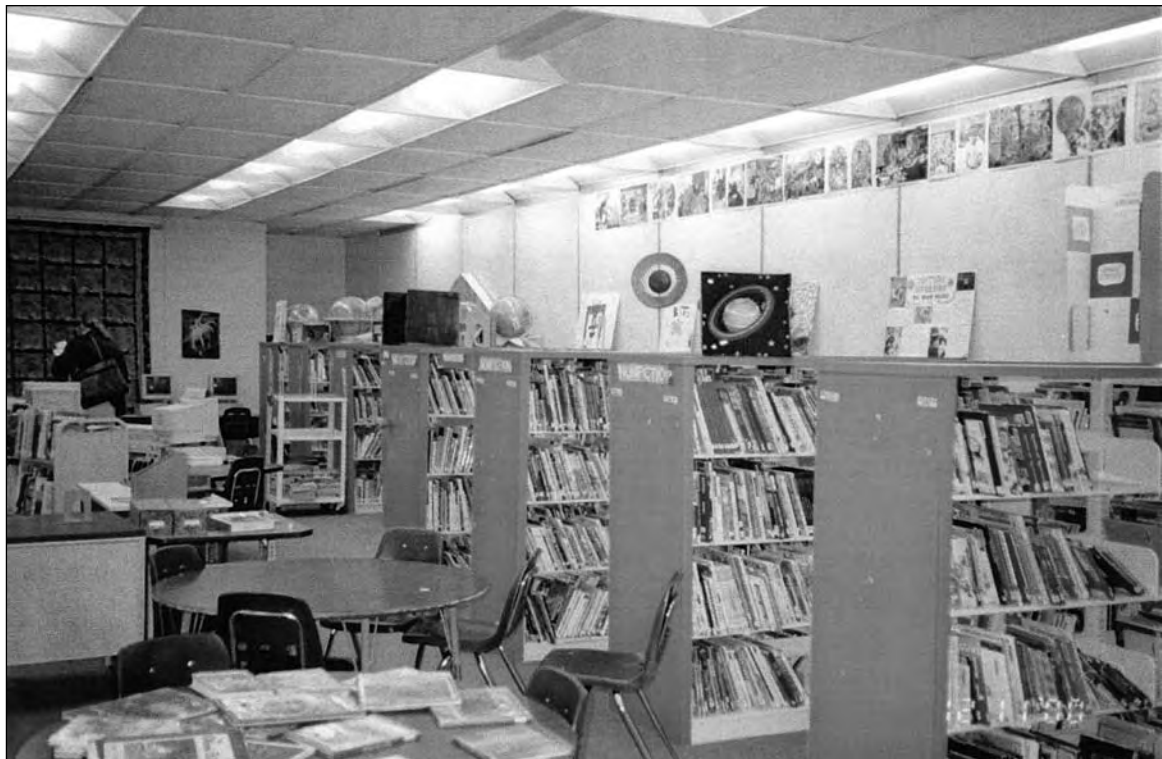
Figure 2. Library area of similar school

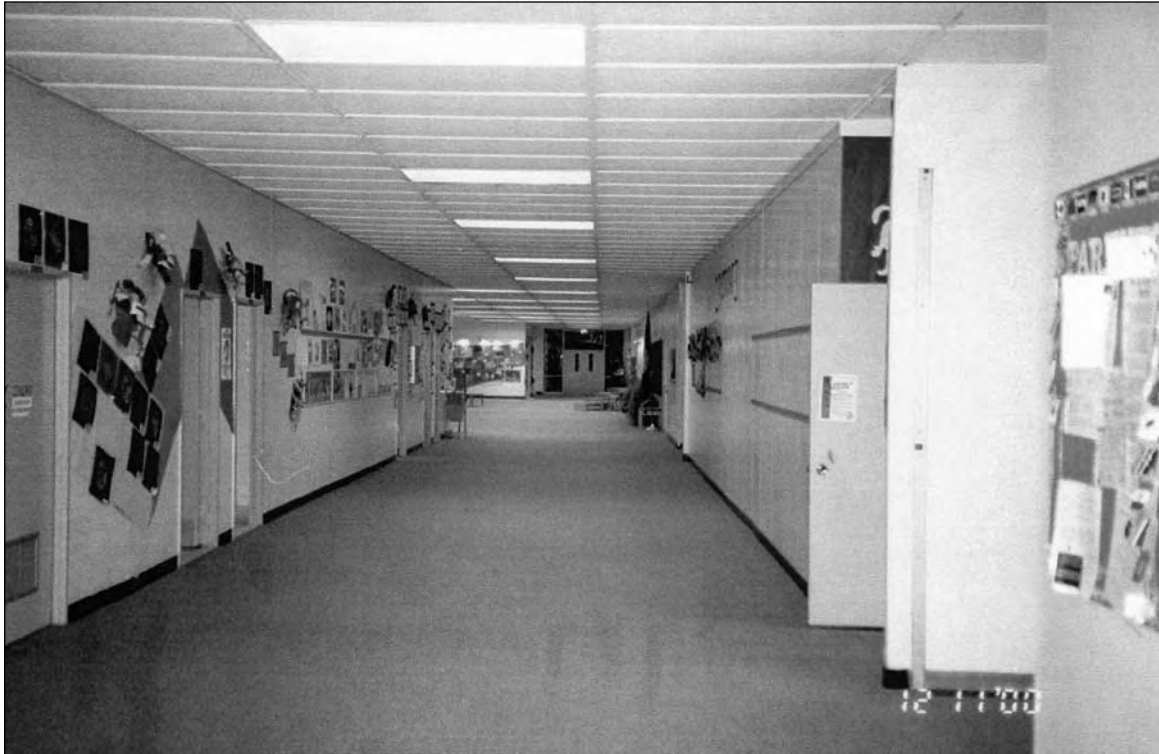
Figure 3. View along hallway of local school similar “open classroom forum” design. Note use of “demountable” partitions for room and hall definition.

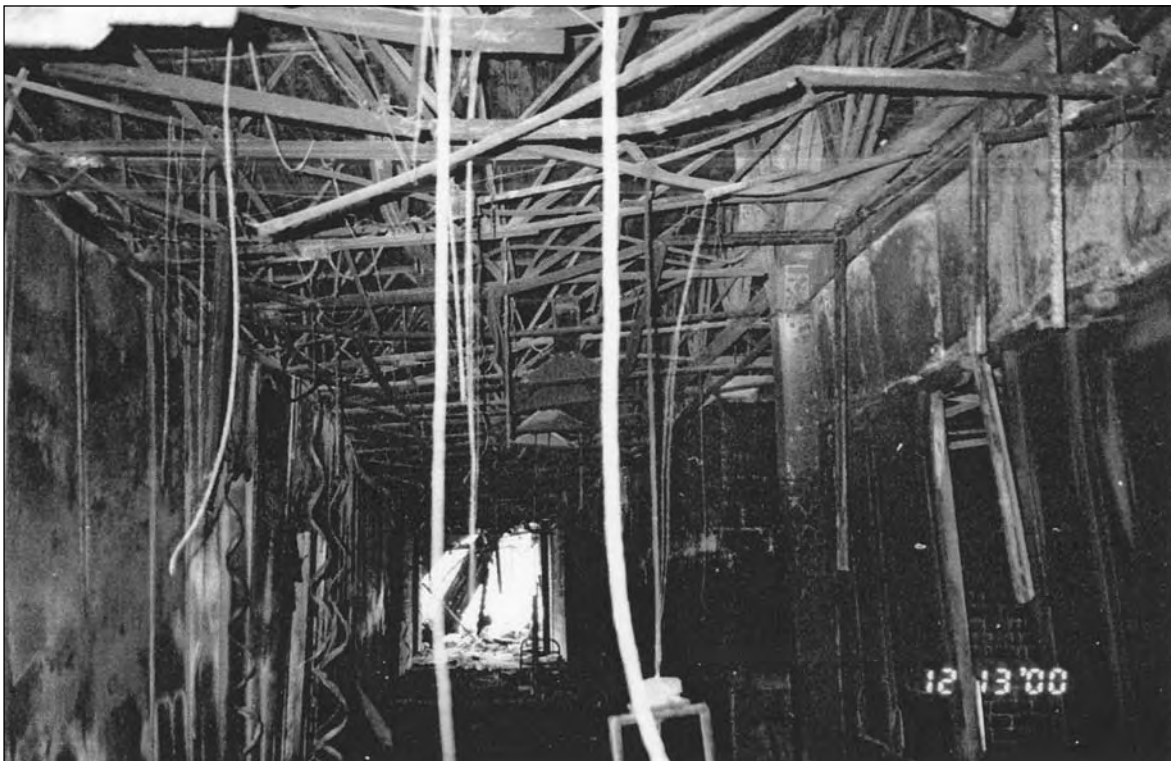
In the plenum space were the load bearing girders, bar joists, HVAC ducts (both sheet and flex), roof drainpipe (heavy gauge steel), copper plumbing feeds, and electrical wiring. No PVC tubing was observed or detected during the post-event examinations, and an interview with the school construction inspector revealed that none existed in the plenum space at the time of the fire.

Figure 4. Similar hallway in non-collapsed portion of Dogwood Elementary School after fire. Collapse of ceiling tiles has exposed bar joists (spanning hallway) and girders in plenum area.

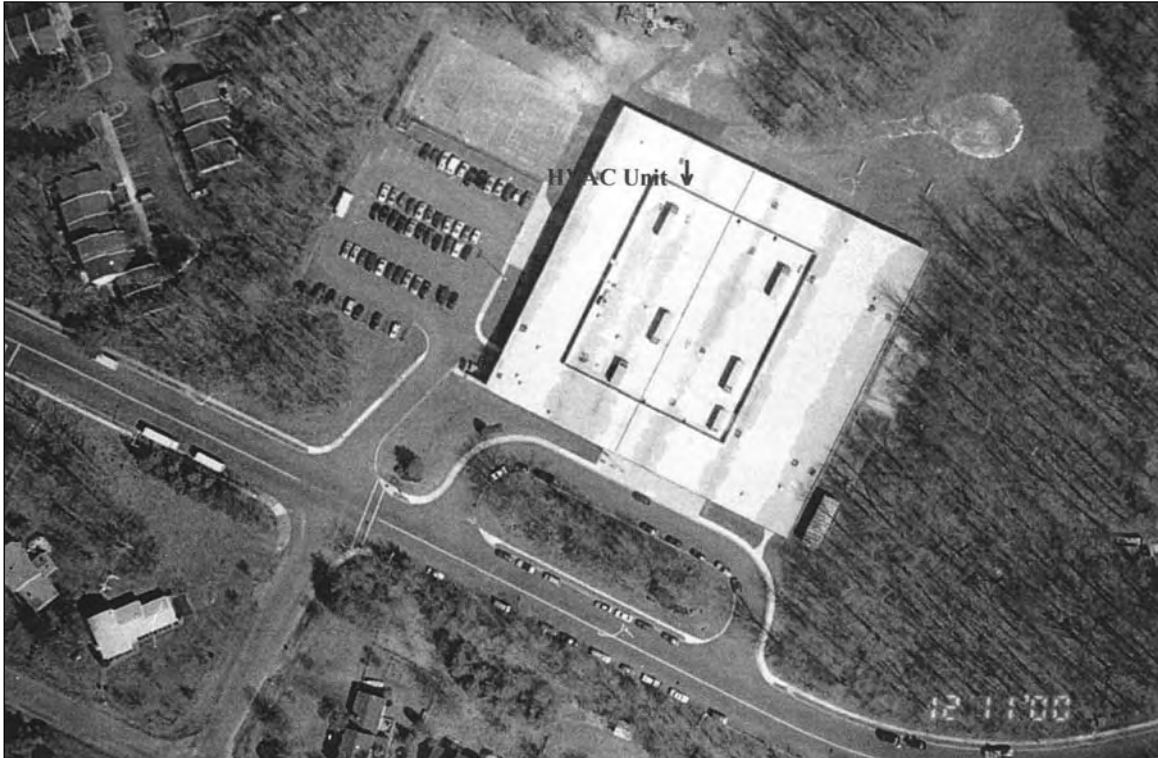
Load-bearing columns were positioned 30 feet apart in the approximate north-south directions of the school and were spanned by girders. The columns were spaced 60 feet apart in the perpendicular direction and were spanned by bar joists (Appendix C, Figure 4). The columns were comprised of 8-inch square tubular (welded) wrought steel of quarter-inch wall thickness, and girders of 3/8-inch wrought steel. Seven HVAC units were positioned on the building rooftop. The HVAC unit above and closest to the probable area or origin (indicated in Appendix C, Figure 5) and similar to five of the other six HVAC units on the roof, weighted 4-1/4 tons. An aerial view of the school, both before and after the fire, can be found in Appendix C, Figures 5 and 6. Appendix C, Figure 9, shows a post-fire view of the debris under the area of the HVAC unit indicated in Figure 5.

The rapidity of propagation, due primarily to almost unlimited fuel and ventilation availability, caused such extensive damage that Dogwood Elementary was declared a total loss, valued at \$12 million. The located of seven HVAC units on the roof, most weight 4 ¼ tons, combined with the overhead presence of other heavy gauge steel structure and drainpipe, significantly accelerated structural collapse.

Figure 5. Aerial view of Dogwood Elementary School before fire, with HVAC unit closest to fire origin indicated. HVAC unit, one of 7, weighed 4-1/4 tons.

Positioning seven HVAC units weighing nearly 4-1/4 tons each on the school’s roof dramatically accelerated structural collapse due to the inverse relationship of the structural steel yield stress to temperature. This phenomenon is known as creep, where a metal can yield at stresses much below its normal yield strength when subjected to elevated temperatures (above approximately 1000 degrees F) while under load.

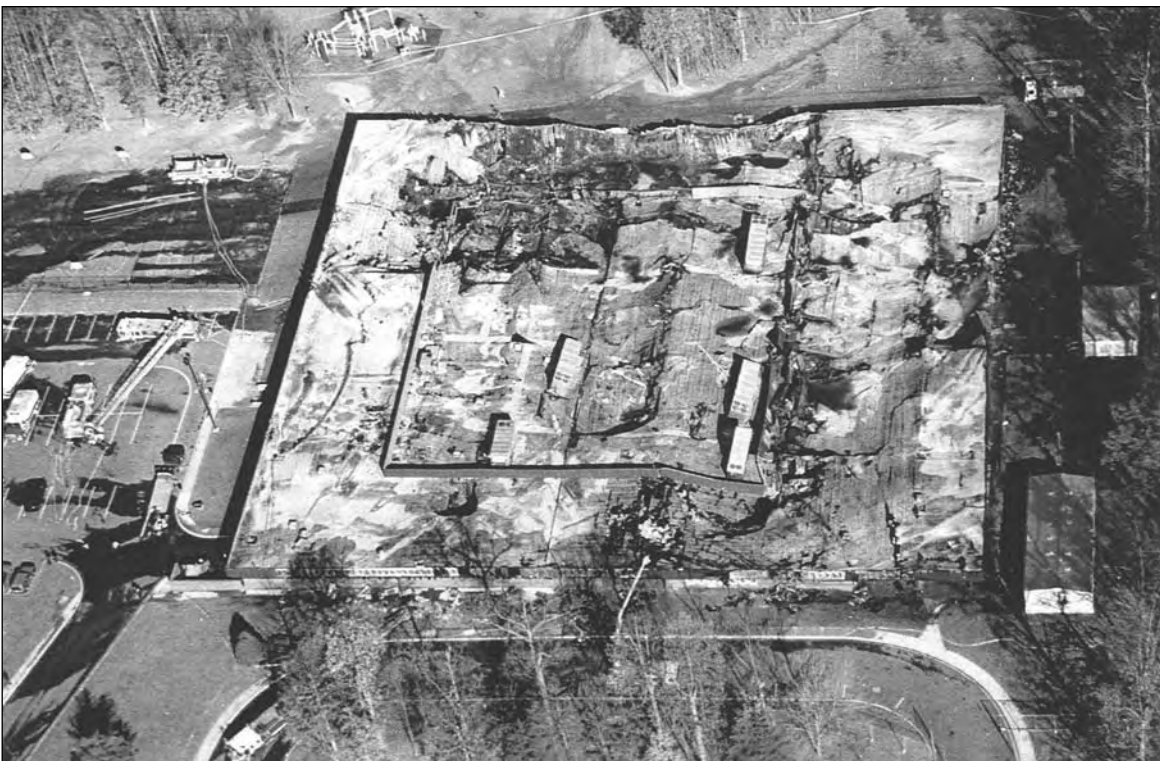
Figure 6. Aerial view of Dogwood Elementary School after the fire.

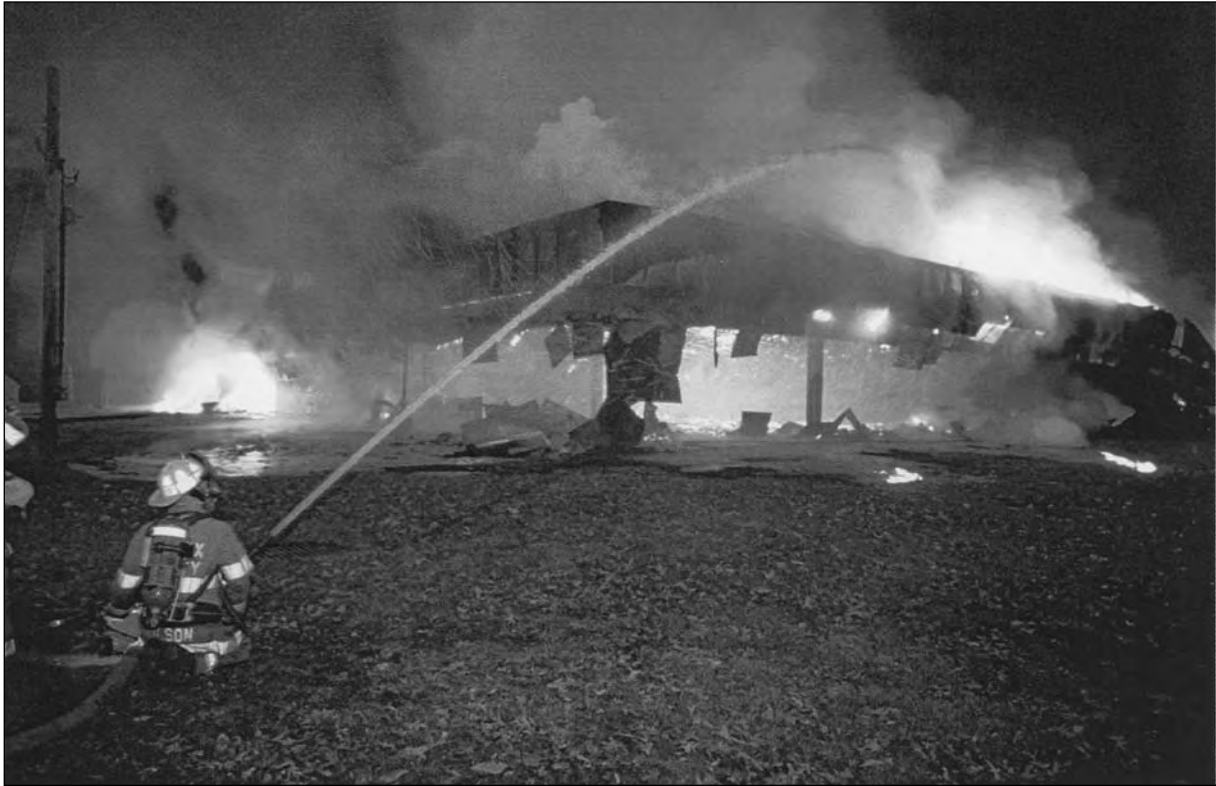
Figure 7. View of fire suppression operations

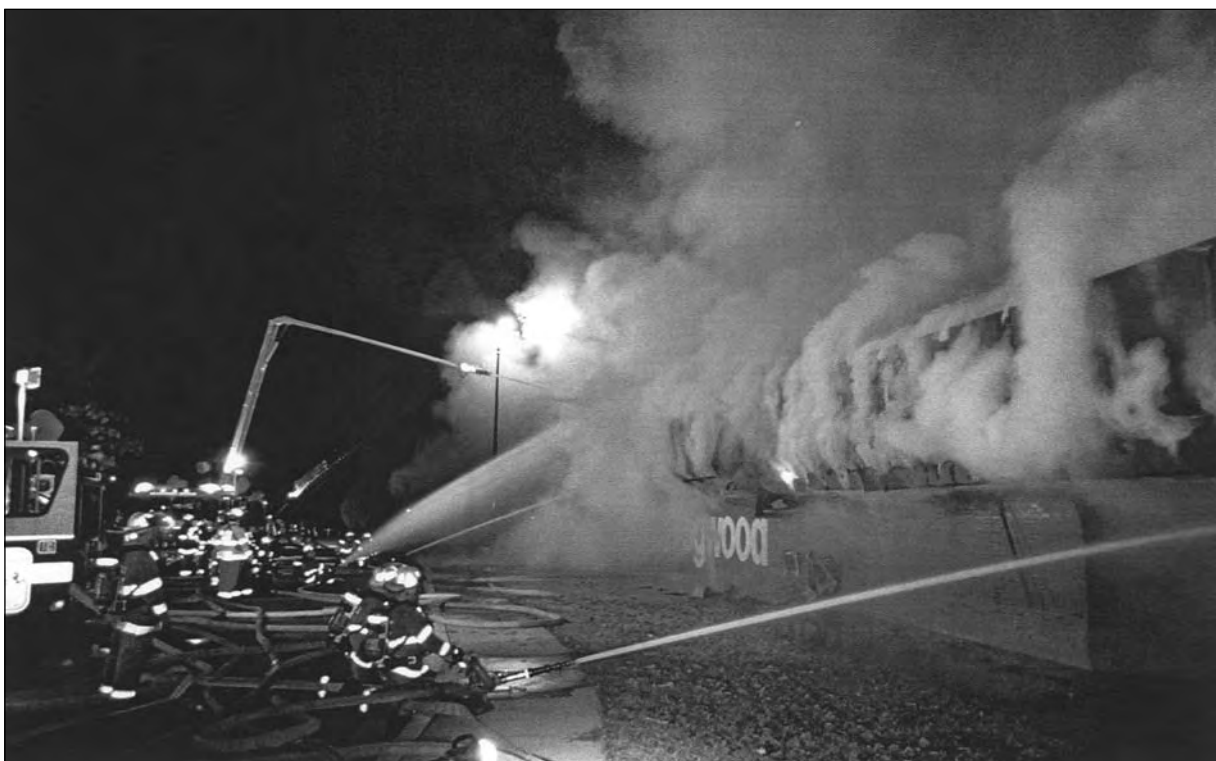
Figure 8. View of fire suppression operations, Side 1

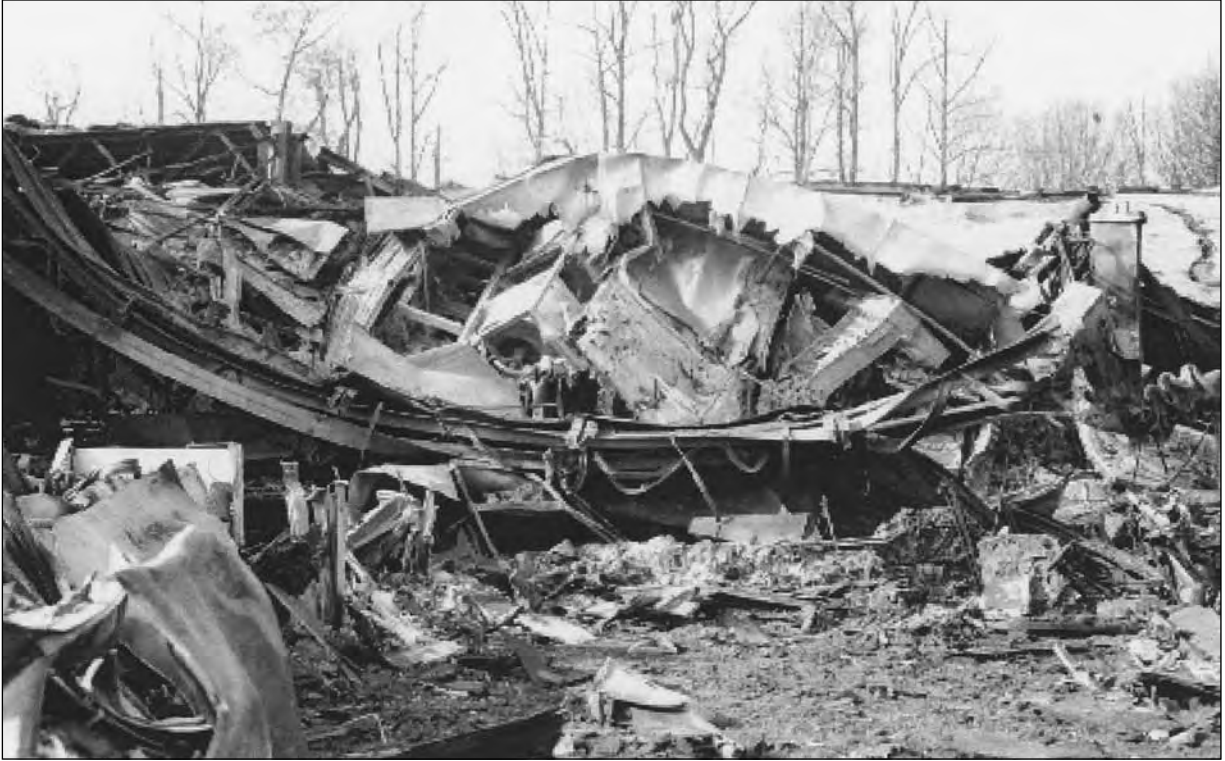
Figure 9. HVAC unit (arrow in Figure 5) after fire, viewed from northeast.

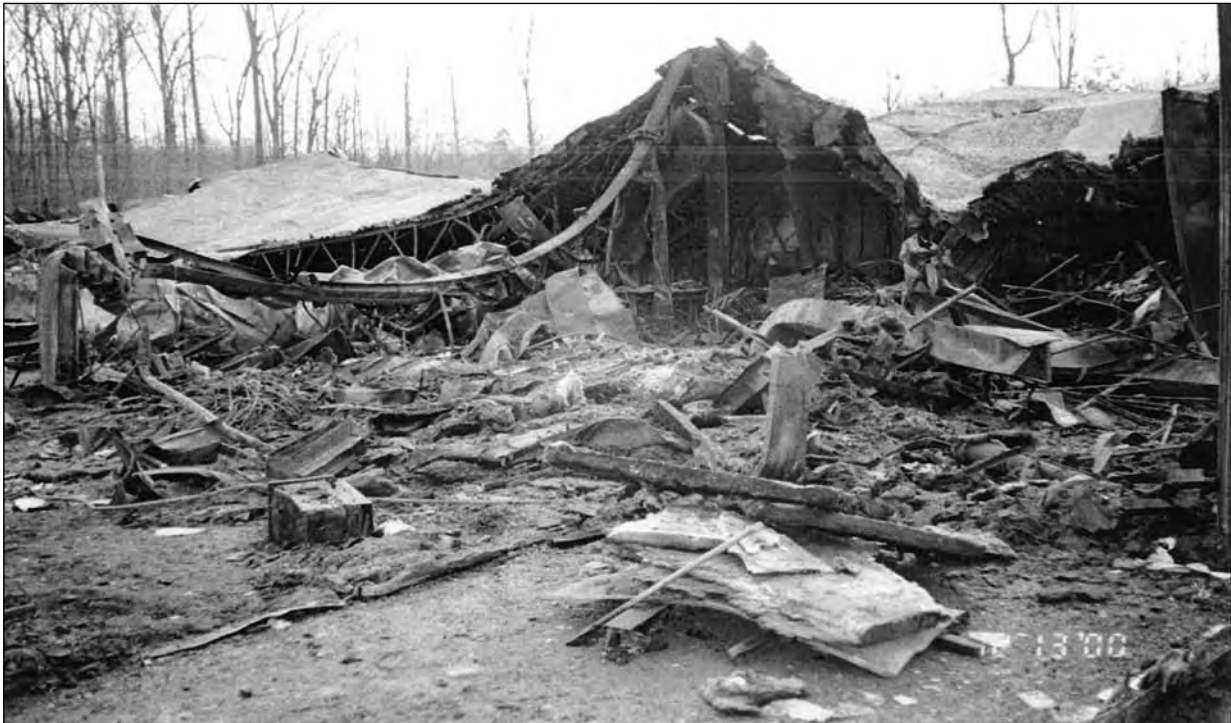
Figure 10. View of collapsed truss and accordioned support column (left side of picture).
