**FEDERAL AVIATION ADMINISTRATION
AIRWORTHINESS DIRECTIVES
LARGE AIRCRAFT**

BIWEEKLY 2008-04

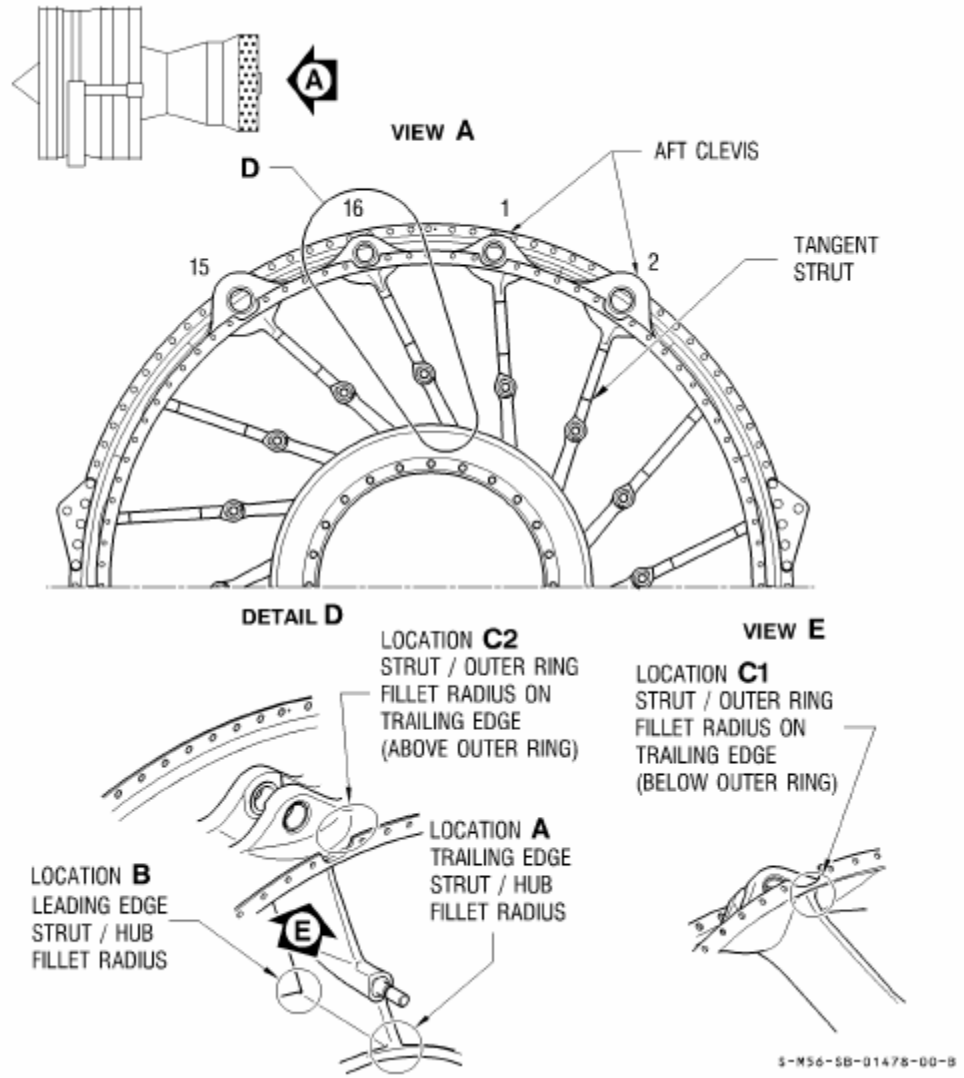
Figure 805
Turbine Rear Frame with Tangential Struts P/N 340-166-205-0,
340-166-206-0, 340-166-207-0, 340-166-208-0, 340-166-209-0, 340-166-210-0 – Areas to Be
Inspected

(d) This AD results from a refined lifing analysis by the engine manufacturer that shows the need to identify an initial threshold for inspecting certain TRFs. We are issuing this AD to prevent failure of the TRF from low-cycle fatigue cracks. Failure of the TRF could result in engine separation from the airplane, which could lead to loss of control of the airplane.

NOTE: * Applicable to all inspection locations.
If inspection is not performed, part must be removed.
