Official Accident Report Index Page

Report Number	NTSB-AAR-82-5
Access Number	PB82-910405
Report Title	Eastern Airlines Flight 935, Lockheed L-1011-385, N309EA, Near Colts Neck, New Jersey, September 22, 1981.
Report Date	June 1, 1982
Organization Name	National Transportation Safety Board Bureau of Accident Investigation Washington, D.C. 20594
WUN	3529
Sponsor Name	NATIONAL TRANSPORTATION SAFETY BOARD Washington, D. C. 20594
Report Type	Aircraft Accident Report September 22, 1981
Distribution Status	This document is available to the public through the National Technical Information Service, Springfield, Virginia 22161
Report Class	UNCLASSIFIED
Pg Class	UNCLASSIFIED
Pages	40
Keywords	Rolls-Royce RB-211 engine; inadequate lubricating oil supply; low pressure location bearing; oil leaks; coupling seal displacement; oil spray; fire; fan shaft overheat; fan shaft failure; fail-safe shaft failure.
Abstract	<p>About 1140 e.d.t. on September 22, 1981, the No. 2 engine, a Rolls-Royce RB-211-22B, failed as Eastern Airlines Flight 935, a Lockheed L-1011-385 (N309EA), was climbing through 10,000 feet after departing Newark International Airport, Newark, New Jersey, for San Juan, Puerto Rieo.

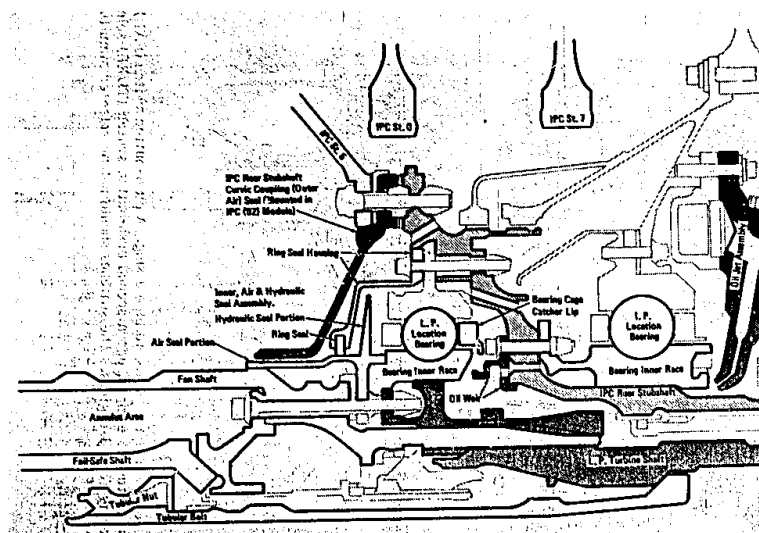
Figure 5. -- Installed Position of Components Associated with LPLB Failure.

The outer surface of the LPLB ring seal housing was heavily heat damaged and was dry. Heat produced by the rubbing had discolored the inner diameter of the ring seal housing. Heat discoloration was greatest at the housing's inner portion near the ring seal. The piston ring was seized in its seal locating groove. Evidence of oil leakage was observed between the abutment faces of the IPC rear stubshaft and the LPLB oil weir and between the abutment faces of the intermediate pressure location bearing (IPLB) inner race front flange and the IPC rear stubshaft.

The low-pressure location bearing had deteriorated from intermittent spalling of the bearing's outer race that encompassed 250° of its circumference. The area of apparent fatigue spalling was biased toward the rear side of the

The oil scavenge cavity located in the intermediate pressure compressor rear stubshaft contained a mixture of metal and oil sludge in the scalloped area of the cavity, although none of the oil scavenge holes was clogged. The mating abutment faces of the rear stubshaft of the IPC and the inner race front locating flange of the intermediate pressure location bearing exhibited paths of leaking oil and embedded fine metallic particles which had formed scoring paths.

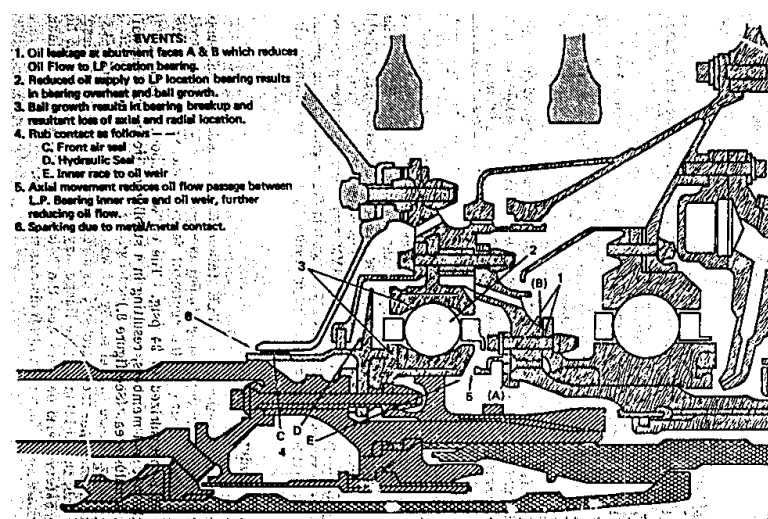
Figure 7. -- Initial Failure Sequence.

The initiating event in the LPLB failure was an inadequate oil supply to the bearing because of oil leaks between abutment faces of the IPC rear stubshaft and the LPLB oil weir and leaks between the abutment faces of the LPLB inner race locating flange and the IPC rear stubshaft. Each of these interfaces had evidence of oil leakage path stains and foreign debris entrapment. (See figure 7.) The LPLB oil supply system does not provide a positive oil feed to the bearing, but rather a "slinger" type is used to lubricate the bearing. Since the oil supply jet was not positive and since leaks occurred across the flanged abutment faces, probably as a result of poor mating of these surfaces following overhaul, the LPLB inner race flange may have become distorted at high power settings. The Safety Board believes that the "slinger" oil supply and oil leaks at the abutment faces are major factors in LPLB distress situations.

The inadequate supply of oil allowed the LPLB assembly to overheat and provided a temperature high enough to induce bearing outer race fatigue spalling, which in turn would have induced ball tightening and rubbing in the bearing cage pockets. The bearing cage and the bearing inner race lands also would have rubbed together, causing the cage to expand. These factors, in addition to high centrifugal force loadings, would allow the balls to grind and skid. The condition of the bearing's inner race and balls indicated that the balls were skidding and grinding into the bearing's inner race track in both the fore and aft directions, as shown by the contour match of the balls relative to the bearing's inner race track.

The predominant wear and damage pattern occurred at the front of the bearing's inner race. This failure pattern indicated that gross ball sliding took place when the engine was operating at a relative low power setting.⁵

Examination revealed that the inner rear face of the LPLB inner race and the forward lip of the oil weir had come into contact; the contact was caused by rearward axial movement of the inner race. These contact marks indicated that the LP system was rotating when the LPLB was displaced rearward. This would have further reduced oil flow between the LPLB bearing's inner race and the oil weir and thereby reduced oil flow to the LPLB itself.

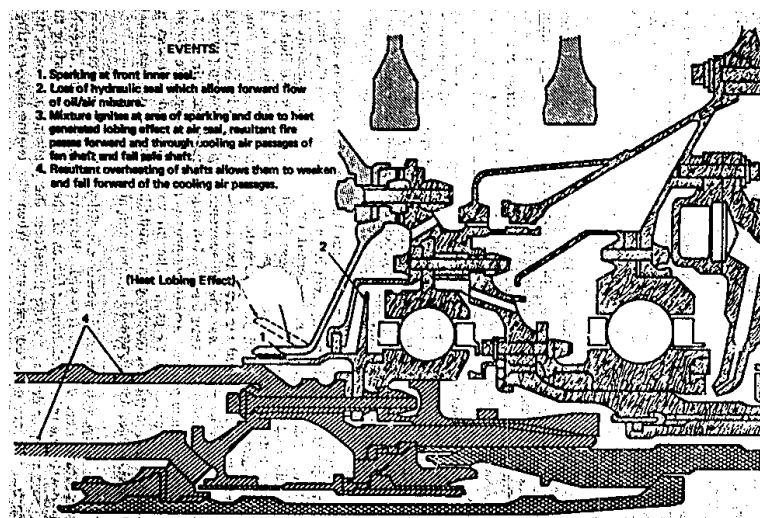
Figure 8. -- Engine Fire Sequence.

The ring (piston) seal housing and the ring (piston) seal which is adjacent to the hydraulic seal fin were also rubbed heavily. Oil level-type marks present on the rear face of the ring seal housing arm suggest that different levels of oil were present in the ring seal housing/hydraulic seal cavity. The differences in oil levels indicated that the normal capillary-type seal between the hydraulic seal and the ring seal housing had been compromised, thus allowing LPLB oil to eject into the fan shaft area. The oil that escaped was mixed with pressurized air from two sources and was injected into the fan shaft annulus area. The first source was the oil scavenge cavity, located between the LP and IP location

bearings, which is pressurized by 7th stage compressor air to 39 psig with the engine operating at climb power. Additional pressurized air is provided from the IPT pressure seal; it is pressurized to 24 psig. The oil was vaporized and was ignited by contact with the hot seal members, resulting in a stabilized fire in the fan shaft and the fail-safe shaft annulus area. (See figure 8.)

The stabilized fire degraded the material properties of the retained section of the fan shaft and caused the shaft to fail in a torsional and shearing mode. The degradation of material properties was evident by the discoloration patterns on the fan shaft fracture surface which indicated that the area adjacent to the fail-safe shaft fracture also reached a temperature probably in excess of 900° C. The recovered section of the fail-safe shaft exhibited rapid tensile/torsional overload fractures which also occurred as a result of exposure to these high temperatures.
