**EMPO-561**  
**Rev. 0**

**Oak Ridge Reservation**  
**Public Warning Siren System**  
**Annual Test Report**

October 2000

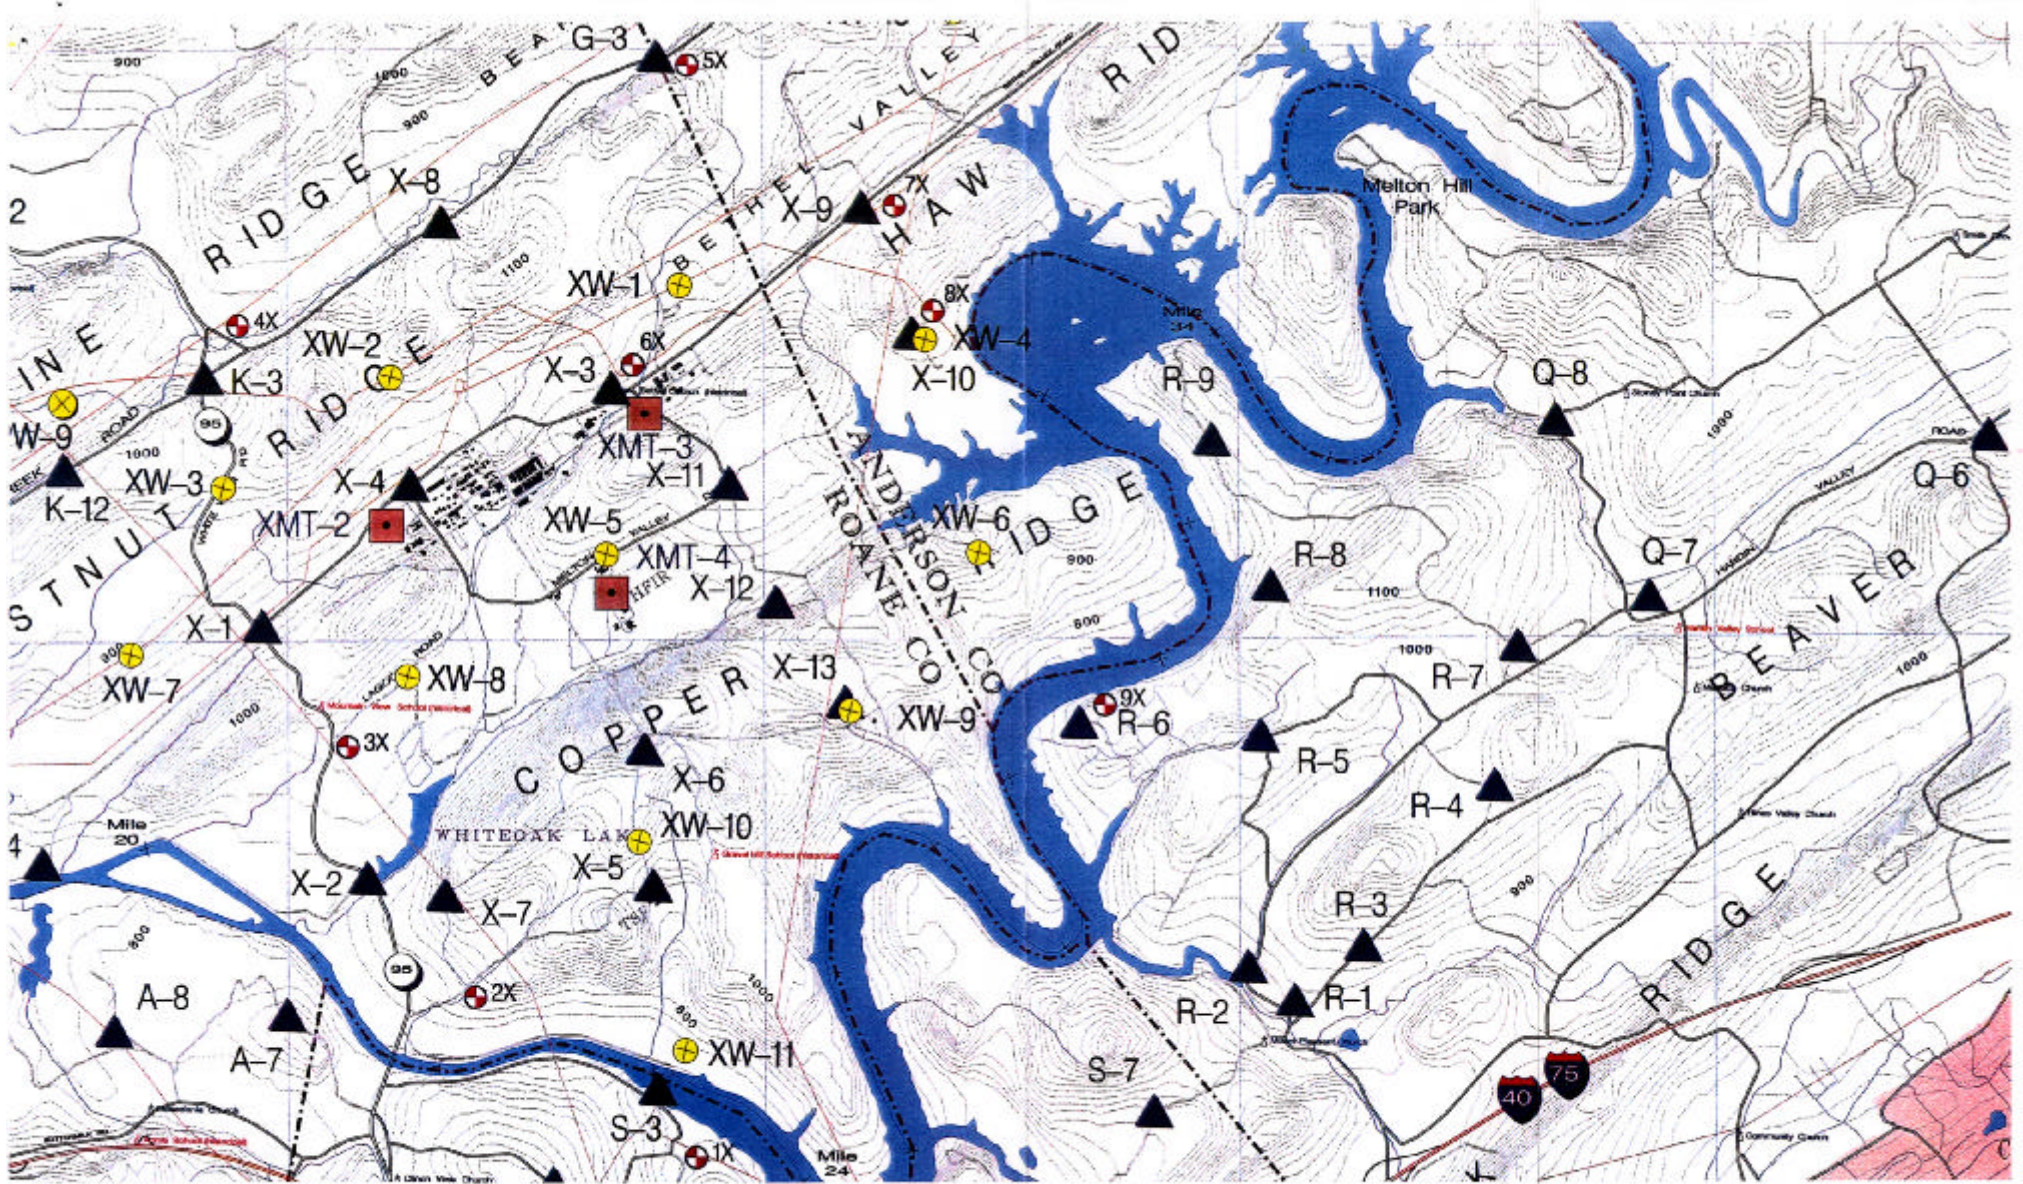
Fig. 3. ORNL measurement locations.

Measurement location 2X exhibited low sound level, however, the individual performing measurements at this location reported that the sirens were clearly audible. This is supported by the fact that the sound levels measured while the sirens were activated were approximately 2 - 5 dB above the background sound level measurements. This location was chosen due to the fact that it corresponds to a gap in the calculated 60 dB coverage area for the ORNL siren group as indicated on drawing E2E900031A004. The measurements support the calculated coverage gap. This measurement point will be moved to a different location for next year's test.

Measurement location 5X is located across Chestnut Ridge from any of the ORNL sirens. This location is also outside the calculated 60 dB coverage area for the ORNL siren group. This measurement point will be moved to a point near the construction site for the Spallation Neutron Source for next year's test.

Measurement location 7X was located in an area with heavy vehicle traffic (Bethel Valley Rd.). The individual performing measurements at this location reported that the sirens could be heard, but not very well above the traffic noise. This point is located at the edge of the ORNL INZ.
