[Docket No. FAA-2008-0101; Directorate Identifier 2007-SW-76-AD; Amendment 39-15357; AD 2007-26-51]

Airworthiness Directives; Eurocopter Deutschland GmbH Model EC135 Helicopters

2007-26-51 Eurocopter Deutschland GmbH: Amendment 39-15357. Docket No. FAA-2008-0101; Directorate Identifier 2007-SW-76-AD.

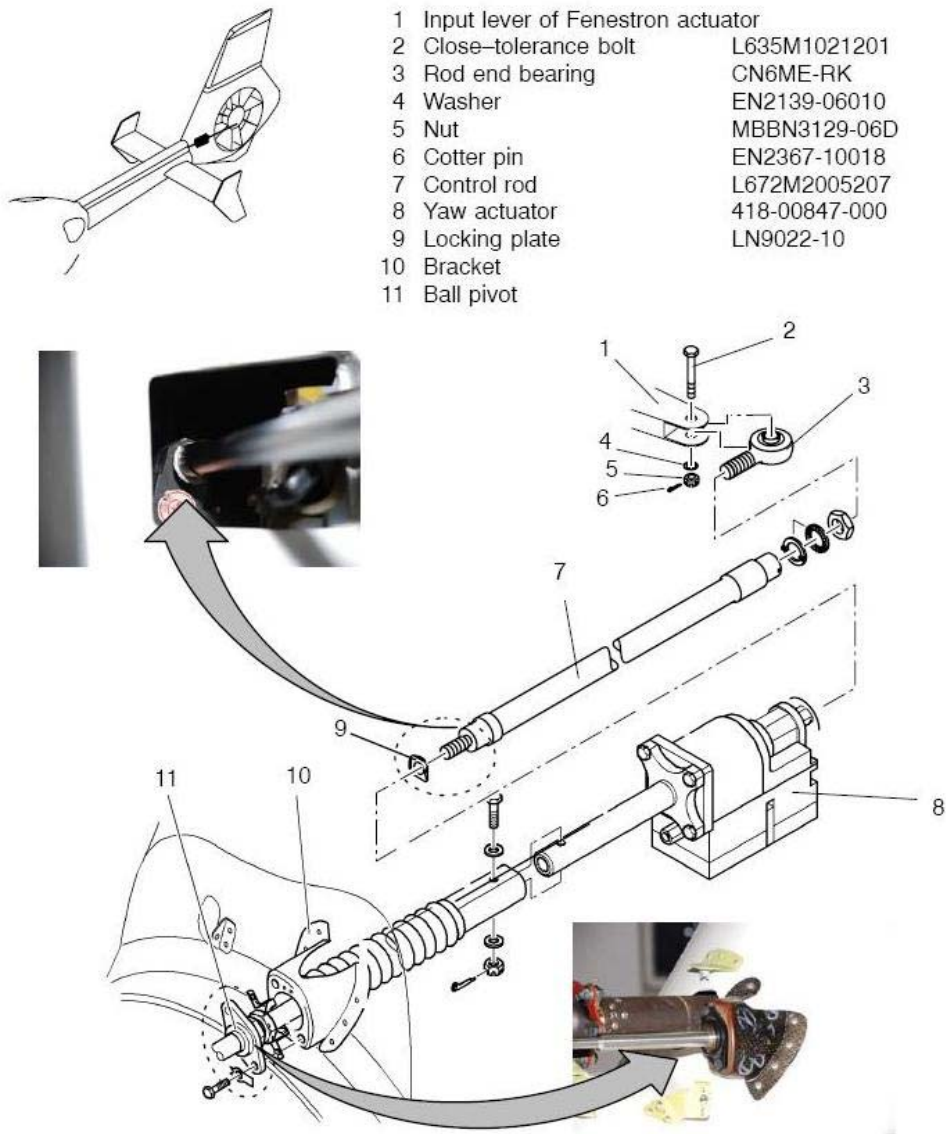
Ball Pivot and Control Rod
Figure 1

SUPPLEMENTARY INFORMATION: On December 14, 2007, the FAA issued Emergency AD 2007-26-51 for Eurocopter Model EC135 helicopters, which requires, within 5 hours TIS, inspecting the control rod and adjoining ball pivot and replacing any unairworthy parts before further flight. That action was prompted by a report of a fatal accident involving the failure of a control rod. This condition, if not corrected, could result in the failure of a control rod and subsequent loss of control of the helicopter.

The European Aviation Safety Agency (EASA), which is the Technical Agent for the Member States of the European Community, notified us that an unsafe condition may exist on Eurocopter EC135 and EC635 helicopters. EASA advises that an accident recently occurred with an EC135 helicopter in Japan. Preliminary investigation results indicate that the helicopter loss of control was due to the failure of the control rod.

(a) Within 5 hours time-in-service (TIS), inspect the control rod, shown in item 7, Figure 1, of this AD, with the parts identified in parenthesis as follows:

(1) Pull the control rod (7) until it reaches its stop position. Inspect attachment hardware of control rod (7) for a tight fit. Manually inspect for possible relative motion between control rod (7) and yaw actuator (8).

(2) Inspect the locking plate (9) for a tight fit.

(3) Visually inspect the attachment hardware between control rod (7) and yaw actuator (8) for play or thread exposure. If play or thread exposure is found, before further flight, replace the control rod with an airworthy control rod.

(b) Inspect the ball pivot as shown in item 11, Figure 1, of this AD by removing the tail rotor drive shaft fairing and inspecting for a loose bearing or play. If a loose bearing or play is found, before further flight, replace the ball pivot with an airworthy ball pivot.
