STS-104
FLIGHT READINESS REVIEW

June 28, 2001

Ground Operations

STS-104
FLIGHT READINESS REVIEW
BACKUP

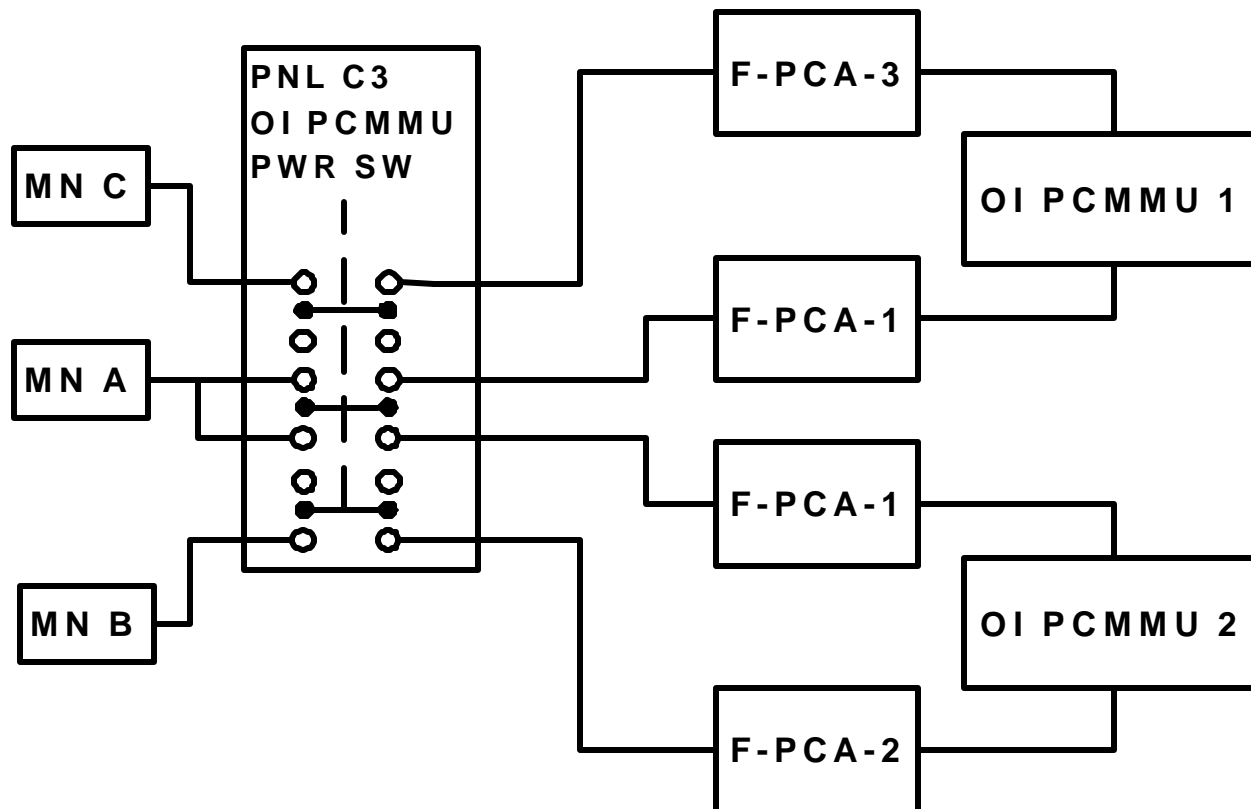
PCMMU 1 and 2 Power Circuit Diagram

- Observation
 - On 3/22/01, during switchover from PCMMU #2 to PCMMU #1, no data was received in LPS and RPS
 - Switching back to PCMMU #2 restored data flow,
 - Subsequent switching to PCMMU #1 resulted in good data flow to LPS and RPS
- Concerns
 - Loss of data visibility to critical systems performance and function

- Discussion
 - PCMMU's have a definite current draw signature when powered on and off
 - The OI PCMMU PWR SW is a 3 pole toggle switch which provides 2 individual power sources to the PCMMU

- Actions Taken
 - Data retrievals of the AC bus current at the time of the initial anomaly were reviewed
 - AC Current dropped when PCMMU #2 was switched OFF
 - AC Current did not increase when PCMMU #1 was switched ON

- Actions Taken (Cont'd)
 - Review of Data retrievals of the AC bus current during subsequent PCMMU switchovers were nominal
 - AC Current dropped when PCMMU #2 was switched OFF
 - AC Current increased when PCMMU #1 was switched ON
 - Performed Troubleshooting of the OI PCMMU PWR SW
 - Cycling from OFF position to PCMMU #1 Position - 10 times
 - No discrepancies were noted
 - Observed Nominal AC Current traces for all cycles

- Actions Taken (Cont'd)
 - Physical analysis of the OI PCMMU PWR SW was performed by USA and NASA system engineers by comparison to the PCM FORMAT SW
 - Switch “FEEL” and “DETENT” were analyzed
 - No differences or discrepancies were noted

- Possible Causes
 - Human Error by failing to place the OI PCMMU SW to the PCMMU-1 Detent Position
 - Mechanical Failure of the OI PCMMU PWR SW for both sets of contacts from Control Bus AB1 and CA1
 - Simultaneous Intermittent wiring failure of two isolated paths

- Conclusions
 - PCMMU #1 did not receive power during initial anomaly from 2 separate circuits
 - OI PCMMU PWR SW is working nominally

- Most Probable Cause
 - Switch was not correctly positioned during anomaly

- Flight Rationale
 - PCMMU #2 is redundant to PCMMU #1 and each has redundant power supplies
 - Function and feel of OI PCMMU PWR SW has been verified nominal
 - PCMMU #1 and #2 have been functionally tested and verified fully operational

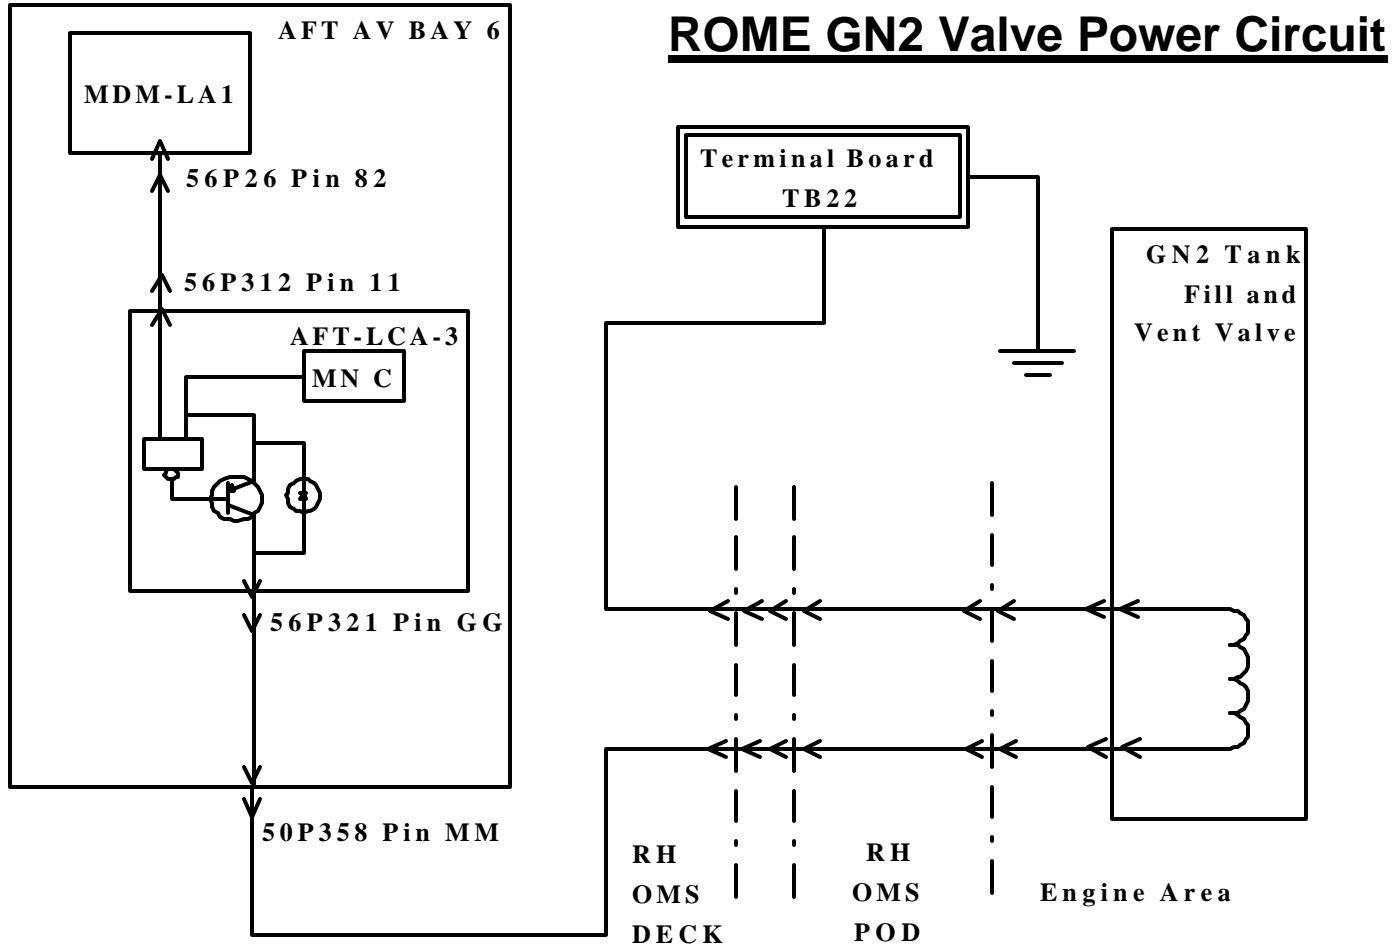
- Observation
 - During LCA Retest, the Right OME Fill Valve (LV001) did not cycle open when commanded. Valve operation is normally verified by audible means. A total of 5 attempts were made and no positive results were observed
 - IPR 104V-0047 was initiated to document and troubleshoot the condition

- Discussion
 - This circuit does not have electrical power to the valve coil during flight
 - Three items in this circuit were reworked during this STS-104 flow since the last usage of the GN2 Fill Valve during the STS-98 flow
 - Aft LCA #3
 - Due to another system problem
 - Connector 56P321
 - Due to connector issues with R/R of the LCA
 - Connector 56P312
 - Due to connector issues with R/R of the LCA

- Actions Taken (Cont'd)
 - Troubleshooting was performed by installing a BOB at connector 56P321
 - The valve was commanded with the BOB in-place and there was 28.8 VDC coming from LCA #3
 - A resistance check towards the valve coil read 17 ohms
 - Both indications are nominal performance of the system
 - The BOB was removed and a “Pull” test was performed at 56P321
 - Pin GG passed - showing no signs of being loose

- Actions Taken (Cont'd)
 - The back shell of connector 56P312 was removed and a pull test was performed
 - Pin 11 passed - showing no signs of being loose
 - The system was returned to flight configuration and retested completely
 - Nominal Retest – no recurrence of the anomaly

- Possible Causes
 - GN2 Fill Valve Sticking
 - No prior history of these valves sticking
 - Defective Circuit in Aft LCA #3
 - New LCA was installed and passed ADP and Functional Retest
 - MDM LA1 did not issue command to LCA #3
 - Subsequent cycles were verified by a Bite Test 4 check
 - Intermittent connection, loose pin or contamination in connectors 56P321 or 56P312

- Most Probable Cause
 - Intermittent connection, unseated pin or contamination preventing proper mate of connector 56P321, which was cleared by the troubleshooting and BOB installation
 - This was the only component disturbed since the failure of the GN2 valve and it's subsequent nominal operation
- Risk Assessment
 - No risk to Mission success or Flight and crew safety
- Flight Rationale
 - The valve has been fully retested successfully
 - The valve is only used for ground operations
 - Loss of power causes the valve to fail closed
