ISL Cooling Leak

All Experimenters Meeting

May 19, 2007

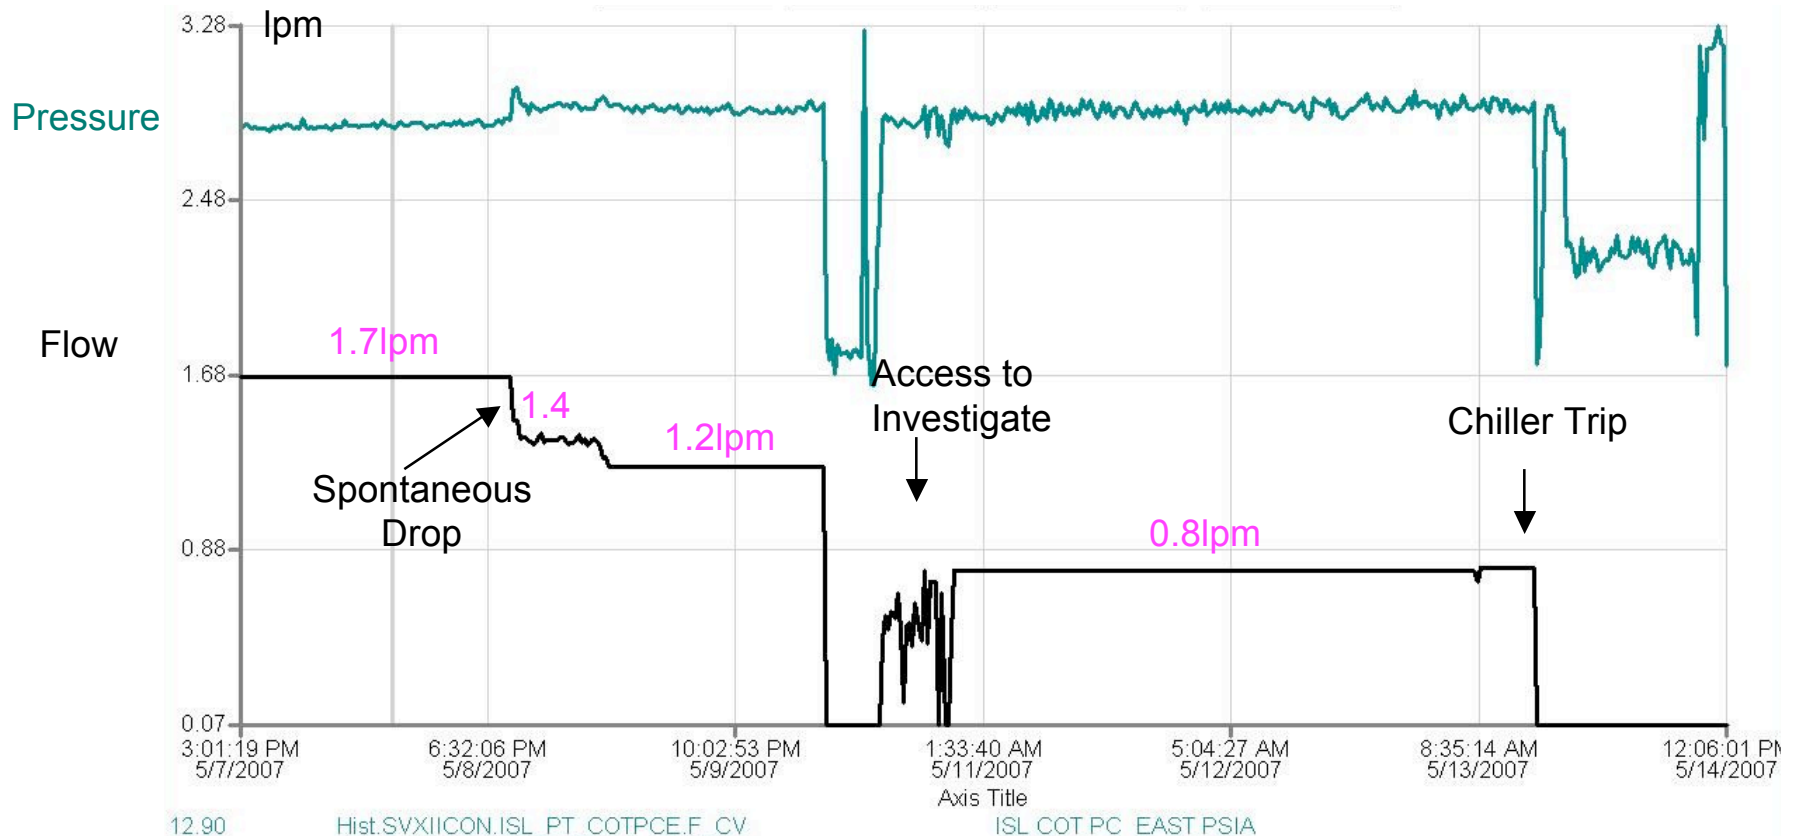
- May 8-13 flow in East ISL/L00 portcard circuit dropped from 1.7 lpm (nominal) to 0.0 lpm:

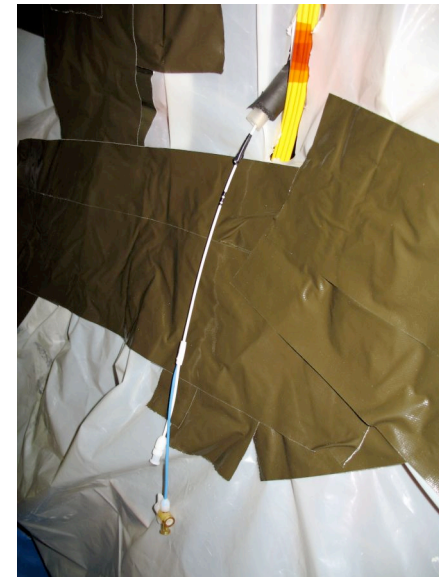
- Access Wednesday May 16:
 - Open east plug calorimeter
 - Access COT face and Silicon cooling lines
- Further isolate (and we hoped fix) leak
 - Ruled out leak in junctions or tubing on the COT face
 - Leak inside silicon N₂ inerting volume (cold)
 - Using catheters with balloon and line to apply pressure, isolated leak to manifold for cooling ISL (L00) portcards

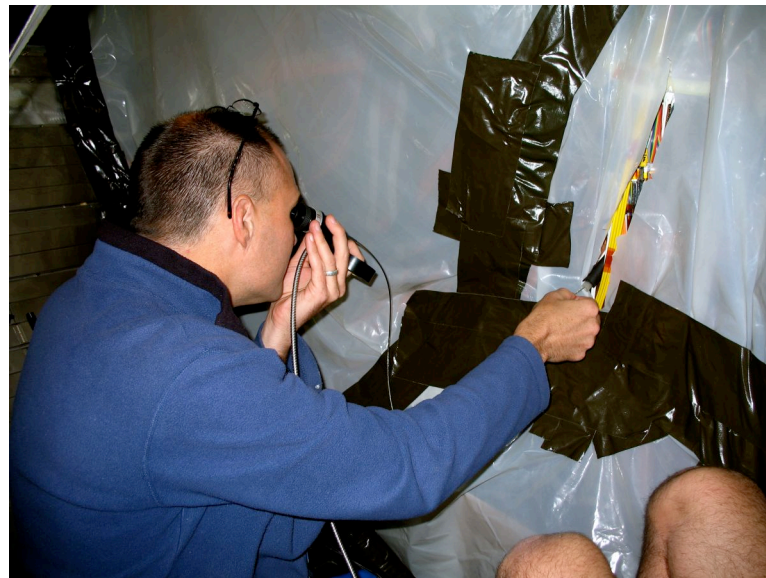
- Used boroscope to examine manifolds
 - Signs of erosion and/or corrosion at 2 locations on supply manifold and 2 locations in return manifold
 - Experts are convinced there is a hole at one of these locations on supply manifold

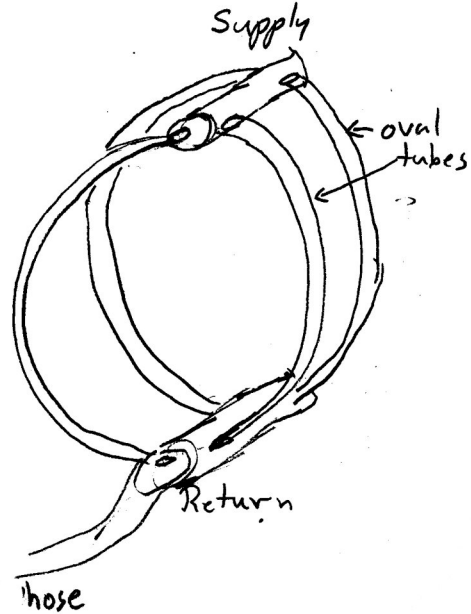
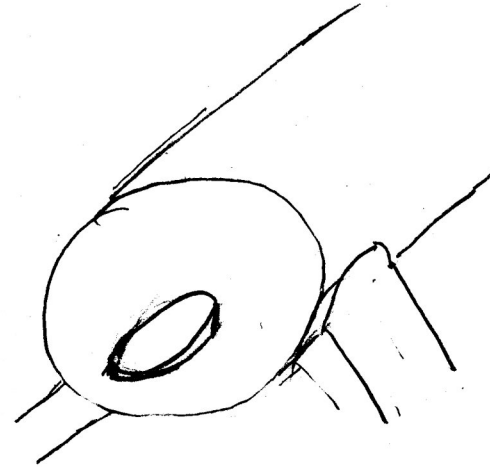
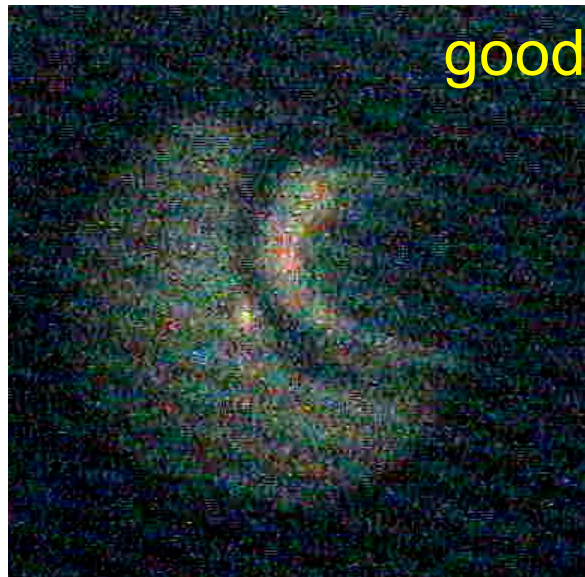
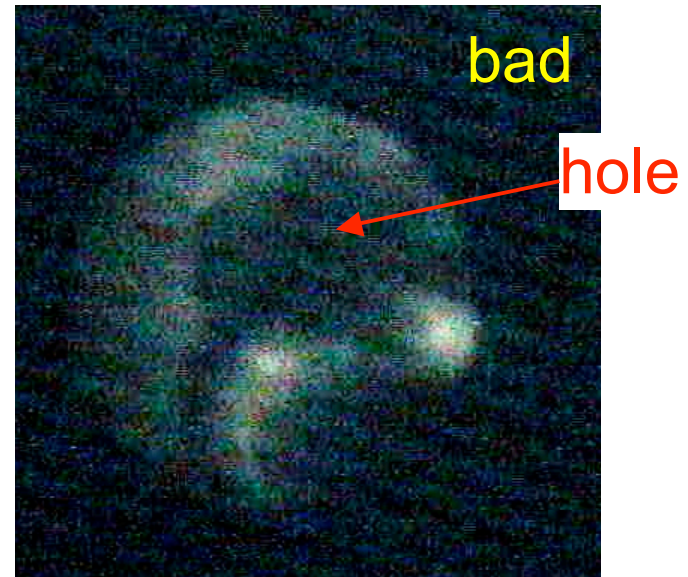
Boroscope pictures

- Visual evidence suggests erosive and/or corrosive process
- Possibility of corrosion due to recent experience of acidic coolant
 - Coolant became ionized during 2006 shutdown (see All Expt talk by Mary Convery March 19)
 - Recognized as acid (pH=2.2) in mid-March 2007
 - Drained and flushed April 3 (pH=2.9)
 - Rapid de-ionization May 10 (pH=4.7)
 - No significant Aluminum seen in coolant samples (Aug '06 and March '07)
- Possibility of erosion due turbulence in region of damage due to cooling tubes protruding into manifolds
- Exact cause not yet established - need to keep open minds during investigation

- Already developing ideas for repair
 - Most involve epoxy from inside
- Develop repair technique on a mockup of system
