U.S. CHEMICAL SAFETY AND HAZARD INVESTIGATION BOARD

INVESTIGATION REPORT

CONFINED VAPOR CLOUD EXPLOSION

CAI, INC. AND ARNEL COMPANY, INC.

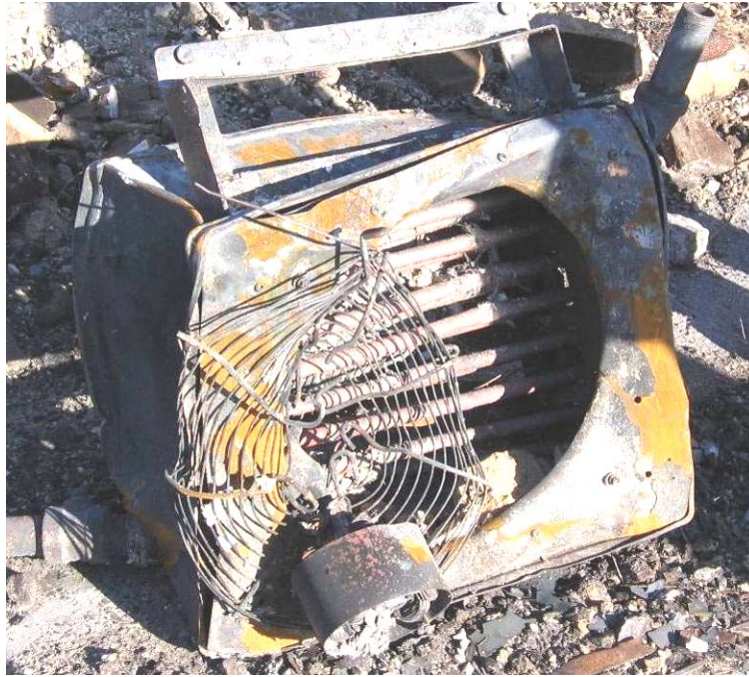
atmosphere because they were located high on the wall and far from the process equipment where flammable vapors could be present. Employees reported that the heater fans in the production area were controlled by wall-mounted on/off switches and remained on during cold weather even when the building was unoccupied, which was the case on the night of the explosion.

Figure 4. Steam coil air heater recovered from the debris. Fan motor is at the lower center of the photo.

¹¹ The fan motor and nameplate were destroyed by the fire, preventing investigators from determining if the assembly was rated for use in a flammable vapor environment.

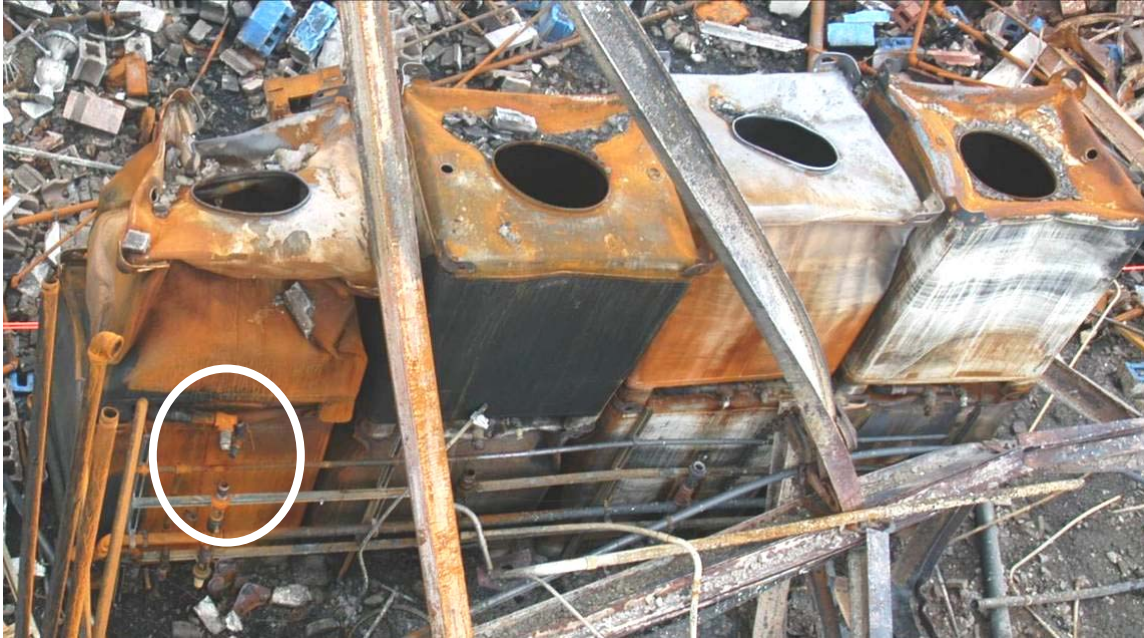
The CSB investigators noted that the solvent storage located in area E was not compliant with certain state fire code or OSHA worker safety requirements. First, the unsealed solvent storage totes vented directly into the room, not outdoors. Second, Class I flammable liquids¹⁴ were discharged through the bottom drain valve outlet on each tote, not pumped out from the top of the tote. Third, the totes had no spill containment system around them to contain a flammable liquid release, such as overflow during a filling operation. Finally, the pipe manifold connected the totes to the pump using combustible elastomeric hoses between each tote and the manifold, not steel pipes.

Figure 7. CAI totes stored flammable liquids in area E. Circled area shows one of the flexible hose connection points to the manifold pipe.

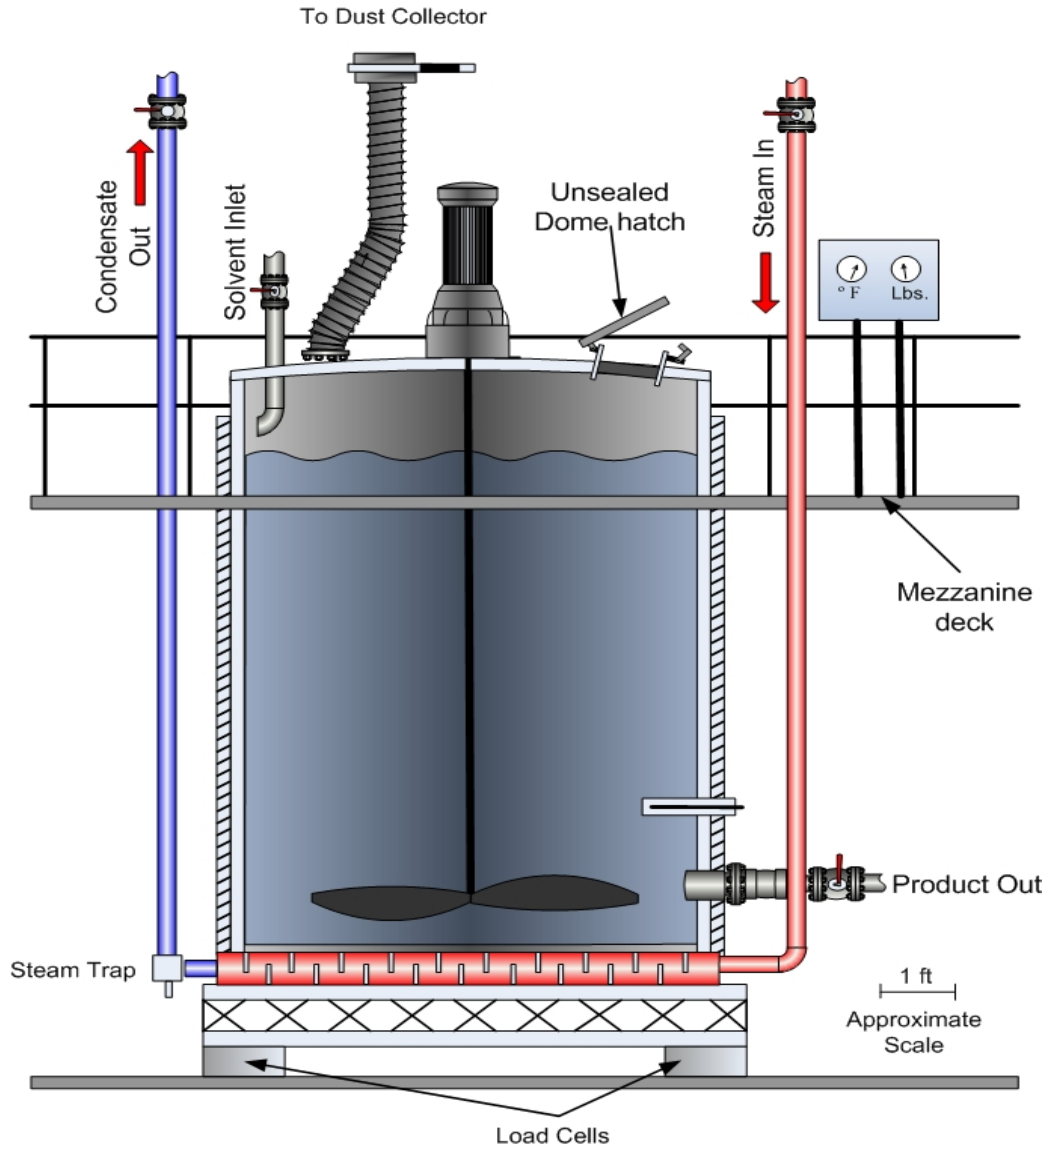
CAI's production manager was responsible for operating the four mix tanks. He told the CSB investigators that he typically heated the mixture in mix tank 3 to 90 to 120°F to help dissolve the resin and then closed the steam supply valve. He said he did not leave the steam on during non-work hours, although he routinely left the mixer running. However, CAI did not have written procedures for the operation of process equipment; rather, they used ink vehicle recipes. These recipes listed the materials and quantities needed for each specific batch, but did not include checklists or other written instructions to ensure that equipment was operated correctly and consistently.

Figure 8. CAI ink vehicle insulated mix tank 3.

Because mix tank 3 was not vented to the building's exterior, uncontrolled tank heating could cause the mixture to rapidly vaporize and release enough vapor into the production area to fuel the explosion. The ink vehicle mixture properties and tank heating capacity were analyzed to determine how much heptane could have been released into the unoccupied building.

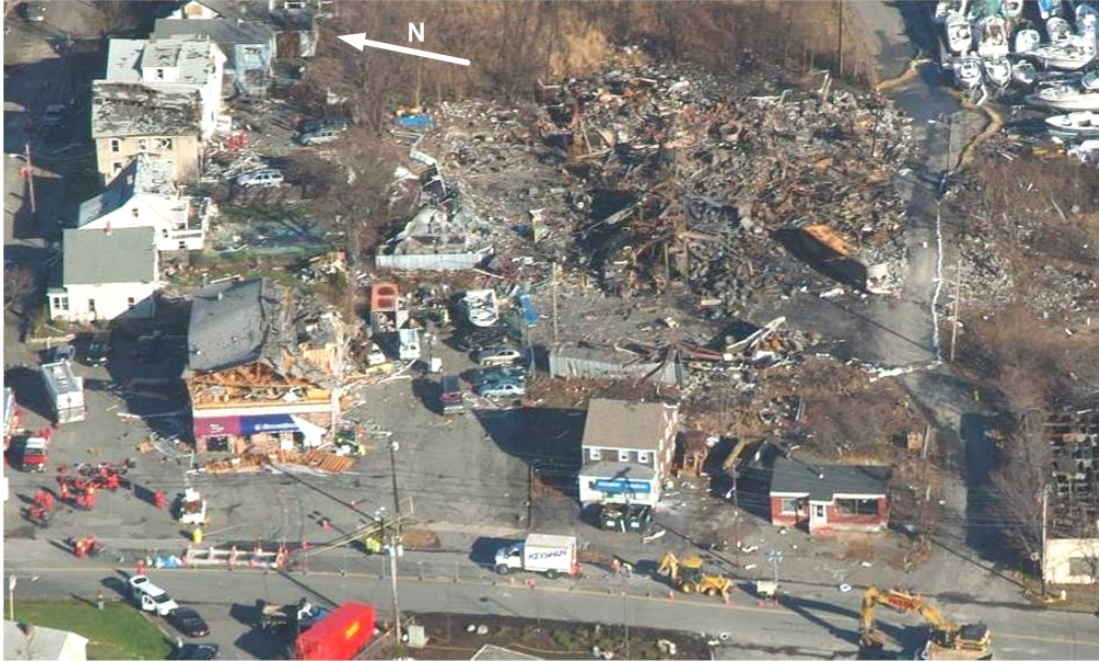
The explosion and fire leveled the CAI/Arnel facility (Figure 10). One hundred and fifty to 300 feet to the north, the force thrust windows and doors, with their frames, into houses (Figure 11). Ceilings inside houses collapsed on sleeping occupants. Large appliances and kitchen cabinets were thrown across rooms. One hundred feet northwest of the CAI/Arnel building, the bakery's roof and second story collapsed (Figure 12). Brick chimneys as far as 500 feet from the facility were knocked down or heavily damaged. Seventy-seven families were forced to relocate to temporary housing because their homes were heavily damaged; 24 homes were later declared damaged beyond repair.

Figure 10. Aerial view of CAI/Arnel facility after explosion and fire (bakery/pizzeria building lower left) (ATF photo).

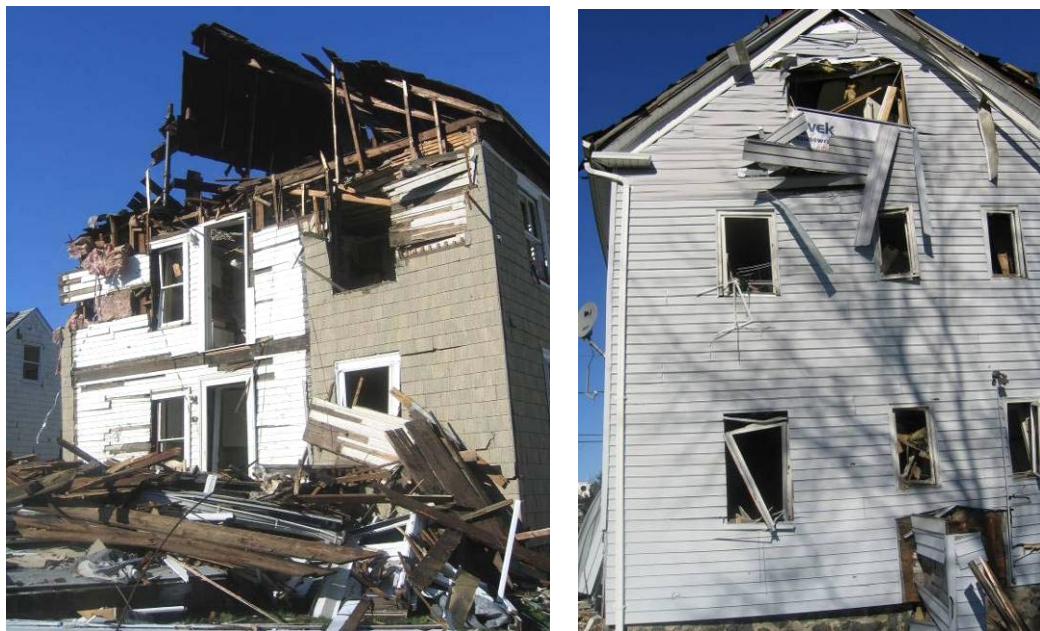
Figure 11. Houses destroyed by the explosion.

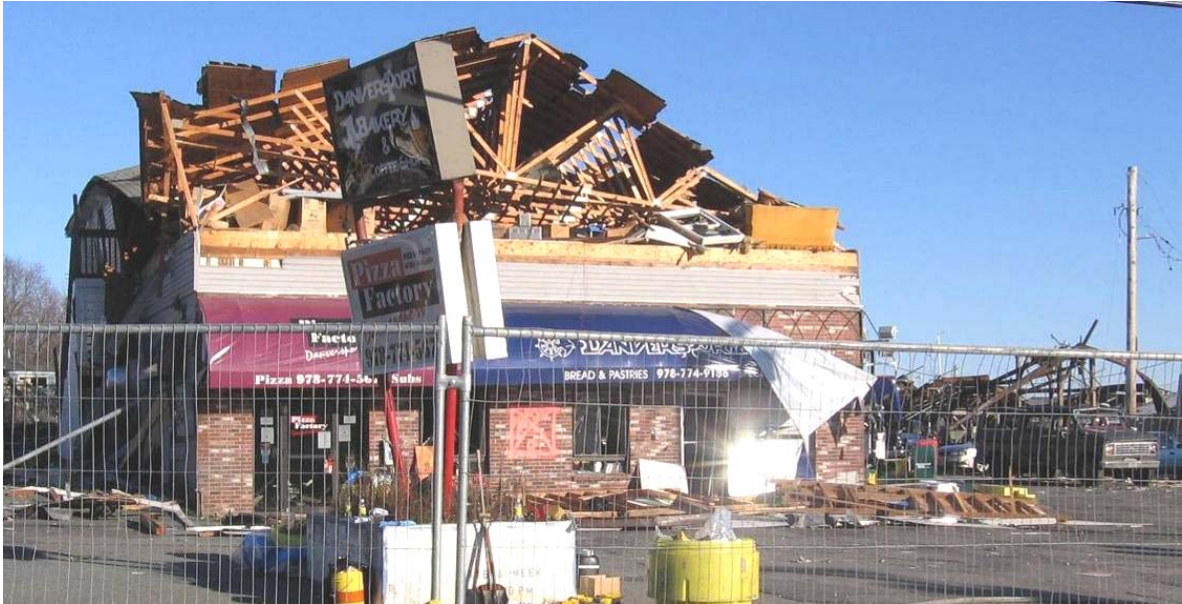
Figure 12. Bakery/pizzeria building destroyed by the explosion (CAI/Arnel building far rear on right).

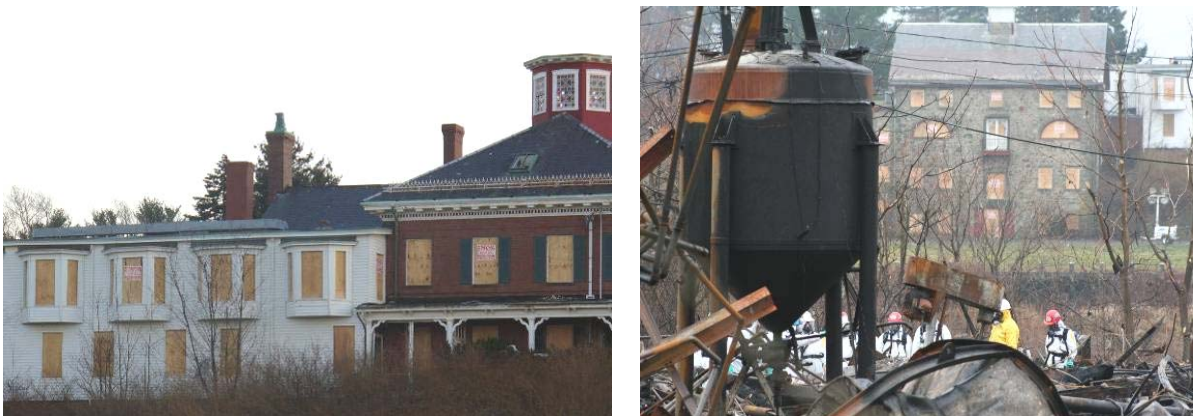
Explosion damage was widespread: 800 feet south of the facility, nearly every window and door facing the CAI/Arnel facility at the New England Home for the Deaf was shattered or blown in (Figure 13), forcing the evacuation of 60 assisted living residents.

Figure 13. Shattered windows and doors boarded up at the New England Home for the Deaf, 800 feet from the explosion.

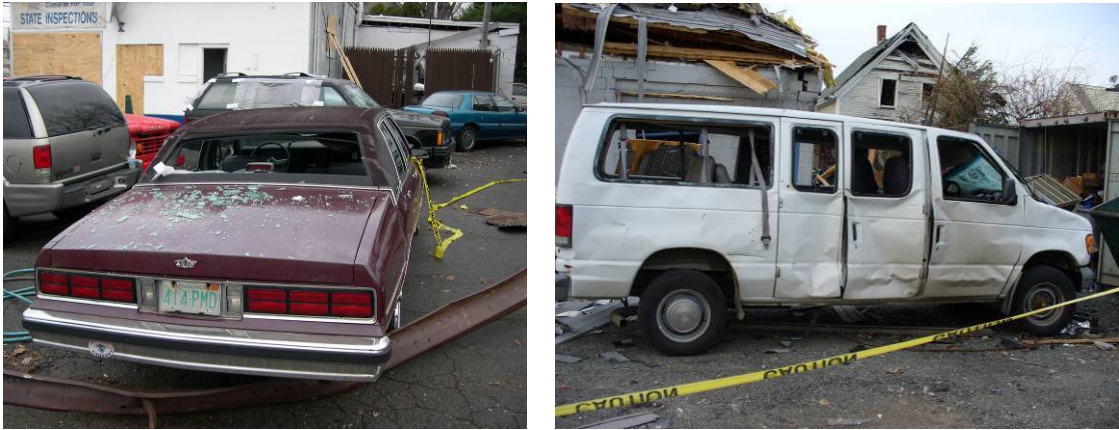
Inch-thick pieces of concrete as large as 10 inches in diameter were thrown hundreds of feet into the surrounding community and marina. Large pieces of wood and other debris littered Bates Street, some 200 feet away. The blast wave shattered windows and buckled doors and panels on vehicles parked as far away as 300 feet (Figure 14).

Figure 14. Shattered windows and buckled panels on vehicles.

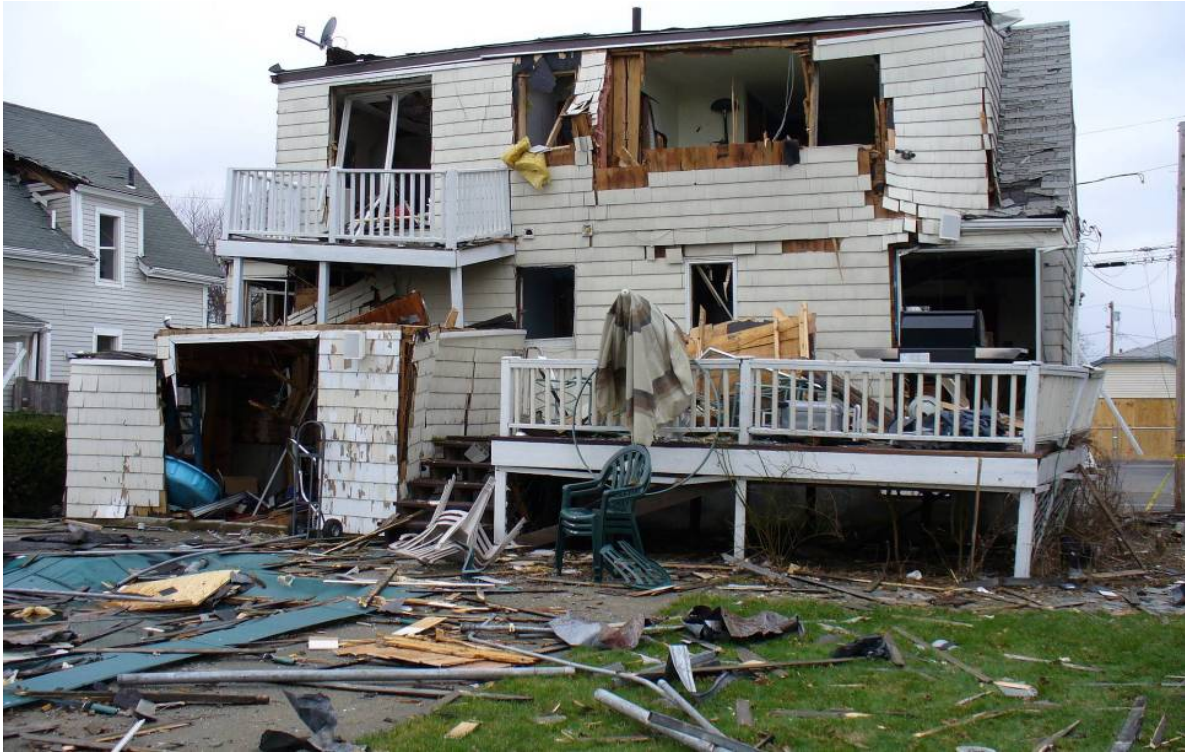
Remarkably, only 10 people were injured; all of them were treated for cuts and bruises then released from the local hospital. The low number of injuries and absence of fatalities are attributed to the time of the explosion, 2:46 am, when most occupants were in their houses lying in their beds, covered with blankets that protected them from flying glass and debris. The few occupants who were not in bed and the employees working in the bakery happened to be in rooms shielded from the explosion rather than standing or sitting in rooms directly facing the facility. It is likely that fatalities, or at least life-threatening injuries, would have resulted had the explosion occurred when people were outdoors or standing at rear-facing windows or doors in houses abutting the property (Figure 15).

Figure 15. Bates Street home 150 feet north of CAI/Arnel facility destroyed by the explosion.

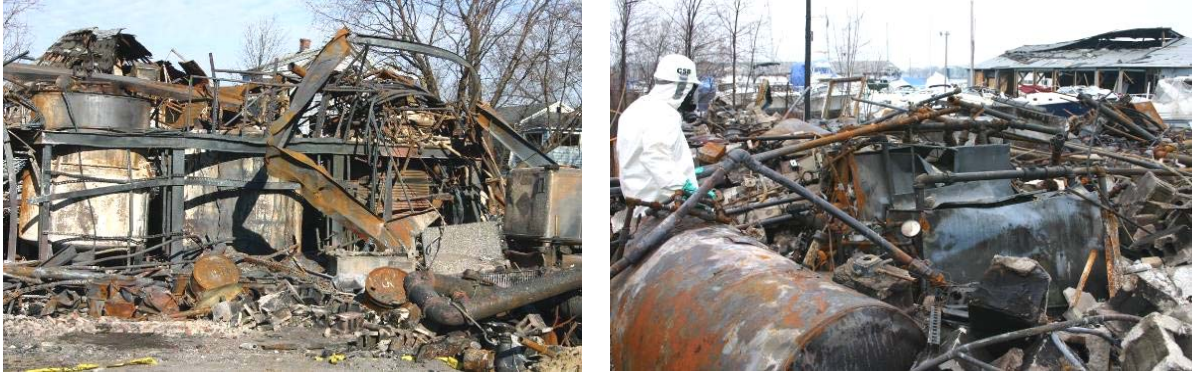
Pipe joints on the underground cast iron natural gas distribution pipe more than 200 feet away (on Water Street to the west of the facility and Bates Street to the north of the facility) began leaking natural gas.¹⁷ Although the explosion damaged natural gas pipes at a few houses, none of the leaking natural gas ignited, and only the CAI/Arnel building burned (Figure 16).

Figure 16. Explosion and fire destroyed the CAI/Arnel building.

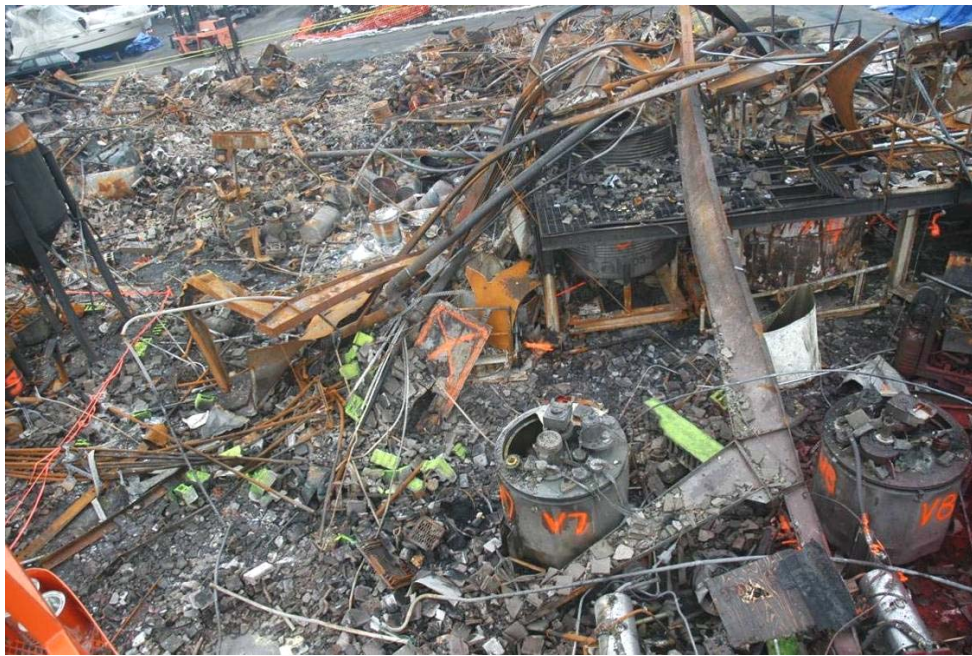
Most of the CMU walls in the CAI/Arnel building were destroyed (Figure 17). The Arnel storage trailer on the east side of the facility was knocked on its side. Other 40-foot long semi-truck trailers parked on the north and south sides of area C were displaced more than 30 feet and their explosion-facing sides caved in under the force of the explosion. Thousands of gallons of solvent, paint and ink products, the building's heating oil, and more than 50,000 pounds of nitrocellulose burned for many hours.

Figure 17. Debris from shattered CMU walls and collapsed roof trusses in area C.

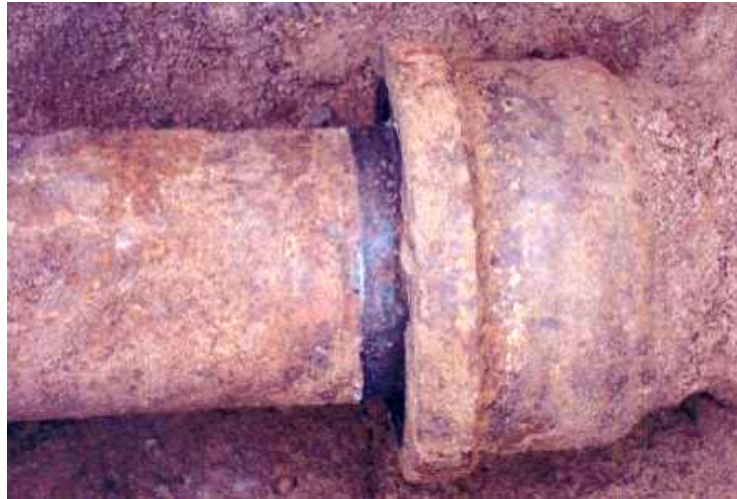
Figure 19. Old 4-inch cast iron buried gas distribution bell and spigot pipe joint partially separated by the explosion (KeySpan photo).

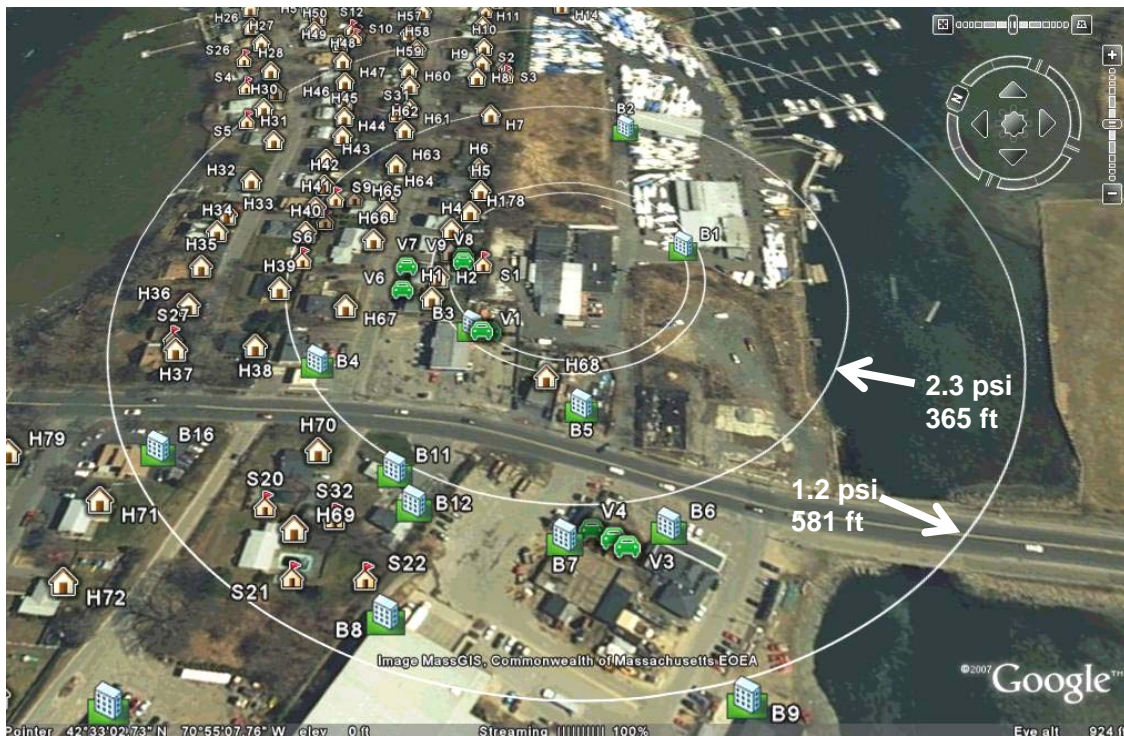
The CSB conducted a community damage survey focused on characterizing the damage sustained in the area surrounding the explosion site. The CSB survey teams photographed and catalogued more than 260 damaged buildings and vehicles. Structures damaged by the blast wave overpressure were observed as far as two miles from the CAI/Arnel facility. The survey data were overlaid on a pre-event satellite photograph of the Danversport peninsula to display the extent of documented community damage (Figure 20).

Figure 20. Aerial view showing some damage data points and estimated explosion overpressures out to about 600 feet from the facility (double circle, center). Google Earth Pro

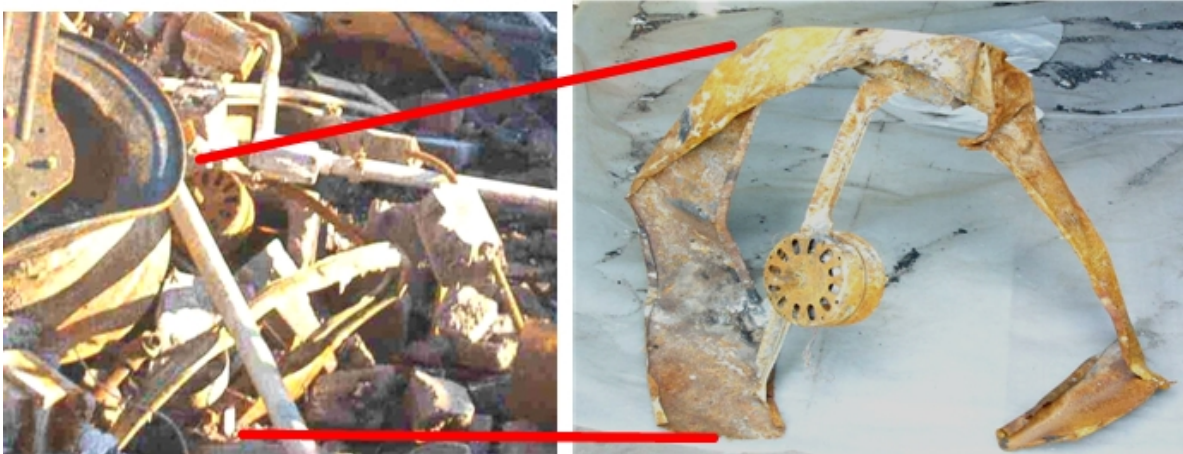
Even though the explosion and subsequent fires prevented the CSB from identifying the specific ignition source, the team located some equipment in the debris that could have ignited the vapor inside the building. The CSB investigators recovered non-rated electrical equipment in the debris, including a consumer-type box fan (Figure 22) that might have been inside the production area, which was likely equipped with a thermostat control.²⁵ These simple bi-metallic thermostats typically generate a spark when the contacts open and close, which could ignite a flammable vapor. However, the explosion and intense fires destroyed any evidence establishing the pre-explosion location and operating status of these devices.

Figure 22. Box fan, a possible ignition source recovered from the debris near area E.

²⁵ This type of fan frequently is equipped with an adjustable thermostat. The recovered metal frame contained two manufactured holes, most likely for the on/off switch and a thermostat.

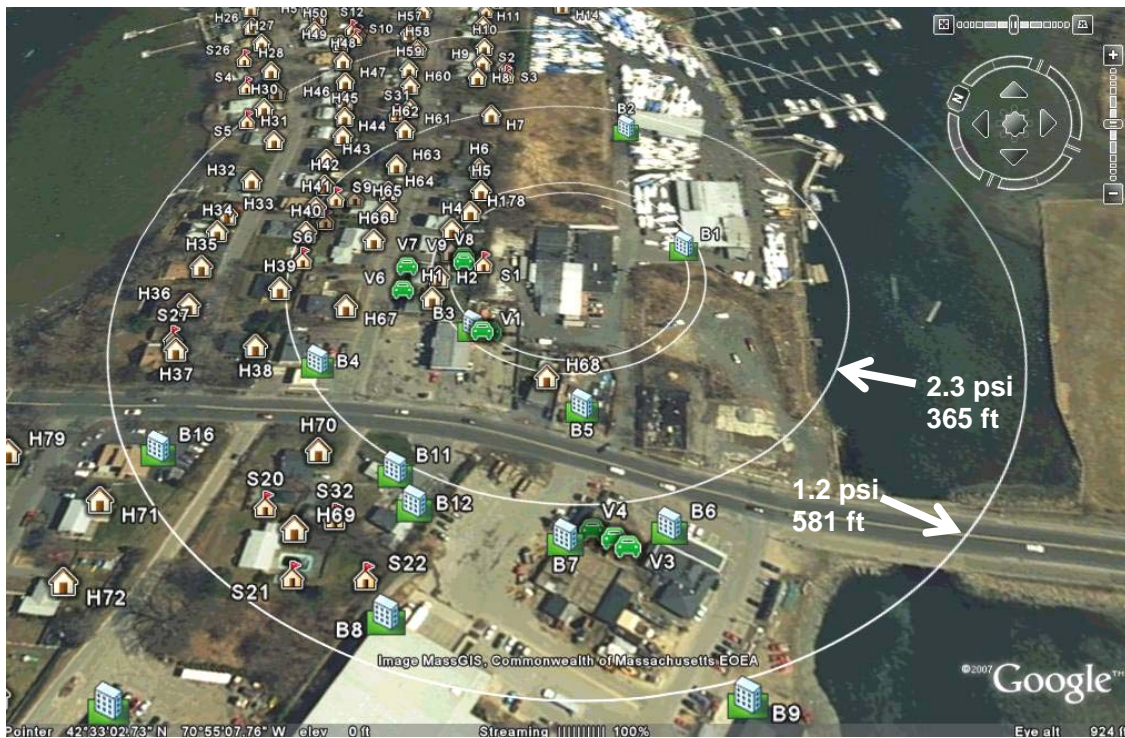
The CSB investigation team surveyed the community to characterize the damage sustained in the area surrounding the explosion site. The CSB survey teams photographed and catalogued more than 260 buildings and vehicles using global positioning satellite (GPS) coordinates to ensure accurate positioning. The damage data were displayed in a format that overlaid the consequence information on a pre-event satellite photographic image of the area (Figure A-1). Damage was observed as far as 9000 feet from the explosion site.

Figure A-1. Aerial view showing damage data points and estimated explosion overpressures. CAI/Arnel facility is in the double circle, center. (graphic: Google Earth Pro)
