12.0 Mexican Hat, Utah, Disposal Site

12.1 Compliance Summary

The Mexican Hat, Utah, Disposal Site, inspected on April 26, 2006, was in good condition. Runoff from storm events continues to transport sediment into the west diversion channel resulting in vegetation growth within the channel; performance of the diversion channel has not been impaired. Repairs were made to the perimeter fence, boundary monument BM-7, and perimeter sign P27. The entrance gate was found damaged, however, vehicles are still able to access the site; therefore, no repairs are planned at this time. Tamarisk plants found on site were cut and treated with herbicide. Trash and tumbleweeds continue to accumulate on the site and along sections of the perimeter fence and may require maintenance in the future. An evaluation of the monitoring program was conducted and presented in the draft report *Resolution of Seep and Ground Water Monitoring at the Mexican Hat, Utah, UMTRCA Title I Disposal Site* (March 2006). Recommendations to discontinue seep water quality monitoring and to continue annual observations of seep flows were conditionally concurred in by the Navajo Nation; NRC approval is pending. Navajo Nation

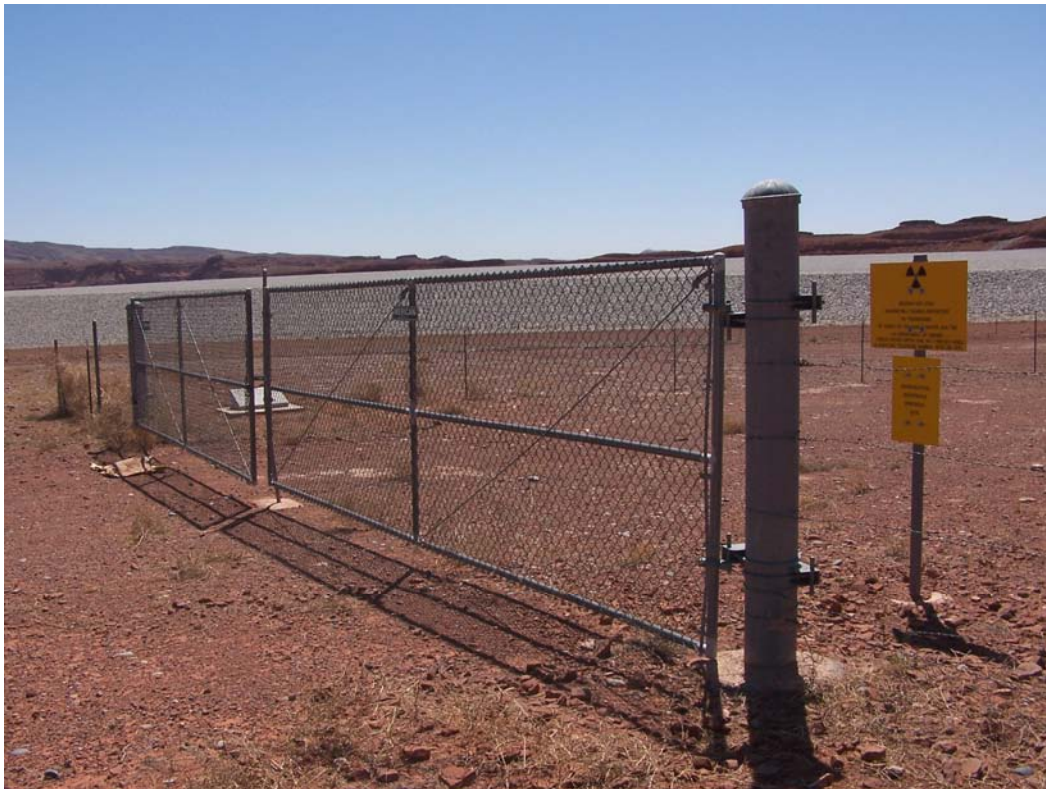
12A A barbed-wire perimeter fence set inside the property boundary, with a chain-link gate at the site entrance, encloses the site. The center rod to the entrance gate was damaged, causing the west half to be inoperable; however, vehicles can still access the site through the east half of the gate and, therefore, no repairs are planned at this time (PL–1). Damage caused by livestock to the perimeter fence in two locations was repaired: at the north end of the west diversion channel near its outlet and directly north of the east toe drain to the disposal cell.

HAT 4/2006. PL-1. Entrance gate (showing bent center rod) and sign, site marker; disposal cell in the background.

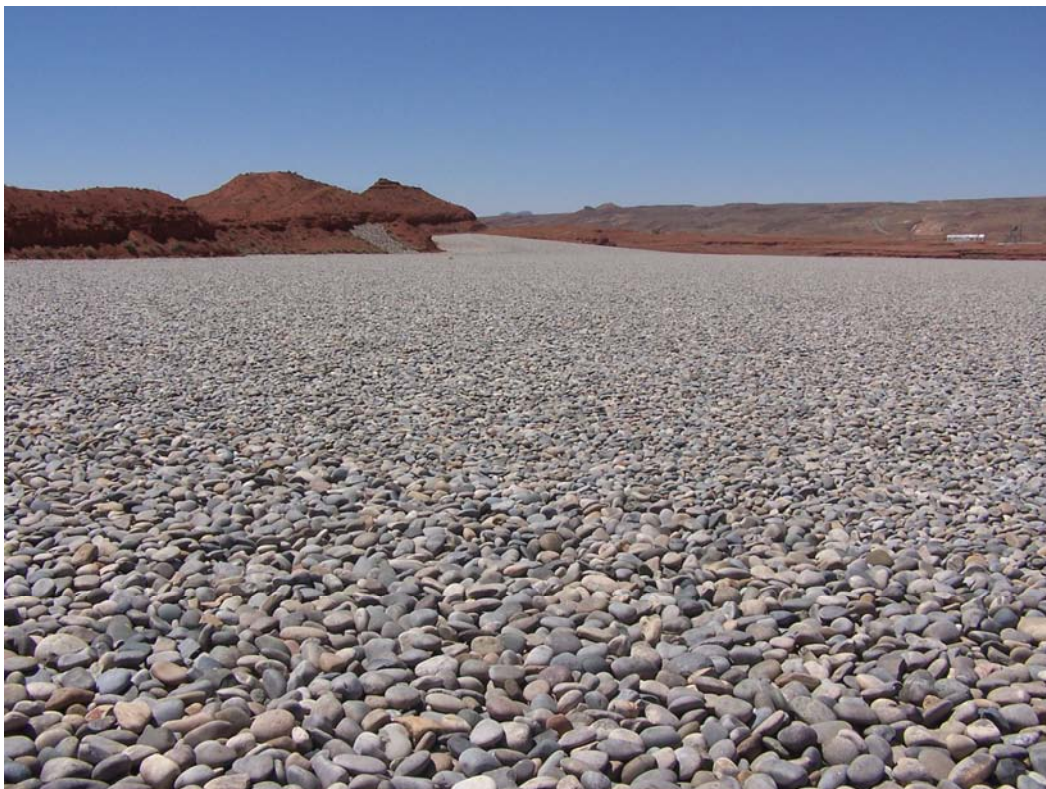
Top of Disposal Cell—The top of the riprap-armored disposal cell was in excellent condition (PL-2). There was no evidence of differential settling, cracking, burrowing, or other modifying process that could affect the integrity of the cell. All visible components of the disposal cell and cover were functioning as designed. No vegetation was observed to be growing on top of the disposal cell.

HAT4/2006. PL-2. View southwest across the cell top from the crest of the east side slope of the cell; south slope of the cell top in the background.

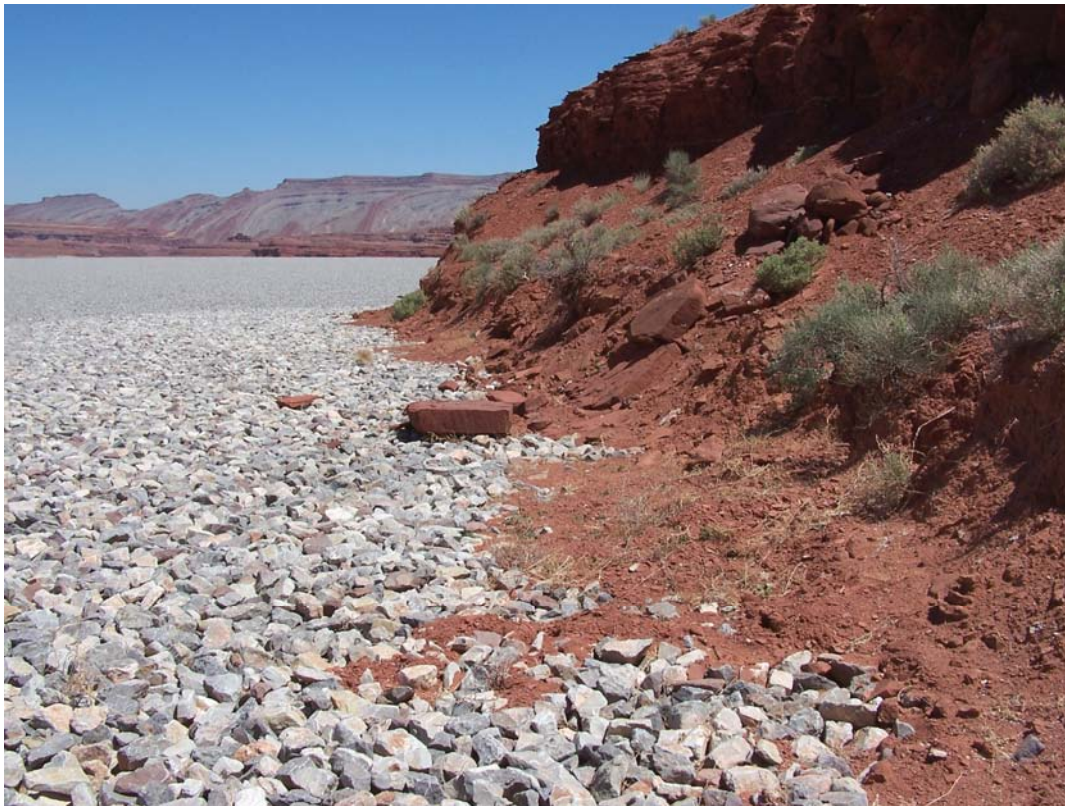
A section along the south apron has been closely monitored since construction because rock and soil have sloughed off the adjacent steep hill slope onto the apron. Based on comparisons with photographs from previous inspections, there was no significant increase in accumulation of the red sandstone and soil along the south apron (PL-3). As observed in past years, there was no evidence of channel erosion in this area, and the sloughed material has not filled the void spaces in the apron riprap beyond the toe of the hill slope. It is anticipated that a minor amount of unstable rock from the hill slope will, over time, continue to fall onto the apron; however, the amount of material that will eventually accumulate on the edge of the apron in this area will have no detrimental impact on the performance of the apron or the disposal cell. However, as a best management practice, inspectors will continue to observe material that has fallen and accumulated on the edge of the apron in this area.

HAT 4/2006. PL-3. View northeast along the southeast apron showing insignificant accumulation of detritus.

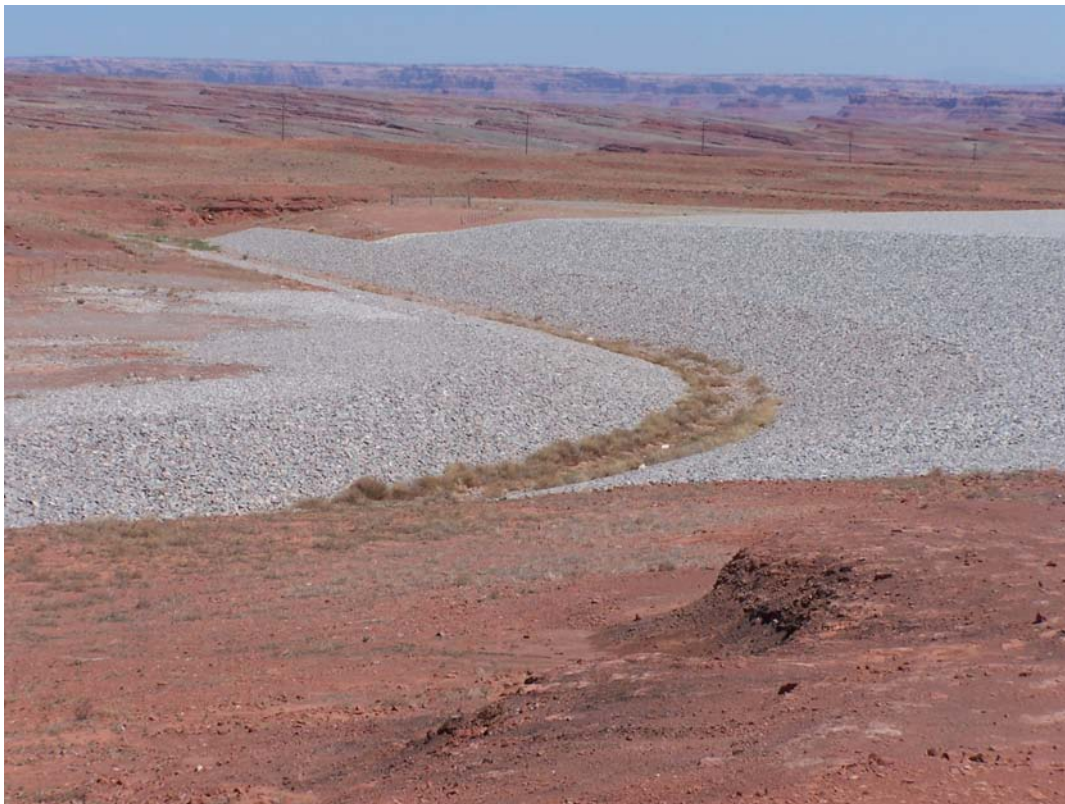
Areas off-site and upgradient continue to erode and transport sediment into the west diversion channel and the southwest ditch. Plant growth, primarily annual weeds, is establishing where the sediment has accumulated in the west diversion channel (PL-4). The sediment accumulation and plant growth have not affected the performance of these storm water diversion structures, and the rate of sedimentation is expected to diminish as the upgradient landscape stabilizes.

HAT 4/2065. PL-4. Sediment and vegetation in the upper reach of the west diversion channel.

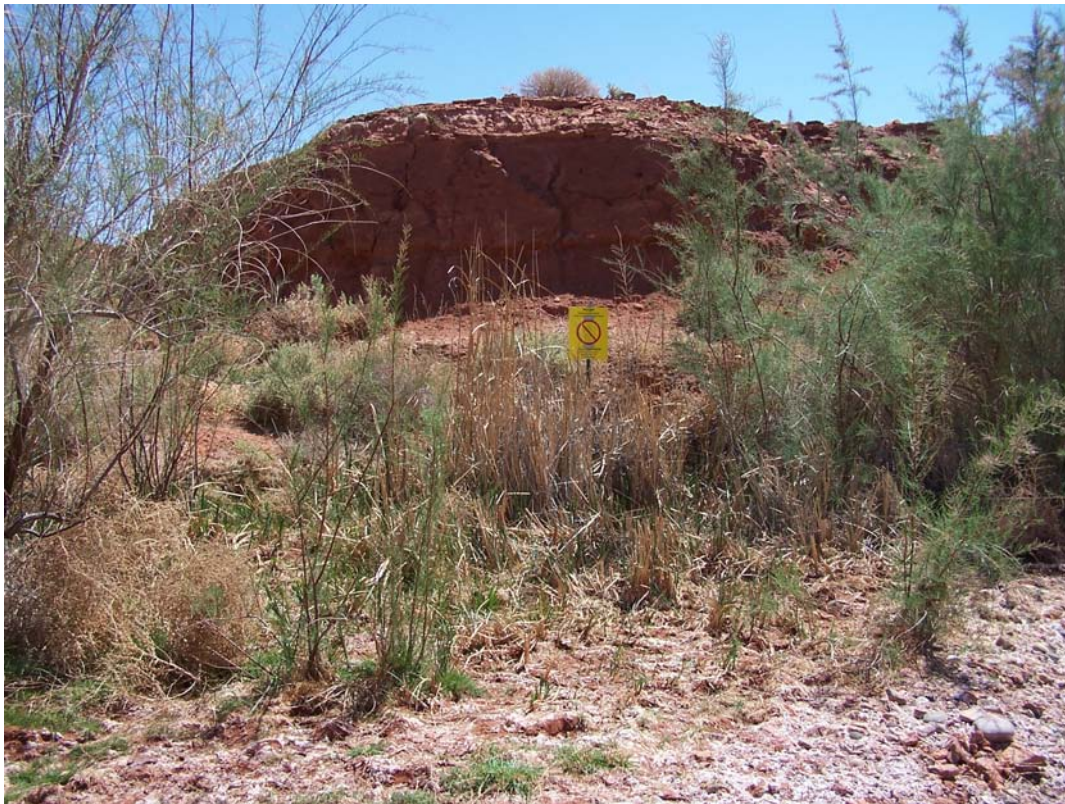
0264	North Arroyo	Downgradient	Most significant flow (still minimal), no flow occurring past the immediate wetted area (~ 15' x 25'), several small pools of standing water (~1' diameter, ~1" depth) occur within the wetted area, riparian vegetation occurs within the wetted area (including tamarisk).
0922	South Arroyo	Downgradient	Small area of moist soil and evaporite present beneath rock outcrop, no flow or standing water, some riparian vegetation (including tamarisk).

HAT 4/2006. PL-5. Seep 0264.

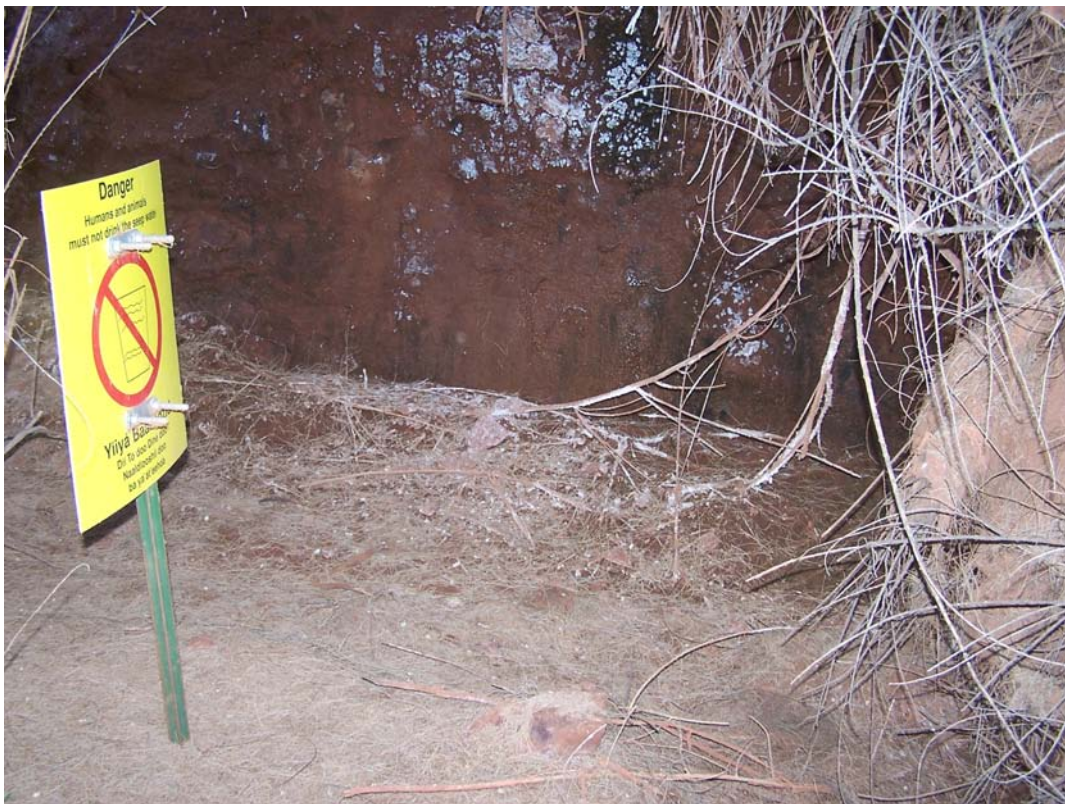
Seep Location Number	Drainage	Flow Orientation from Disposal Cell	Observations and Descriptions of Seep Flow (Qualitative)
0248	Gypsum Creek	Downgradient	Minimal seep flow (dripping from rock outcrop), very small pool of standing water (~1' diameter, ~1" depth), soils moist in surrounding area against rock outcrop, no flow from immediate area, minimal vegetation – primarily tamarisk (very little other riparian vegetation).
0249	Gully 2	Downgradient	Dry, no flow or standing water, no evidence of seep (i.e.; no moist soils or riparian vegetation were present).
0251	North Arroyo	Downgradient	Dry, no flow or standing water, slightly moist soil in a very small and localized area against rock outcrop, small amount of evaporite present, minimal vegetation – primarily tamarisk (very little other riparian vegetation).
0254	South Arroyo	Downgradient	Dry, no flow or standing water, evaporite present is the only evidence of soil moisture or seep (very little riparian vegetation).

HAT 4/2006. PL-6. Seep 0248.
