Coal Mine Fatal Accident 2003-24

| Operator: | RAG Coal West, Inc. |
| Mine: | Belle Ayr Mine |
| Accident Date: | September 9, 2003 |

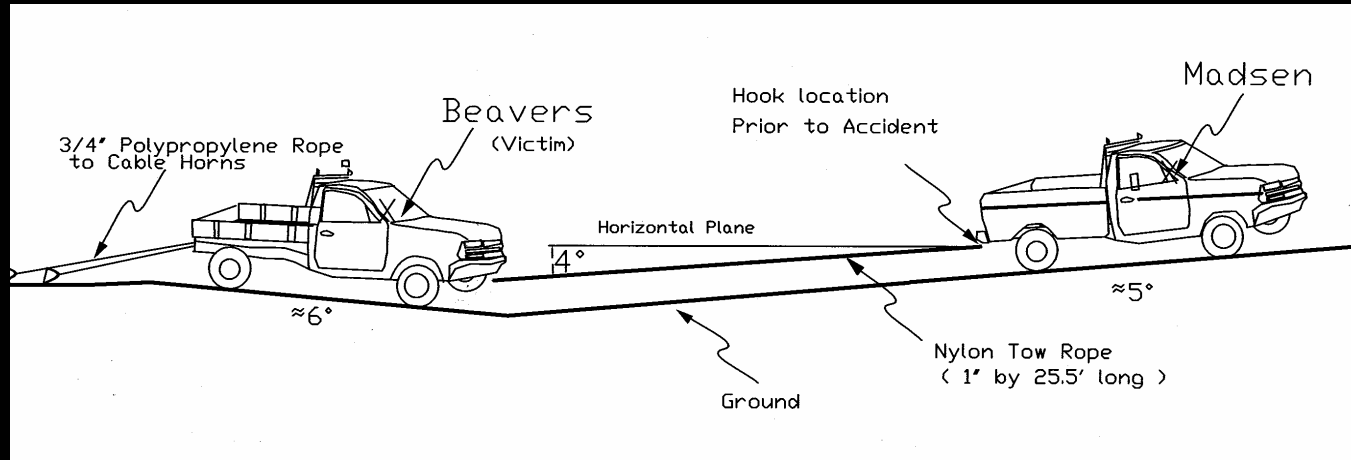
- On September 9, 2003, a 36-year old utility person with 4 years of mining experience was fatally injured when he and a co-worker were using two pick-up trucks to move power cable for an electric shovel.
- One of the trucks lost traction in a muddy area and a nylon tow rope was attached to a hook on the truck's front end. The tow rope was then attached to a hook on the back of the second pick-up.

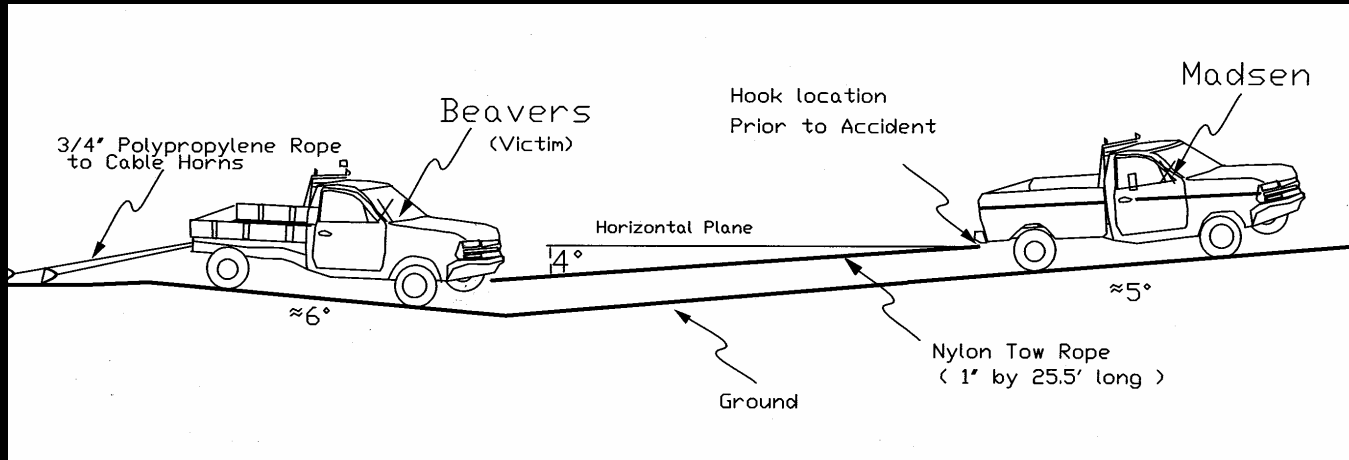
- On the first attempt to pull the truck, the metal hook broke loose from the hitch of the front truck, pierced the windshield of the rear truck and struck the victim's head.
- The use of a hook, welded on the hitch receiver of the towing truck, as the attachment point for the tow rope, created an unsafe condition that resulted in the hook fracturing the receiver steel and projecting back towards the truck being towed.
- The use of a nylon tow rope as the towing device contributed to the cause of the accident as the elongation characteristics of the nylon rope allowed greater energy storage than that which would occur in other types of towing devices.

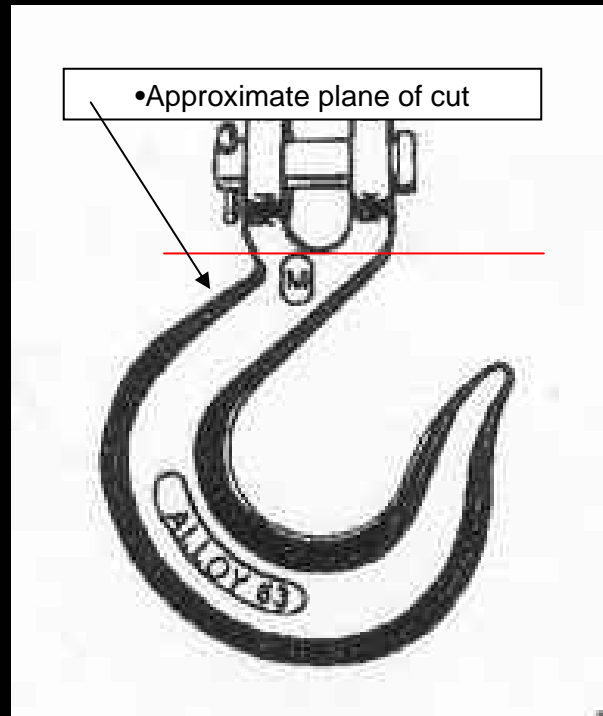
- The clevis pin eyes had been cut off, leaving a base on the hook approximately $\frac{3}{4}$ inches thick and $1\frac{1}{4}$ inches in length.
- The base of the hook appeared to have then been butt welded to the receiver hitch's tubular frame.

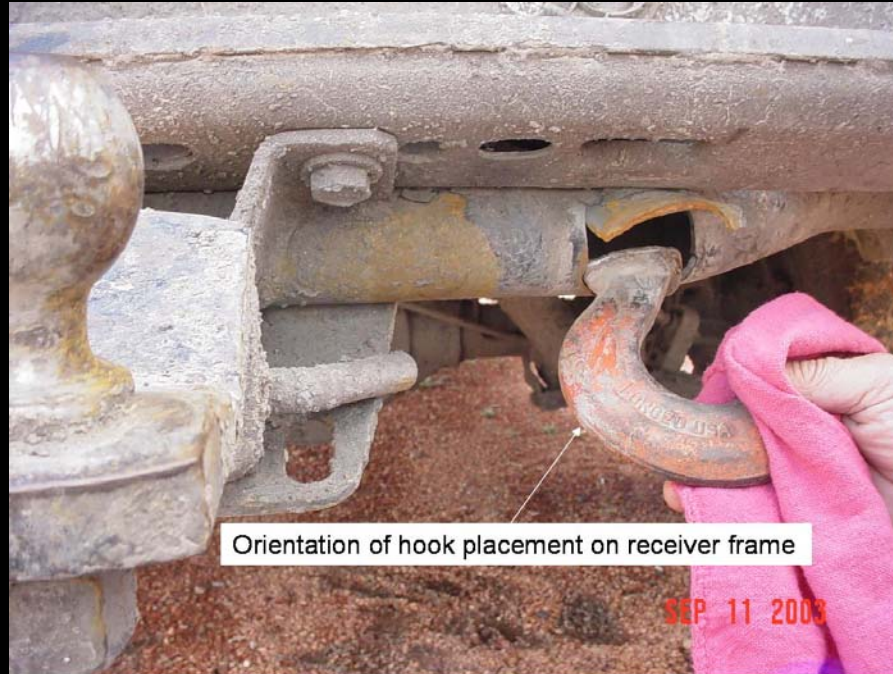
- Two metal hooks had been welded to the tubular steel hitch receiver on Madsen's truck (towing truck).
- These hooks were mainly used to attach the ropes from the cable horns when moving trailing cable.
- The hook on the left side had broken off previously, but the area where it was welded was clearly visible.
- Madsen attached the tow rope to the hook on the right side when hooking up to Beavers' truck before the accident.
- He placed the eye with the clevis on the hook.
- Examination of the hook found no markings from the steel clevis, indicating only the rope eye had been placed over the hook.
- The tubing of the receiver frame failed, allowing the hook to dislodge from the receiver frame.

- This hook broke off during the attempt to pull Beavers' truck and projected back causing the injuries to Beavers.
- Visual observations indicated the welds remained intact but the tube wall failed around the welds on the sides adjacent to the hook base.

- **Causal Factor:** The tow rope was attached to a hook welded on the hitch receiver of the towing truck.
- **Corrective Actions:** The rope's pulling force was not applied to the hitch, the point of the receiver designed to carry the rated load. The operator removed all rear tow hooks from all light service vehicles and implemented a policy that hooks shall not be installed in this manner on such trucks in the future.
- **Causal Factor:** A nylon rope was used as a tow rope between the two trucks.
- **Corrective Actions:** The elongation characteristics of the nylon rope allowed greater energy storage than that which would occur in other types of towing devices. The operator has stopped using nylon tow ropes for towing vehicles and will use other devices such as straps which store less energy when stretched.

- **Causal Factor:** Corrective actions were not taken regarding welded hooks on receivers following the previous incident when the hook on the left side of the receiver broke off during a towing operation.
- **Corrective Action:** Following the September 9, 2003, accident RAG removed all rear tow hooks from all light service vehicles and implemented a policy that hooks shall not be installed on such trucks in the future.

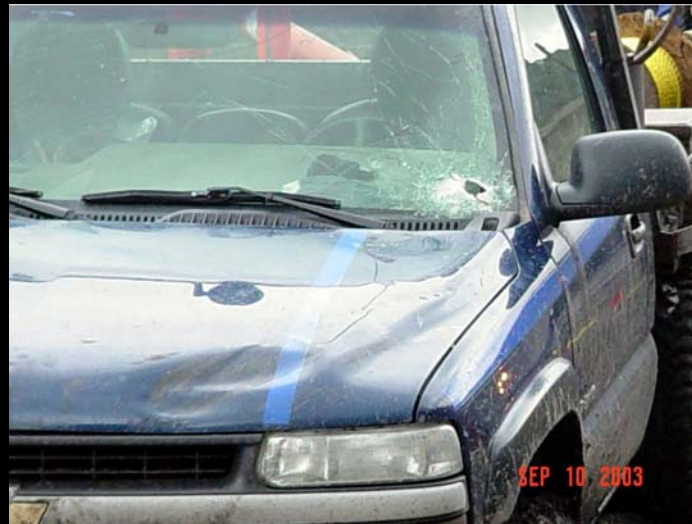
- The broken hook was found on the floor of the truck. The weight of this hook was 2.5 pounds.
- The tow rope was found on the ground on the left side of the truck to the rear.
- Damage to Beavers' truck, indicated the tow rope flipped back over the hood at an angle from right to left, denting it in the front and marking the hood at an angle from the front/middle toward the back/left side of the hood.

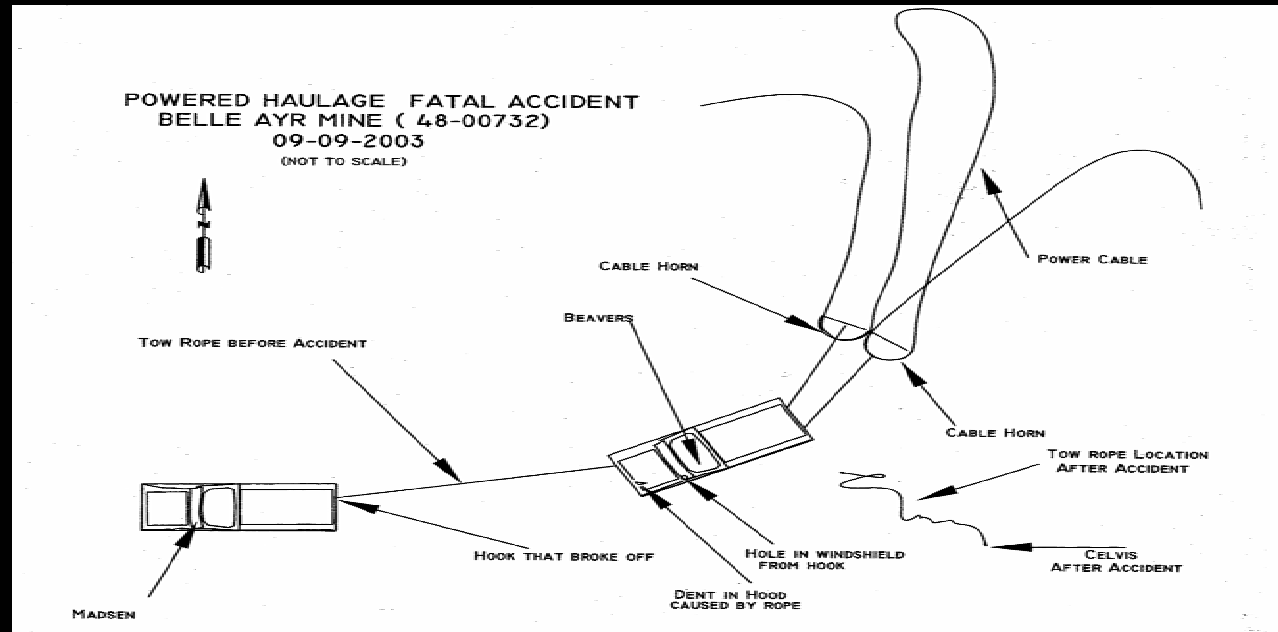
- At the time of the accident, Beavers truck was crossing from the coal seam to the bottom of the ramp through soft, muddy material. He had almost exited this material when his tires lost traction. His truck stopped on a slight downgrade of approximately 6 degrees.
- Madsen's truck was on the ramp on an upgrade of approximately five degrees. The ramp surface consisted of loose dirt with small granular material and small rocks. It was relatively dry at the time of the accident.
