**Internal Review of MSHA's Actions at the
Aracoma Alma Mine #1
Aracoma Coal Company, Inc.
Stollings, Logan County, West Virginia**

U.S. Department of Labor
Mine Safety and Health Administration
Program Evaluation and Information Resources

June 28, 2007

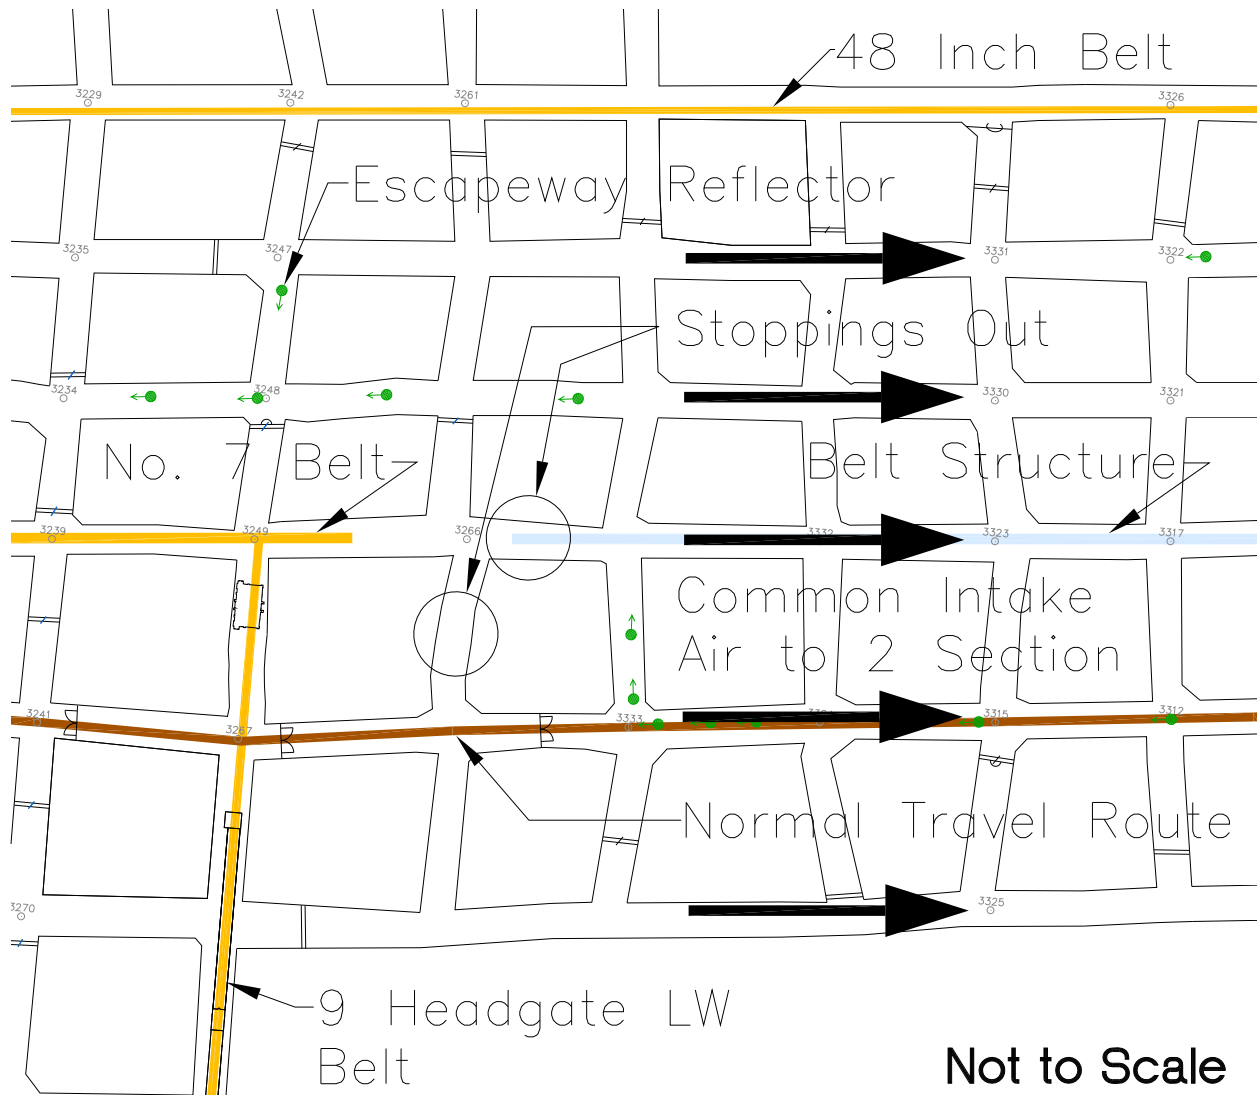
The last MSHA presence in 2 Section primary escapeway was on January 12, 2006, when an inspector documented inspection of the primary intake escapeway from the “box cut” to “2 Section.” During interviews, the District 4 inspector stated that he traveled the escapeway in a common entry and checked the stoppings along the 48-inch belt for 2 Section because he had already been to No. 7 belt and “...was assured that that stopping line was in.” When asked about the condition of the stopping lines in the primary and secondary escapeways going to 2 Section, the inspector stated that “[w]e basically traveled these every day in and out of the coal mines. The air velocity was good so I didn’t see anything that caused me a problem other than airlock doors being left open and damage which I wrote [a citation].” However, the daily route of travel in and out of the mine on the mantrip did not follow the primary escapeway for 2 Section for the entire length. The route of daily travel actually departed from the 2 Section primary escapeway and crossed the longwall belt entry as shown on the following map.

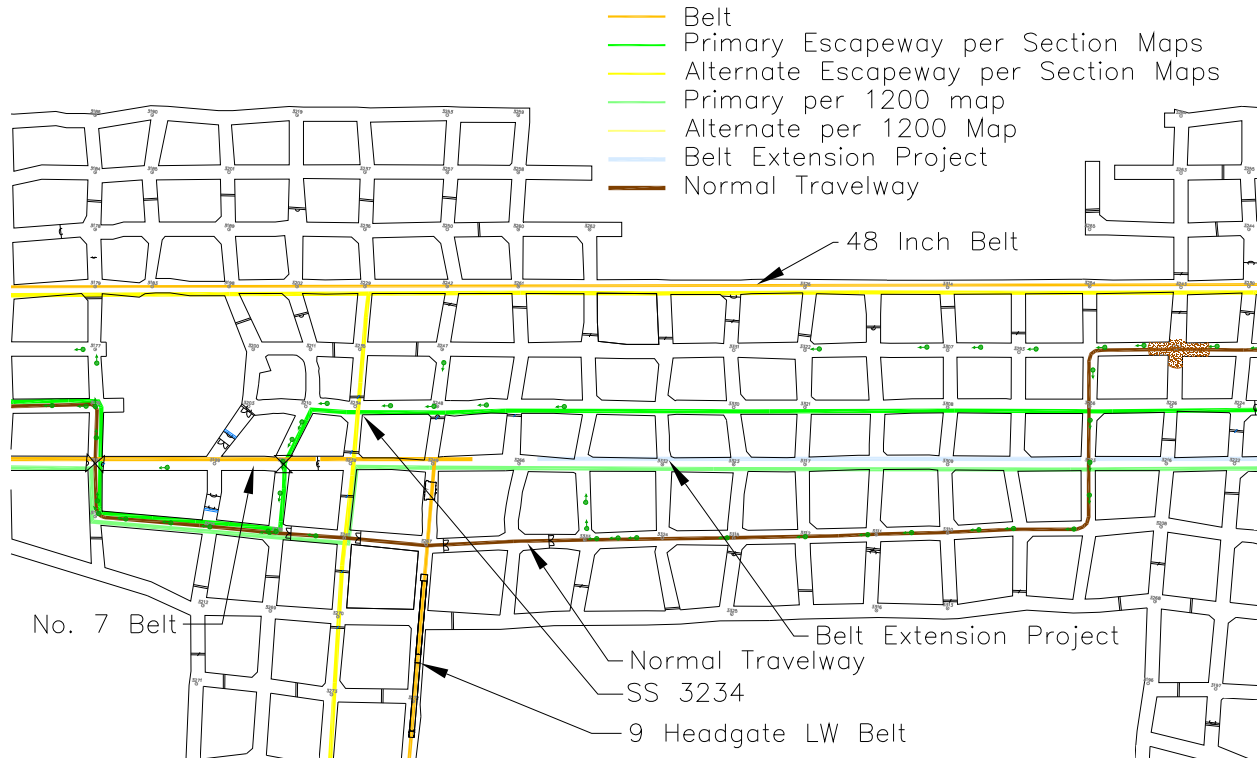
The last MSHA presence in 2 Section escapeway prior to the fatal fire was on January 12, 2006, when an inspector documented traveling the intake escapeway for the 2 Section and inspected outby areas near 2 Section. During interviews, one inspector stated that the primary escapeways were marked with green reflectors and the secondary escapeways were marked with red or yellow reflectors. A second inspector stated that he rode the diesel mantrip to inspect the 2 Section primary escapeway and did not remember the condition of the escapeway markers. However, the daily route of travel in and out of the mine on the mantrip did not follow the primary escapeway for 2 Section for the entire length. The route of daily travel actually departed from the 2 Section primary escapeway and crossed the longwall belt entry. This was the same route taken during escapeway drills by the crews on 2 Section. The following map indicates the primary and alternate escape routes from 2 Section and the Longwall Section as it was depicted on the 30 CFR 75.1200 map and the section escapeway map.
