INVESTIGATION TEAM REPORT

**Pacific Northwest
National Laboratory**

331 Building Arc Flash Investigation Team Report

May 2006

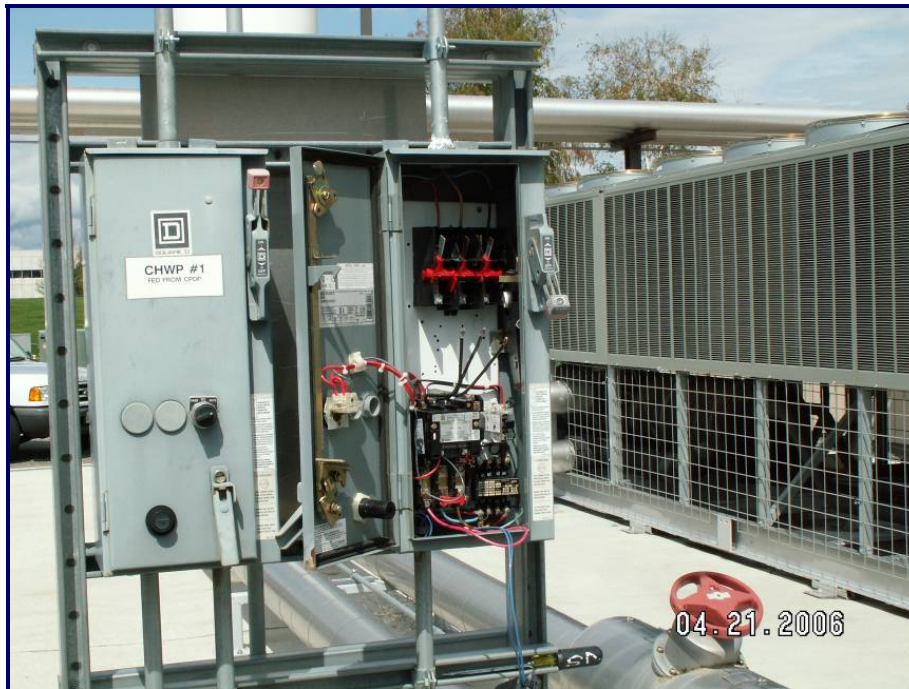
On Thursday, April 20, 2006, around 1800 hours the 331 Building chilled water pump (CHWP) #2 failed to run. The operator noted in the shift log "...When the breaker to the #2 pump was opened, the #1 pump/chiller shut down. Alarms from the wet lab started to come in, when the breaker to the #2 pump was closed the #1 pump/chiller came back on line ?...". The power operator notified the building engineer of this condition and was instructed to submit a service request to troubleshoot and repair CHWP #2. On Friday, April 21, 2006, after approval of the Service Request work scope, an electrician was dispatched to perform any necessary repairs. During performance of the troubleshooting and associated repairs, an electrical arc flash occurred inside the combination motor starter for CHWP #2. The electrician was taken to the on-site medical provider for evaluation and was subsequently released to return to work without restriction.

Figure 1.1. 331 Building Chilled Water Pump #2 Electrical Panel

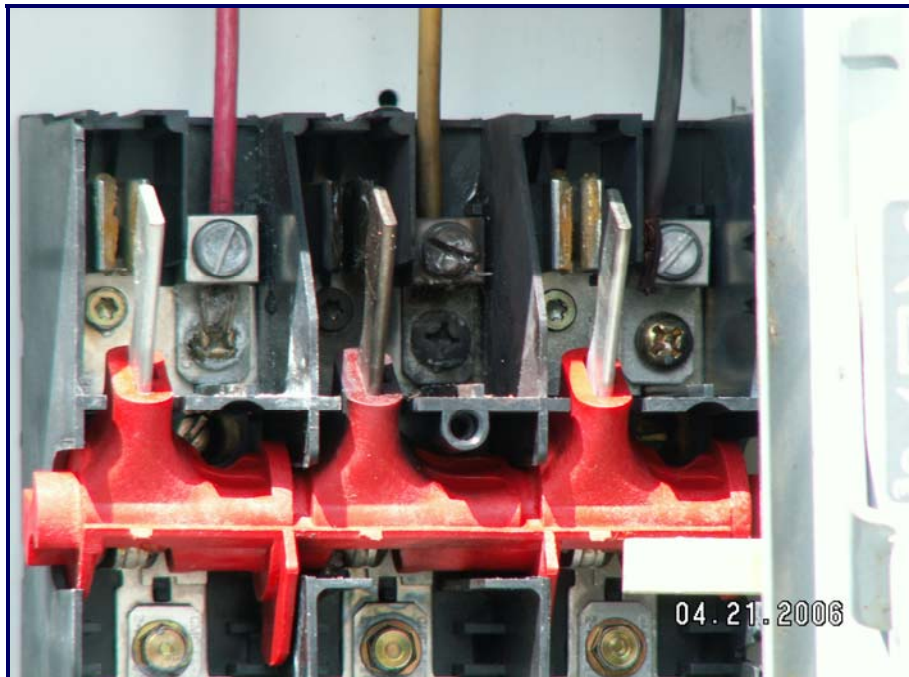
In the course of troubleshooting, a failed control transformer was diagnosed as the likely cause of the CHWP #2 failure. A replacement control transformer was obtained and repair activities began for changing out the failed control transformer. Later during the process of installing the new control transformer, an arc flash occurred. (~ 1320 hrs). The cause of the arc flash was determined to be associated with the installation of the new control transformer and repositioning the combination motor starter internal mounting plate, which also has the disconnect line-side phase lugs attached to it. During manipulation of the mounting plate, the line-side C phase conductor came out of its lug and contacted the B Phase lug resulting in an arc flash.

Figure 1.2. C and B Phase Conductors where arc flash occurred

The electrician performing the work did not contact any energized components, but received a minor, superficial (first degree) burn on the left wrist due to close proximity to the arc flash. Additionally, the electrician sustained a minor contusion on the back of the left hand from striking the combination motor starter panel door as a result of a reflex action from the arc flash.

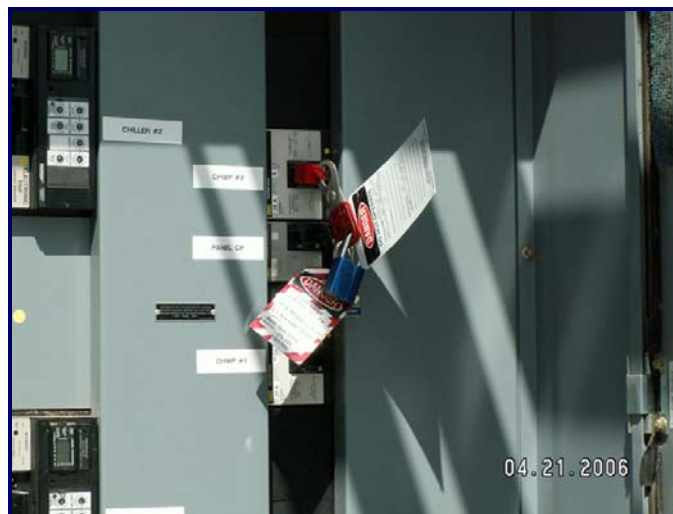
Post-event inspection of the chilled water system components identified that labels for the breakers supplying power to CHWP # 2 and CHWP #1 were reversed.

Figure 2.1. 331 Building, CHWP #1 and #2 Breaker, Labels

This labeling error dating from the time of system construction in the summer of 2000 contributed to incorrect system configuration and placement of LOTO on the wrong breaker.

PNNL's procedures for commissioning new or modified systems need to be revised to include verification of proper labeling. In addition LOTO Safe-Condition/Safe-to-Work verification procedures need to be revised to provide additional requirements and guidance.

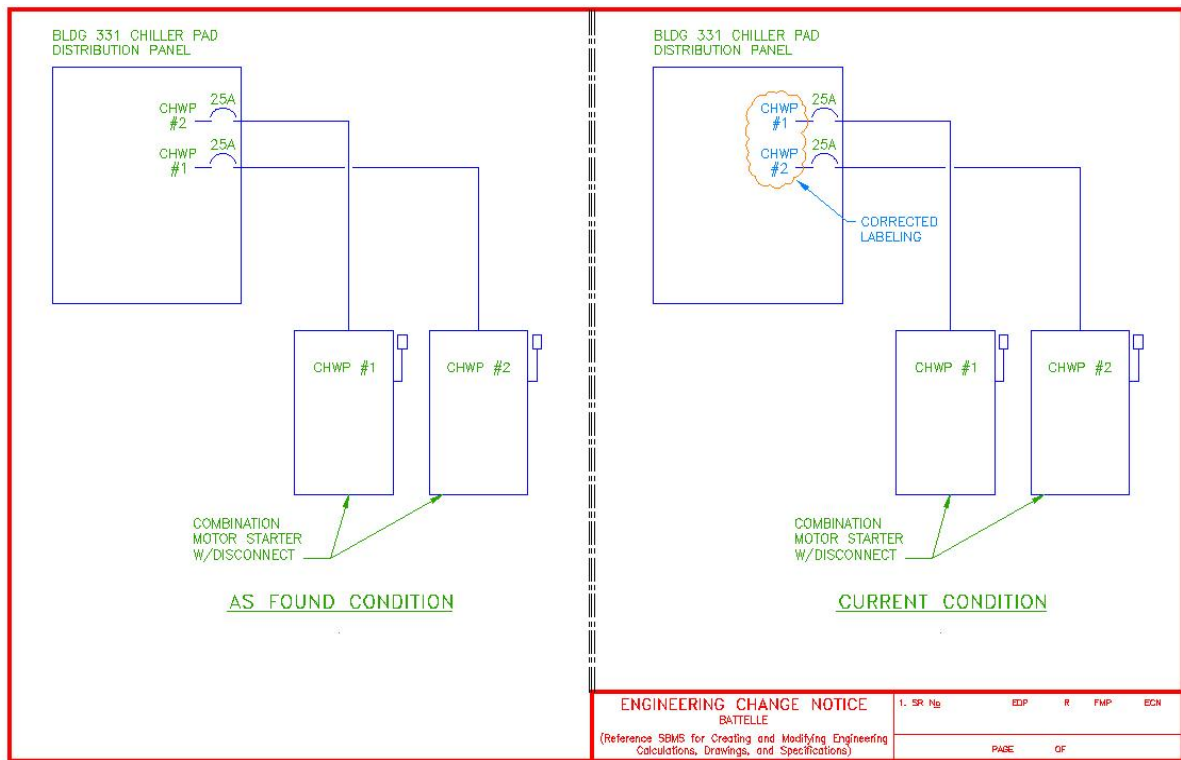
Figure 2.2. 331 Building, CHWP #1 and #2 Electrical Diagram

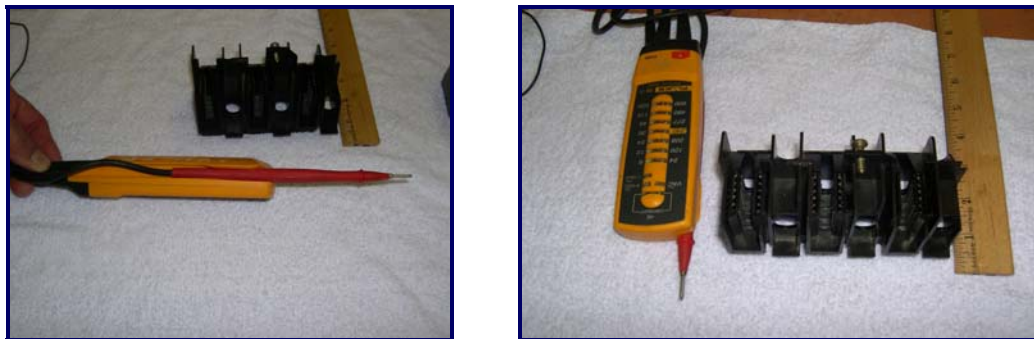
1. Use of the probe holder, on the Fluke model T-2 meter, to position the test probe could have resulted in failure of the probe to contact the phase lug.

If the probe was not positioned in the meter probe holder correctly or if the probe shifts position (slides back) in the holder as a result of contact with other conductors during previous checks, the probe may not reach far enough through the arc suppressor to make contact with the phase lug.

Figure 2.3. Fluke T-2 Meter with Probe in Housing

- R2. Electrical Safety and LOTO procedure requirements and training needs to be revised so that workers verify the electrically de-energized condition (Safe-Condition and Safe-to-Work Check) by observing the test meter probe contact with the component to be tested. These procedures should also incorporate the option, where appropriate, to allow for verification of the test meter probe contact by watching presence of electrical energy and the test meter indications falling when de-energized. Specific areas of existing procedures that need to be clarified or revised include
