**UNITED STATES
DEPARTMENT OF LABOR
MINE SAFETY AND HEALTH ADMINISTRATION
COAL MINE SAFETY AND HEALTH**

**REPORT OF INVESTIGATION
Underground Coal Mine
Fatal Fall of Face Accident
January 29, 2006**

**Aberdeen Mine
Andalex Resources, Inc.
Price, Carbon County, Utah
ID No. 42-02028**

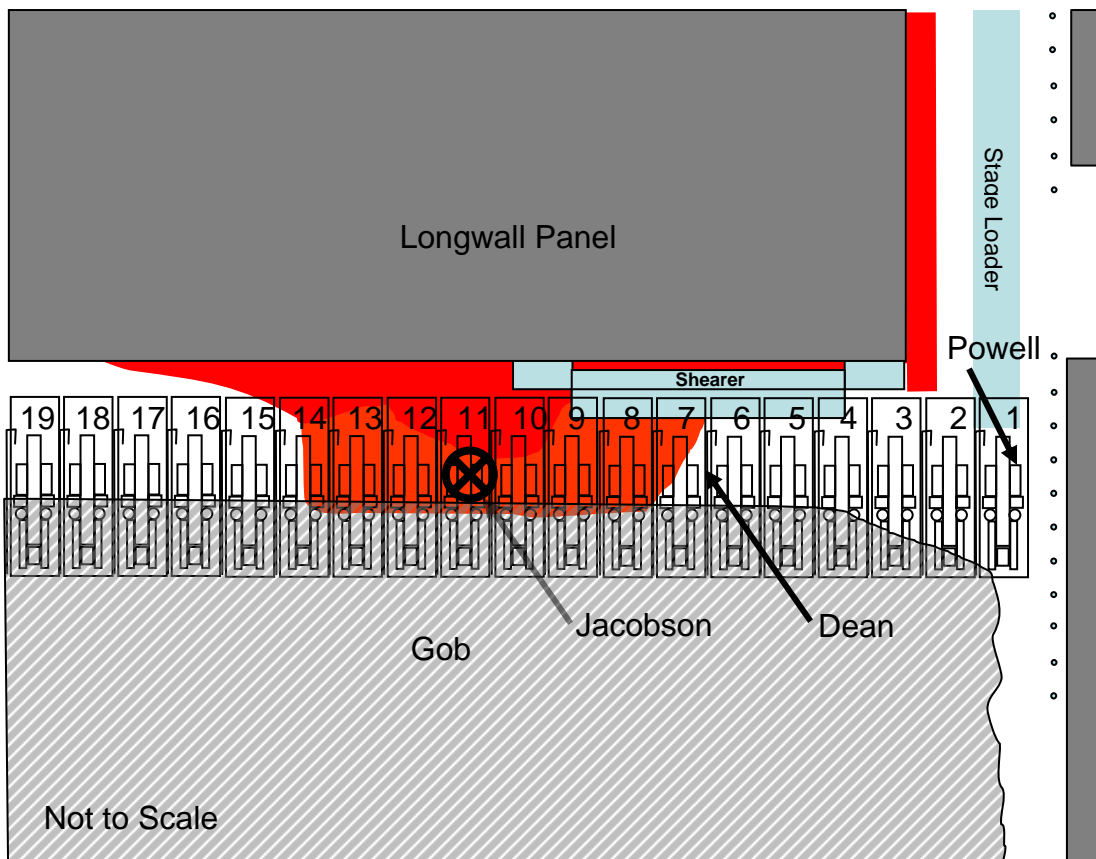
SKETCH OF ACCIDENT SITE
12th EAST LONGWALL (PANEL NO. 7)

Note: Red area designates extent of outburst

As the cutout at the headgate was being completed, a bounce with coal outburst occurred. The outburst extended approximately 30 to 40 feet up the face and 40 feet from the corner down the headgate entry on the solid coal block. Coal from the face came over the face conveyor into the shield area from Nos. 7 to 14 shields.

The fatal bounce/bump event caused coal to be thrown from the panel face across the chain conveyor and into the travelway between the conveyor and the shield legs. The affected portion of the face appeared to extend from shield No. 18 to the headgate corner. However, the largest cavity was immediately in front of shield No. 11. This cavity was in the upper half of the face and was as much as 2 ½ feet deep (beyond the shearer bit marks) for a distance of about 7 ½ feet. The ejected coal appeared to release along a nearly horizontal, planar discontinuity near the top of the coalbed. This feature was visible in the face from shield Nos. 8 to 18 and in some locations had a reddish appearance common to bumped/bounced strata surfaces.

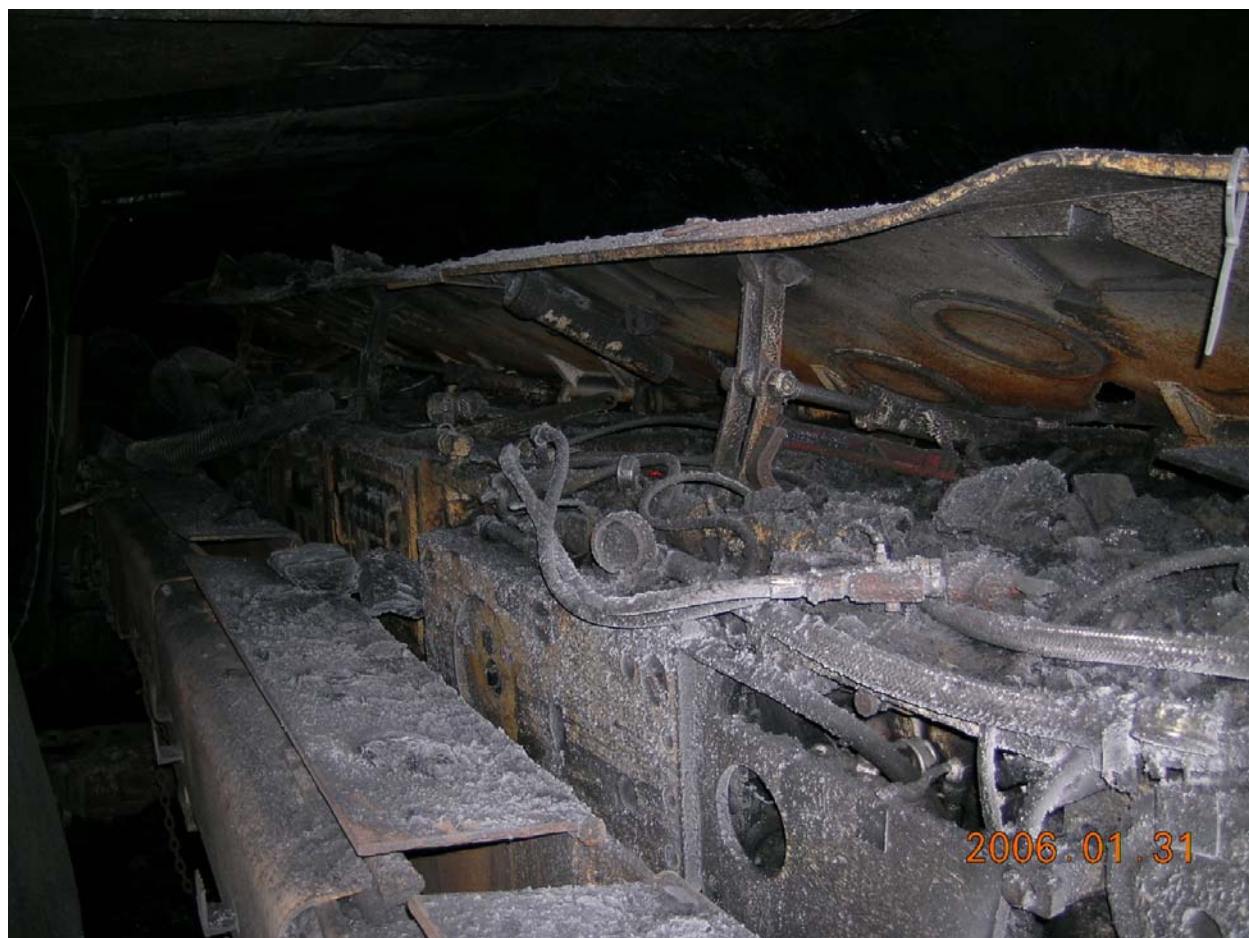
**PHOTOGRAPH OF SHEARER WITH
DEFLECTOR SHIELD IN RAISED POSITION
12th EAST LONGWALL (PANEL NO. 7)**

The shearer is equipped with a 24-foot long deflector shield or sloughage plate that can be raised 20 inches above the top of the machine. This device deters sloughed or bumped coal from entering the walkway between the shearer and the shields. Expanded metal guards are attached to the armored face conveyor periodically along the walkway for the same purpose. The guard frames were fabricated using square metal tubing and covered with expanded metal. Each was approximately 5 feet wide and extended about 20 inches above the cable trough. Similarly, 5-foot wide by 5- or 6-foot long sheets of conveyor belt were suspended from the bottom of the shield canopies along the walkway. These belt guards were not attached or restrained at the bottom, but several had chains around the metal guard and the belt guard to hold the belting to the metal guard.

During the investigation, the shearer was observed at the headgate end of the panel with both drums positioned near the floor. The tailgate drum was located near shield No. 10 and the headgate drum was near shield No. 3. The sloughage (or deflector) plate affixed to the top of the shearer was in the fully extended position. Between shield Nos. 1 and 18, metal bounce guards were in place on shield Nos. 7, 9, 11, 13, 15, and 17 and conveyor belting was suspended from shield Nos. 5 to 14, and 16 to 18. The victim was located on shield No. 11.

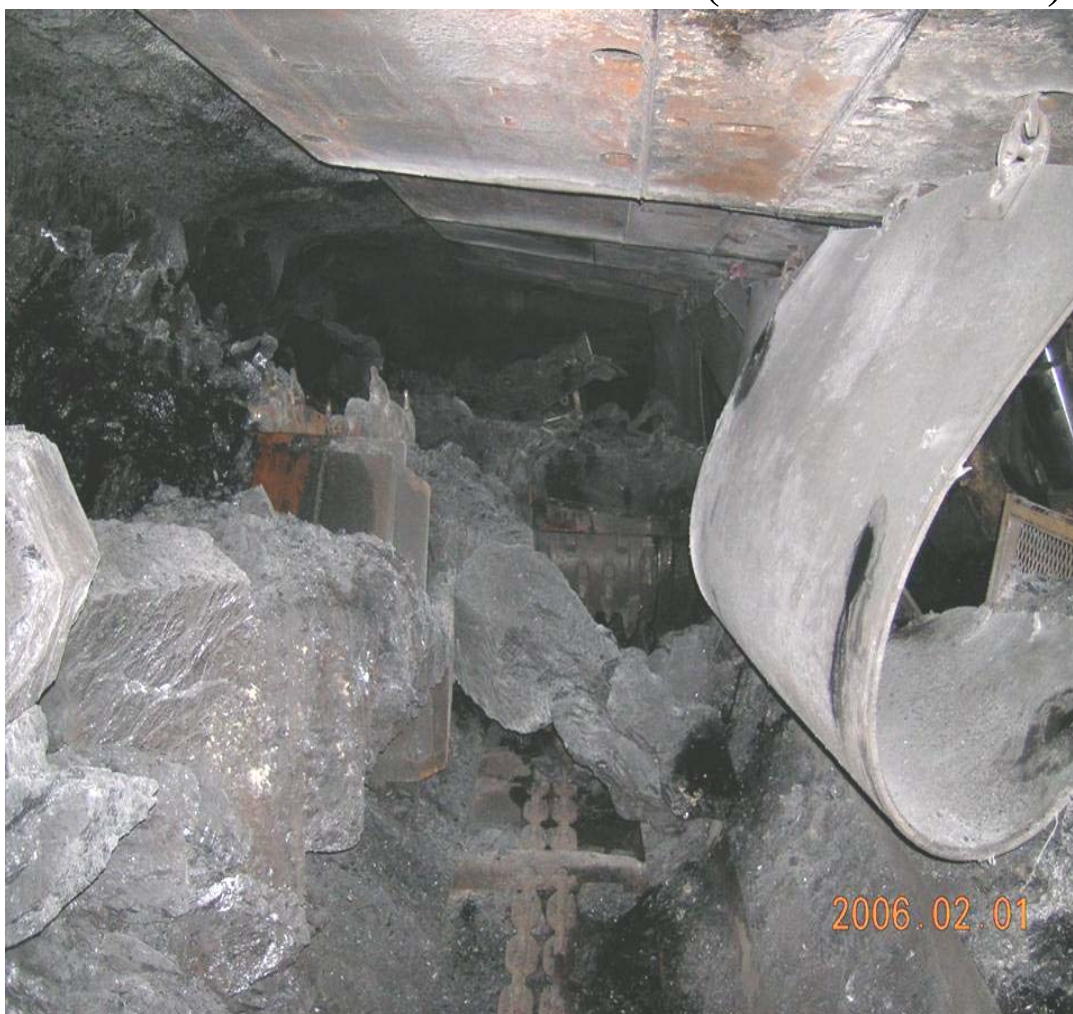
PHOTOGRAPH OF EXTENT OF OUTBURST AT ACCIDENT SITE 12th EAST LONGWALL (PANEL NO. 7)

View from shield No. 11 in face conveyor panline looking toward shearer and the headgate area. Note that conveyor continued to run after accident, emptying ejected coal and rock from the face conveyor.

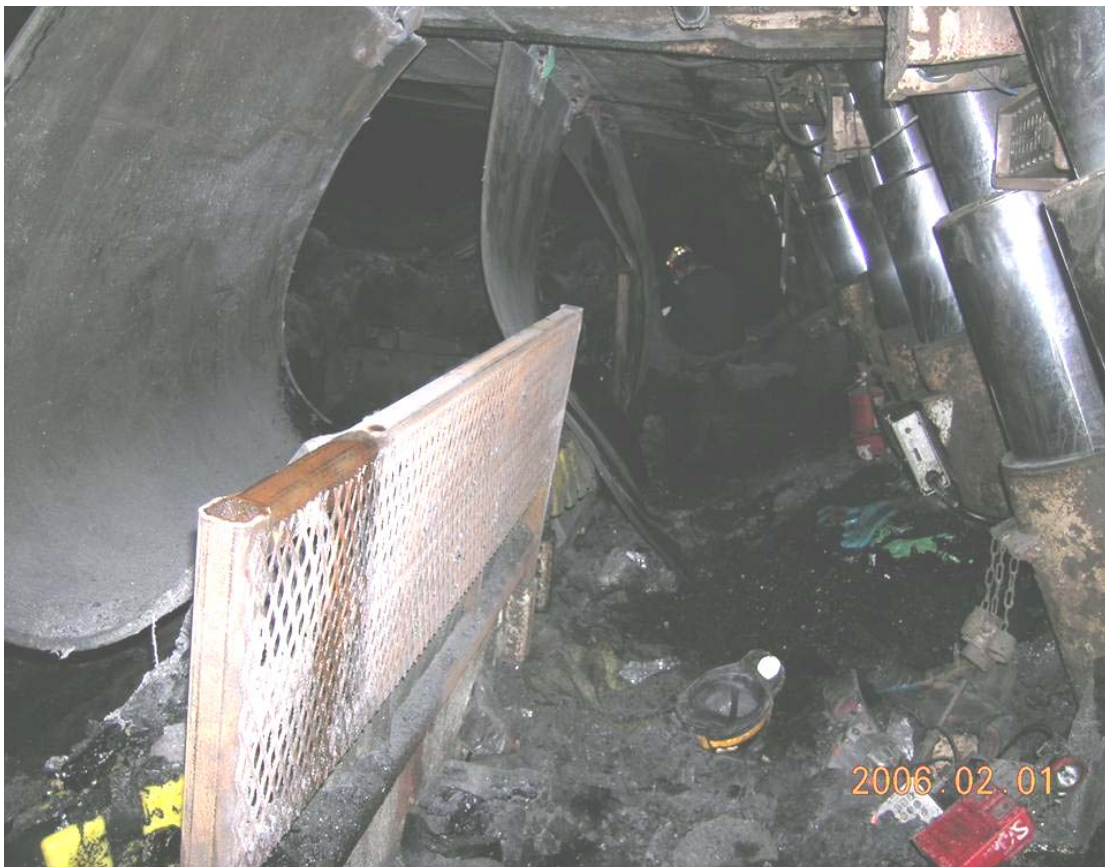
PHOTOGRAPH OF BOUNCE GUARDS IN PLACE AT ACCIDENT SITE, SHIELD NO. 11 12th EAST LONGWALL (PANEL NO. 7)

The approved roof control plan at the time of the accident required that shields in the area where bursts were occurring be equipped with conveyor belt guarding hanging from the bottom of the shield canopies between the walkway and face conveyor. These guards were required to be 60 inches wide, 5 to 6 feet long, and nominally ½ inches thick. They hung loose at the bottom. Shearer operators were required to be positioned in a safe location behind the shearer guard (deflector plate on the shearer) or the shield guards (conveyor belt guarding hanging from the shield canopies). These guards were in place at the time of the accident and Jacobson was positioned behind a conveyor belt guard and an expanded metal guard at No. 11 shield.

1. Root Cause: Management did not have sufficient procedures in place to ensure that adequate barriers were installed and used in a manner to protect miners from hazards related to outbursts on the longwall face.

Note: Belt guard normally is on right side of metal guard, but was moved after accident for recovery purposes.

Corrective action following the January 29, 2006, accident required conveyor belt guards and metal guards to be installed from shield Nos. 5 to 135 with the conveyor belt guards attached at the bottom to the face conveyor to limit the amount they could travel into the walkway. The belt guards were also restrained by two horizontal chains attached to the metal guards. Requirements restricting travel on the longwall section were implemented. Shearer operators were required to position themselves behind the elevated cutter drums, shearer lump breaker, or shearer sloughing plate (deflector plate) during the cutting sequence. In addition, headgate and tailgate entries were required to be mapped for geologic features and, where sandstone channels were found, the normal 30-inch cutting web at the face would be reduced to 15 to 18 inches. These requirements were incorporated into a roof control plan amendment approved February 10, 2006.

Corrective Action: Conveyor belt guards and metal guards were installed from shield Nos. 5 to 135 with the bottom of the conveyor belt guards attached to the face conveyor to limit movement into the longwall walkway. The belt guards were also restrained by two horizontal chains attached to the metal guards. Requirements restricting travel on the longwall section were implemented. Shearer operators were required to position themselves behind the elevated cutter drums, shearer lump breaker, or shearer sloughing plate (deflector plate) during the cutting sequence. In addition, headgate and tailgate entries were required to be mapped for geologic features and, where sandstone channels were found, the normal 30-inch cutting web at the face would be reduced to 15 to 18 inches.

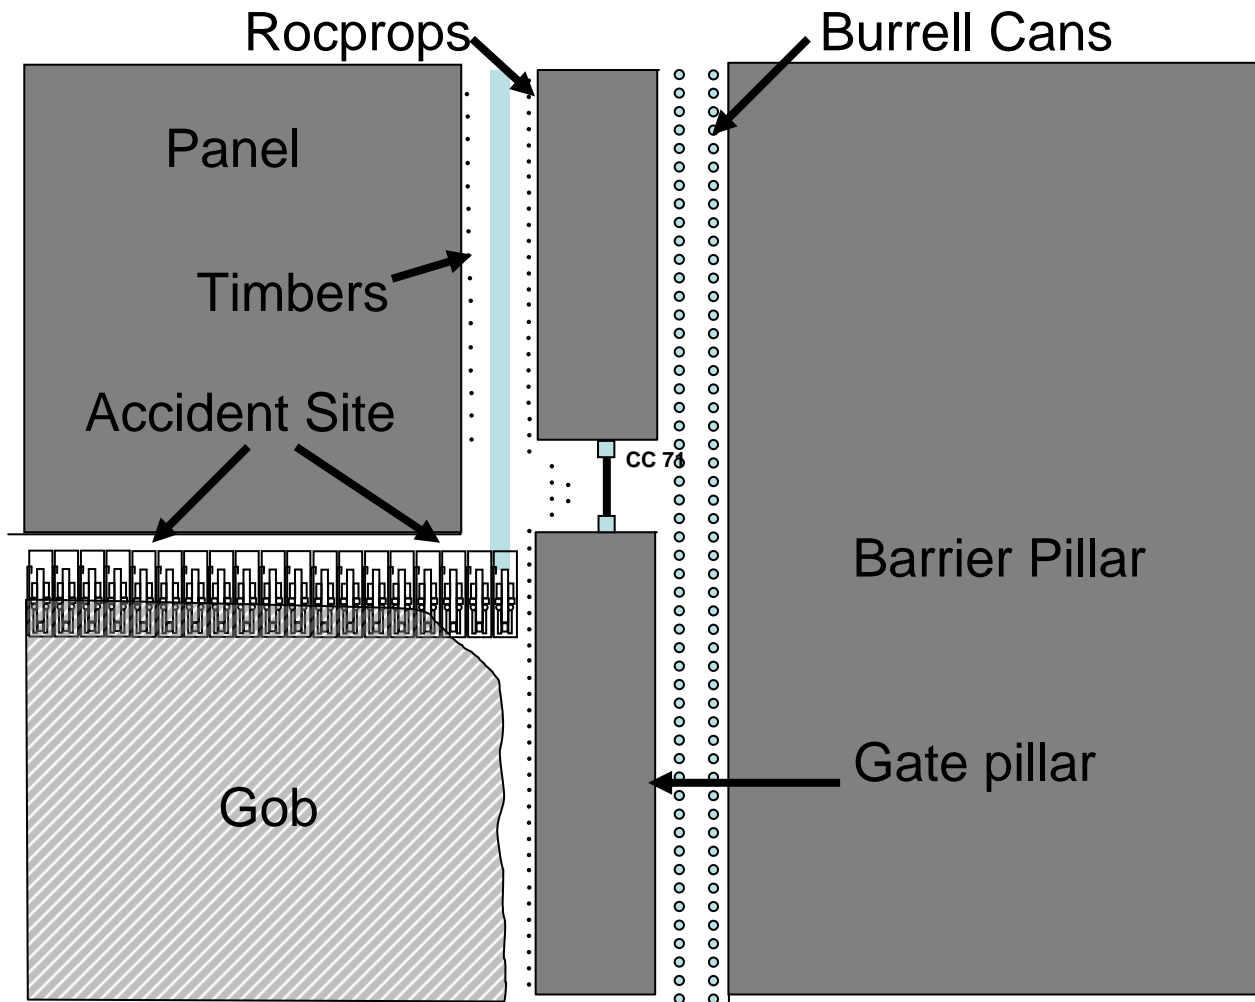
SKETCH OF AREA SUPPLEMENTAL SUPPORT

The type and density of standing support varies in each of the entries that comprise the headgate and tailgate. Rocprops (35- to 45-ton units) are installed on approximately 3-foot spacings near the gate pillar ribline on the walkway side of the beltline. A tapered wood cap block (4 inches by 6 inches tapered to 2 inches by 6 inches by 24 inches long) is placed atop each prop prior to pressurization to about 1500 psi internal pressure using either longwall hydraulics and emulsion or a water pressure washer. Chain link fencing (6 or 7 feet high) is anchored behind the props to contain coal sloughed or bounced from the pillar ribs. On the opposite side of the belt, 6- to 8-inch diameter wood posts are installed on approximately 5-foot spacings near the rib. These

The headgate travel entry is supported with two rows of 24-inch diameter Burrell cans. The cans are placed on 4-foot centers down the entry to create a 5 ½-foot wide walkway. Cribs blocks are placed between the mine roof and the top of the cans and either wood wedges or a square steel bladder (typically 3 feet on each side) is used to preload the support. The bladder (referred to as a “Jack Pack” or “pillow”) is pressurized to between 150 and 450 psi using the section water line. Chain link fencing (6 or 7 feet high) is anchored behind the cans on each side of the entry to contain coal sloughed or bounced from the ribs. Active load provided by the bladders helps prevent the cans from toppling as ribs slough against the supports.
