Docket No. SA-522

Exhibit No. 15-C

NATIONAL TRANSPORTATION SAFETY BOARD

Materials Specialists' Submission
Selected Photographs of the Fractographic
Examination of the Vertical Stabilizer

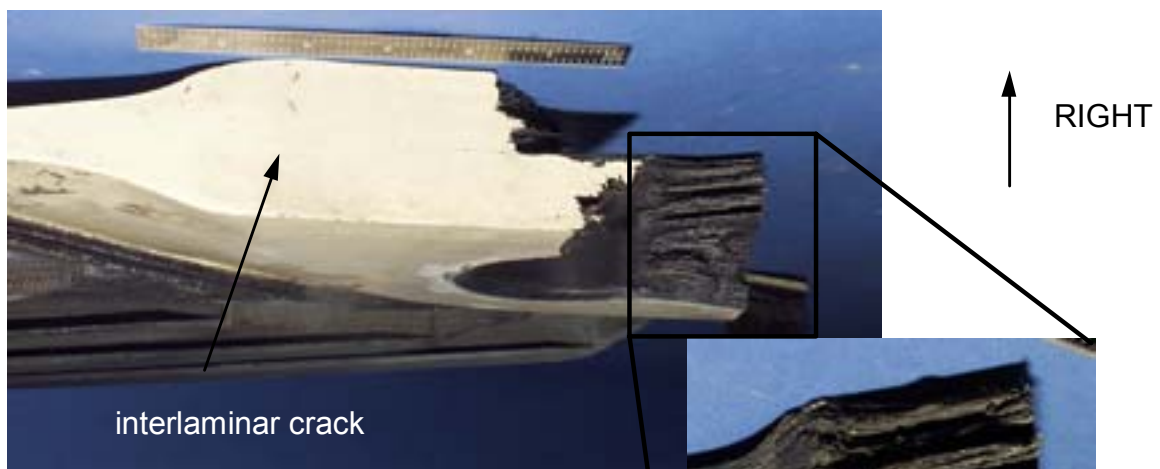
Figure 5. The right aft lug as viewed looking upward and forward. The fracture surface on the forward leg of the lug is shown in detail. Unlabeled arrows indicate bearing damage adjacent to the fracture.

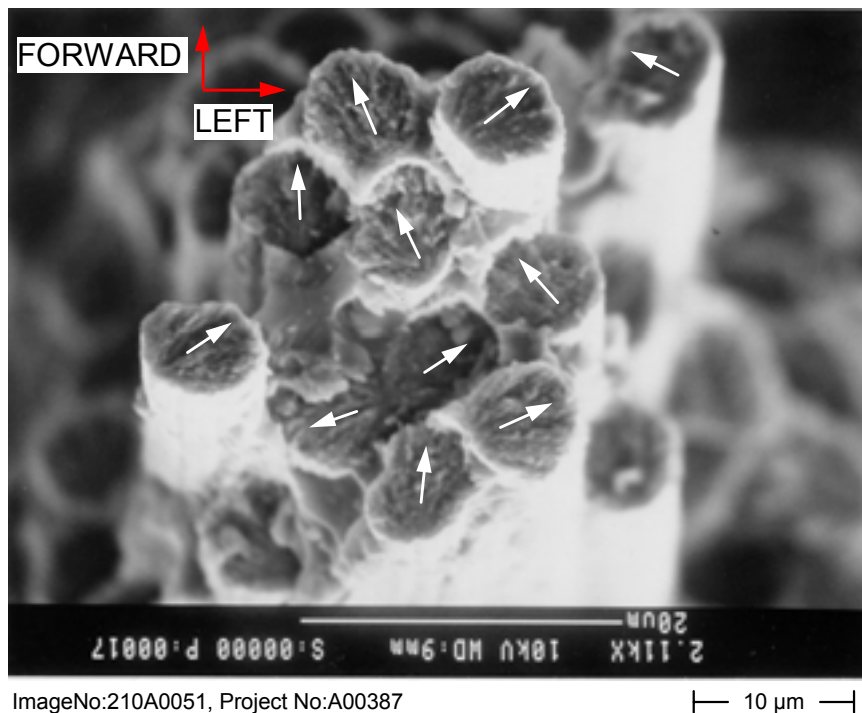
Figure 8. Typical appearance of the fractured zero-degree fibers on specimen RA3-2 near the center of the total lug thickness. Arrows on fractured fibers indicate direction of fracture propagation through the fiber.

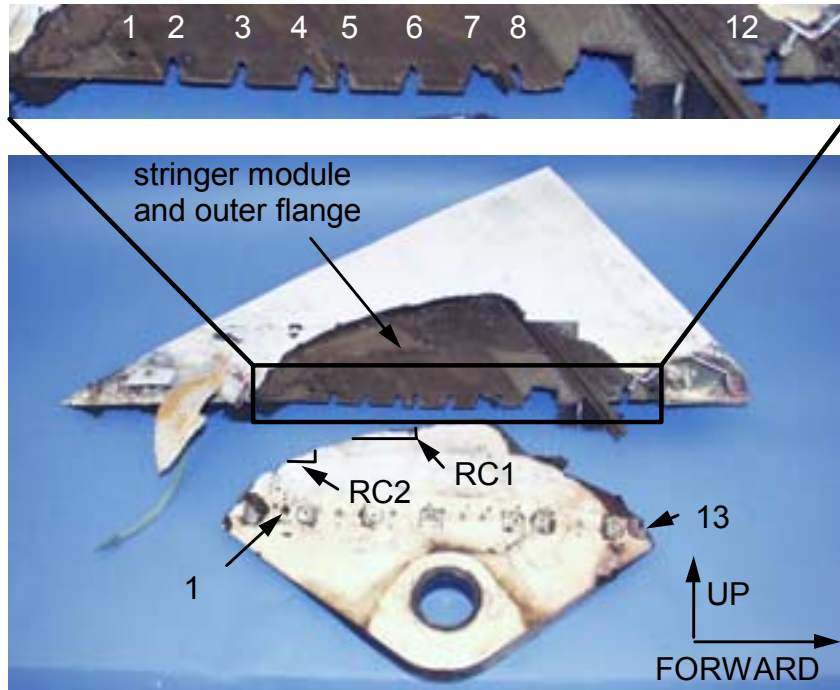
Figure 9. Overall view of the right center lug pieces viewed from the right with the upper photograph showing details of the rib 1 fastener hole tearouts in the stringer module and outer flange layers.

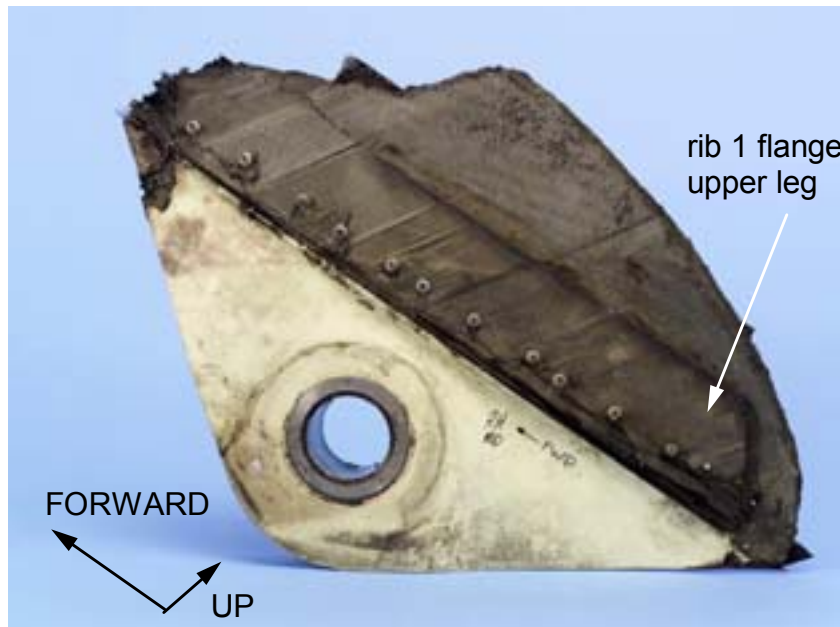
Figure 10. Overall view of the right center lug, lower piece, looking from the left.

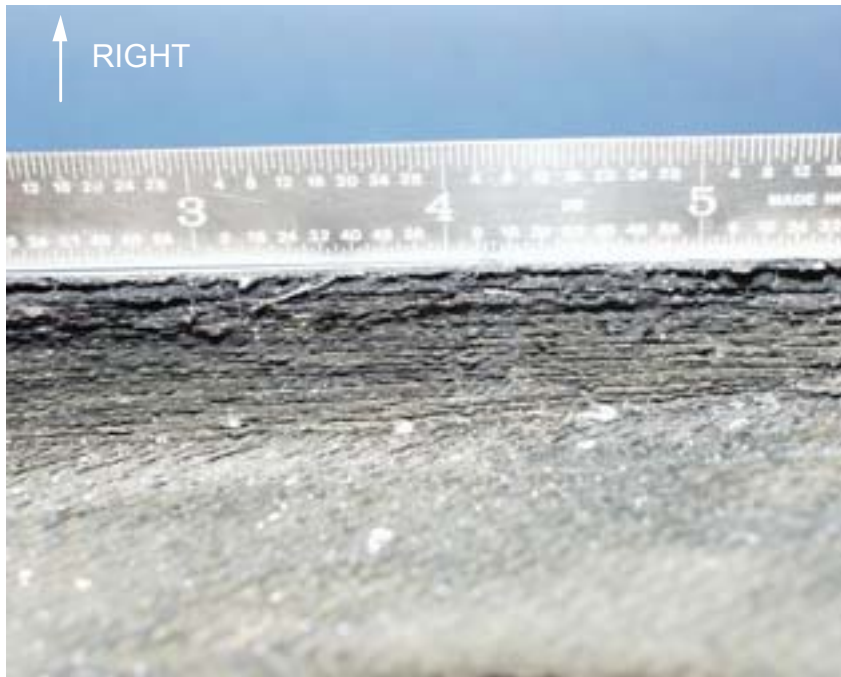
Figure 11. Right center lug upper fracture surface viewed looking upward parallel to the zero-degree fiber direction.

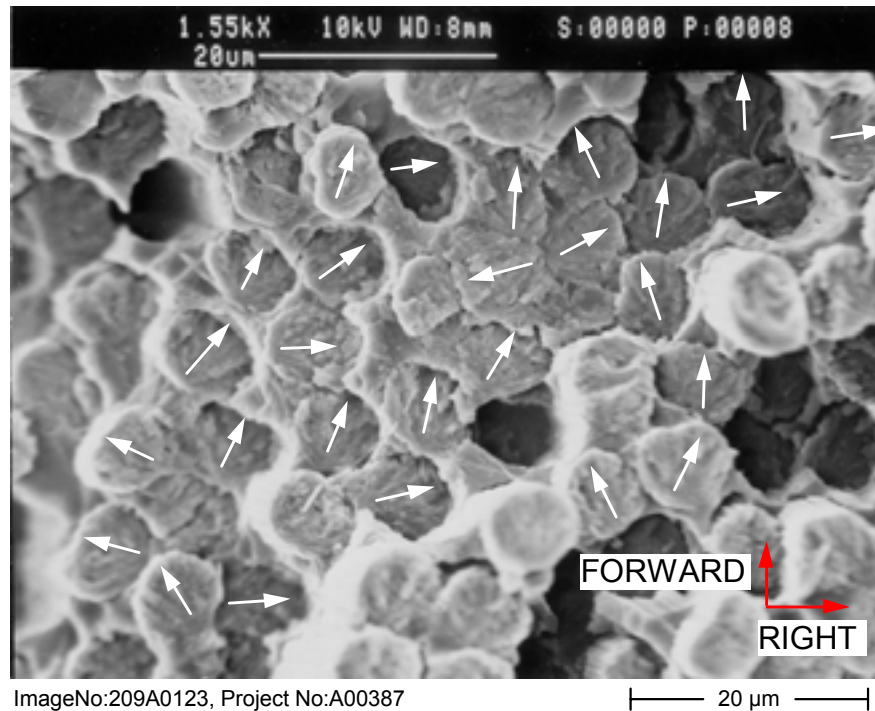
Figure 12. Typical appearance of the fractured zero-degree fibers on specimen RC2 near the exterior surface. Arrows on fractured fibers indicate direction of fracture propagation through the fiber.

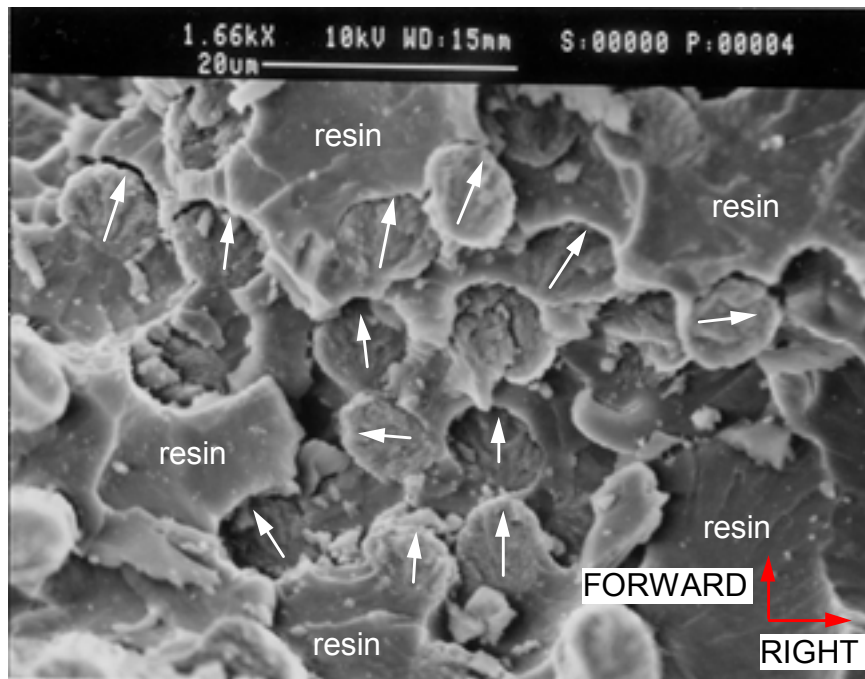
Figure 13. Typical appearance of the fractured zero-degree fibers on sample RC1 near the exterior surface. Arrows on fractured fibers indicate direction of fracture propagation through the fiber.

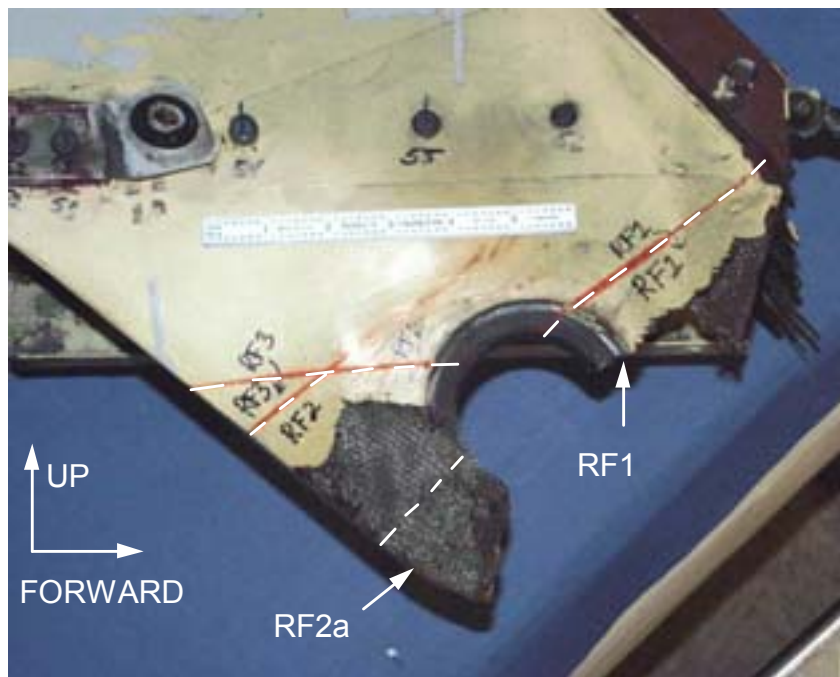
Figure 14. Overall view of the right forward lug upper fracture area. Dashed lines indicate locations where cuts were made.

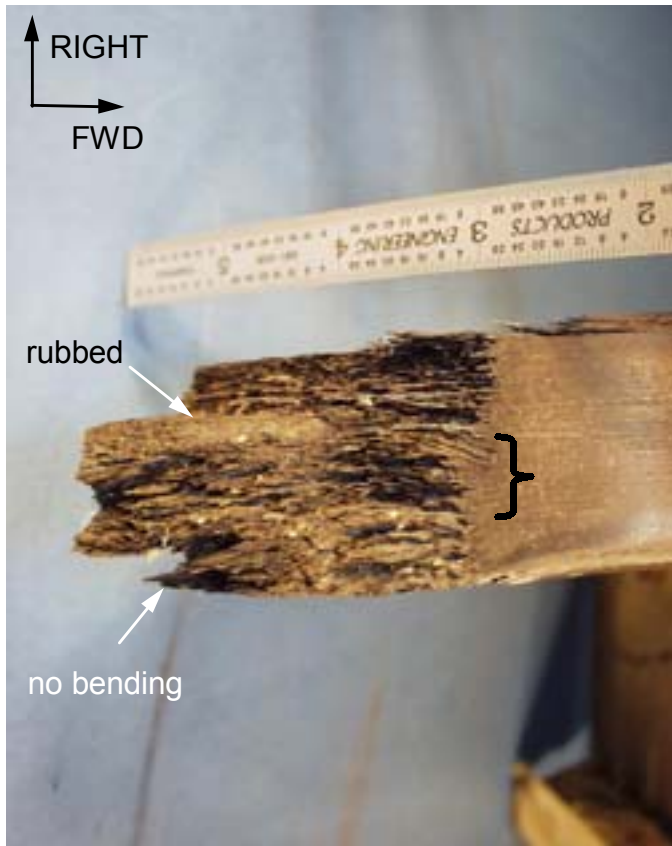
Figure 15. Direct view of the right forward lug, aft leg looking upward and aft. The bracket indicates fiber ends bent to the right.

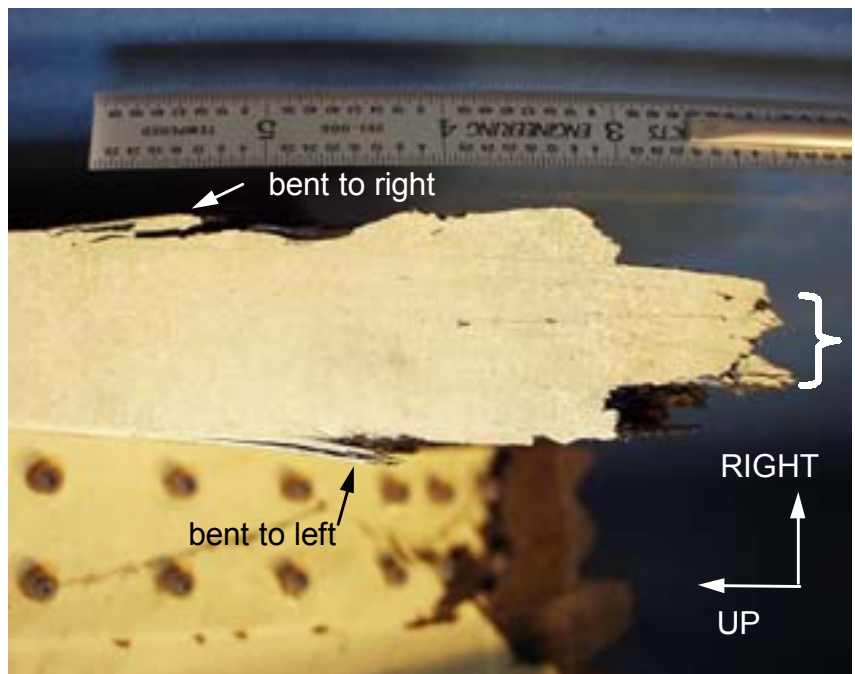
Figure 16. The aft surface of the right forward lug above the fracture through the aft leg, showing delaminations. View is looking upward and forward. The bracket indicates fiber ends bent to the left.

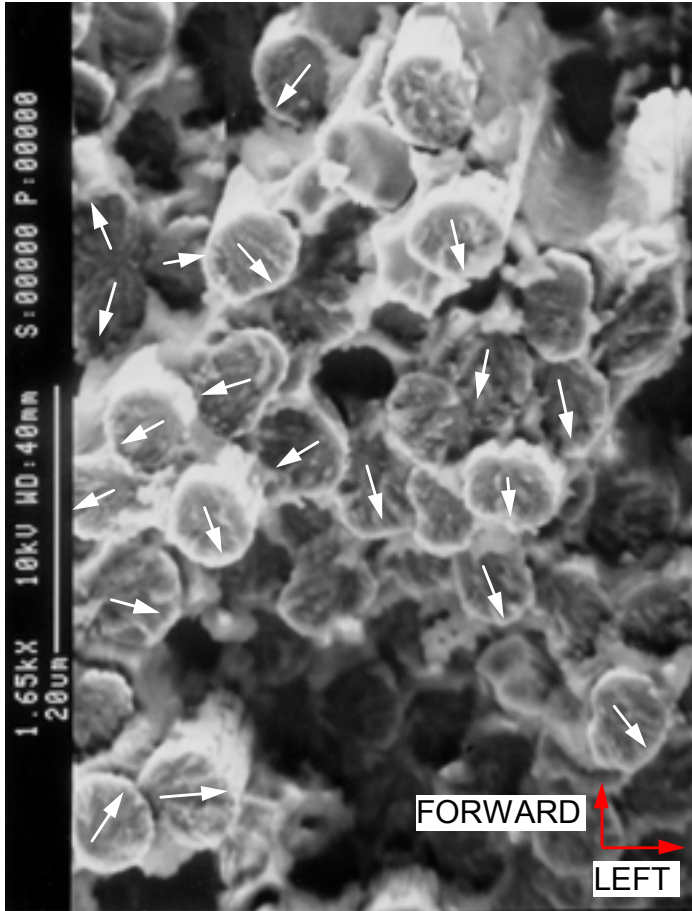
Figure 21. Typical appearance of the fractured zero-degree fibers on sample RF2a near the exterior surface. Arrows on fractured fibers indicate direction of fracture propagation through the fiber.

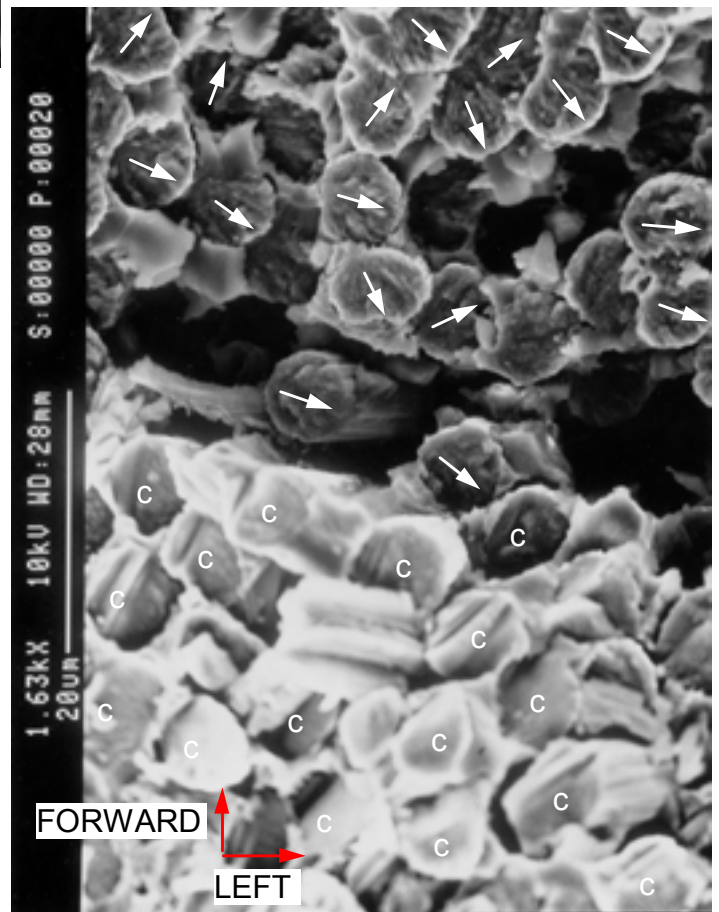
Figure 22. Typical appearance of the fractured zero-degree fibers on sample RF2a near the forward and center portions of the fracture. Arrows on fractured fibers indicate direction of fracture propagation through the fiber.

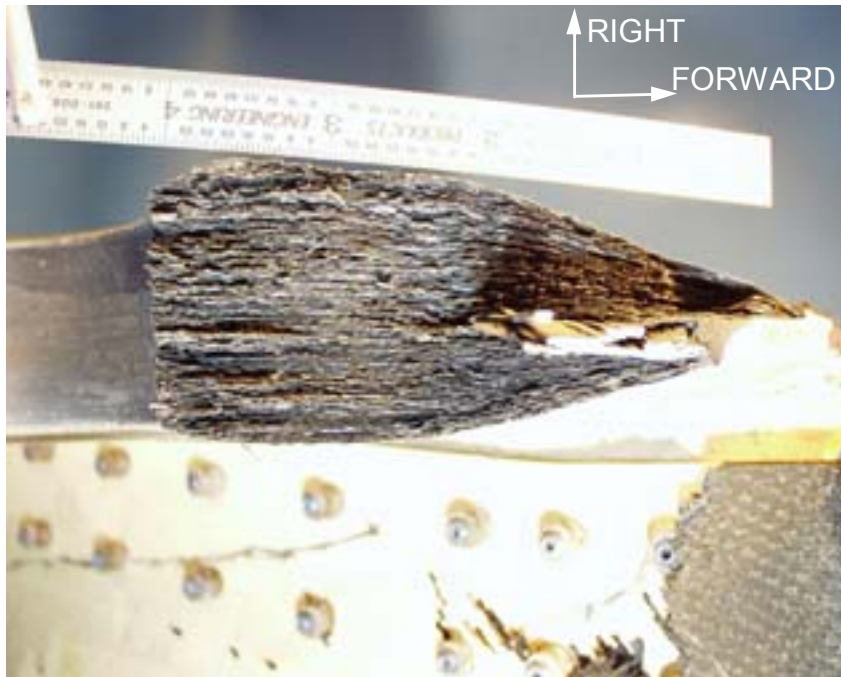
Figure 23. Fracture surface on the forward leg of the right forward lug, View is looking upward parallel to the zero-degree fiber direction.

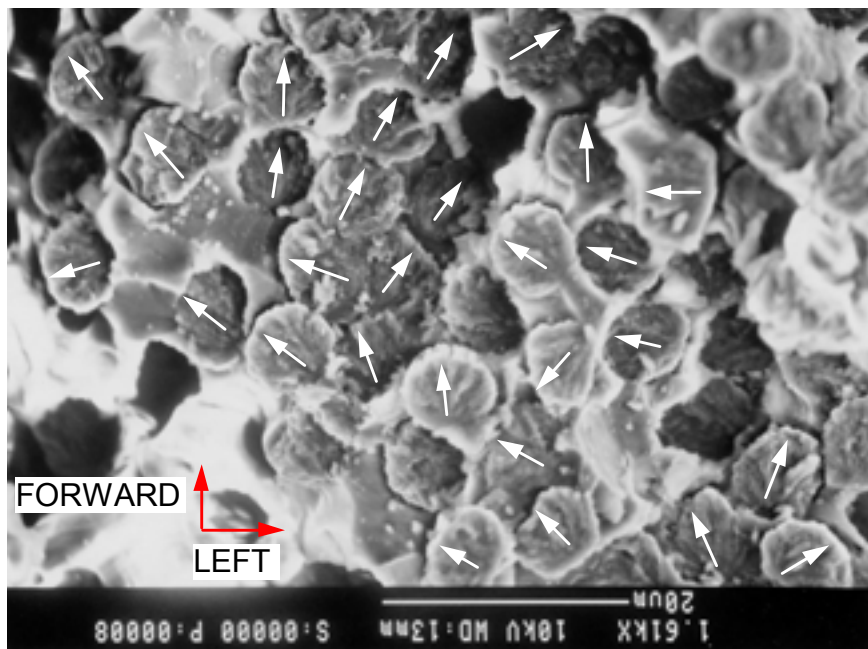
Figure 24. Typical appearance of the fractured zero-degree fibers on sample RF1 near the outer and aft portions of the fracture. Arrows on fractured fibers indicate direction of fracture propagation through the fiber.

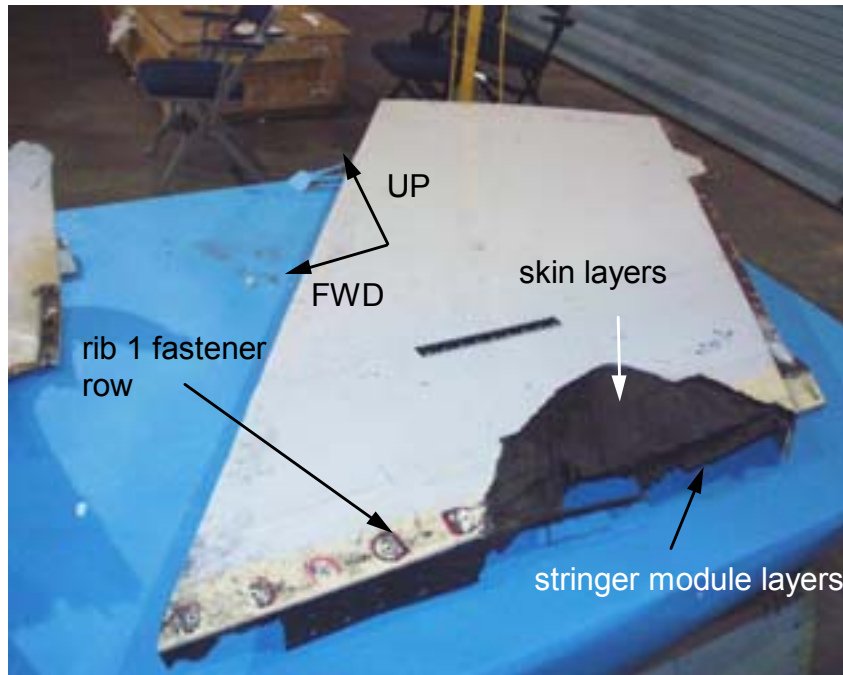
Figure 25. Overall view of the upper skin panel piece containing the upper portion of the fracture at the left aft lug, viewed looking up and to the right.

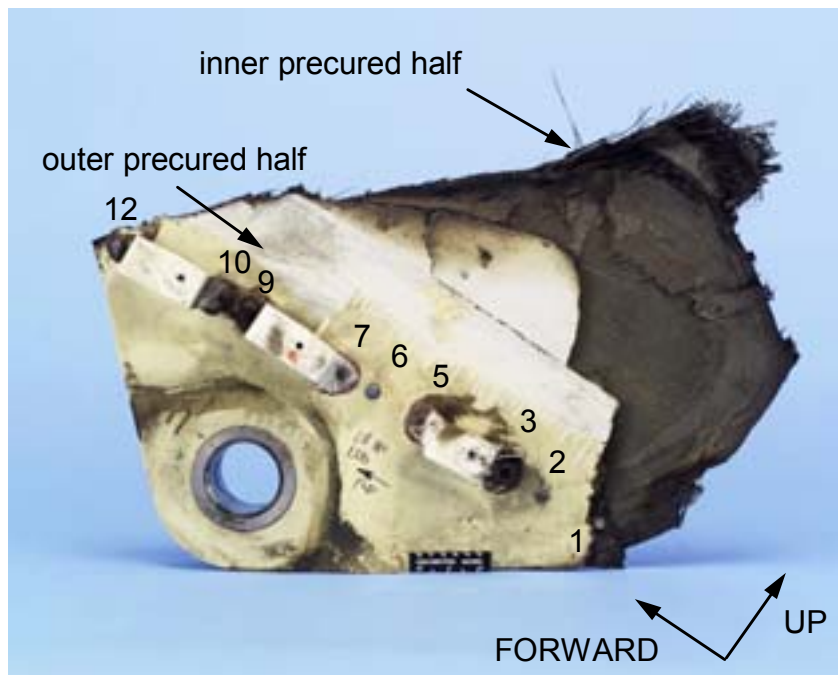
Figure 26. Overall view of the lower piece of the left aft lug, viewed looking to the right.

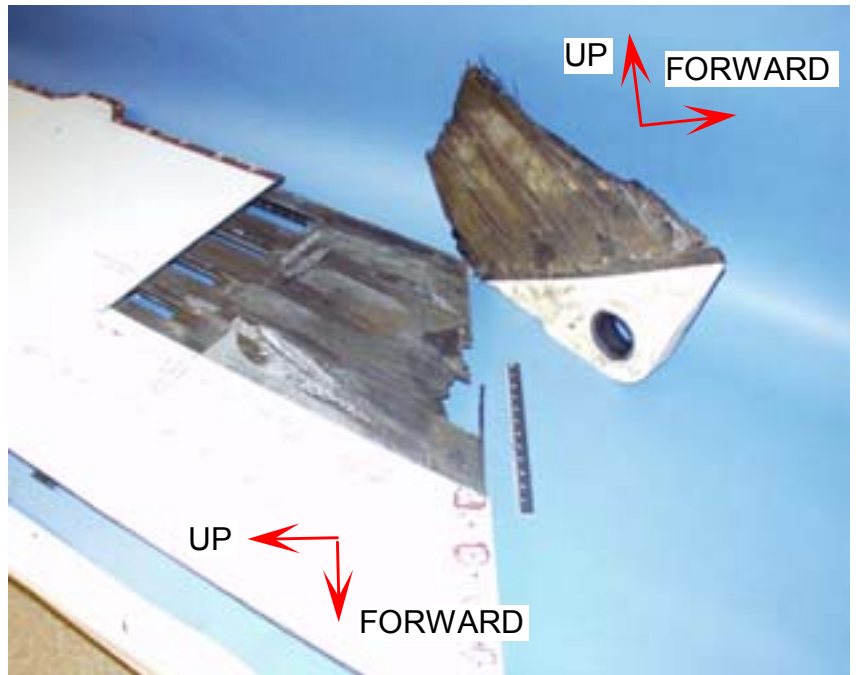
Figure 27. Mating fracture surfaces between the inner precured lug layers and the interior stringer structure of the left aft panel after cutting the skin panel section.

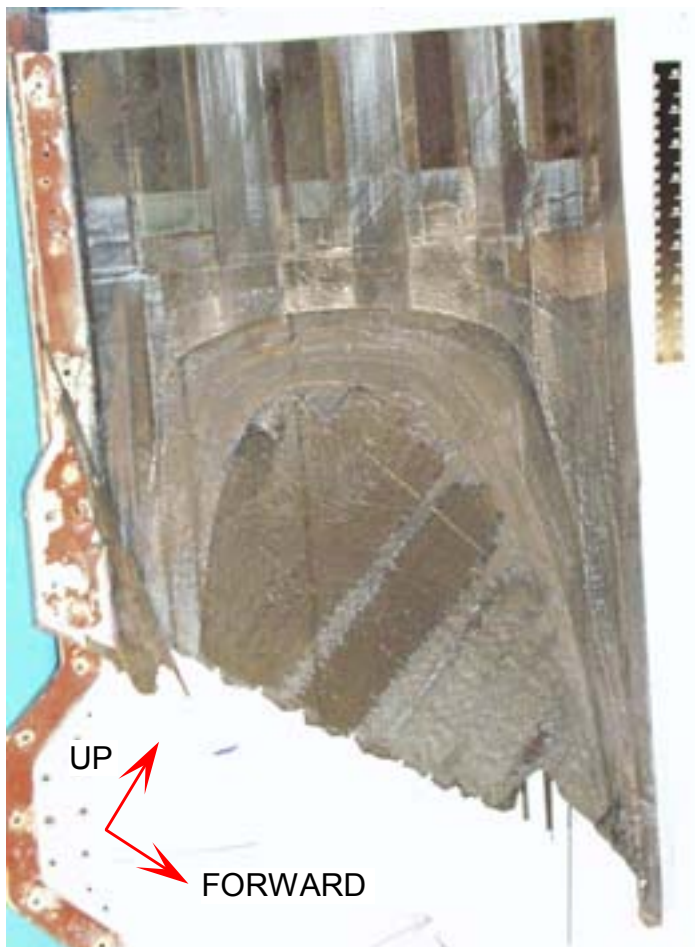
Figure 28. Inner surface of the vertical stabilizer left side skin section at the left aft lug after cutting from the upper skin panel piece. The lower portion of this interlaminar surface mates to the outer surface of the inner precured lug half.

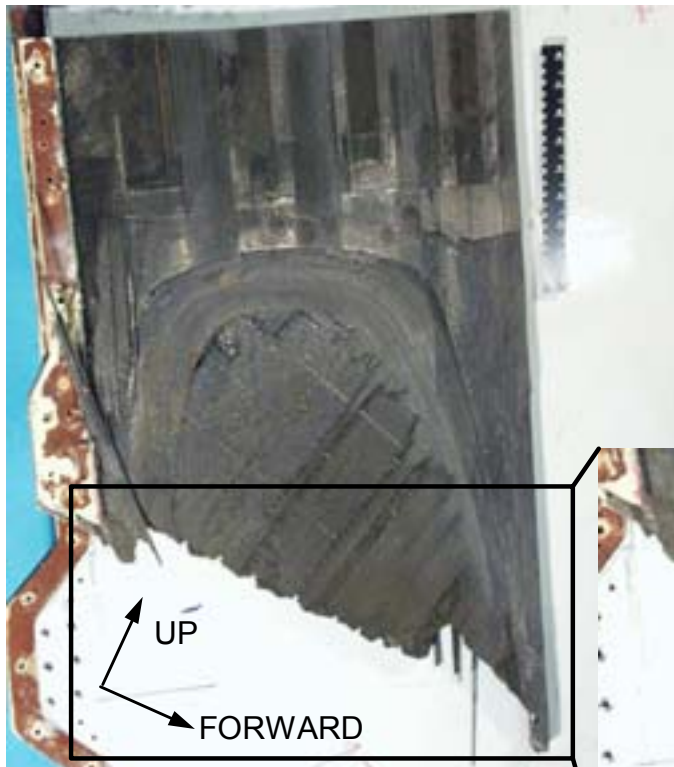
Figure 31. The interior surface of the vertical stabilizer skin section at the left aft lug fracture area after cutting from the upper skin panel piece. Inset photograph shows the numbered rib 1 fastener holes.

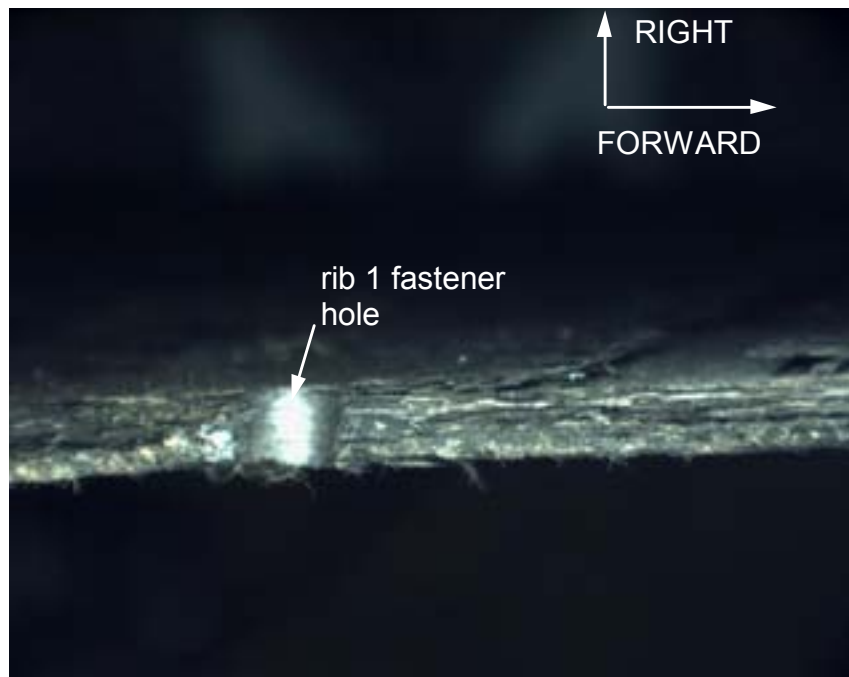
Figure 32. Vertical stabilizer skin fracture at a rib 1 fastener hole in the vicinity of the left aft lug, viewed looking upward.

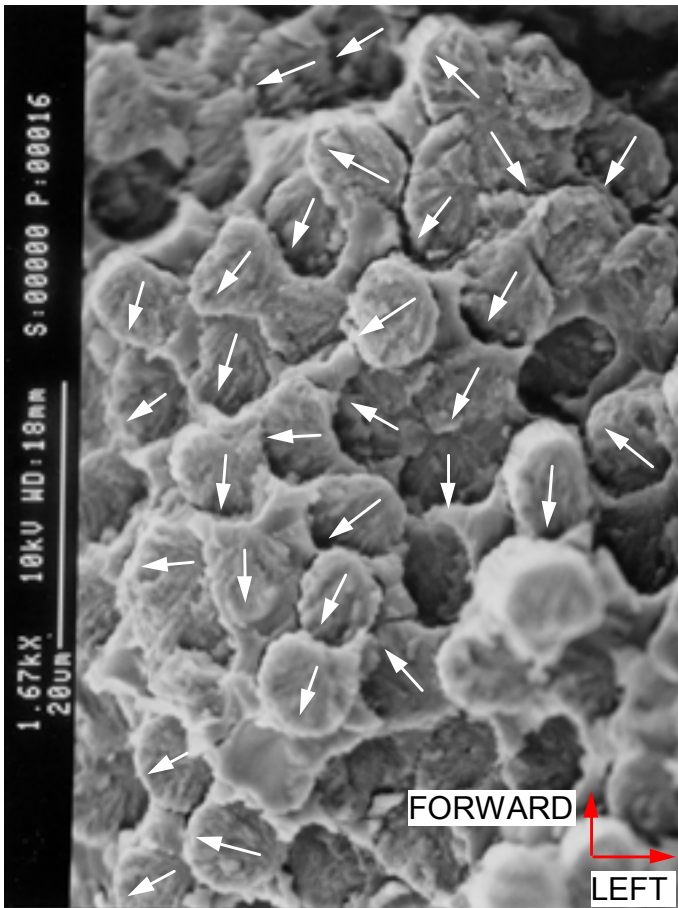
Figure 33. SEM photograph with arrows indicating the direction of tensile crack propagation on the ends of zero-degree fibers from the inside edge of specimen LA5a.

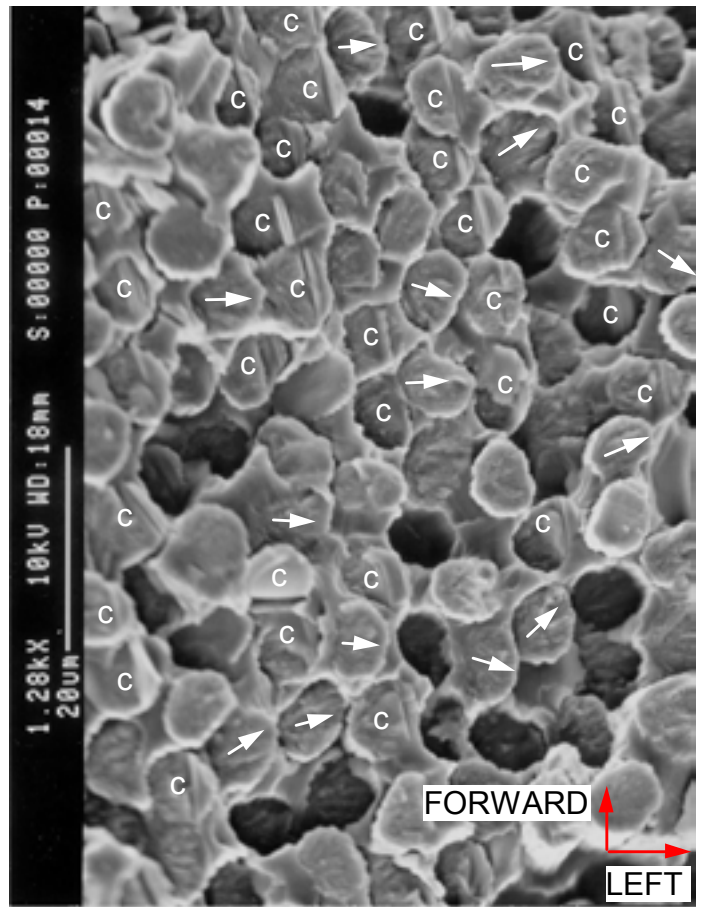
Figure 34. SEM photograph from the center of specimen LA5a. Arrows indicate the direction of tensile crack propagation and labels "c" indicate compressive failure on the ends of zero-degree fibers.

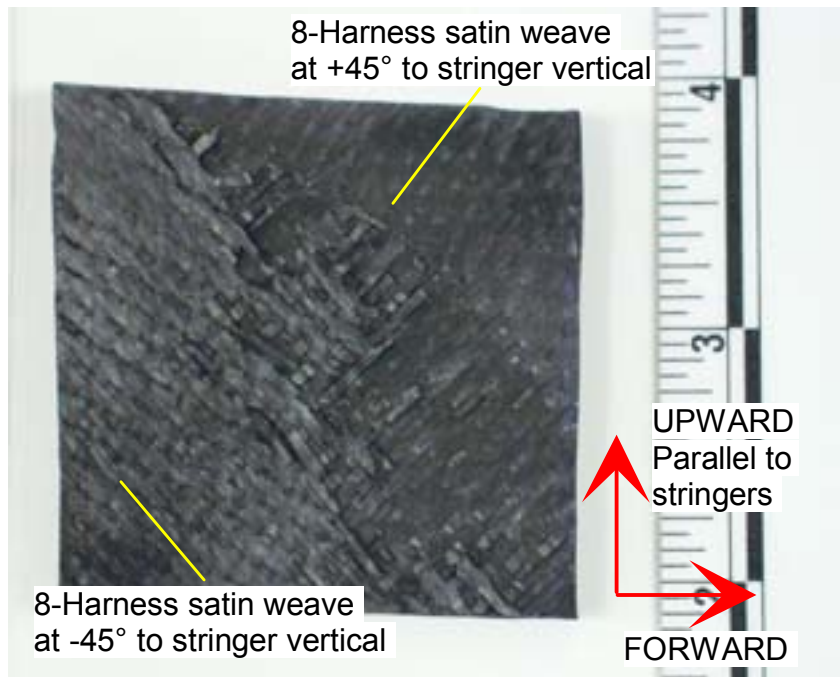
Figure 35. Fracture surface of specimen LA1a.

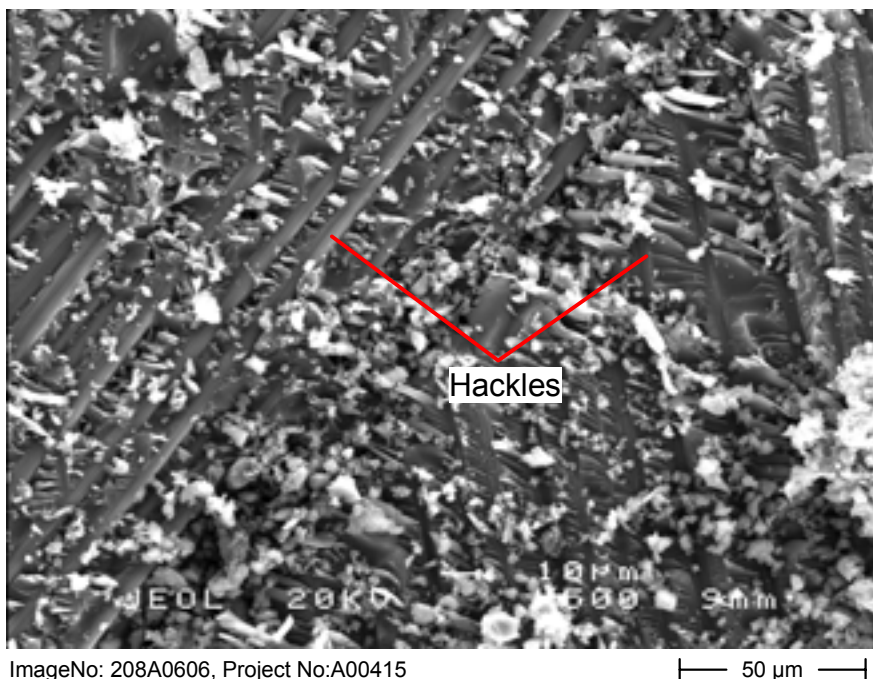
Figure 36. Example SEM photograph from the top forward area of specimen LA1a. Hackles are indicated between +45-degree fibers (left) and zero-degree imprints (right), pointing up and forward. Orientation as in figure 35.

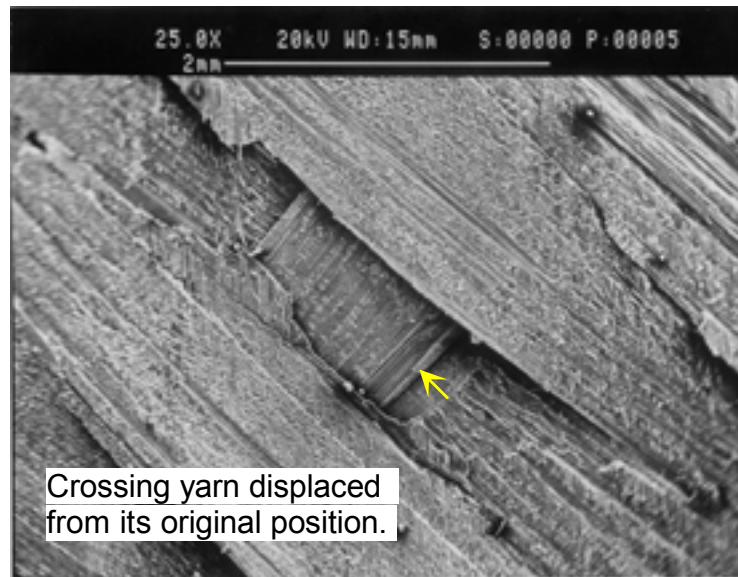
Figure 37. Specimen LA5 inner surface. An unlabeled arrow indicates a crossing yarn that was displaced from its original position. Orientation as in figure 35.

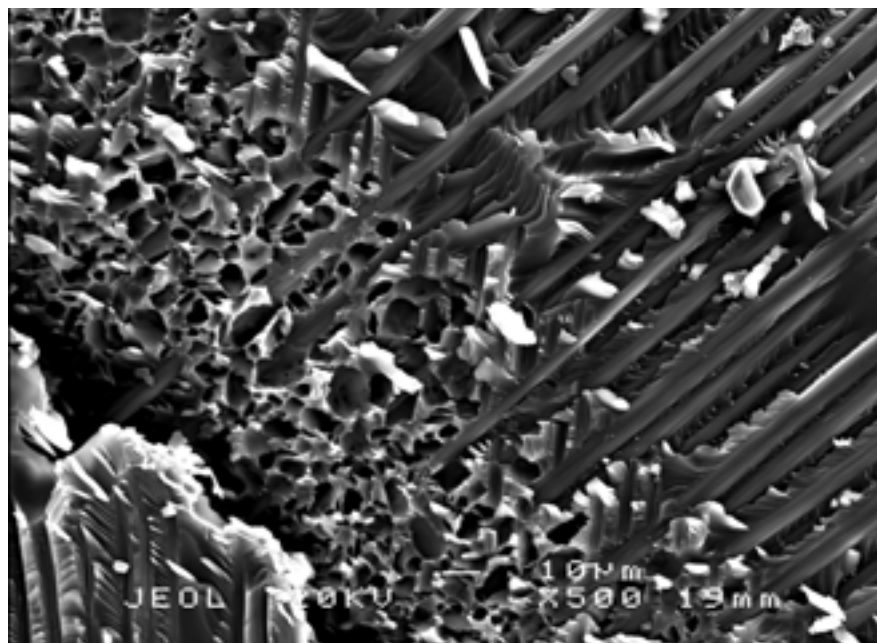
Figure 38. Microscopic matrix porosity in a region where yarns cross on specimen LA1b. The main yarn is at the upper right, with vertical imprints at the lower left. Orientation as in figure 35.

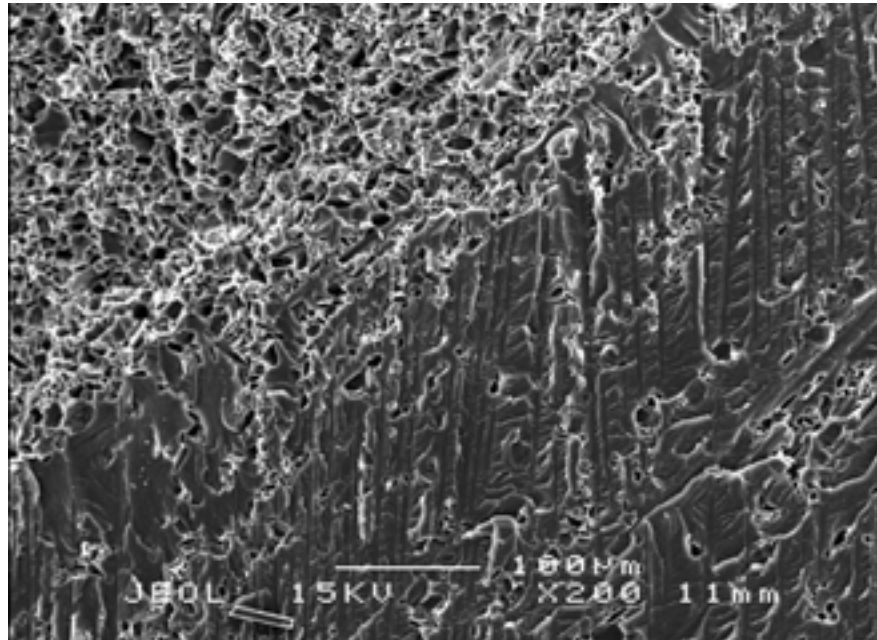
Figure 39. Microscopic matrix porosity on the outboard piece of LA1c. This porosity is shown at the upper left, with ill-defined hackles shown at the lower right. Orientation as in figure 35.

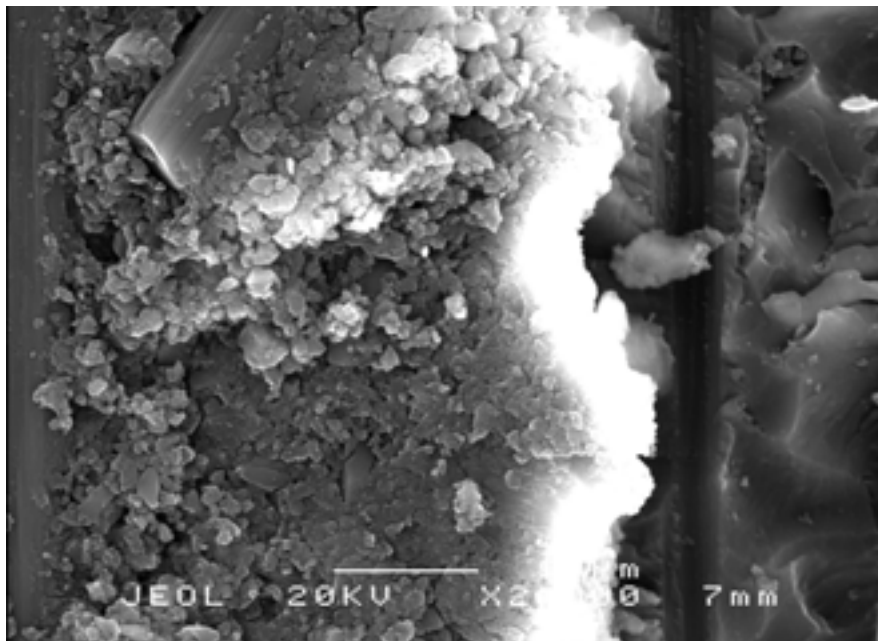
Figure 40. Microscopic matrix granularity on the outboard piece of LA1c. A fiber fragment is shown at the upper left. Orientation as in figure 35.

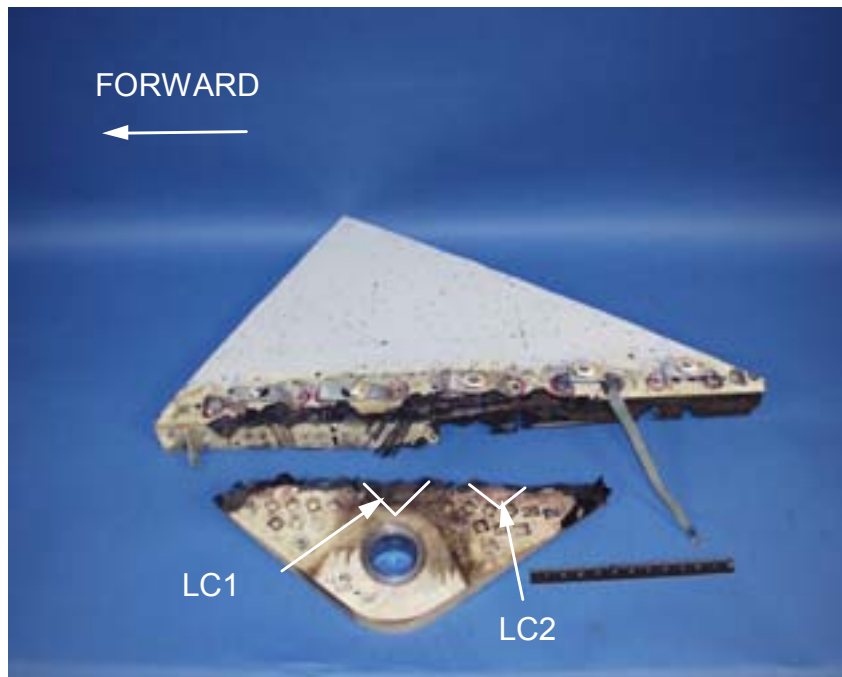
Figure 41. Overall view of the two portions of the fractured structure at the left center lug viewed looking from the left.

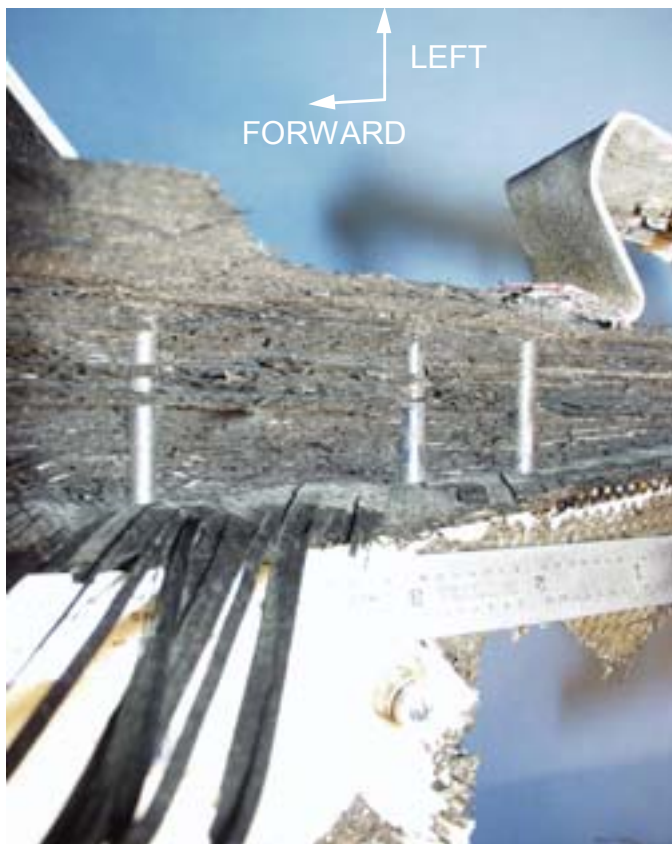
Figure 42. Upper fracture surface at the left center lug, viewed looking upward parallel to zero-degree fibers.

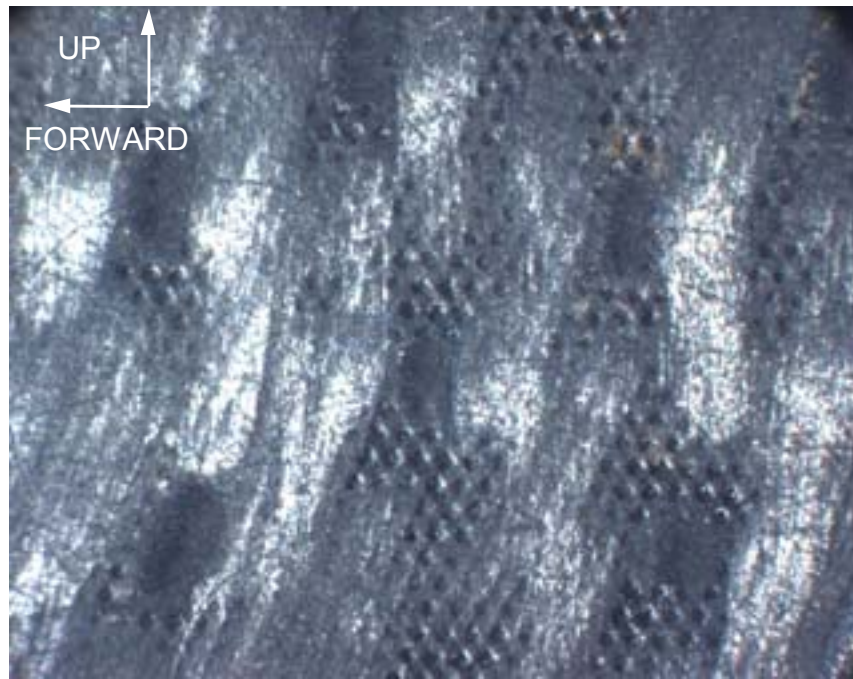
Figure 43. Translamellar fracture surface on the inboard piece of specimen LC2.

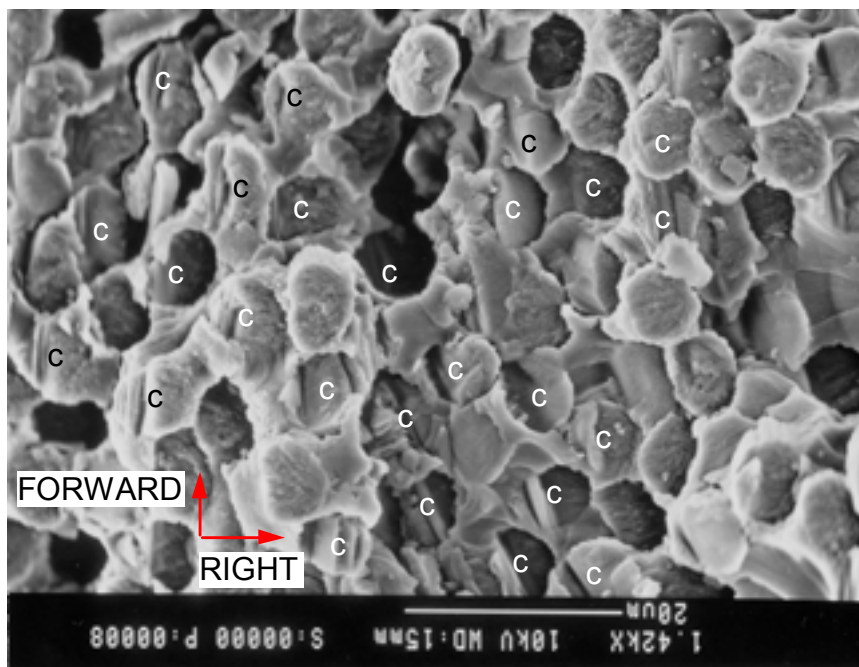
Figure 44. Translamellar fracture surface on the outboard piece from specimen LC2, with the fibers indicated by "c" containing features typical of chop marks.

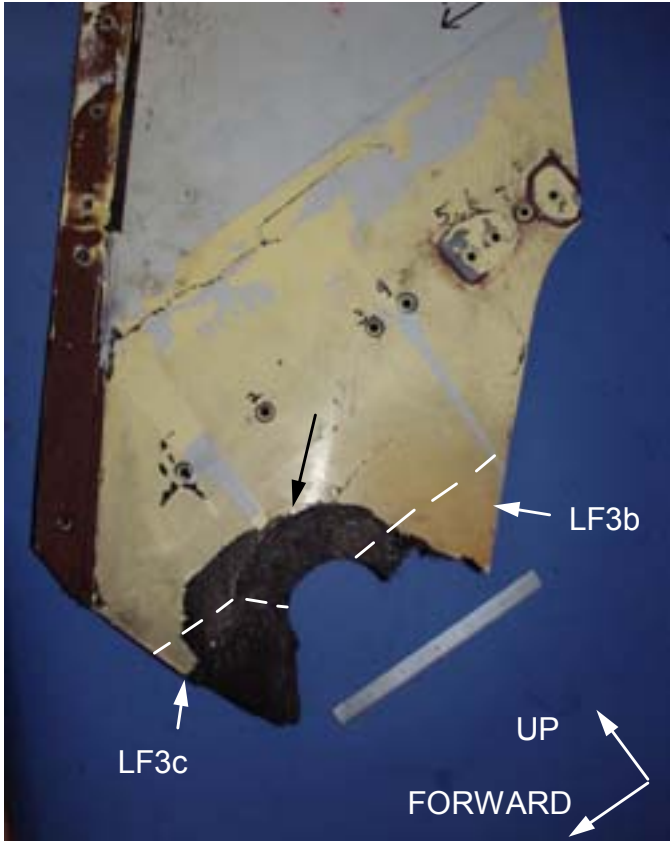
Figure 45. Overall view of the left forward lug translaminar fracture. An unlabeled arrow indicates the upper end of the bearing indentation.

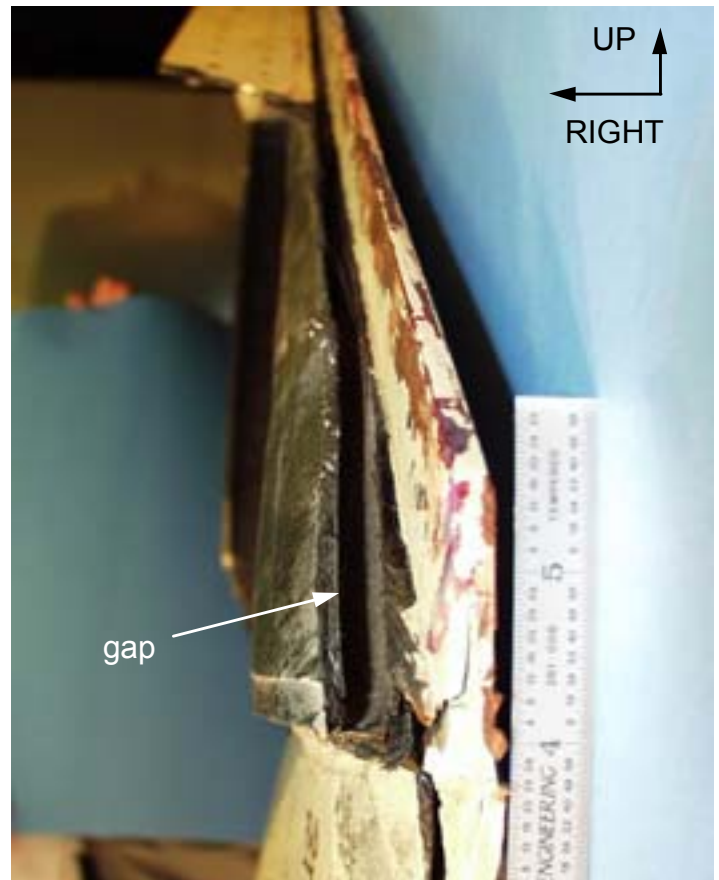
Figure 46. The visible gap at the forward lower end between the inner precured lug structure and the stringer outer flange structure as viewed looking aft.

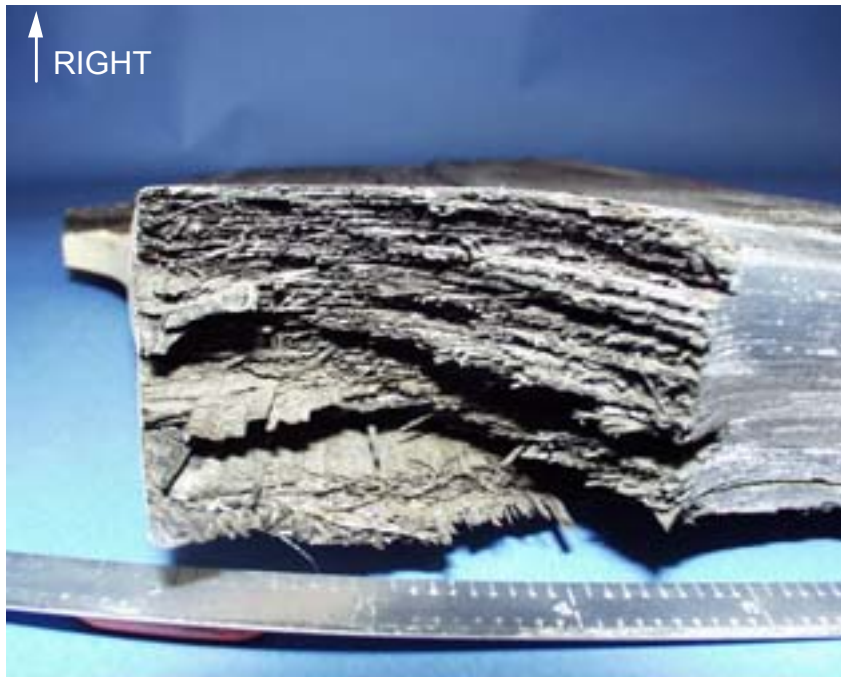
Figure 50. Closer view of the left forward lug upper fracture surface, aft leg, as viewed looking upward parallel to the zero-degree fiber direction.

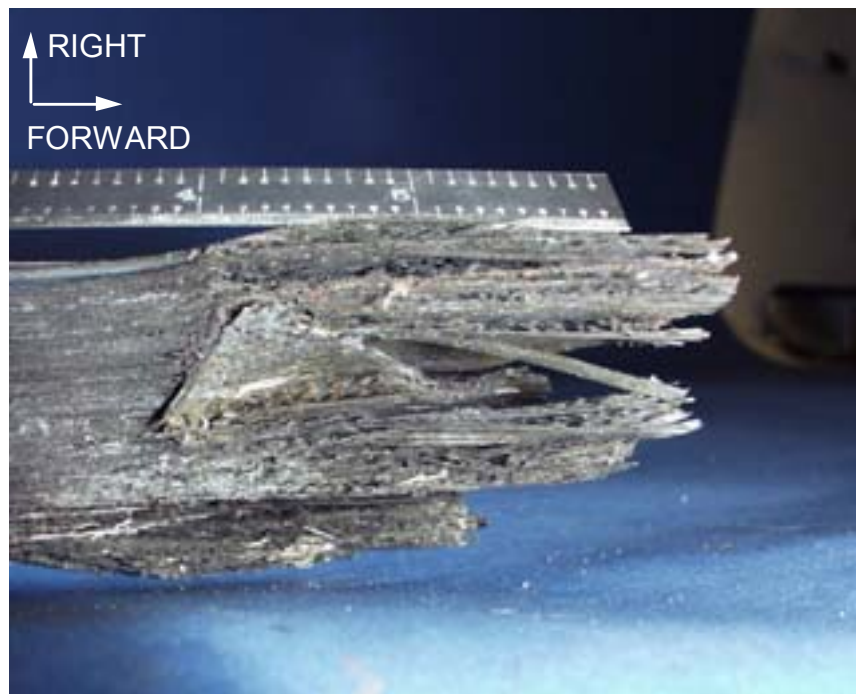
Figure 51. Closer view of the left forward lug upper fracture surface, forward leg, as viewed looking up.

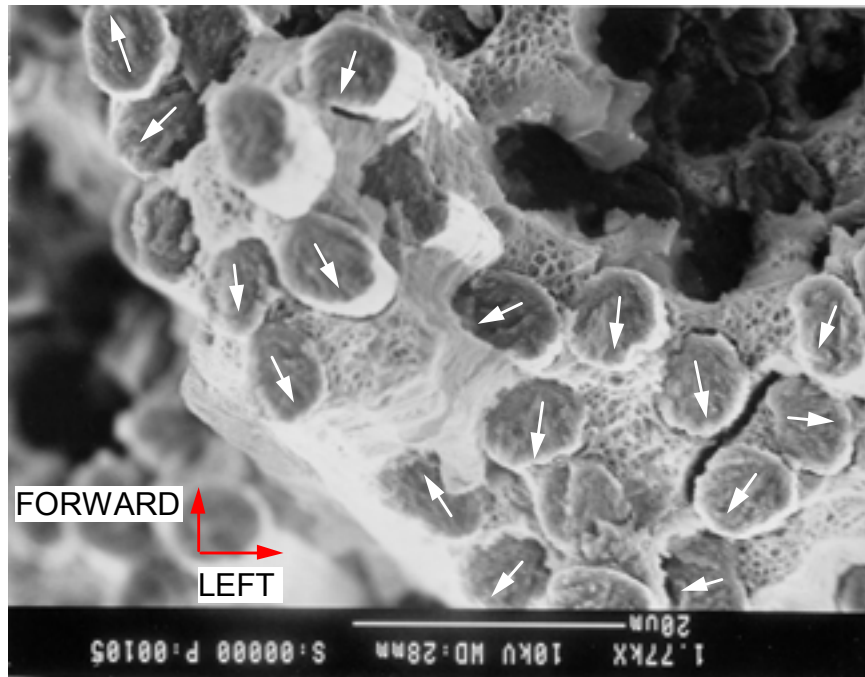
Figure 52. SEM photograph of the ends of zero-degree fibers from specimen LF3b. Arrows indicate fracture propagation direction in fibers with radial marks.
