Docket No. SA-522

Exhibit No. 15-C

NATIONAL TRANSPORTATION SAFETY BOARD

Materials Specialists' Submission
Selected Photographs of the Fractographic
Examination of the Vertical Stabilizer

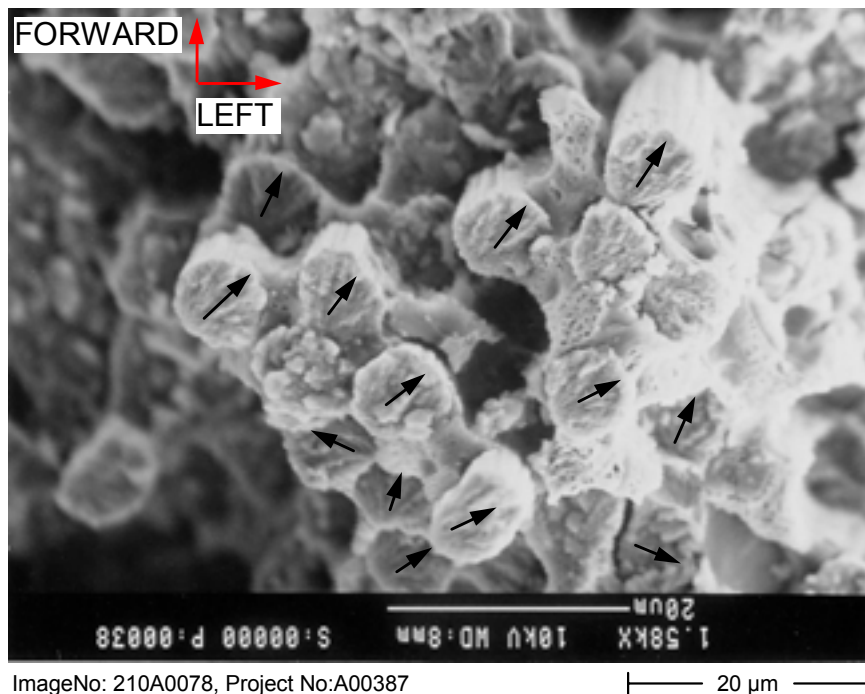
ImageNo: 210A0078, Project No:A00387 | 20 micrometers |
Figure 53. SEM photograph with arrows indicating the direction of tensile crack propagation on the ends of zero-degree fibers from the inboard center piece of specimen LF3c.

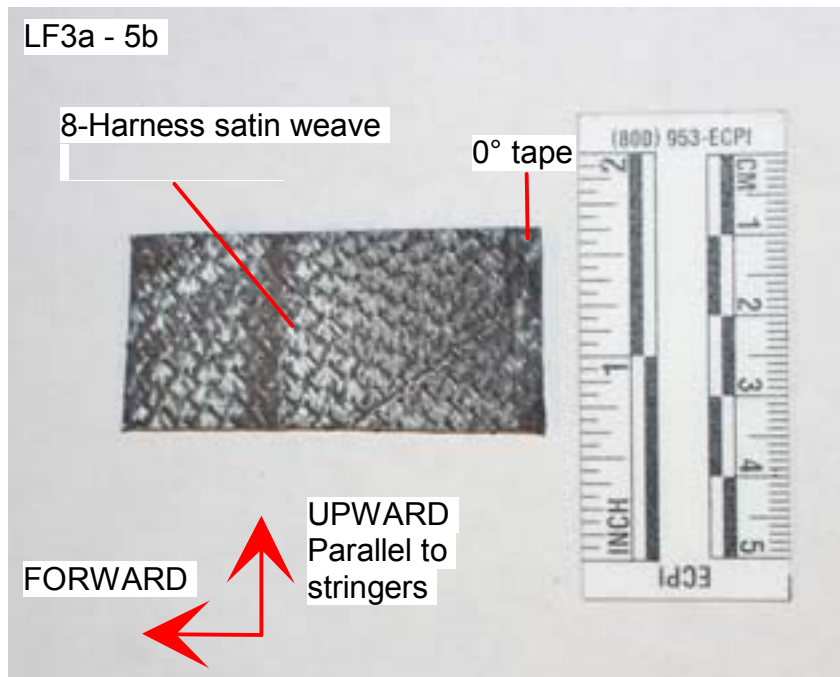
Figure 56. Fracture surface from specimen LF3a-5b.

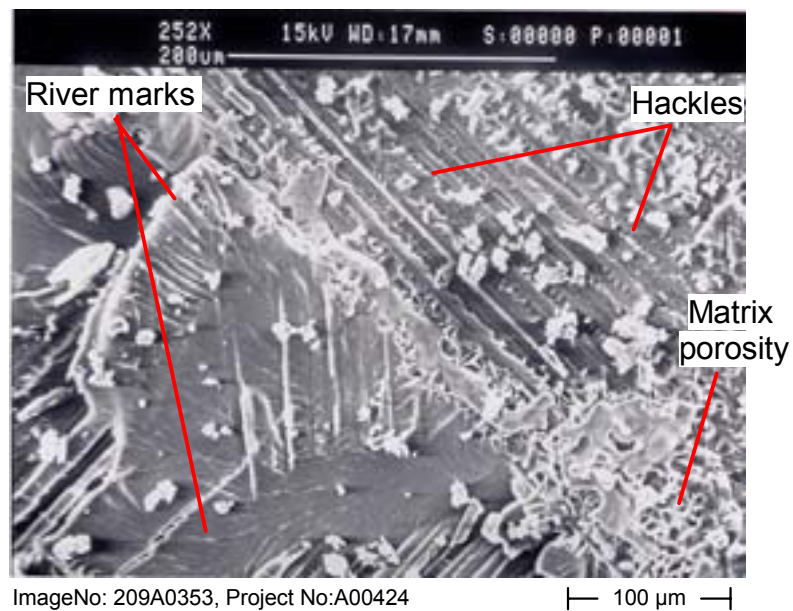
Figure 57. Example SEM photograph from the top forward corner of specimen LF3a-5b. Hackles indicated point up and forward, and river marks also point generally up and forward. Orientation as in figure 56.

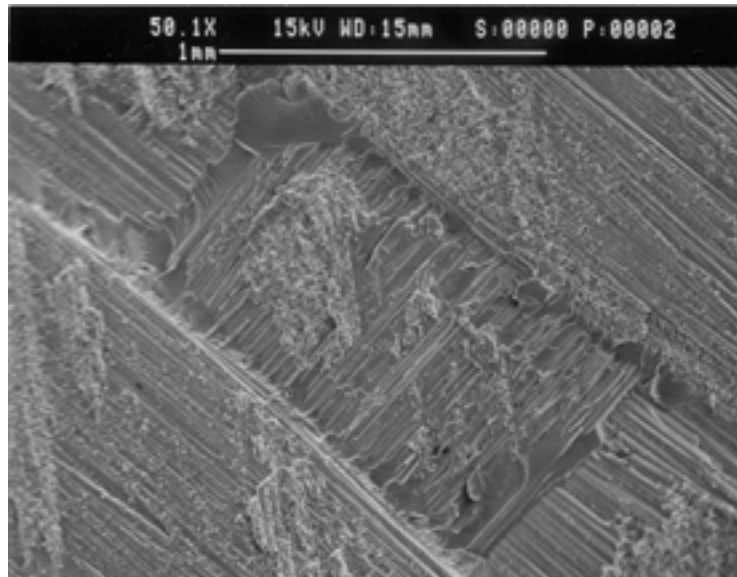
Figure 58. A view of the center of specimen LF3a-5c showing a yarn crossing in the woven fabric. Orientation as in figure 56.

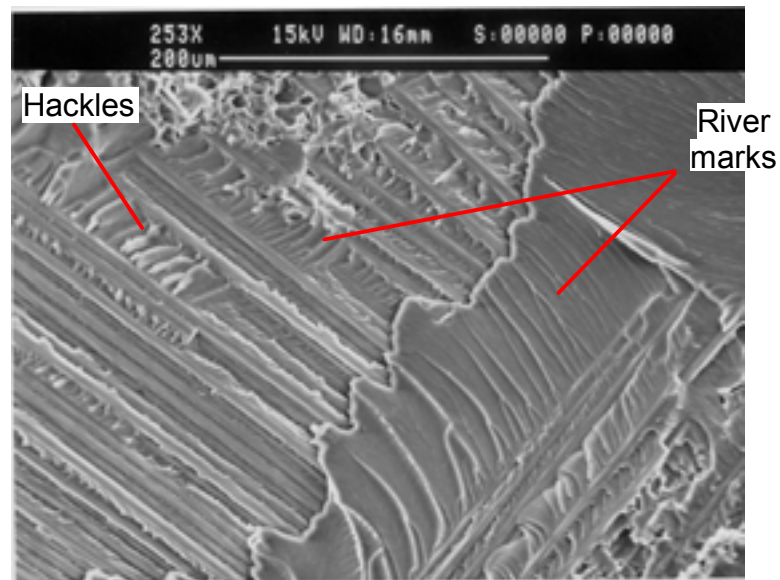
Figure 59. Higher magnification view of the upper left corner of the yarn crossing shown in figure 58. Orientation as in figure 56.

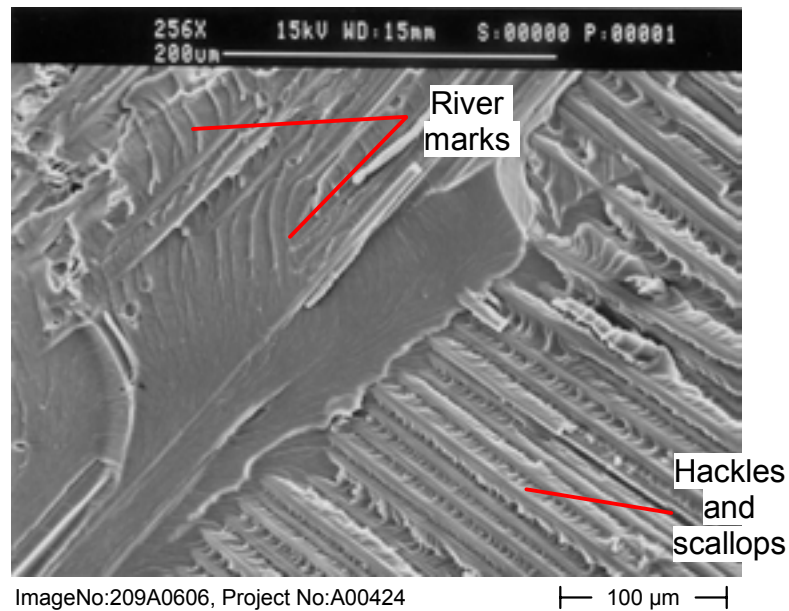
Figure 60. Higher magnification view of the lower right corner of the yarn crossing shown in figure 58. Orientation as in figure 56.

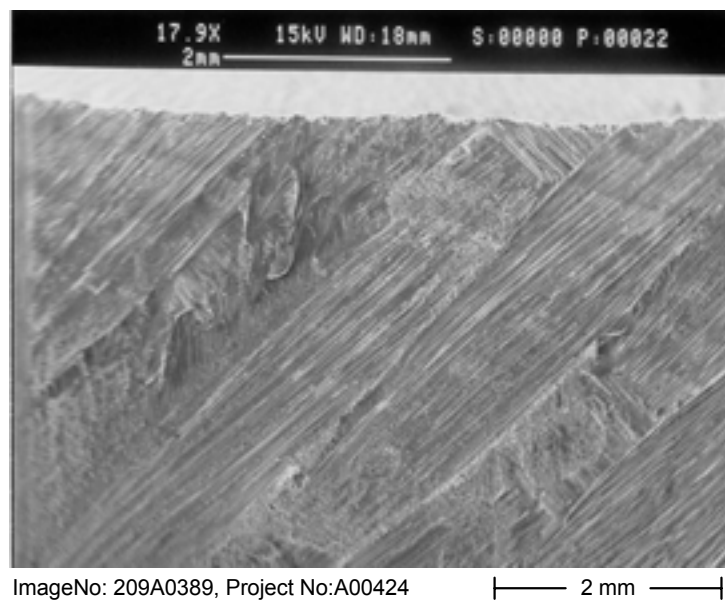
Figure 61. Faint bands at the top forward edge of section LF2b-1 indicate the direction of crack propagation upward and aft. Orientation as in figure 56.
