Building Number: 636

Area: West Barracks
 Date of Construction: 1918-1919
 Period of Significance: 1920-1941
 (per HSR Part One)
 Historic Use: Convalescent Home
 Current/Recent Use: Service Club

Task One: Conditions Assessment

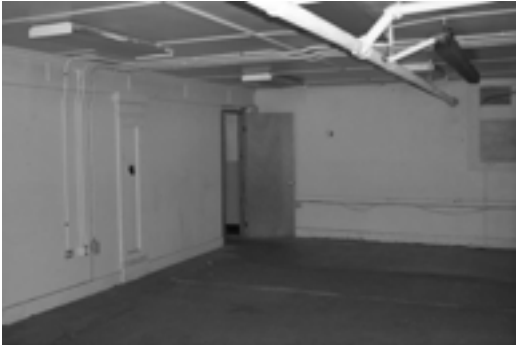
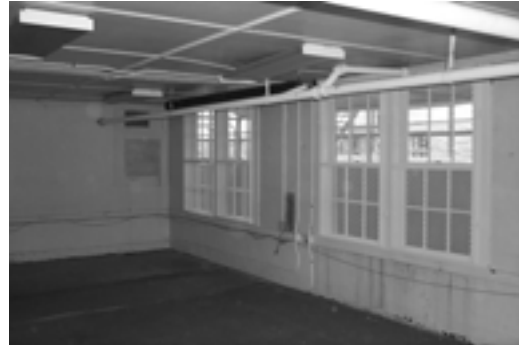
Basement Billiard Hall room shows columns engulfed by the partition wall. Surface mounted conduit and plumbing run helter-skelter throughout. The windows open onto a generous light well but are currently covered with security grating.

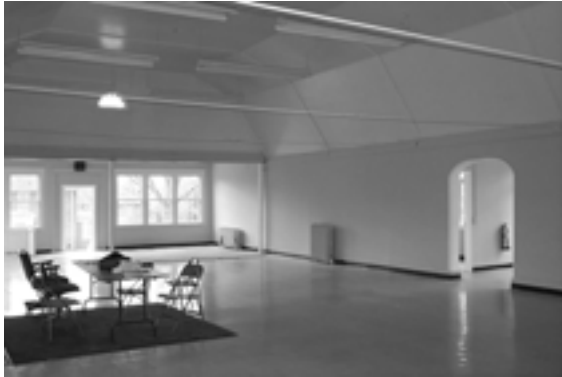
The room was also used for showing films. The ceiling was raised to allow for film projection from an upstairs closet in the north wing. Metal tie rods were added in an effort to arrest the outward rotation of the east and west walls. This movement is presumably a result of the removal of the wood ceiling joists. The tie rods were often removed to prevent them from casting shadows when movies were shown. In addition, initially, according to the Army Corps of Engineers' Maintenance records, the ties were only attached to the trim on the wall. They are now attached to steel plates on the exterior of the building.

The condition of the floor is fair. The walls show substantial damage. The west wall of the auditorium has undergone major changes. The original French doors have been removed and the openings remodeled into a series of arches. These arches, in turn, have been filled in with lath and plaster walls with the exception of two openings. In addition, the Army Corps of Engineers' Maintenance records indicate that the walls have been furred out, obscuring some trim and relief details. This has not been field verified. The windows are six-over-six double hung and need to be refurbished, with missing or broken hardware replaced. Some water damage is present in the ceiling, and cracks should be monitored. A false beam with wood trim is applied to the plaster ceiling. Surface mounted conduit and fluorescent light fixtures attached to the ceiling should be removed.

The Auditorium was opened up to the south porch (seen on the left of the photo) and the west wall doorways were filled in (seen on the right of the photo). The collar ties can be seen at the top of the photo.
