Patient Safety Alert

AL09-07

December 22, 2008

Item: Improper set-up and reprocessing of flexible endoscope tubing and accessories

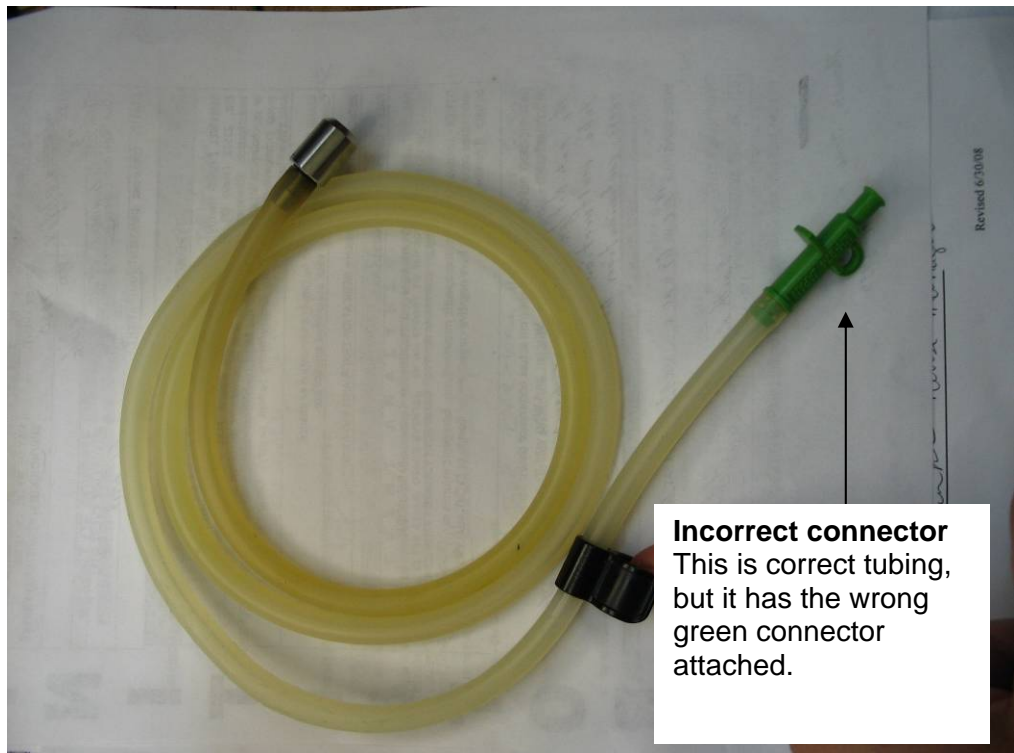
Specific Incident: Correct tubing modified with an incorrect connector was used to attach an Olympus flexible endoscope to its irrigation source (Olympus Flushing Pump and accessories). This resulted in a backflow of body fluids into irrigation source tubing (where backflow should not occur) during an endoscopic procedure.

Specifically, during some endoscopic procedures, the facility used an Olympus Auxiliary Water Tube (MAJ-855) that was modified to have an Olympus Washing Tube (MH-974) connector attached instead of the connector intended to be used with the Olympus Auxiliary Water Tube (MAJ-855).

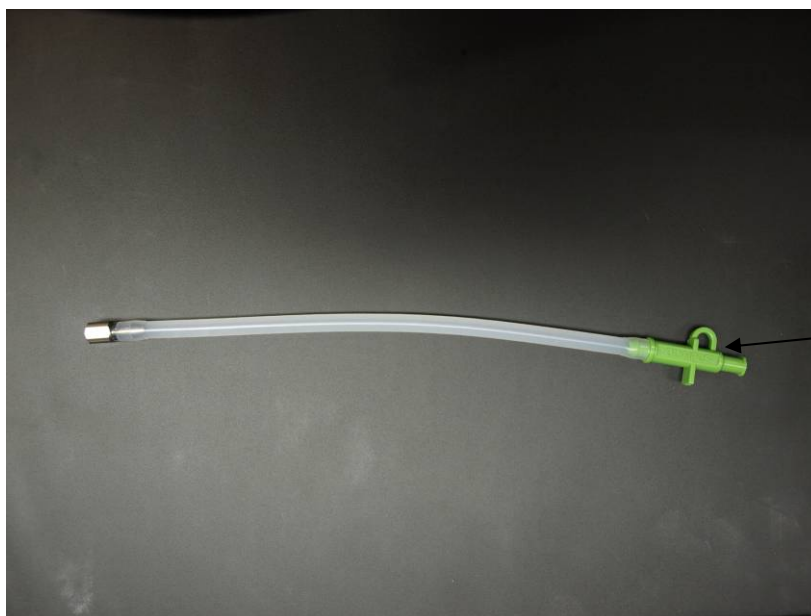
**Olympus
Washing
Tube
(MH-974)**

General Information: Tubing design may have contributed to the reported event. Both of the tubings, while different in diameter and length, have green connectors. The green connector on the Washing Tube (MH-974) has one less wing than the green connector on the Auxiliary Water Tube (MAJ-855). See photographs of the tubings below, which show the connectors. NOTE: The manufacturer uses green connectors to indicate that the tubing is to be reprocessed, not discarded.

Its green
connector
has only 1
wing.

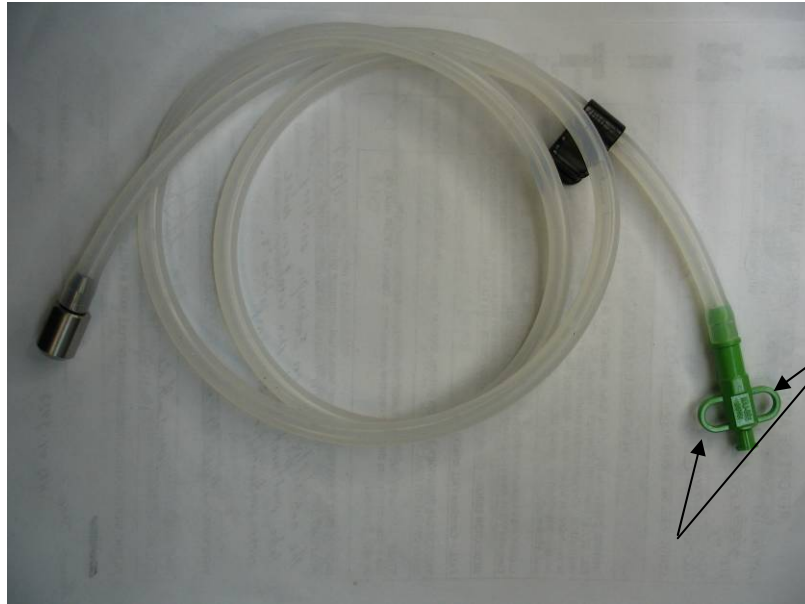
**Olympus
Auxiliary
Water Tube
(MAJ-855)**

The Auxiliary Water Tube (MAJ-855) is required to connect the Auxiliary Water Port on the endoscope to the Olympus Flushing Pump (OFP) Filter (7501335), which is connected to the OFP Irrigation Tube (7501669). (See the photograph in Attachment 1, which depicts proper set-up of the equipment.) The MAJ-855's connector has a one-way valve and is a standard feature on the MAJ-855. The MAJ-855's one-way valve prevents backflow of body fluids from contaminating the

OFP Filter (7501335) and OFP Irrigation Tube (7501669). The Washing Tube's (MH-974) connector does not have a one-way valve.

Its green
connector with
one-way valve
has 2 wings.

- ii. the Olympus Auxiliary Water Tube (MAJ-855) is supplied non-sterile, and needs to be reprocessed before initial use and after each patient using steam sterilization (refer to the instruction manual for your particular endoscope).

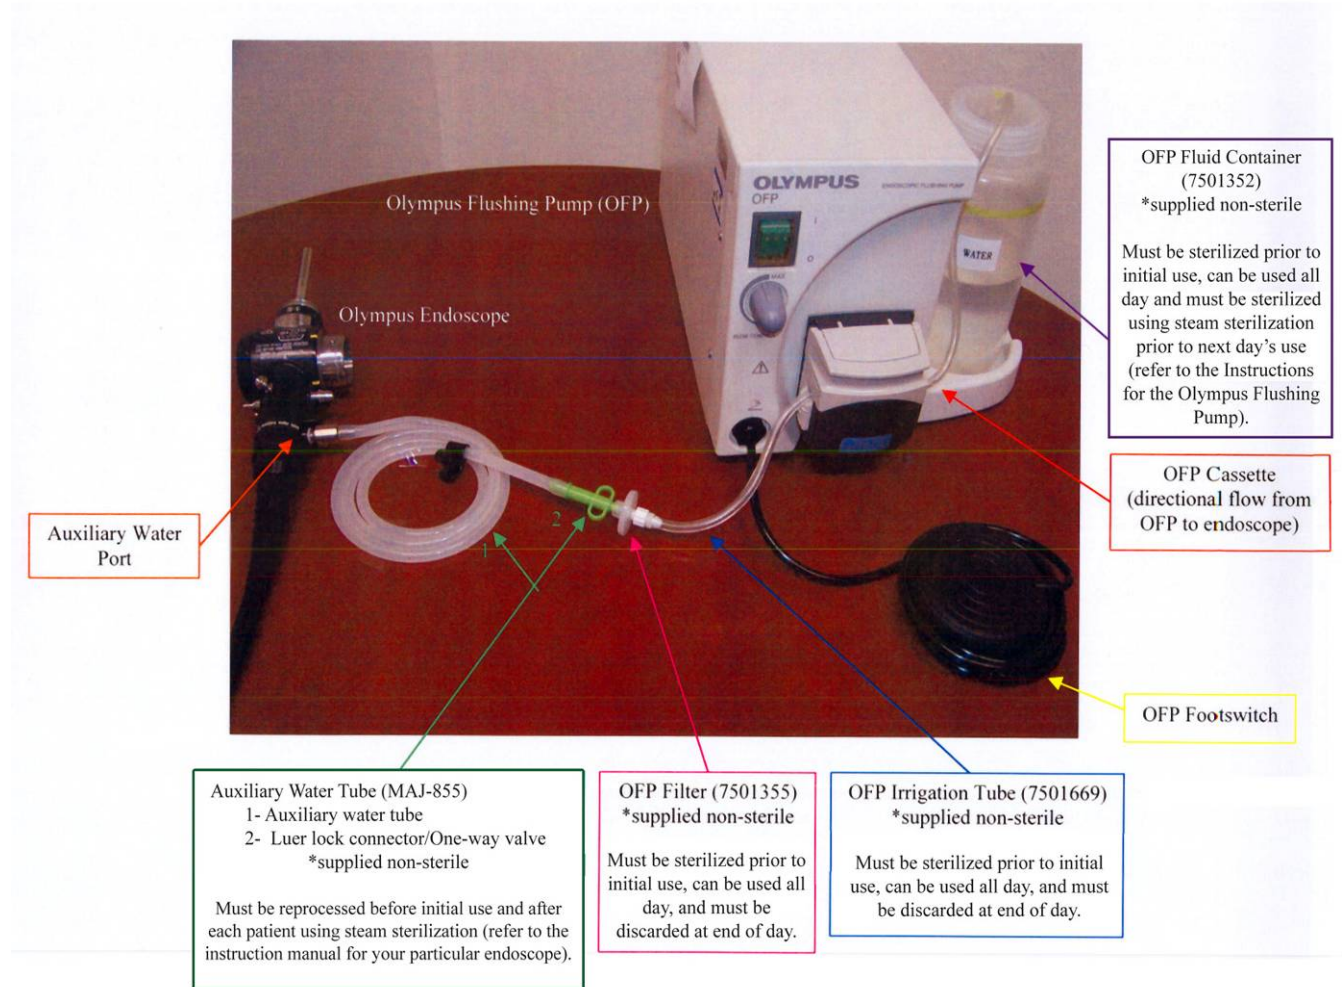
ATTACHMENT 1

Photograph depicting the correct set-up using the Olympus Flushing Pump

2. For those facilities using the Olympus Flushing Pump and compatible endoscopes, ensure that:
 - a. the set-up shown in Attachment 1 is being consistently utilized. NOTE: In the photograph, the fluid flows from the Olympus Flushing Pump (located on the right) to the Olympus Endoscope (located on the left). Ensure that the OFP Irrigation Tube (7501669) is placed in the proper orientation through the OFP Cassette.

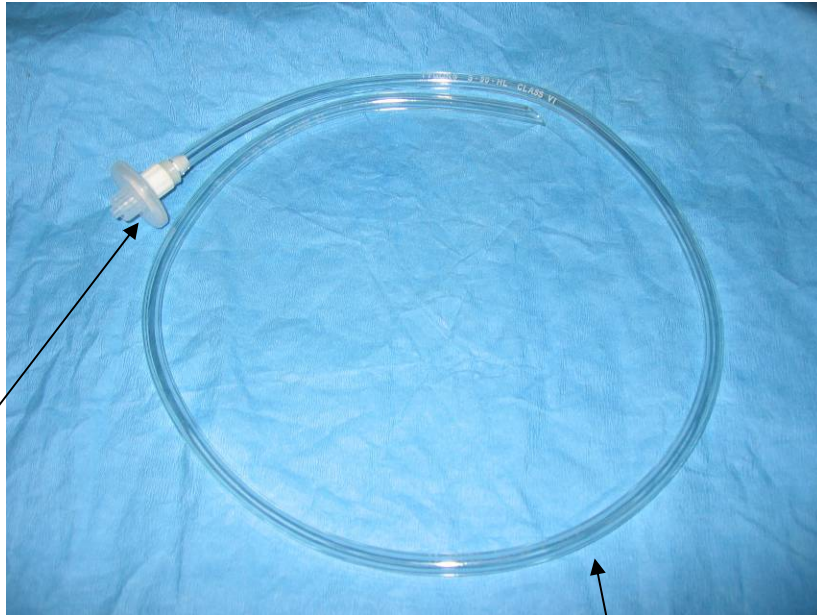
ATTACHMENT 2

1. When the Olympus Auxiliary Water Tube (MAJ-855) with proper connector was used for clinical procedures, it was being reprocessed at the end of each day, instead of between each patient as required by the manufacturer's reprocessing instructions.
2. The OFP Irrigation Tube (7501669) and OFP Filter (7501355) were being reprocessed at the end of each day. The OFP Irrigation Tube (7501669) and OFP Filter (7501355), shown in the photograph in Attachment 2, are to be discarded at the end of each day per the manufacturer's instructions.

Photograph depicting the OFP Filter (7501355) and OFP Irrigation Tube (7501669)

- iii. the OFP Filter (7501355) and OFP Irrigation Tube (7501669) are supplied non-sterile, must be sterilized prior to initial use, can be utilized all day, and must be

discarded at the end of each day, as per the manufacturer instructions.
