TECHNICAL MEMORANDUM

SUBJECT: **PRELIMINARY ASSESSMENT OF SLOPE STABILITY, IRON GATE AND COPCO DAMS AND RESERVOIRS, UNDER RAPID DRAWDOWN**

PROJECT NO.: 06-201

DATE: November 27, 2006

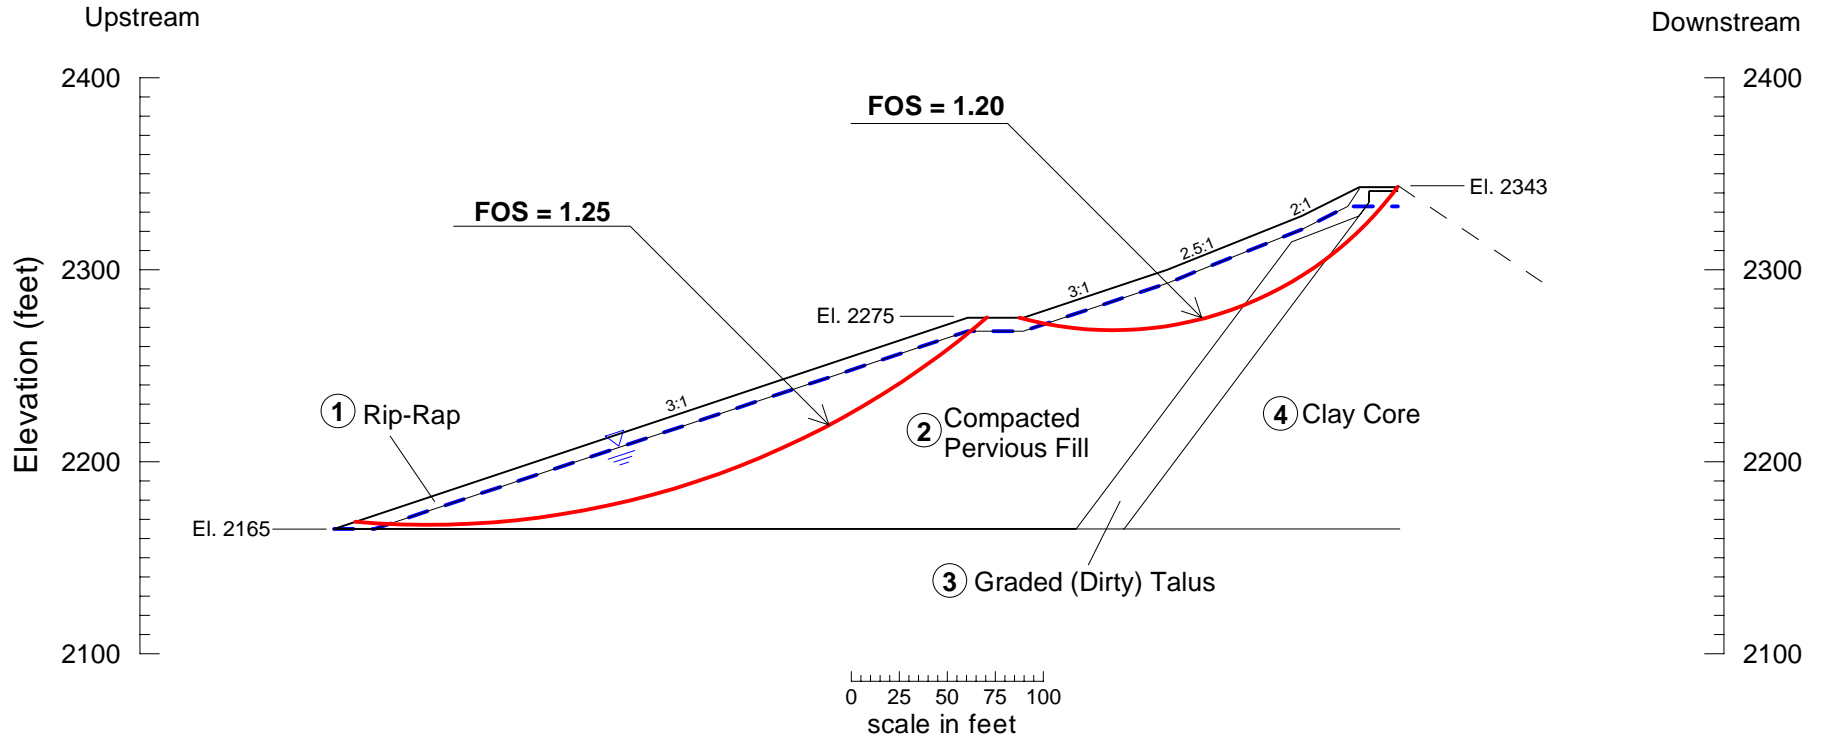
Figure No.  
**1**

The stability of the upstream face of the dam was first evaluated utilizing the soil properties defined in the original stability analysis conducted by the State of California (September 16, 1960). While the materials in zone 1 and zone 1A are expected to differ somewhat, we used the California zone 1 soil properties for both zones in this analysis. This was based on the inference that the zone 1A materials, while dirtier than the zone 1 material, still met specification. Differing slightly from the 1960 analyses which did not include rip rap in the stability evaluation, our model included rip rap with an assumed friction angle of 42 degrees and a unit weight of 125 pcf.

As seen in Figures 1 and 2, the lowest factor of safety was found to correspond to a circular failure surface near the top of the slope, where the slope face is steepest. Factors of safety of 1.20 and 1.38 were calculated for the upper slope utilizing the original soil properties and revised soil properties, respectively. A circular failure surface through the toe of the slope was also analyzed. As shown on Figures 1 and 2, the lower circular surface had computed factors of safety of 1.25 and 1.45 utilizing the original soil properties and revised soil properties, respectively.

**RAPID DRAWDOWN  
STABILITY ANALYSIS -  
SOIL PROPERTIES PER STATE  
OF CALIFORNIA ANALYSIS (1960)**

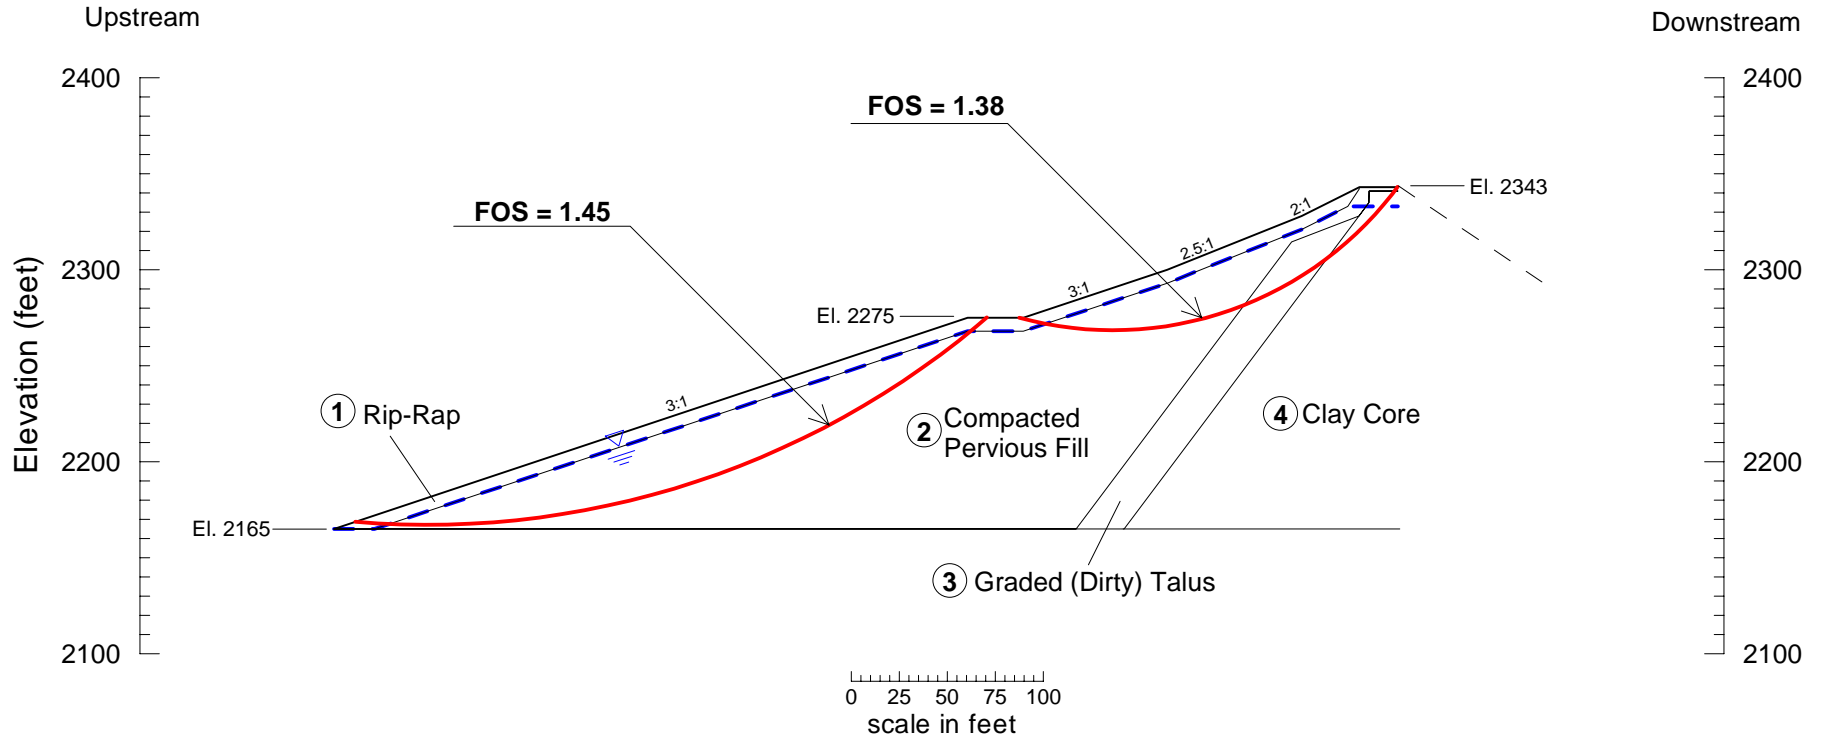
A second stability analysis was then conducted utilizing revised (stronger) soil properties for the upstream shell (i.e. Zones 1 and 1A) as based on our understanding of the actual materials used to construct the shell. Figure 2 presents the soils parameters used for this analysis.

The computed factors of safety from our stability analyses are within or exceed factors of safety of 1.1 to 1.3 established by the US Army Corps of Engineers (EM-1110-2-1902) as being acceptable for the rapid drawdown conditions of the upstream shell of dams. Consequently, we believe that the existing upstream dam face will be globally stable during reservoir drawdown.

**RAPID DRAWDOWN  
STABILITY ANALYSIS -  
SOIL PROPERTIES USED  
IN CURRENT ANALYSIS**
