C *Limited Metallurgical Examination*

C.1 Introduction

Two structural steel members with unusual erosion patterns were observed in the WTC debris field. The first appeared to be from WTC 7 and the second from either WTC 1 or WTC 2. Samples were taken from these beams and labeled Sample 1 and Sample 2, respectively. A metallurgic examination was conducted.

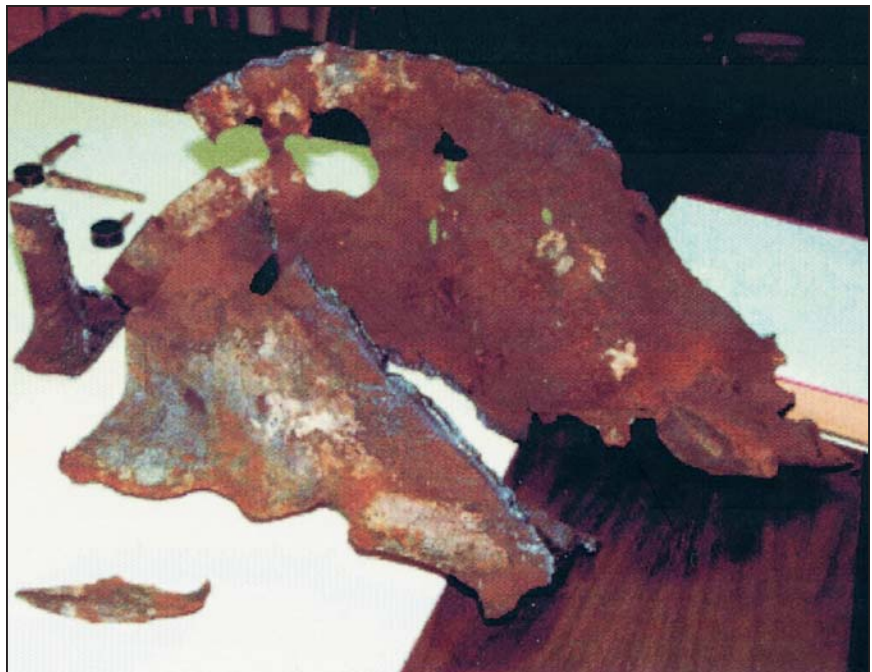
Several regions in the section of the beam shown in Figures C-1 and C-2 were examined to determine microstructural changes that occurred in the A36 structural steel as a result of the events of September 11, 2001, and the subsequent fires. Although the exact location of this beam in the building was not known, the severe erosion found in several beams warranted further consideration. In this preliminary study, optical and scanning electron metallography techniques were used to examine the most severely eroded regions as exemplified in the metallurgical mount shown in Figure C-3. Evidence of a severe high temperature corrosion attack on the steel, including oxidation and sulfidation with subsequent intergranular melting, was readily visible in the near-surface microstructure. A liquid eutectic mixture containing primarily iron, oxygen, and sulfur formed during this hot corrosion attack on the steel. This sulfur-rich liquid penetrated preferentially down grain boundaries of the steel, severely weakening the

Figure C-1 Eroded A36 wide-flange beam.

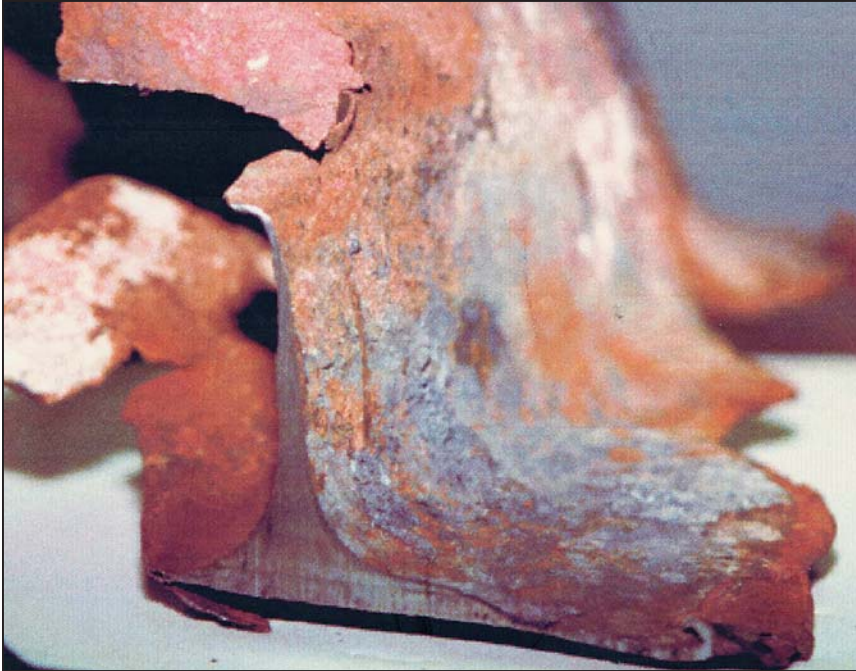
Figure C-2
Closeup view of eroded wide-flange beam section.

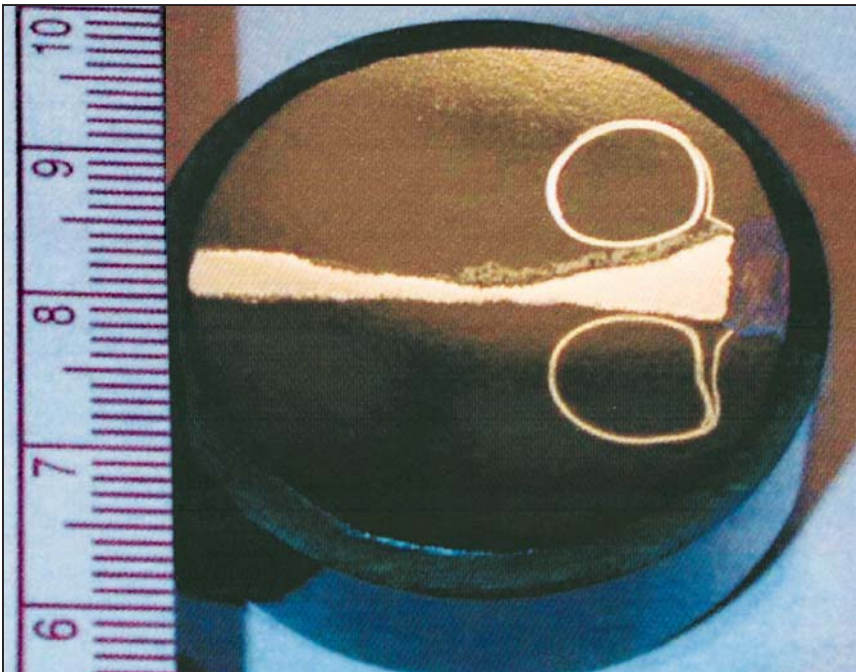
Figure C-3
Mounted and polished severely thinned section removed from the wide-flange beam shown in Figure C-1.

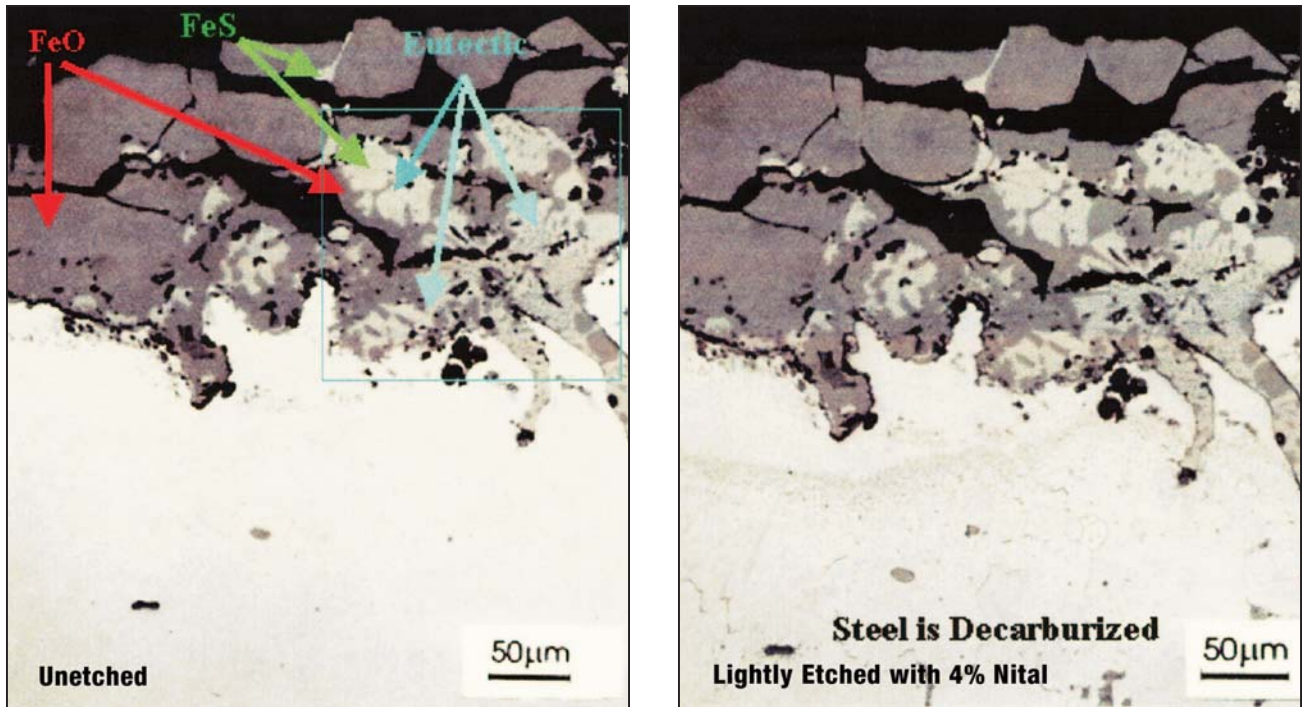
When steel cools below the eutectic temperature, the liquid of eutectic composition transforms to two phases, iron oxide, FeO, and iron sulfide, FeS. The product of this eutectic reaction is a characteristic geometrical arrangement that is unique and is readily visible even in the unetched microstructure of the steel. Figures C-4 and C-5 present typical near-surface regions showing the microstructural changes that occur due to this corrosion attack. Figure C-6 presents the microstructure from the center of a much thicker

Figure C-4 Optical microstructure near the steel surface.

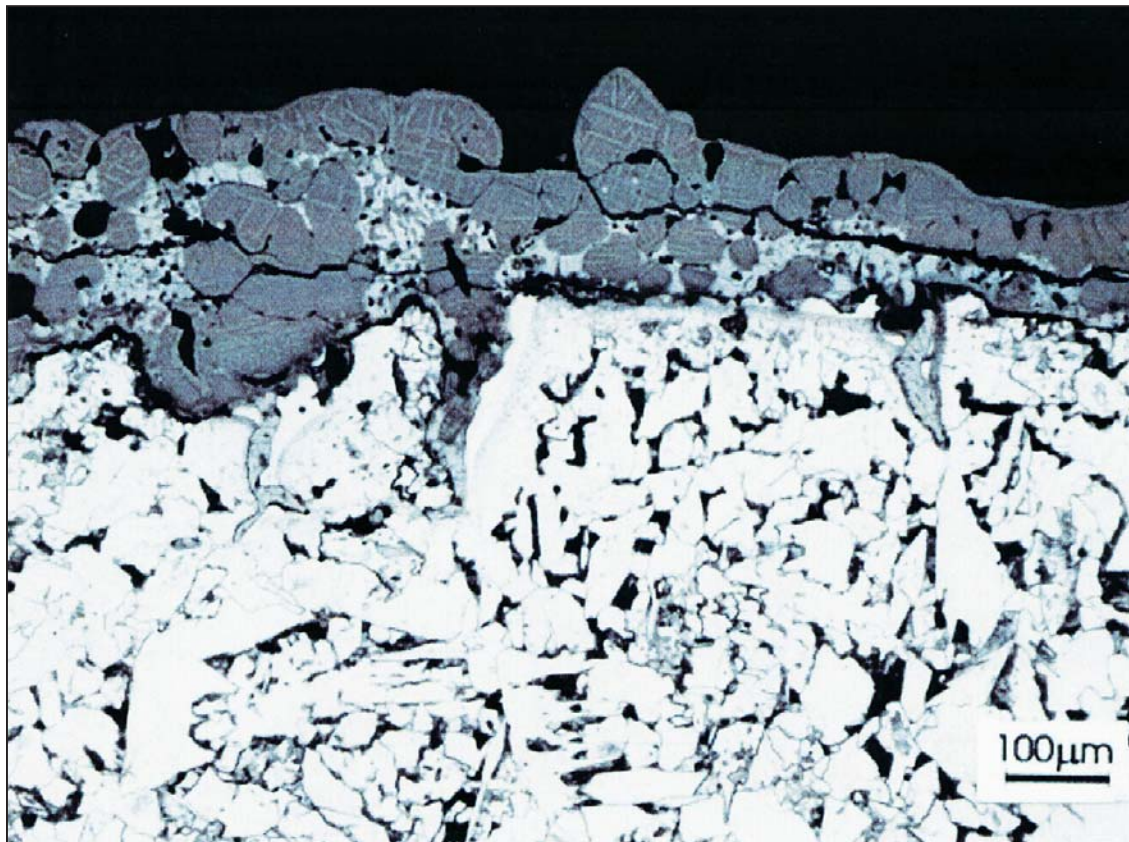
Figure C-5 Another hot corrosion region near the steel surface (etched with 4 percent nital). (Note: (1) Oxide rounding where the FeO-FeS eutectic product is present. (2) Reduction in banding of the steel when re-transformation occurs on cooling from austenite to ferrite and pearlite.)

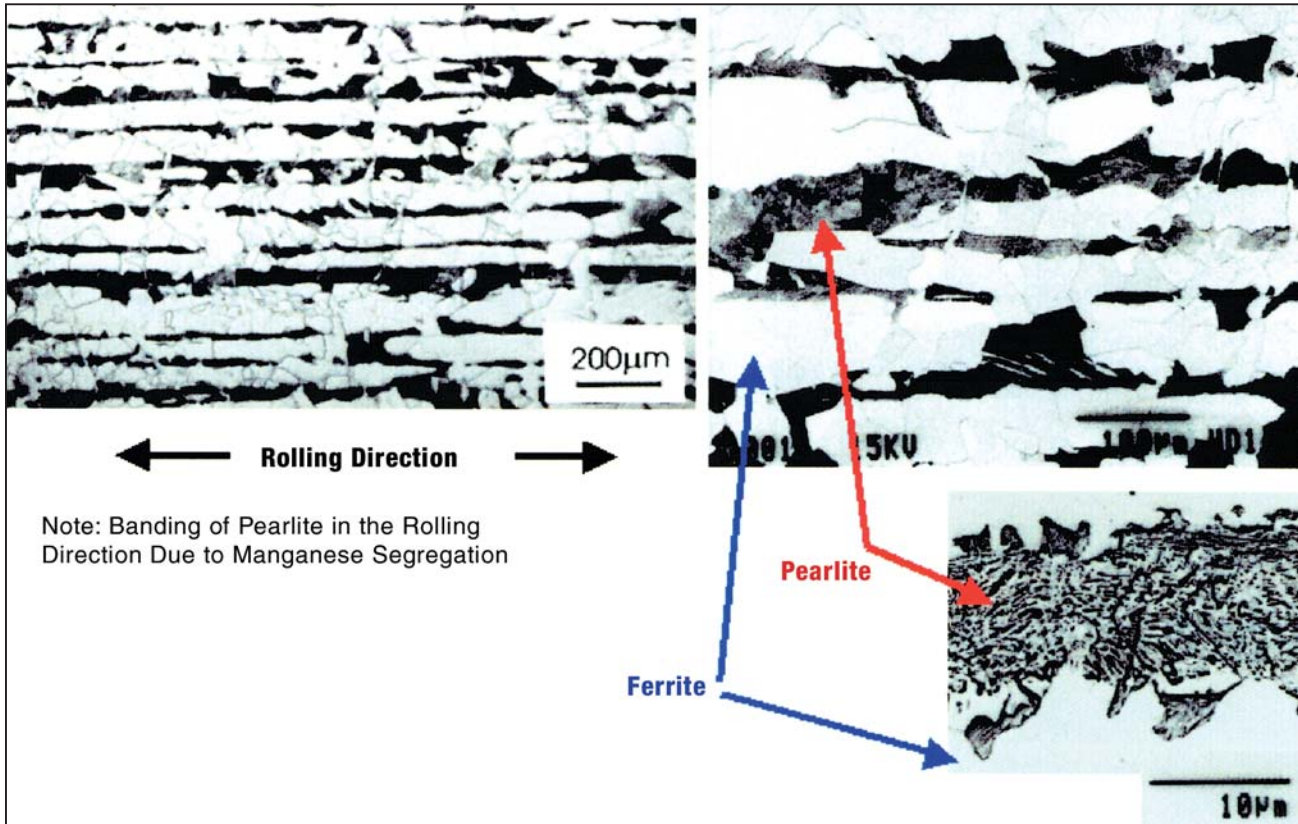
Figure C-6 Microstructure of A36 steel.

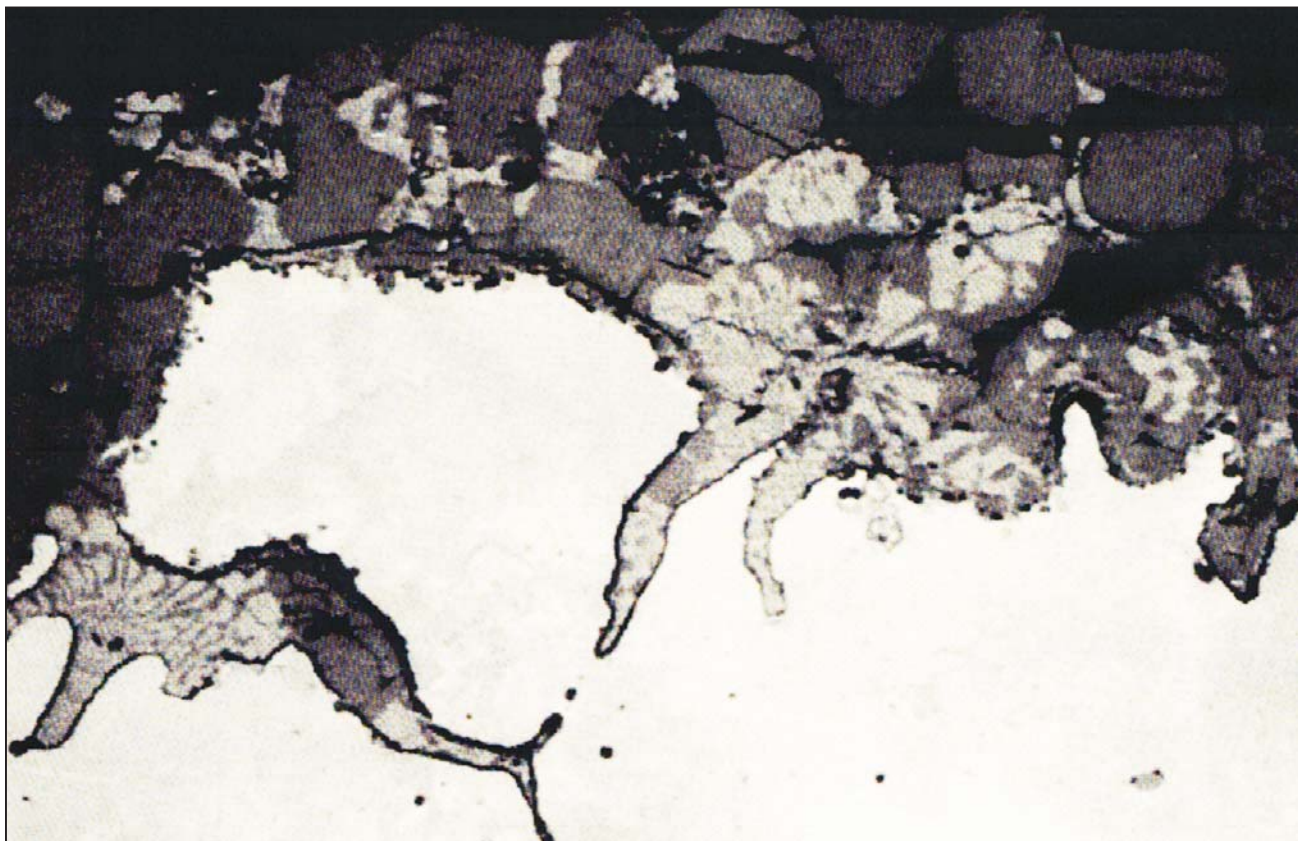
Figure C-7 Deep penetration of liquid into the steel. (Note: Hot corrosion of the steel can produce “islands” of steel surrounded by liquid, which will make erosion of the steel much easier.)

section of the steel that is unaffected by the hot corrosion. Figure C-7 illustrates the deep penetration of the liquid into the steel's structure. In order to identify the chemical composition of the eutectic, a qualitative chemical evaluation was done using energy dispersive X-ray analysis (EDX) of the eutectic reaction products. Figure C-8 illustrates the results of this analysis.

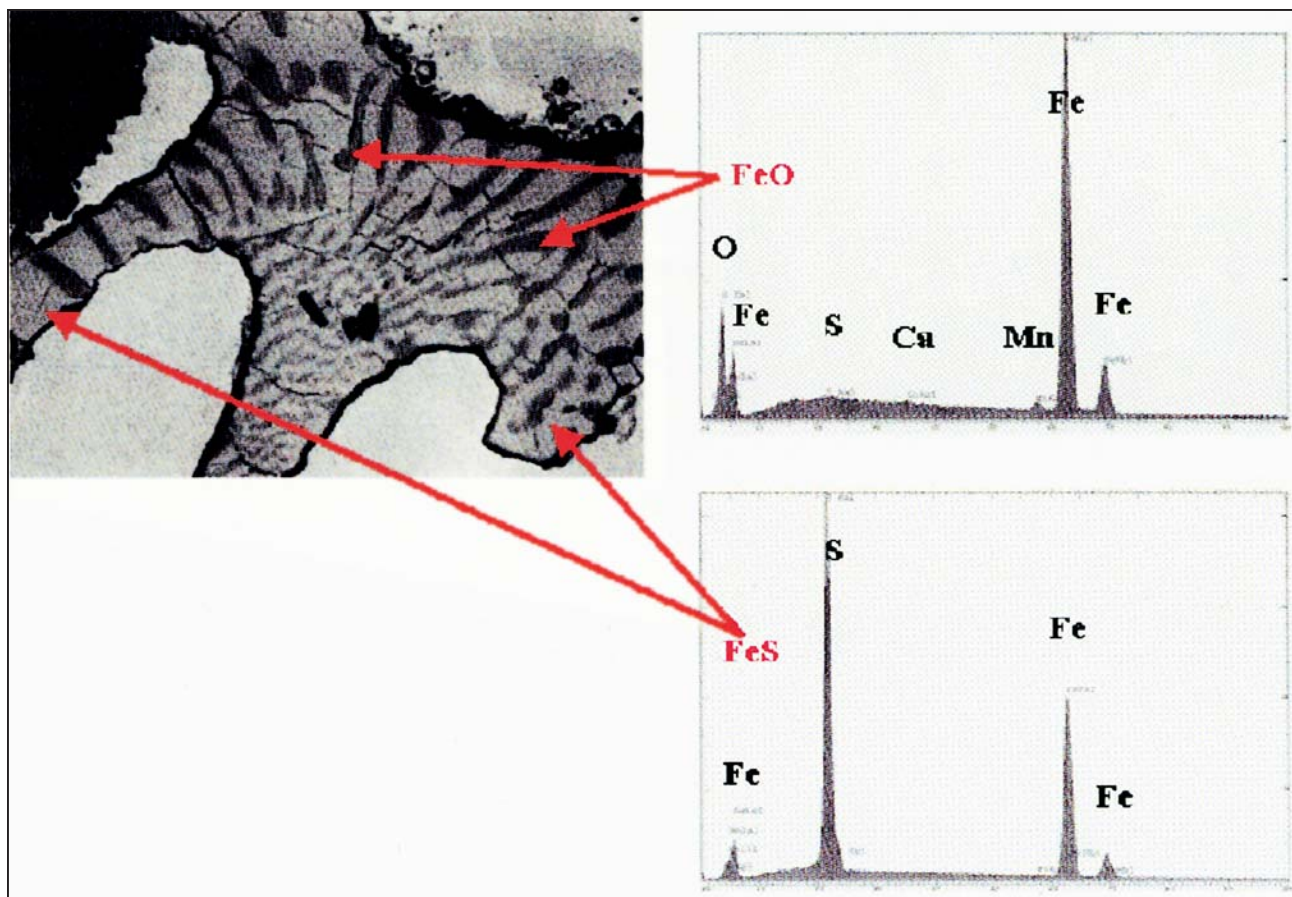
Figure C-8 Qualitative chemical analysis.

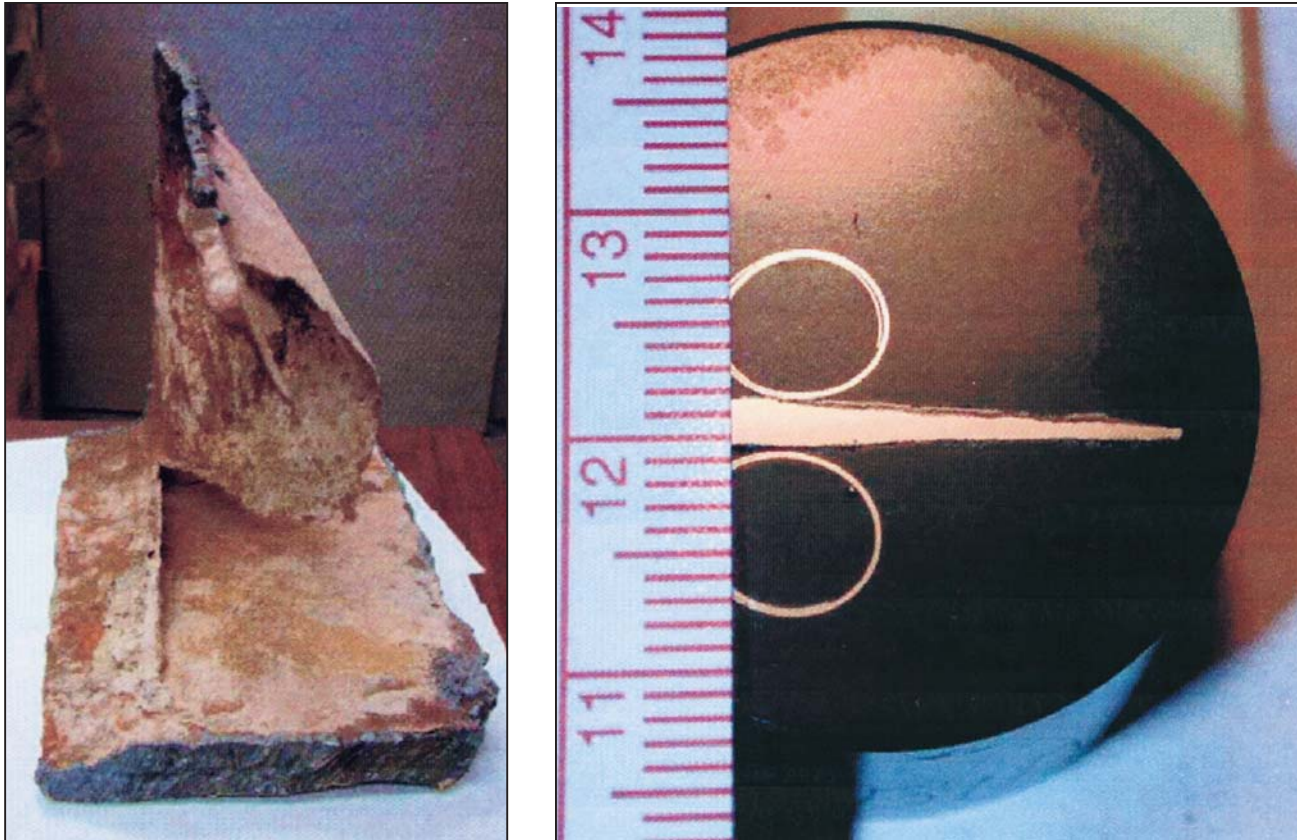
The origin of the steel shown in Figure C-9 is thought to be a high-yield-strength steel removed from a column member. The steel is a high-strength low-alloy (HSLA) steel containing copper. The unusual thinning of the member is most likely due to an attack of the steel by grain boundary penetration of sulfur forming sulfides that contain both iron and copper. Figures C-10, C-11, and C-12 show the region of severe corrosion at different levels of magnification.

Figure C-9 Qualitative chemical analysis.

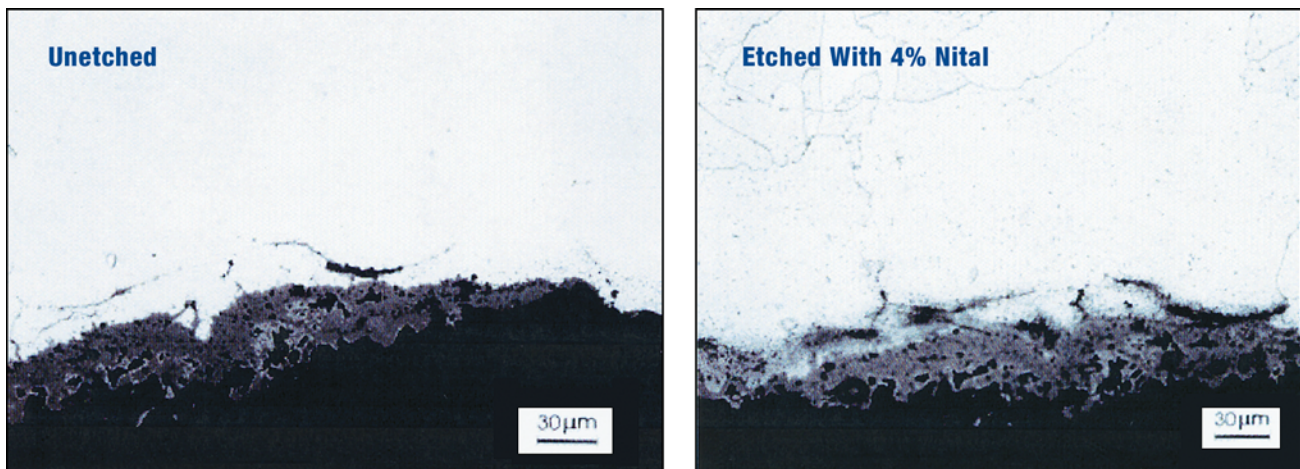
Figure C-10 Grain boundary corrosion attack.

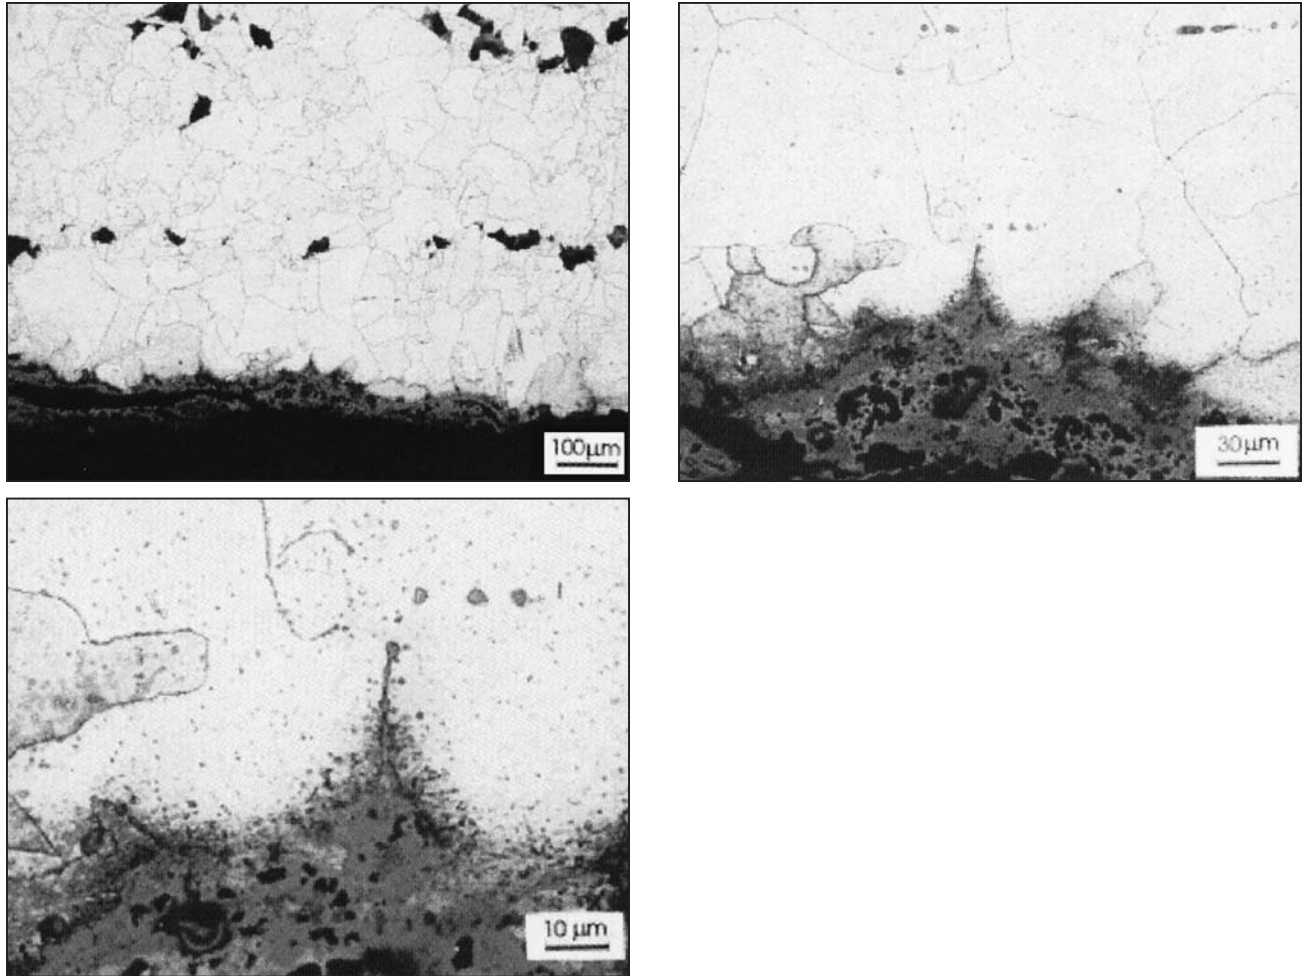
Figure C-11 Microstructure of a typical region showing the surface and grain boundary corrosion attack of Sample 2.

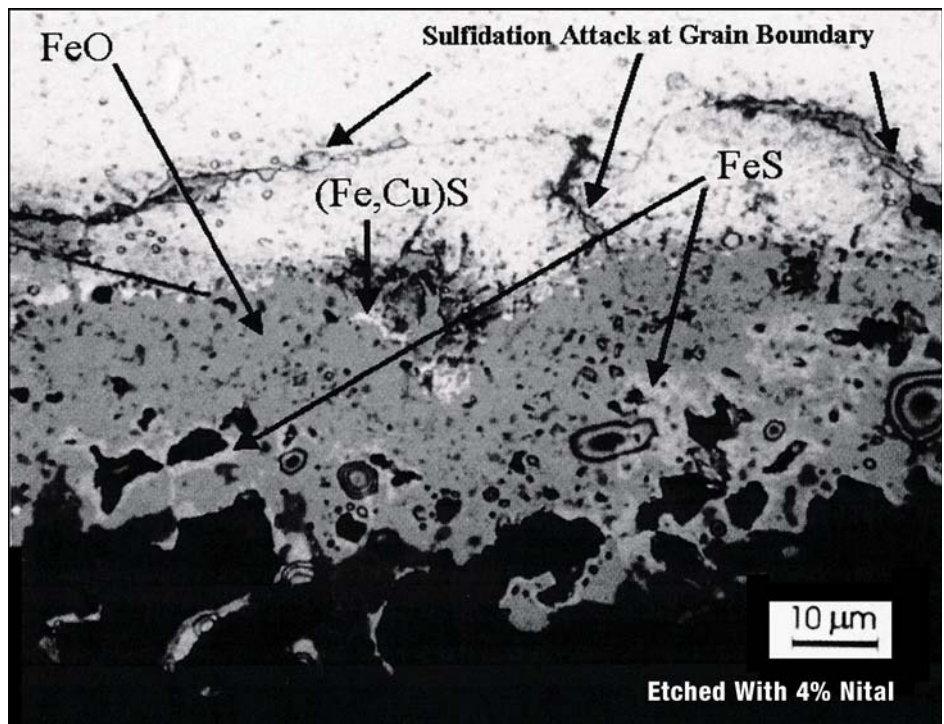
Figure C-12
Higher magnification of the region
shown in Figure C-10.

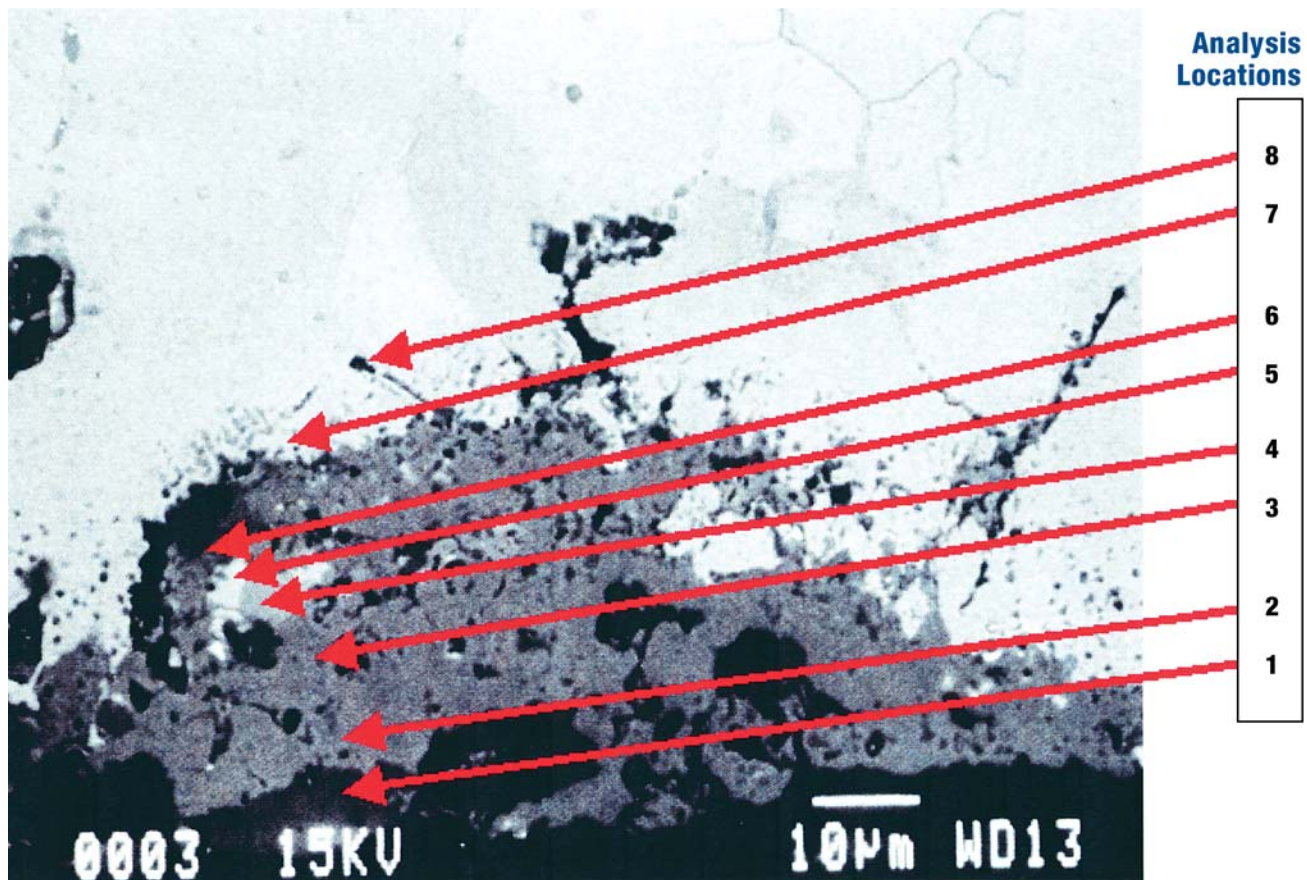
Figure C-13 shows the region where a qualitative chemical analysis of the eroded region was performed. The comparison of the EDX spectra from the specific regions identified in Figure C-13 shows concentration of copper and sulfur in the grain boundaries in addition to iron sulfide formation adjacent to iron oxide in the oxidized surface layer. Sulfide formation within the steel microstructure increases in concentration as the oxidized region is approached from the steel side. This is clearly shown in Figure C-14.

Figure C-13 Regions where chemical analysis was performed.

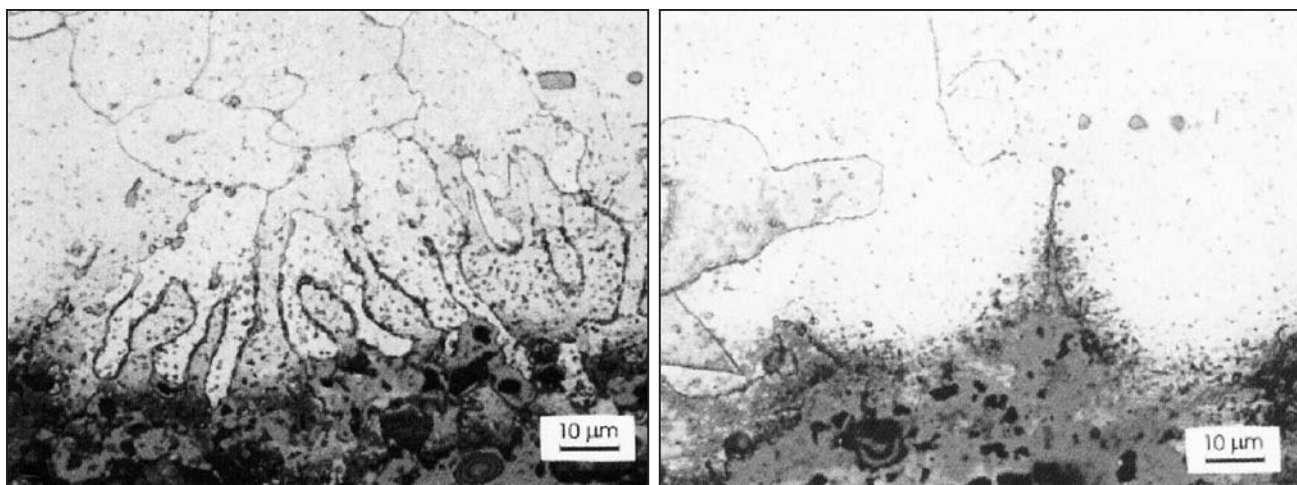
Figure C-14 Gradient of sulfides into the steel from the oxide-metal interface.
