**PHMSA Document Number: [PHMSA-2006-26611-1](#)  
Elan Subdivision Special Permit  
Near Lafayette, LA**

EUT 26-1 TT Elan Longitudinal Seam Susceptibility Analysis  
 Inspection Area from MP 11+2700 to MP 40+1600  
 Long Seam Susceptibility Criteria

EUT 26-1TT Elan Longitudinal Seam Analysis

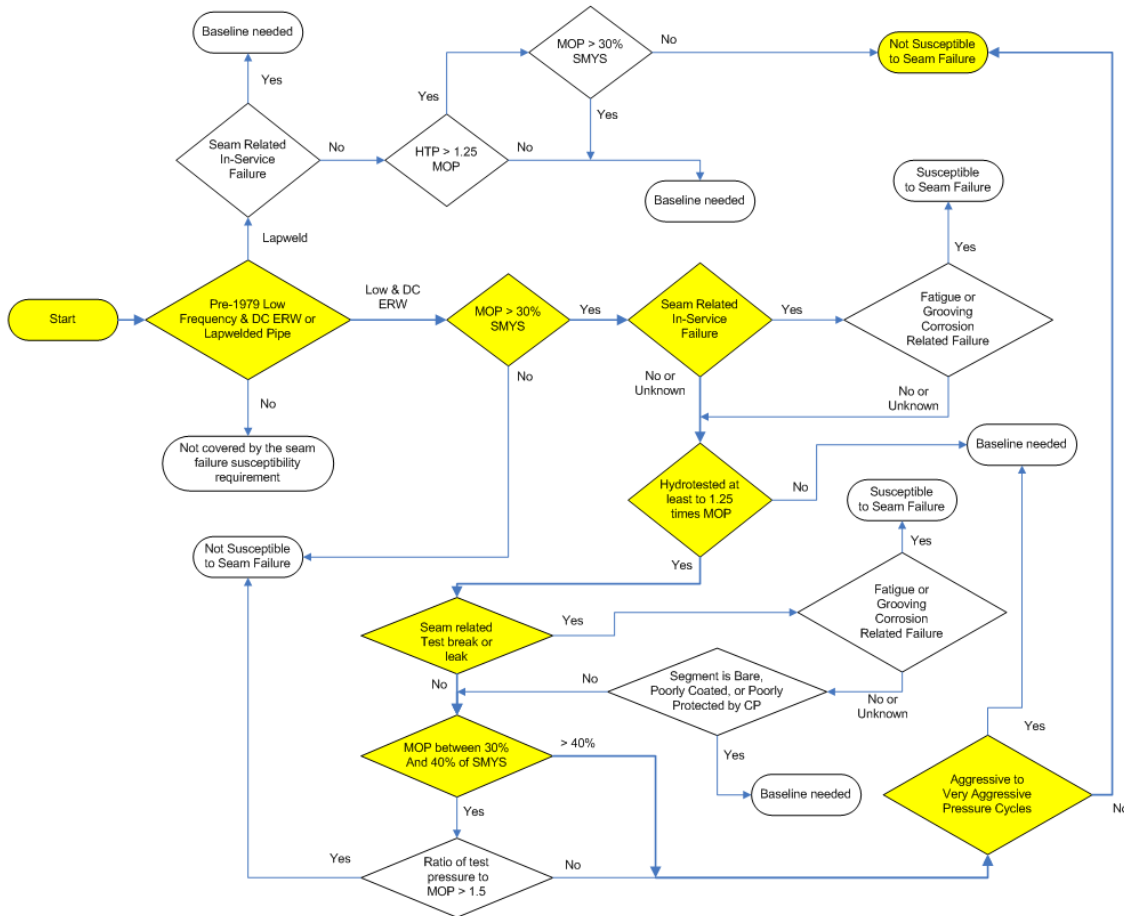
TTO Number 5, Low Frequency ERW and Lap Welded Longitudinal Seam Evaluation, Final Report by Michael Baker Jr., Inc., Revision 3, April 2004 (Baker Report), Figure 4.1		
E'Lan Subdivision EUT 20-1 TT		
Start	Inspection Area from MP 11+2700 to MP 40+1600	Documentation
Pre-1979 Low Frequency & DC ERW or Lapwelded Pipe	AQ Smith EFW	Appendix C - Pipe PC
MOP>30% SMYS	Yes; 100% SMYS = 1461, MAOP = 1052, 72% SMYS Stress Level	
Seam Related In-Service Failure	No	
Hydro Tested at Least to 1.25 x MAOP	Yes 1320, 1956 Test, 1052 MAOP; 1320/1052 = 1.25 1461, 1989 Test, 1052 MAOP; 1461/1052 = 1.39 2175, 1989 Test, 1052 MAOP; 2175/1052 = 2.07 1890, 1981 Test, 1052 MAOP; 1890/1052 = 1.80 2175, 1980 Test, 1052 MAOP; 2175/1052 = 2.07 1461, 1959 Test, 1052 MAOP; 1461/1052 = 1.39 2175, 1994 Test, 1052 MAOP; 2175/1052 = 2.07 1461, 1989 Test, 1052 MAOP; 1461/1052 = 1.39 2175, 1999 Test, 1052 MAOP; 2175/1052 = 2.07 2175, 1993 Test, 1052 MAOP; 2175/1052 = 2.07 2175, 1989 Test, 1052 MAOP; 2175/1052 = 2.07 2175, 1976 Test, 1052 MAOP; 2175/1052 = 2.07 1315, 1984 Test, 1052 MAOP; 1315/1052 = 1.25	Appendix D - Hydro Records and Charts

Seam Related Test Break or Leak	Yes	Appendix D - Hydro Records and Charts
Fatigue or Grooving Corrosion Related Failure	No	
Segment is Bare, Poorly Coated, or Poorly Protected by CP	No	
MOP Between 30% and 40% of SMYS	>40%; 72%	
Aggressive to Very Aggressive Pressure Cycles	No	
<b>Not Susceptible to Seam Failures</b>

TTO Number 5, Low Frequency ERW and Lap Welded Longitudinal Seam Evaluation, Final Report by Michael Baker Jr., Inc., Revision 3, April 2004 (Baker Report), Figure 4.1		
E'Lan Subdivision EUT 26-1 TT		
Start	Inspection Area from MP 11+2700 to MP 40+1600	Documentation
Pre-1979 Low Frequency & DC ERW or Lapwelded Pipe	AQ Smith EFW	Appendix C - Pipe PC
MOP>30% SMYS	Yes; 100% SMYS = 1500, MAOP = 1080, 72% SMYS Stress Level	
Seam Related In-Service Failure	No	
Hydro Tested at Least to 1.25 x MAOP	Yes 1350, 1961 test, 1080 MAOP; 1350/1080 = 1.25 1500, 1963 test, 1080 MAOP; 1362/1080 = 1.26 1730, 1975 test, 1080 MAOP; 1730/1080 = 1.60 2175, 1989 test, 1080 MAOP; 2175/1080 = 2.01 1500, 1989 test, 1080 MAOP; 1500/1080 = 1.39 2077, 1981 test, 1080 MAOP; 2077/1080 = 1.92 1620, 1976 test, 1080 MAOP; 1620/1080 = 1.50 1500, 1989 test, 1080 MAOP; 1500/1080 = 1.39 2175, 1994 test, 1080 MAOP; 2175/1080 = 2.01 2175, 1999 test, 1080 MAOP; 2175/1080 = 2.01 2175, 1993 test, 1080 MAOP; 2175/1080 = 2.01 1952, 1976 test, 1080 MAOP; 1952/1080 = 1.81 1500, 1964 test, 1080 MAOP; 1500/1080 = 1.39 1362, 1984 test, 1080 MAOP; 1362/1080 = 1.26 1350, 1984 test, 1080 MAOP; 1350/1080 = 1.25 2175, 2002 test, 1080 MAOP; 2175/1080 = 2.01 2164, 2002 test, 1080 MAOP; 2164/1080 = 2.00 2164, 2003 test, 1080 MAOP; 2164/1080 = 2.00	Appendix D - Hydro Records and Charts

Seam Related Test Break or Leak	No	Appendix D - Hydro Records and Charts
MOP Between 30% and 40% of SMYS	>40%; 72%	
Aggressive to Very Aggressive Pressure Cycles	No	
<b>Not Susceptible to Seam Failures</b>
