The Collapse of Building 7 by Arthur Scheuerman December 8, '06

WTC's Building 7 was a 47-story office building completed in 1987 by Silverstein Properties on land owned by the Port Authority. It was built according to PA-NY-NJ codes developed for tenant alterations in the tower buildings. Building 7 was not hit by any planes but had some damage from parts of Tower 1 impacting the south wall. Because of the damage to the building and the failure of the water supply, after talking to the owner, the Fire Department decided to evacuate the building and not to attempt to control the fires but to let them burn out. Since it was a "fire resistive" building, there would have been every expectation that the fires would burn out without any local or global collapse. However, given that the towers had collapsed and that there had been a serious interior collapse of Building 5, there was concern, and the collapse area around the building was cleared. The building suffered global collapse from fire after several hours of uncontrolled burning. There were no known injuries or fatalities in the collapse.

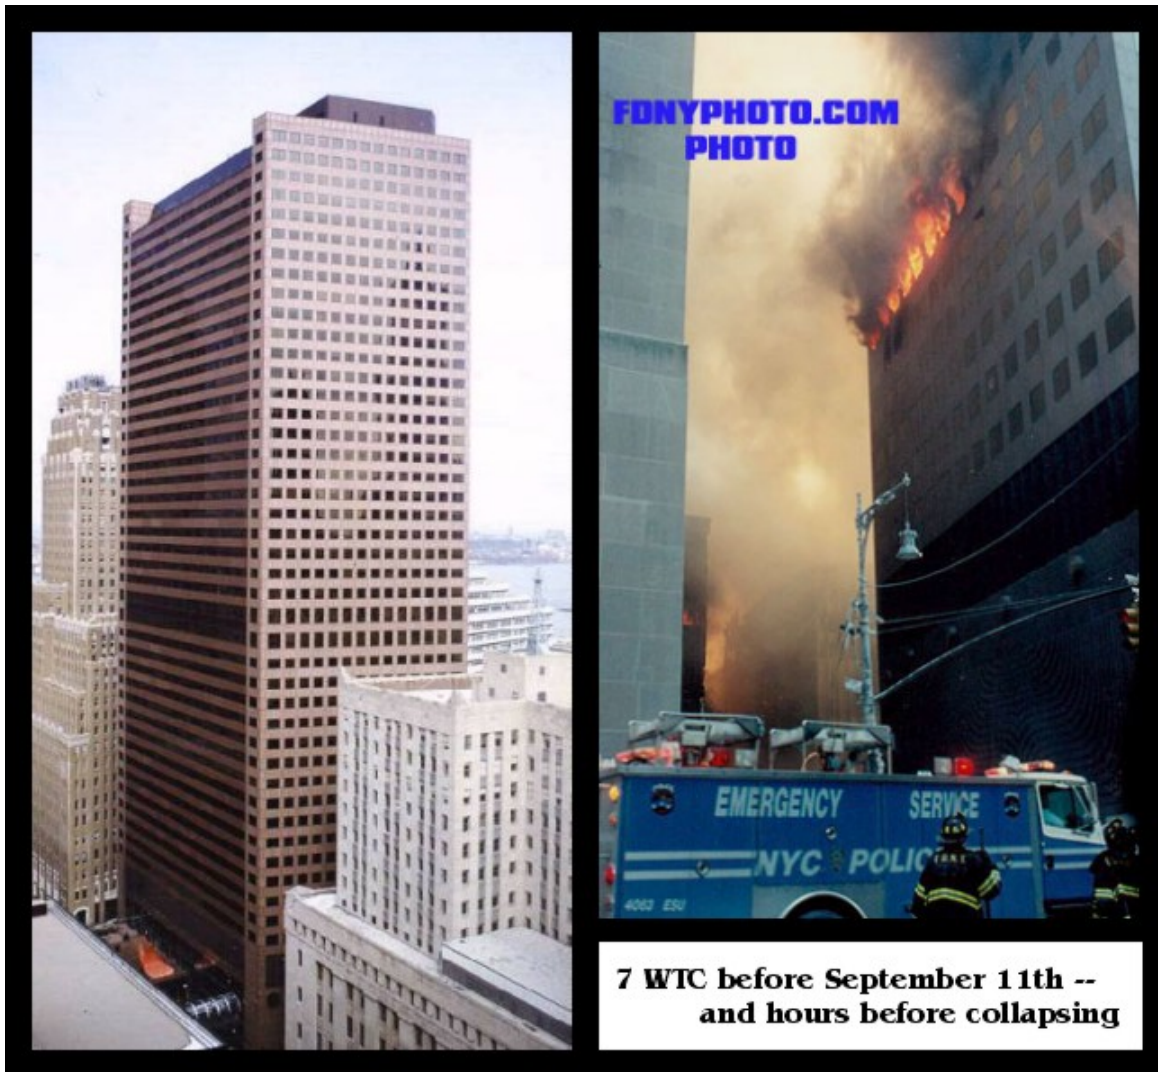
Photo 21. Building 7 before September 11 (left) and hours before collapsing (right). (Courtesy of Fire Department of New York.)

The fire shown in photos 21 and 22 appears to be a very severe, but ordinary, office fire and was well above the area supplied with oil lines. There is a strong possibility that this building collapsed from this office fire alone. NIST was scheduled to complete its analysis of the cause of the collapse in June 2006. This report is my contribution toward the analysis.

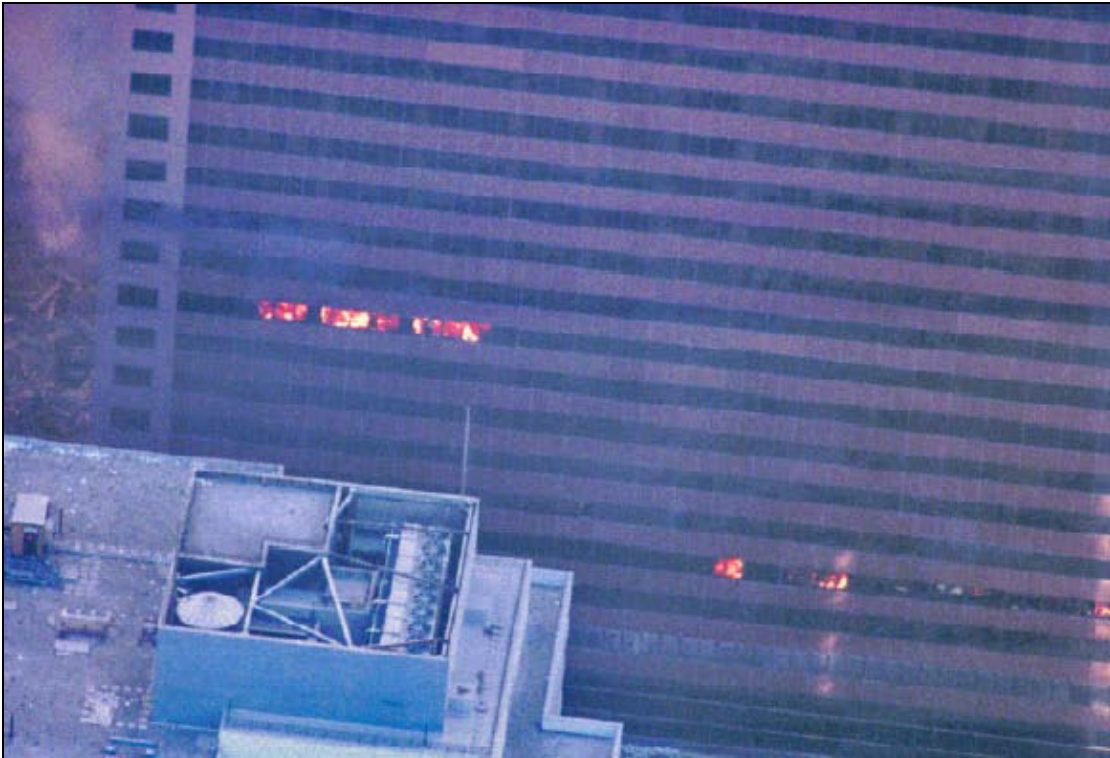
Photo 22. The north side of Building 7. Fires are on the 7th and 12th floors. (Courtesy of NIST.)

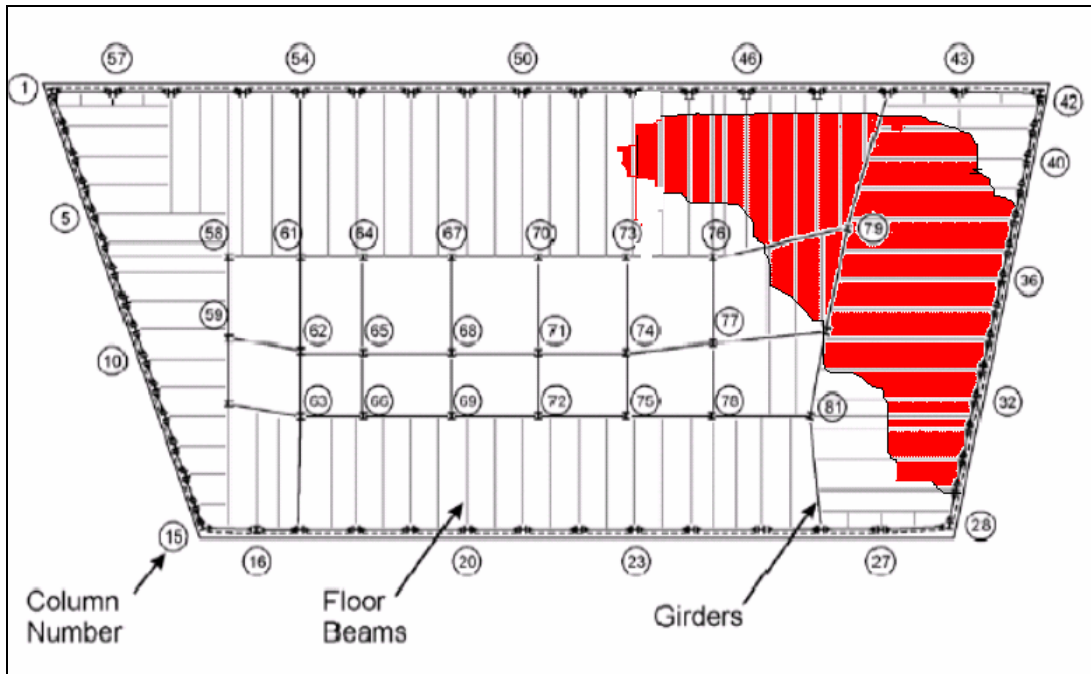
Figure 21. The approximate fire location on the east side of floor 12. (Courtesy of NIST, modified by author)

Fire is coming out of eight windows on the east side on the 12th floor. This fire must have dropped down to the 11th floor, since a later photo shows fire at four windows on the 11th floor. There was also fire showing at multiple 12th-floor windows on the north side. This is a serious high-rise building fire that would have necessitated multiple alarms to control. There were various other fires on different floors. These photos were taken at around 2 p.m.; the building collapsed about three hours later, after the 12th-floor fire had burned out.

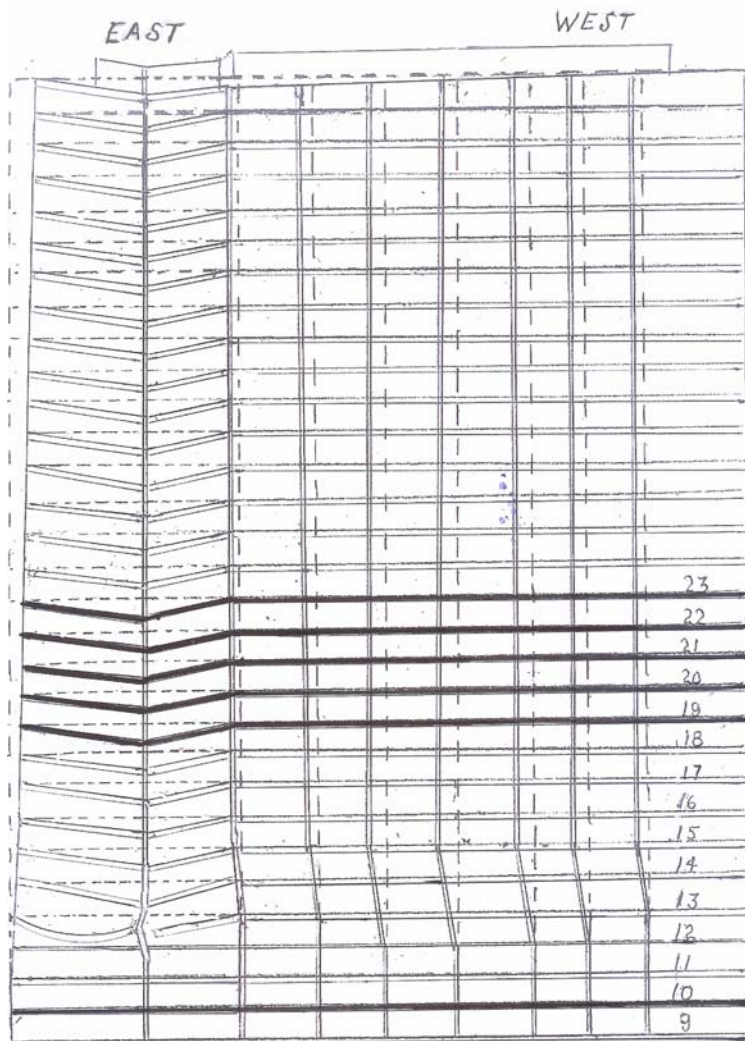
Since the columns were widely spaced and floor spans were on the order of 50 feet, with a column failure, the floors would not have been able to effectively redistribute their loads to other columns, and the collapse would have progressed upward to the top of the building. A semi-plastic hinge would have formed along the north-south girder because of the single-plate, bolted beam-to-girder connections. The tensile pull-in forces in all these upper buckled floors would have been great, since these floors were cool and there would have been no expansion-induced sag. (See Part 3, Theory.)

Figure 22. East-West building section as viewed from the north showing column failure and resulting progression, putting all floors above in suspension; and the east roof shed is sinking. Darker floors are reinforced. (Diagram by author.)

Floors 21 to 23 had slightly heavier steel framing than the others (shown darker in diagram, Figure 22). Portions of Floors 10, 19, and 20 had reinforcing plates on the bottom flange, and certain connections were reinforced. If other floor connections failed, these strong connections might have held and pulled a line of core columns eastward, especially if impacted by falling debris from the collapsing floors above. The fact that Core Columns 76, 77, and 78 on all the floors would have been subjected to pull-in with increasing pull-in on the lower floors should be figured in.

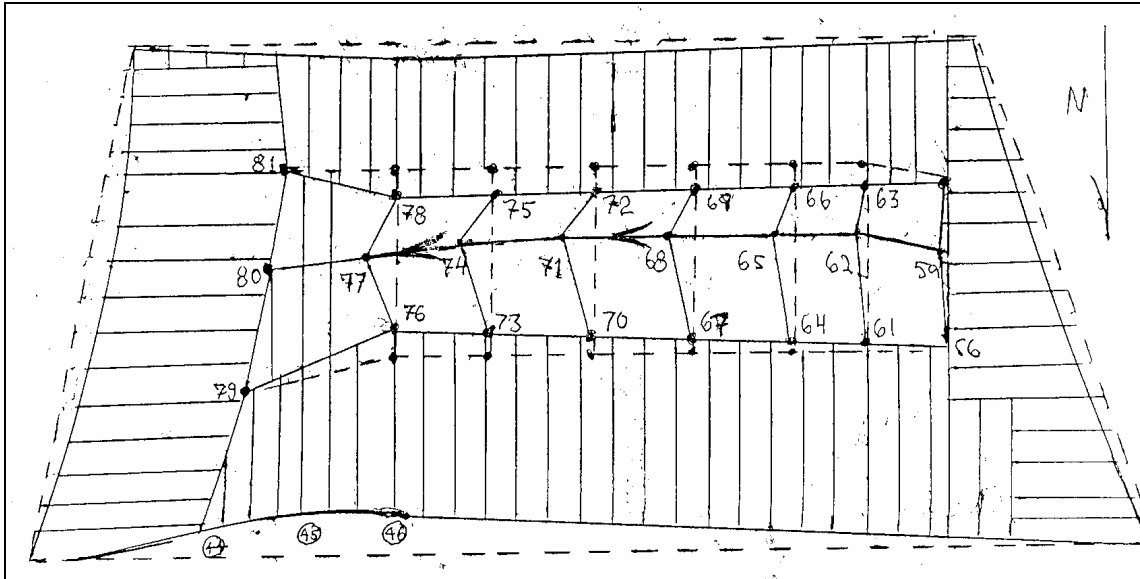
Figure 23. The buckling of Columns 79, 80, and 81 would have allowed the east side floors directly above these columns to go into suspension and would have produced these strains in the remaining structure on all the floors above the 13th. (Diagram by author.)

Tension in the floors above the buckled key columns could have put floor connections to the core columns under immediate severe lateral stress on all the floors above 13. These lateral stresses would be greater on the lower floors because of the exterior wall's leaning inward more at the top. If the floor connections to Column 77's connection held on any of the levels above the 13th floor, the middle line of Core Columns 77 to 62, and possibly 59, could have been pulled eastward under the lateral forces. This line of middle core columns would more easily have been pulled eastward, since there were elevator shafts along this line and there were fewer floors that could have restrained these columns and floor beams from deflection. The connections to columns 76 and 78 on any floor above the thirteenth would probably fail first allowing the connection to column 77 to hold and pull the line the line of core columns 77 to 62 and possibly 59 eastward.

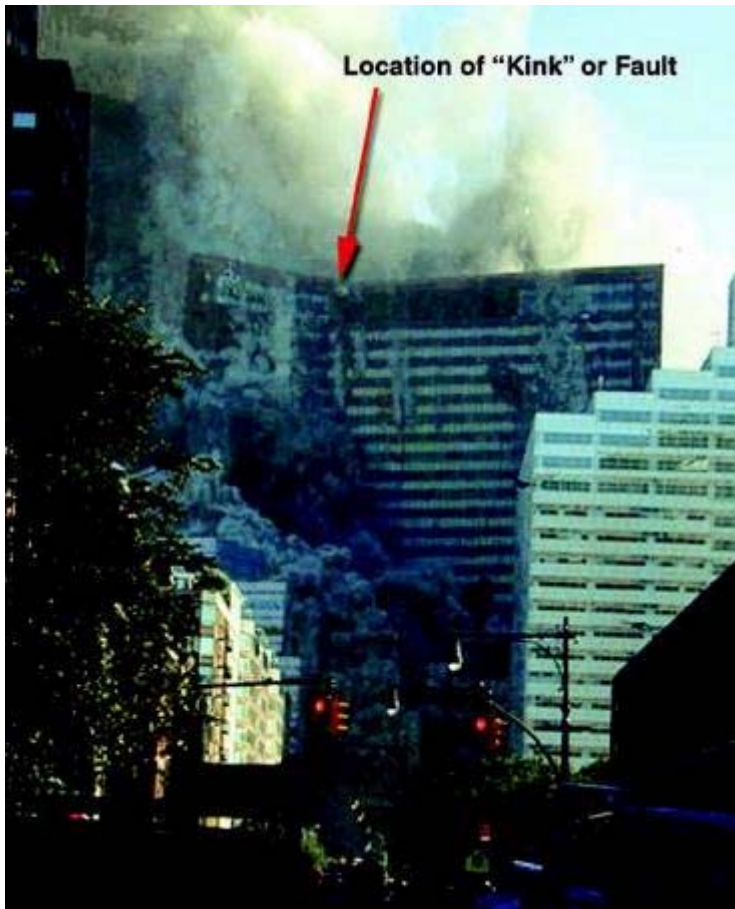
Photo 23. Façade kink. (Courtesy of NIST)

The massive façade kink, which increased as the perimeter wall came down as a unit, was aligned with Columns 76, 77, and 78. This supports the idea that these particular columns were the first core columns to fail on one or more floors and were followed by the remaining core columns, pulling in the entire exterior facade. The pull-in tension on a particular floor or floors could have buckled, say columns 76 to 61, This pull-in tension on the remaining core columns was possibly assisted by a floor or floors disconnecting from the girder along the east-west axis of the core, since “shear studs were not indicated in the design

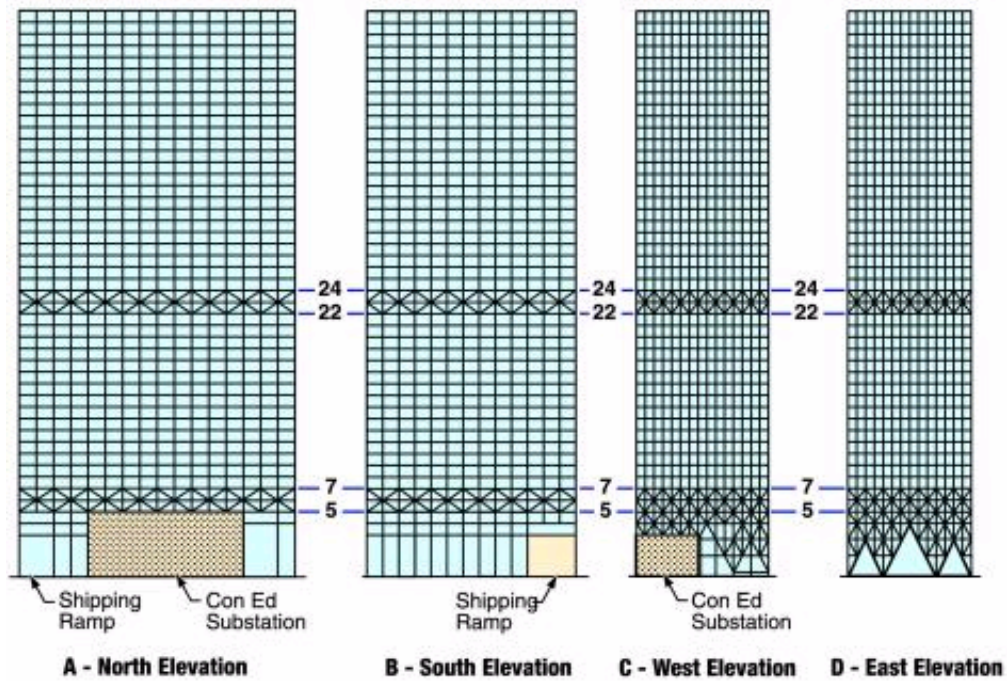
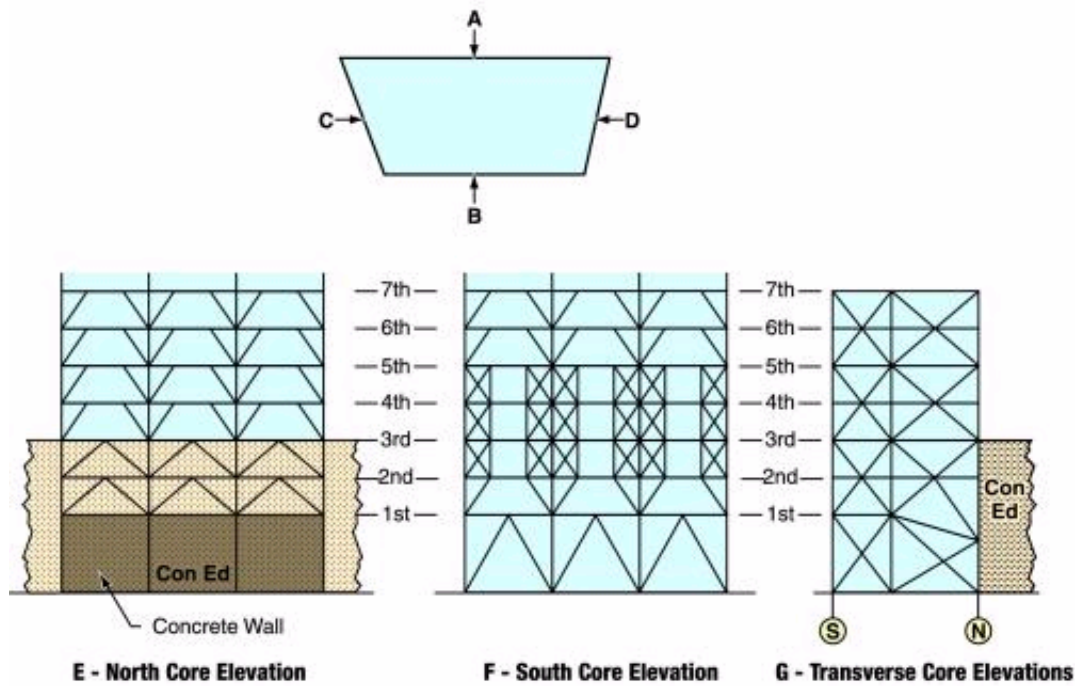
Figure 24. As-built elevations. Building 7.

The belt truss around the building at the 22nd to the 24th floors stiffened the perimeter wall and probably supported the outer frame so that it came down as a unit above the buckling columns.
