Test Report:

Single Event Testing of the TSS901E 1355 Controller

Code 561
GSFC-NASA

16th March 2004

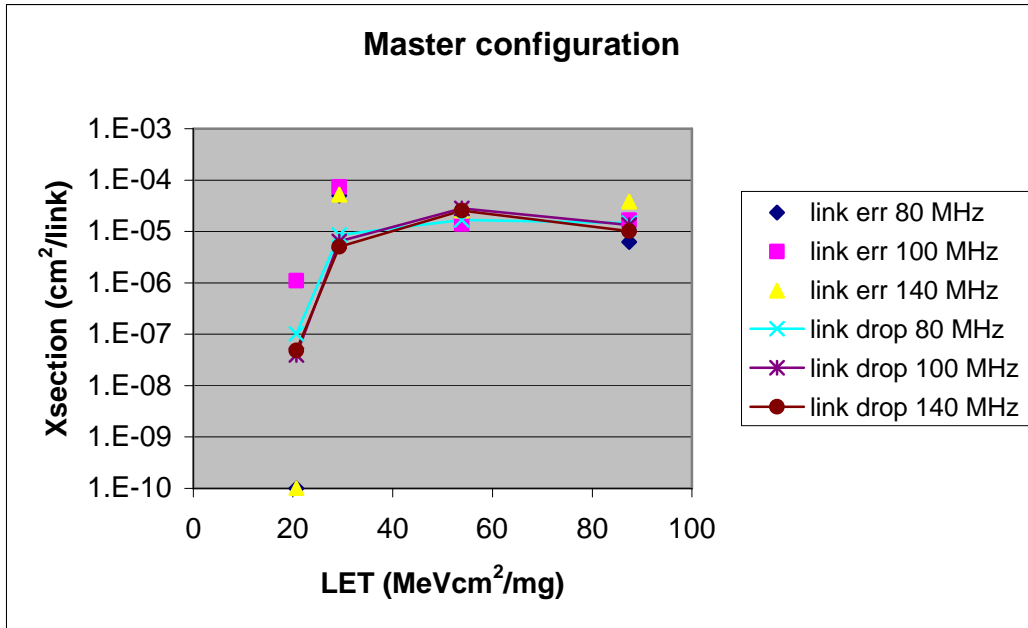
Table I shows the number of SEUs in each of the three links and in the registers following a SEFI. There are three runs for every condition, and the results of those three runs are summed and entered into the table in the next row. The Table also shows that on two occasions there were over 80 million link errors. Such a large number of upsets might be due to a slip in synchronization in the phase lock loop (PLL). It took a while for the software to stop, during which time the large number of errors was accumulated. In some cases, communications were halted as a result of drops in one, two, or three Links.

Figure 2. Cross-section as a function of ion LET for Link errors and Link drops when the DUT was configured as Master. Data are for three different frequencies.

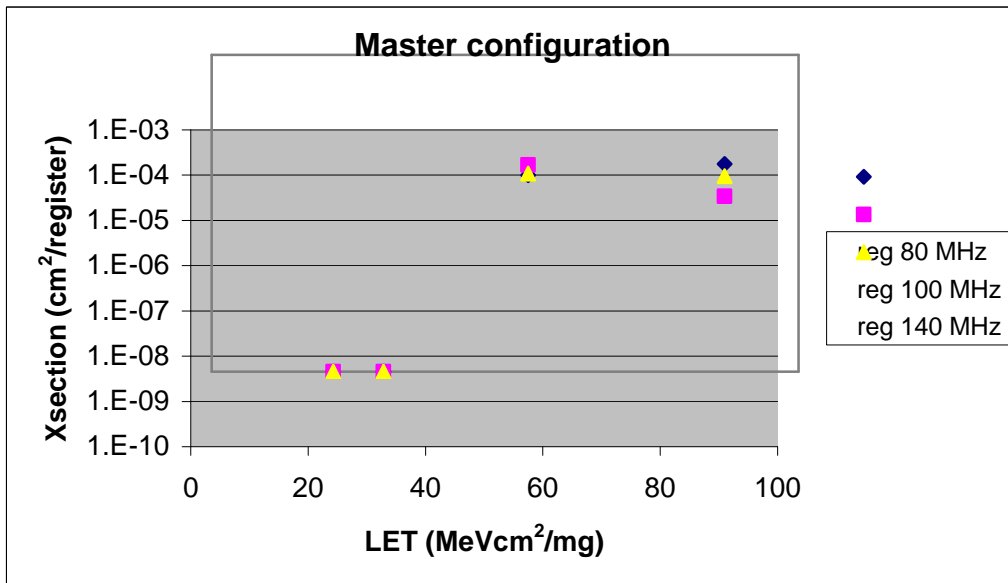
Figure 3. SEU cross-section as a function of ion LET for the registers when the DUT was configured as the Master. The data are for three different frequencies. Since no upsets were observed at the two lowest LETs, the data points represent the maximum possible cross-section.

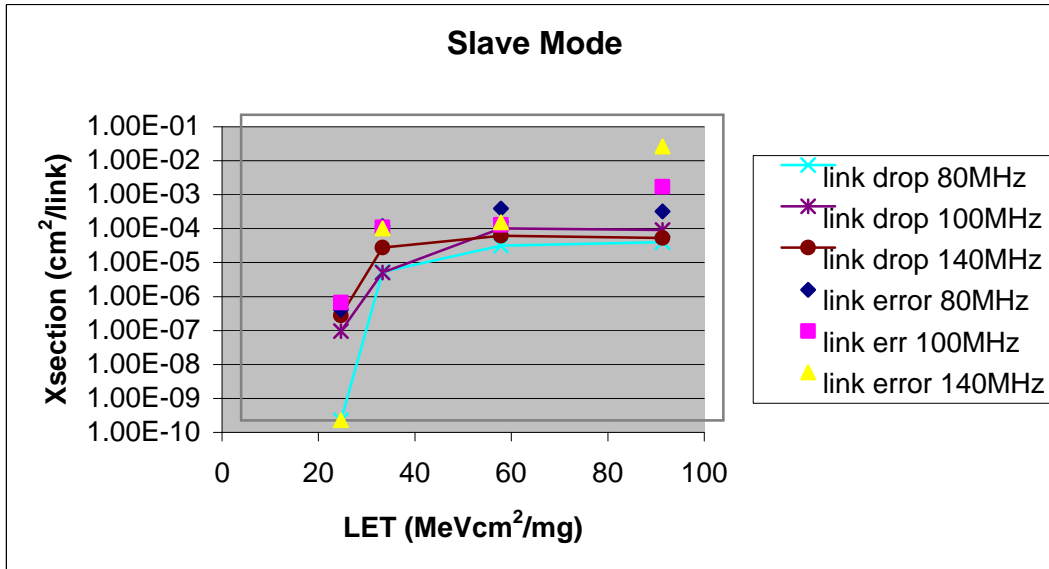
The data in Table II show that no upsets were detected in the slave when the latter was irradiated. This is not surprising because only the master was monitored for errors. In addition, there were five occasions when a large number of errors appeared, most likely as a result of a single ion hit to the phase lock loop. Therefore, the burst of errors is counted as a single event.

Figure 4. Cross-section as a function of ion LET for Link drops and Link errors with the DUT configured to operate in the Slave mode. Data for three different frequencies are included.

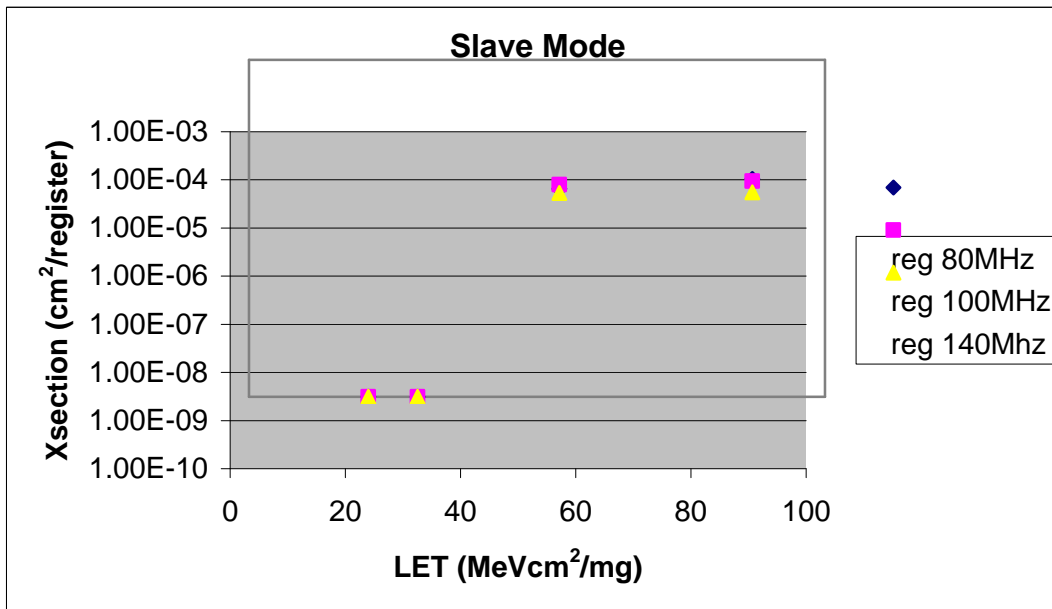
Figure 5. Cross-section as a function of ion LET for register errors with the DUT configured to operate in the slave mode. Data are for three different frequencies.
