NIST-GCR-98-743

**FIRE-RELATED ASPECTS OF THE
NORTHRIDGE EARTHQUAKE**

**Charles Scawthorn, Andrew D. Cowell
and Frank Borden**

**October 1996
Issued March 1998**

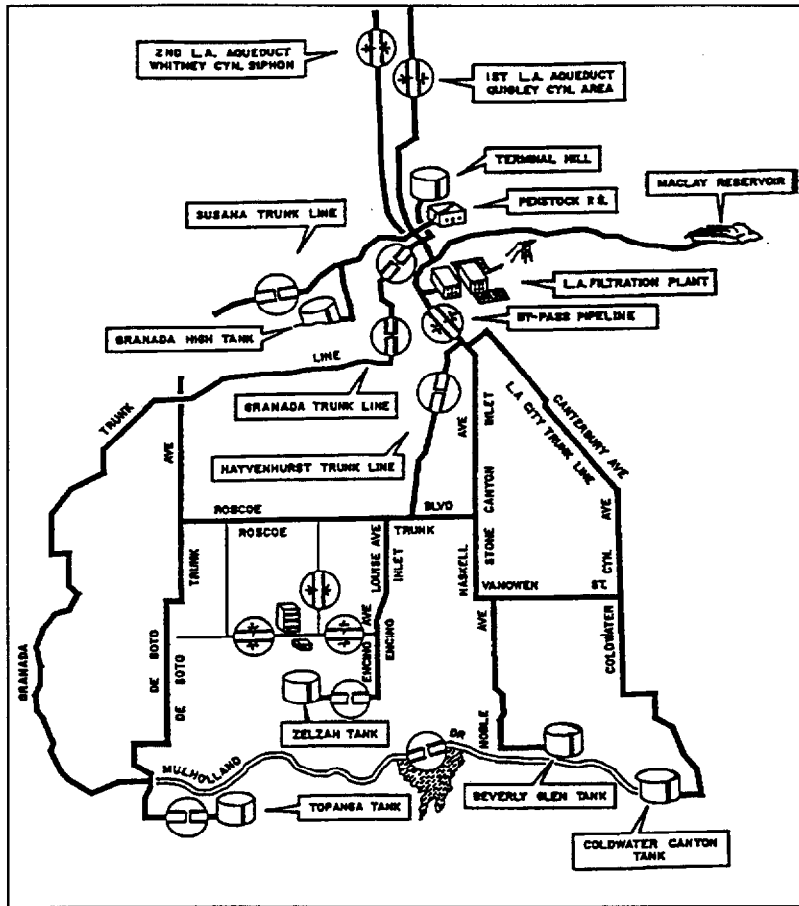
Figure 2-4. Water System Damage, Northridge Earthquake (Courtesy of LAFD)

The Northridge earthquake affected the water supply for portions of the San Fernando Valley. The damage in that area is shown in Figure 2-4. Breaks occurred in at least six trunk lines and a large number of leaks occurred at other locations. The Department of Water and Power estimated that approximately 1,400 leaks were caused by the earthquake, including two lines of the Los Angeles Aqueduct (Lund et al, 1995). Pump stations and storage tanks also sustained damage. The damage to the system resulted

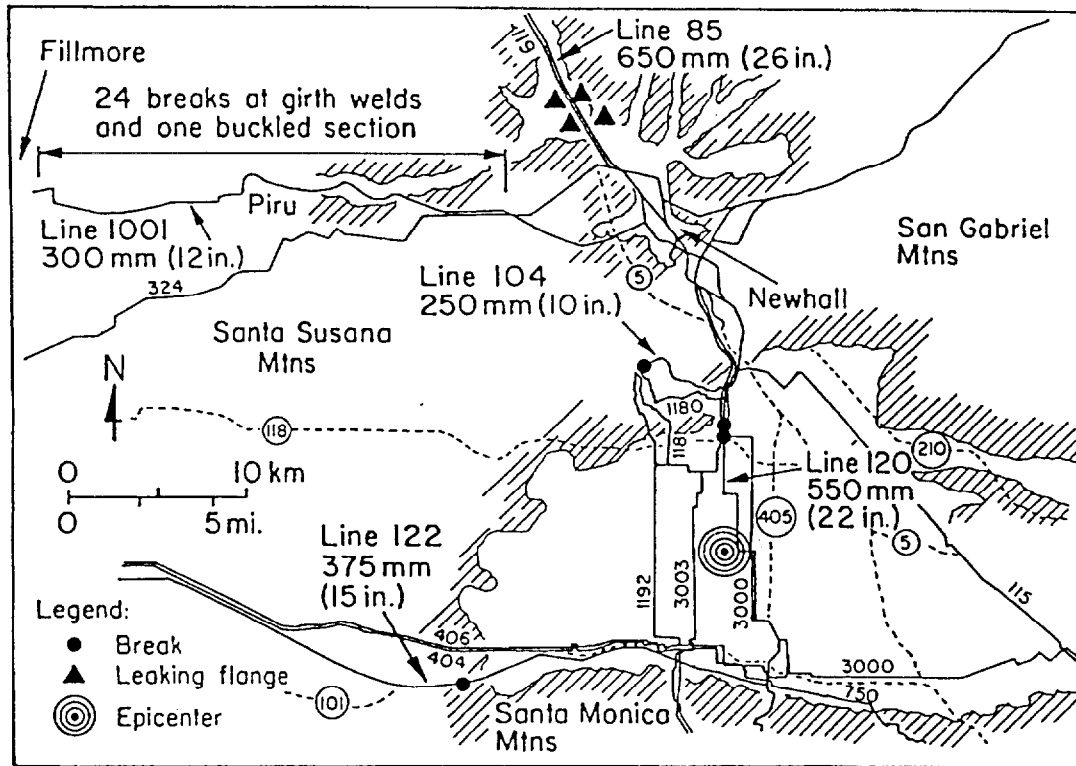
Figure 2-5: Map of selected gas transmission pipes in the Northridge earthquake (after Holzer et al, 1996)

There were 35 non-corrosion-related repairs made to the transmission system, of which 27 were at cracked or ruptured oxacetylene girth welds in pre-1932 pipelines, Figure 2-5. Gas escaping at the break in Line 1001 under Hwy. 126 near Fillmore ignited, possibly by a downed power line. On Balboa Blvd. between Rinaldi and Lorillard, significant permanent ground deformations were experienced due to liquefaction (Holzer et al, 1996), resulting in distinct tension and compression regions affecting several water and gas transmission lines under Balboa Blvd. (Figures 2-6 and 2-7). Line 120 (22 inch. diam. steel) failed, and escaping gas was ignited, reportedly by sparks from the ignition

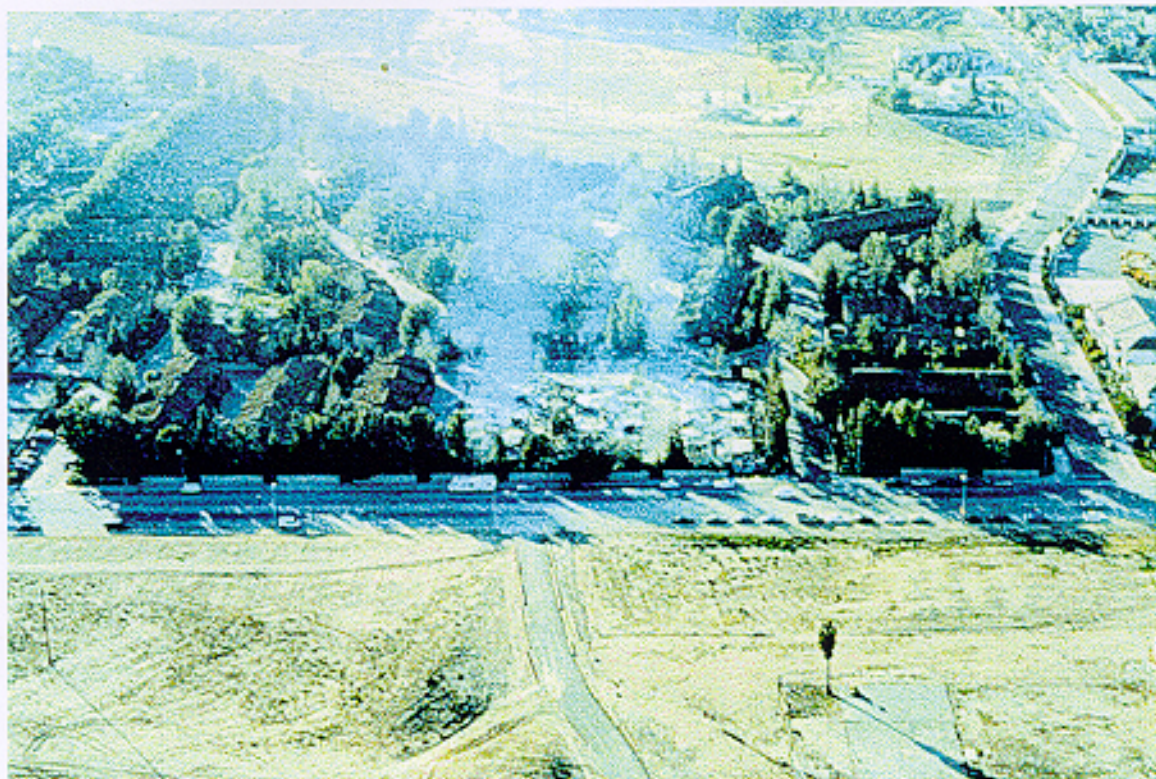
3-5: Multiple structure fire spread, 18110 Andrea Circle North, North San Fernando Valley. (Loss: 17 units, 3 buildings, ~ \$500,000; cause: gas meter damage)

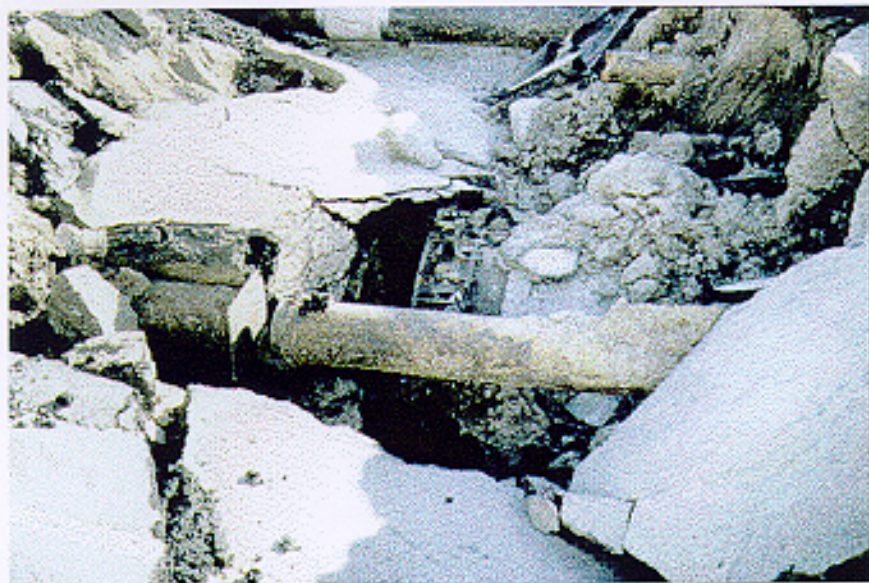
3-6: Broken water and gas mains on Balboa Boulevard in an area of extensive ground failures possibly caused by faulting. The broken gas main (foreground) ignited and caused a fire that burned down five houses and damaged several more.

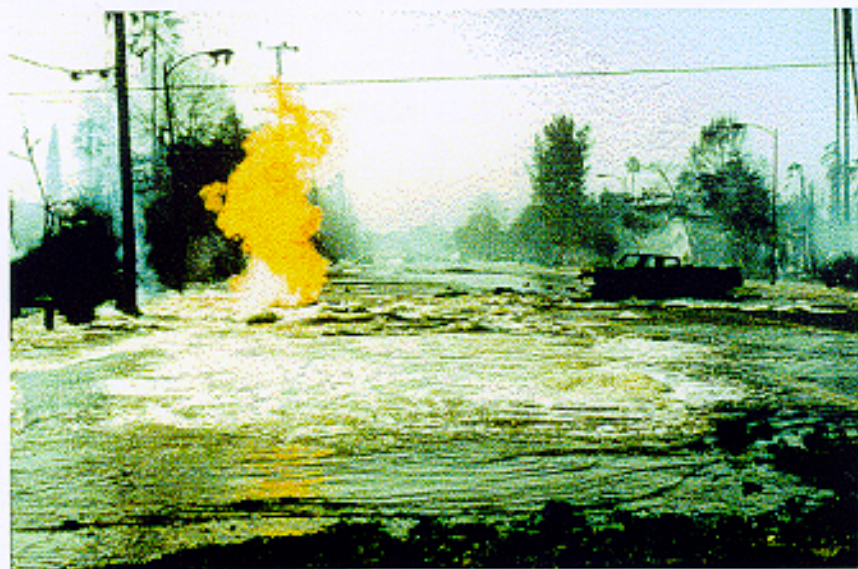
3-7: This fire on Balboa Boulevard in Granada Hills destroyed several homes and was caused by an unusual sequence of events. Adjacent water and gas mains broke because of ground failure (possible faulting). According to eyewitness, the truck stalled because of the flooding, and when the driver attempted to restart the vehicle, the leaking gas was ignited.

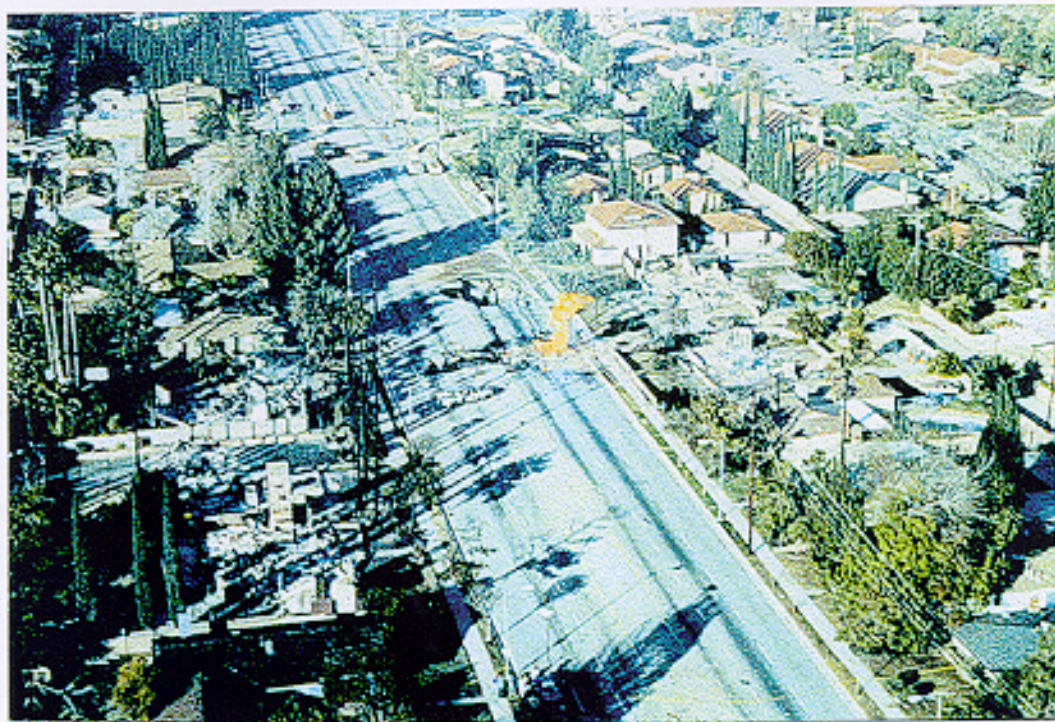
3-8: Burning gas main on Balboa Boulevard, Granada Hills, January 18, 1994.

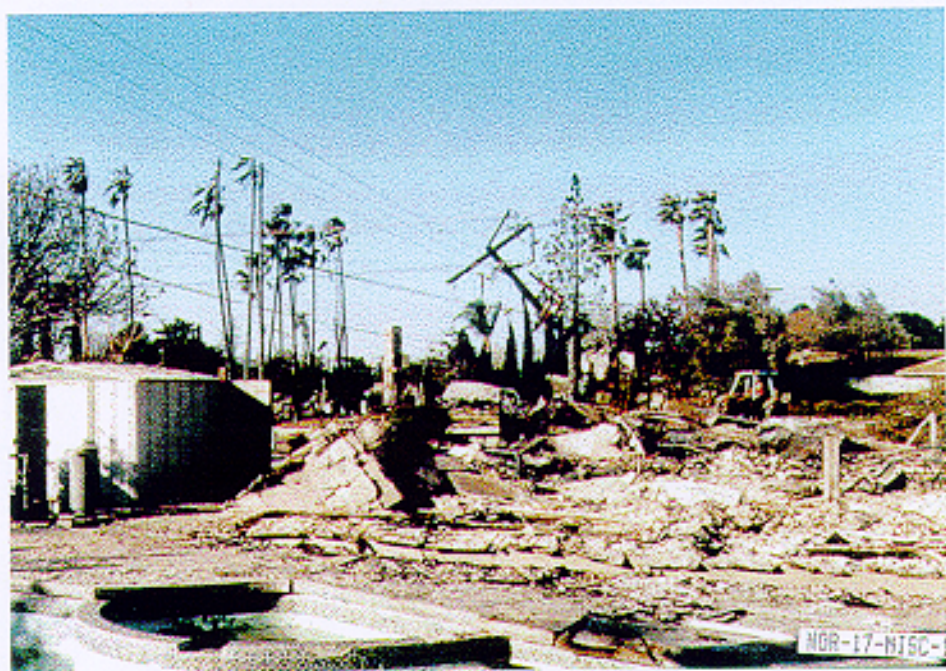
3-9: The remains of a few of the homes destroyed by the fire on Balboa Boulevard.

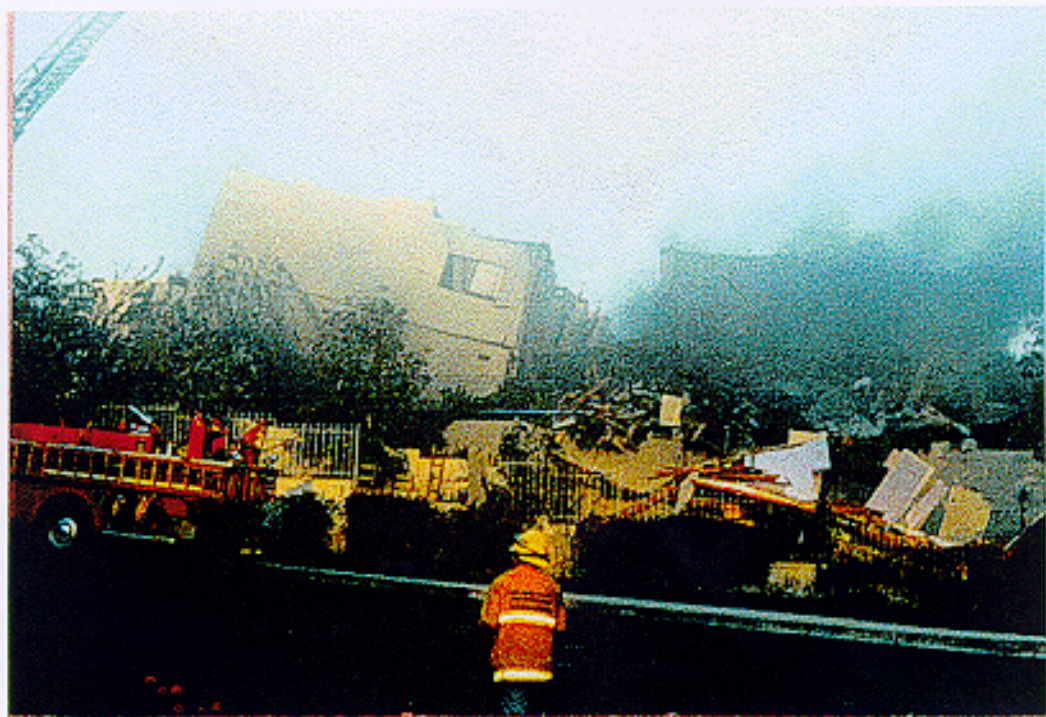
3-10: Collapsed 2-story condominium with fire in debris, 11611 Blucher Ave., Granada Hills.

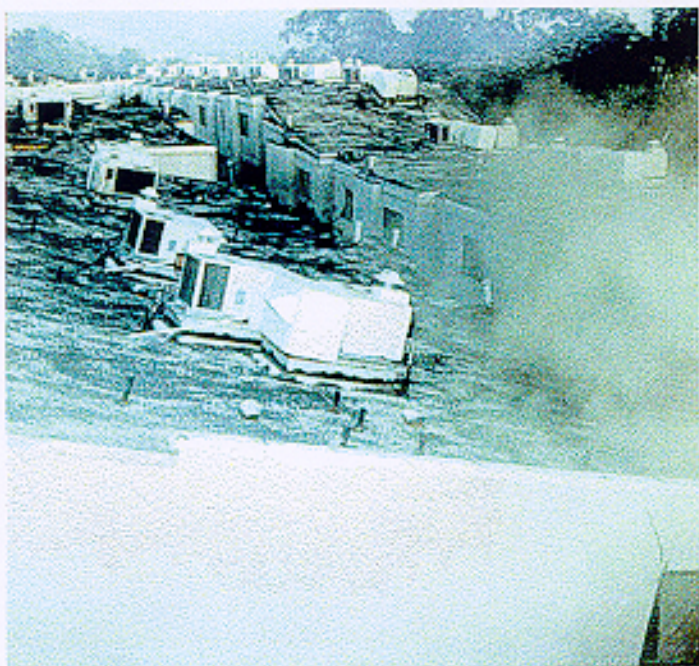
3-11: Roof area of collapsed condominium, Granada Hills.

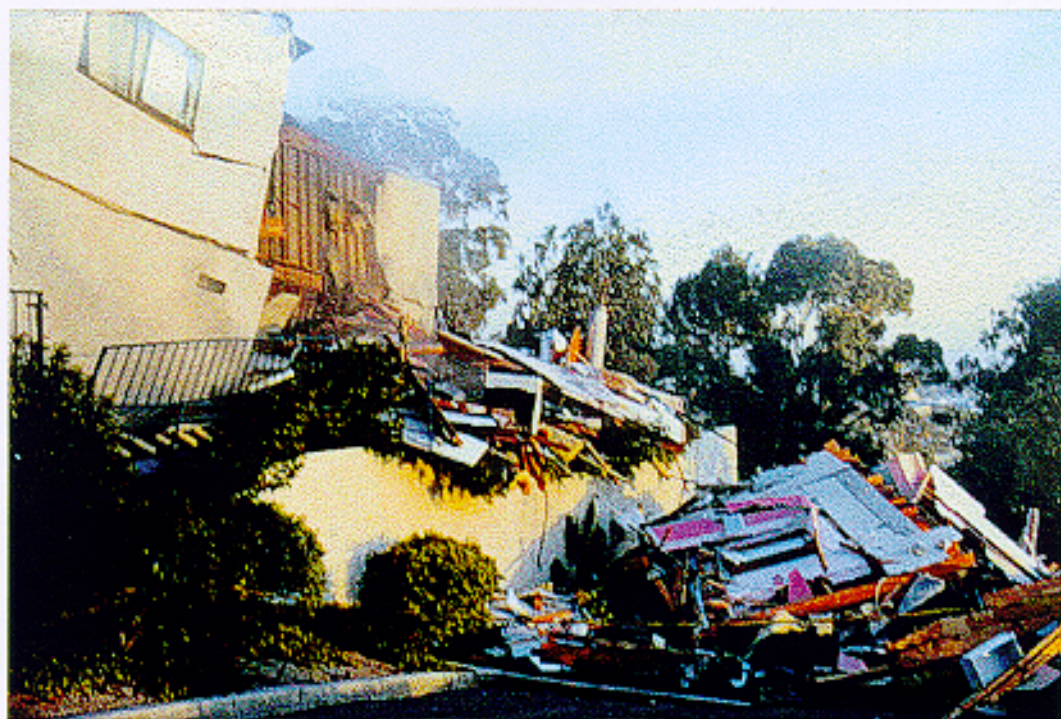
3-13: Total collapse of end units of condominium, Granada Hills.

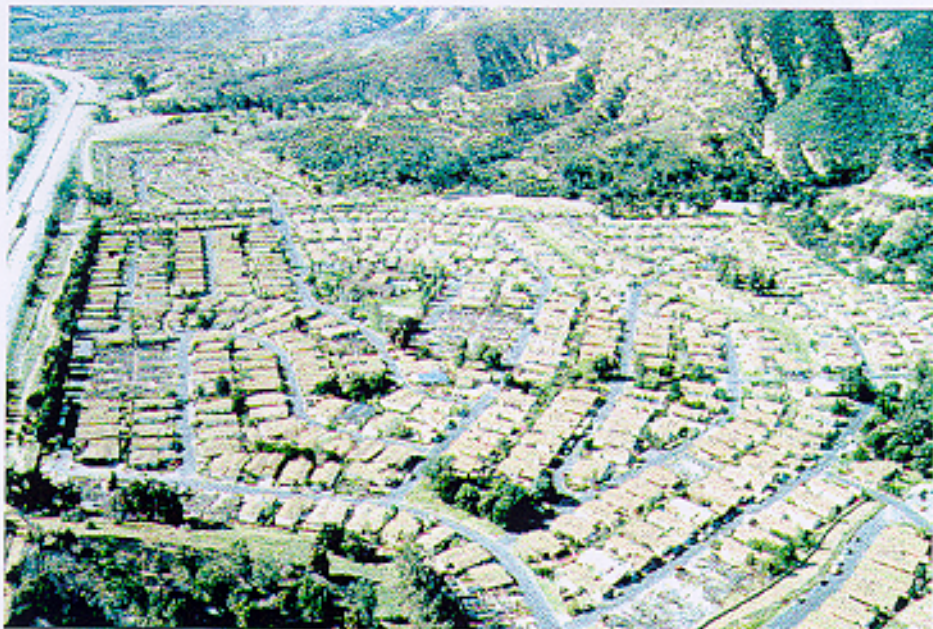
3-15: The large mobile home in San Fernando had at least five separate fires, all caused by mobile homes coming off of their foundations and severing gas lines. The rate of ignitions in mobile home parks was much higher than for housing developments. The rate is higher because in some mobile home parks, as many as 95% of the homes collapsed off their supports.

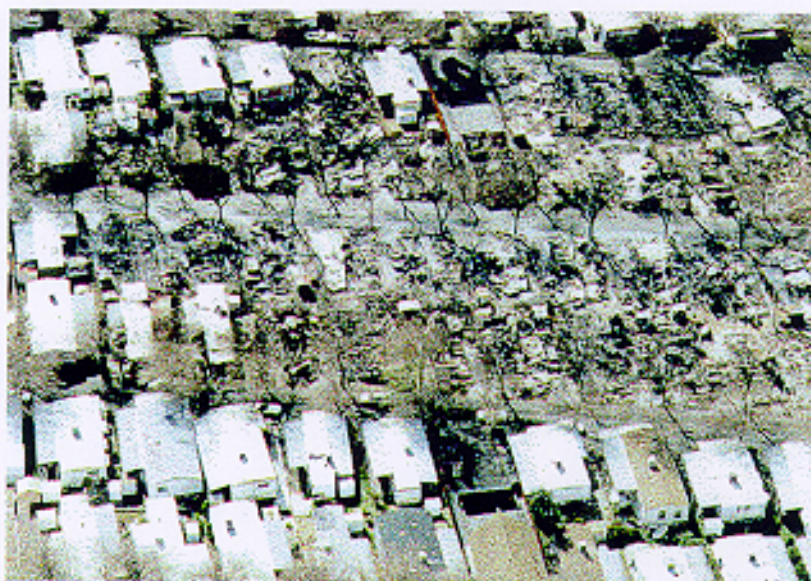
3-16: The remains after a fire in a mobile home development that destroyed at least 36 homes, 15445 Glen Oaks Blvd.

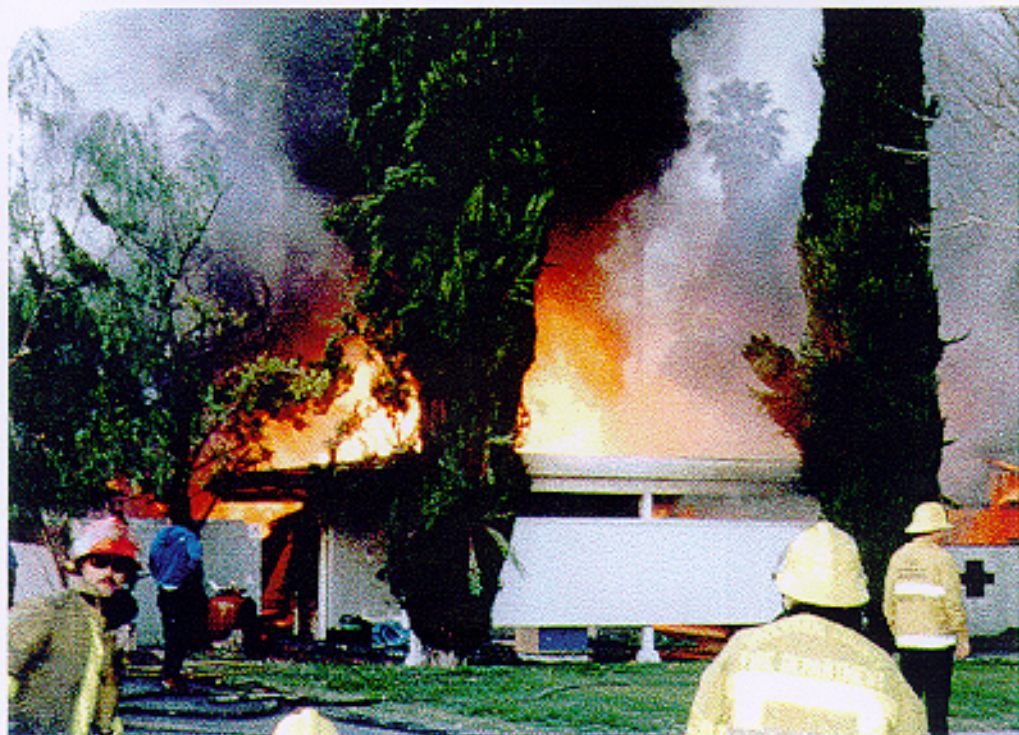
3-17: Residential fire in 18500 block of Strathern St., Reseda, approximately 11AM January 19 (two days after the earthquake). Fire fighters were still hampered by lack of water in the neighborhood to fight the fire. The only water available to fight this fire was from water tenders (tanker trucks) supplied by the Riverside County Fire Department. (Photo: S.P. Harris, EQE)

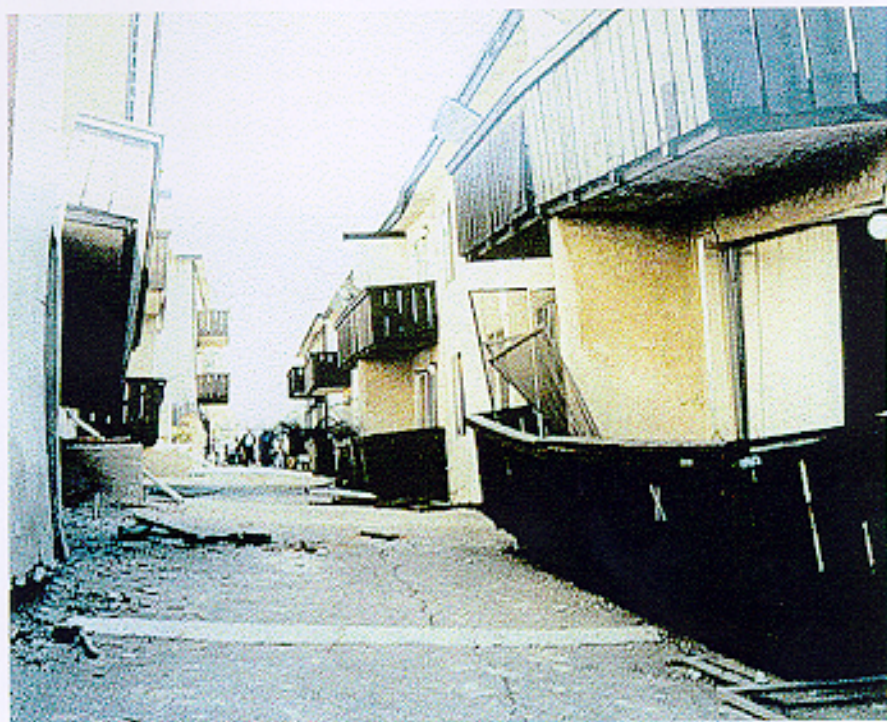
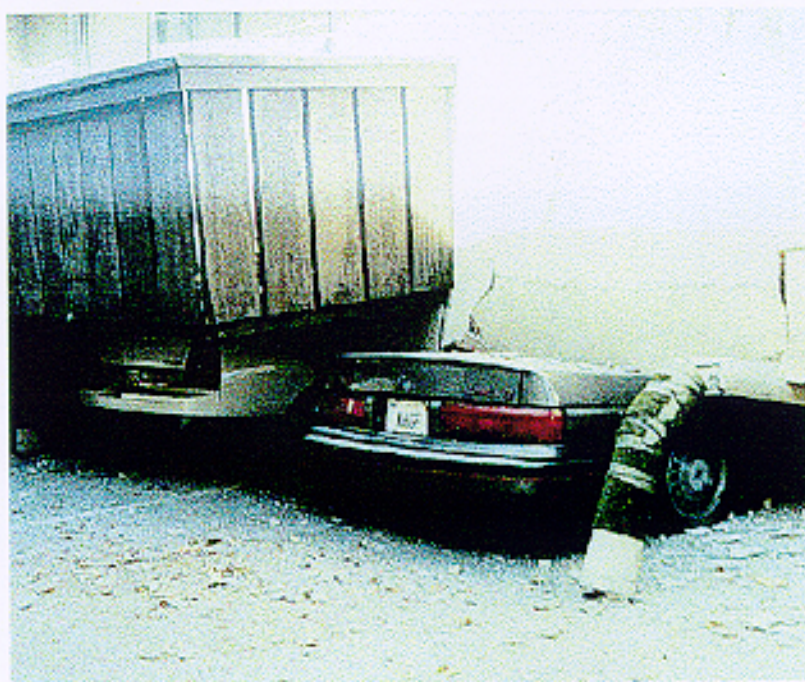
3-19 (top) and 3-20 (bottom): Northridge Meadows Apts. collapse of structure from soft first story parking garage. Three story building, 16 killed, hundreds rescued, 9565 Reseda Blvd.

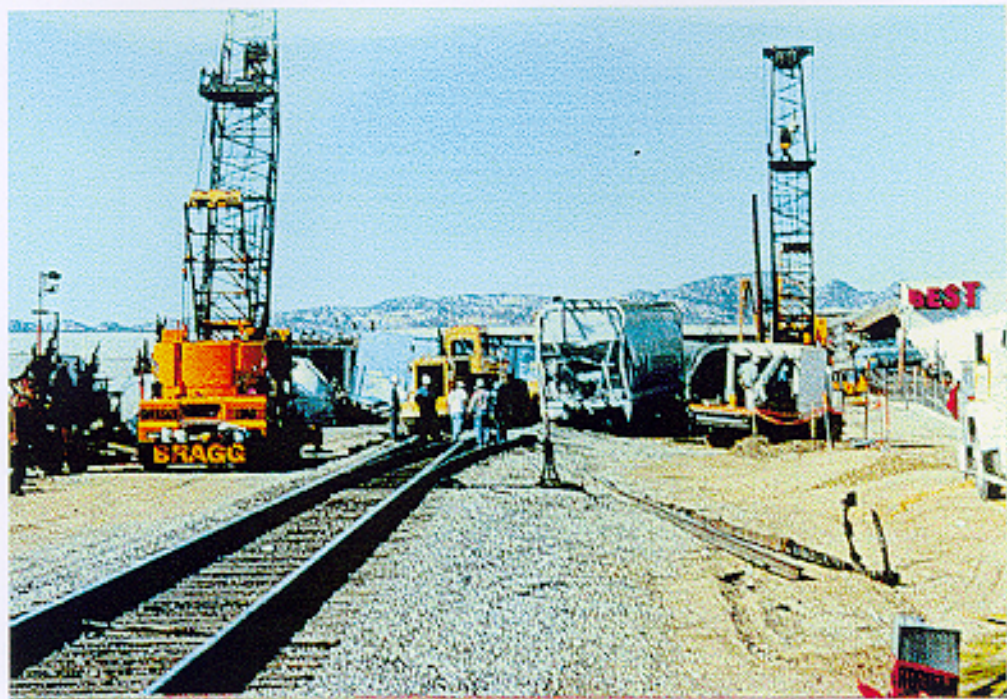
3-23C: Train derailed at Tampa and Nordhoff, 20 cars, one leaked 1,500 gallons of sulfuric acid

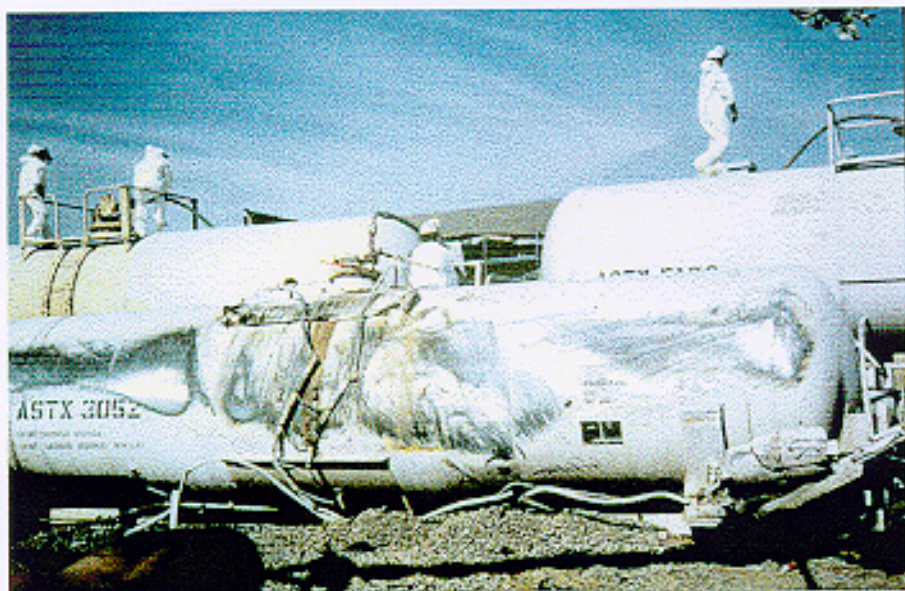
3-23D: These tank cars containing sulfuric acid derailed during the earthquake. Only one leaked.
