COMPLETION REPORT UPPER STOKES FISH PASSAGE IMPROVEMENT PROJECT BEAVER CREEK, METHOW SUBBASIN, WASHINGTON MARCH 2004

Upper Stokes Fish Passage Improvment Project

Appendix A. Construction Photographs (color)

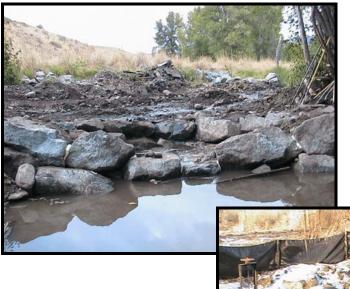
Cover Photo 1. Upper Stokes Fish Passage Improvement Project nearly completed doubledrop (A-shaped) Weir No. 1; backfill not yet done.

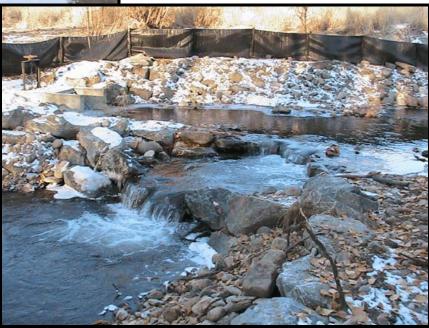
> Cover Photo 2. Upper Stokes Fish Passage Improvement Project — Completed project with silt fence in place. View looking at lower position of A-shaped Weir No. 1. Headgate diversion structure is at left side of photo (photo taken November 2003).

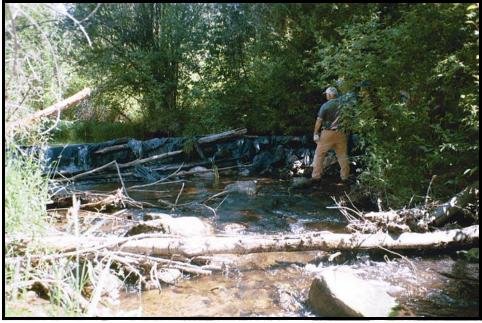
The existing 3¹/₂-foot-high diversion dam, made of stacked logs and lined with plastic (photo A-1), was removed entirely. To replace it, a so-called "Rosgen" rock vortex (A-type) weir (Cover Photo No. 1) was installed at the former site of the existing log structure. The new weir was designed with two drops, each 0.8 foot, which meets State standards for fish passage. Because the large rocks establish a hardened point, Weir No. 1 provides "grade control;" this means the stream is unable to downcut its bed over time. It also forms a small pool at the new point of diversion which was sufficient to allow diversion of the water right.

Photo A-1. Looking upstream at original Upper Stokes Diversion Dam (photo taken July 2002).

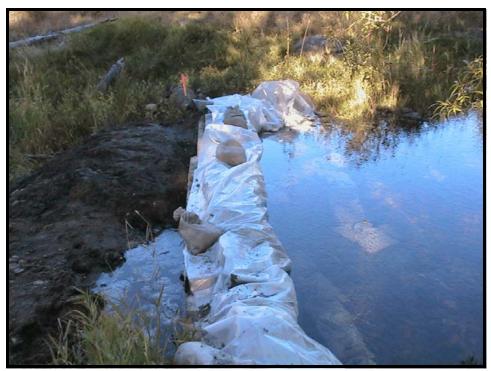
Photo A-2. The ecology block and plastic cofferdam was set about 80 feet upstream from the original diversion dam.

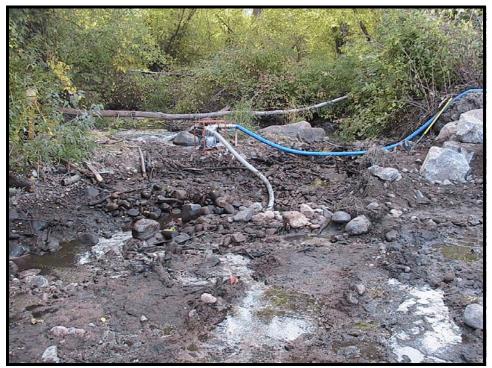
The material excavated from the two rock weir sites was similar in composition and consisted of a silt-sand-gravel-cobble mixture with an occasional large boulder (photo A-3). Typically, the material was "well graded" (evenly mixed) although along the banks of the creek, there was some layering from flood deposits and heavier percentages of fine materials.

Photo A-3. Looking downstream at the double-drop Weir No. 1; rock has been placed and tied into the right bank. This is the upper portion of the A-shaped weir. The suction pump in center picture is sending seepage water into the woods.

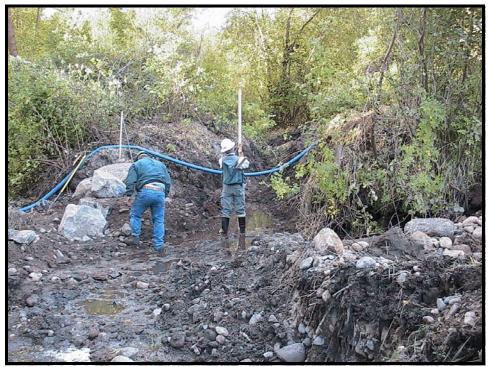
Photo A-4. Looking downstream at site of Weir No. 1 as technicians set elevation for the new diversion structure. The existing ditch was excavated about 12 inches to serve the lower elevation of the new headgate.

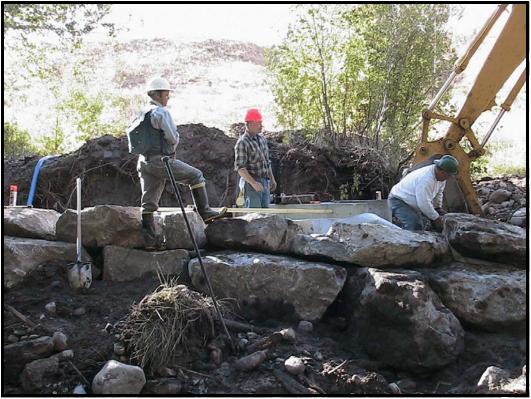
The large-diameter rocks used in this project (photo A-5) were provided by a family-owned quarry located about 30 miles east, near the town of Malott. After inspection and selection, about 100 rocks of various sizes were brought to the site around October 10th. Additional rocks were delivered from another commercial pit but calcite lenses limited their use, and no further rocks were ordered from that pit. The Malott rocks were angular and granitic ranging from just less than 2 feet in average diameter to over 4 feet. The estimated weights of the rocks ranged from 600 to 4,000 pounds.

Photo A-5. Looking upstream at the left arm of Weir No. 1. Diversion structure is set in the center of the photo. The large rocks were brought in from a quarry about 30 miles east. Note the even slope of the rocks and lack of gaps between them.

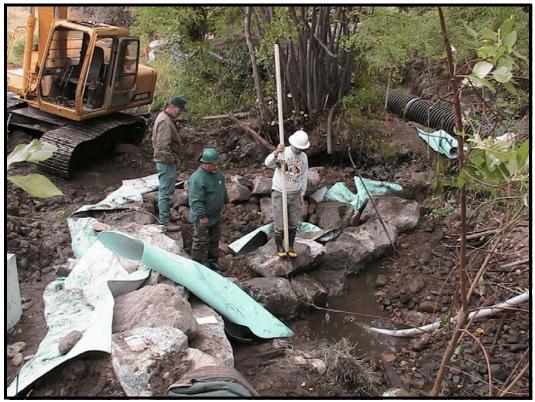
The worksite was dewatered using 30-inch-diameter, double-wall, HDPE pipe, which was routed around the construction area (photo A-6); the pipe and its watertight gaskets were manufactured by the ADS Company. A total of 200 feet of dewatering pipe and two 45-degree fittings were purchased for use on several projects. About 125 feet of dewatering pipe was used for the Upper Stokes project. No fittings were required. Surface excavation ranging in depth from 1 to 5 feet was needed to ensure proper grade. The dewatering pipeline was not backfilled unless necessary for weight on the pipe or where the equipment needed to cross. The dewatering pipe was used for other Beaver Creek projects and OCD divided the cost among them

After the rocks for each weir were in place, an impervious "geocomposite" fabric was spread on the upstream side of each one (photos A-6 and A-7). The purpose of the fabric was to reduce or prevent water from traveling underneath the large rocks and to encourage deposition of fine materials if

Photo A-6. Looking upstream at Weir No. 1. A section of the dewatering pipe can be seen at the upper right; the seepage-pump line is at lower right; and the new diversion box is at the lower left.

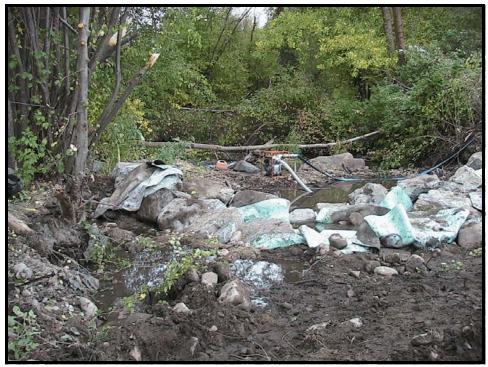
Photo A-7. Downstream view of Weir No. 1; the non-permeable geomembrane has been installed but not fully covered.

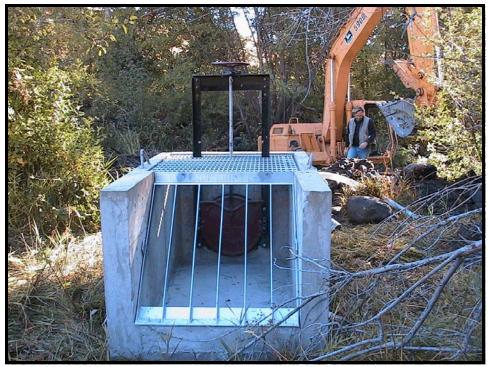
Photo A-8. The intake side of the new diversion box, before placement. Both the trashrack and the grate(on top) are galvanized.

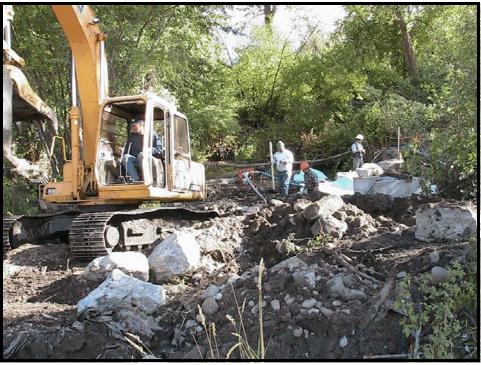
Photo A-9. Looking downstream, the new diversion structure (at middle right) has been set.

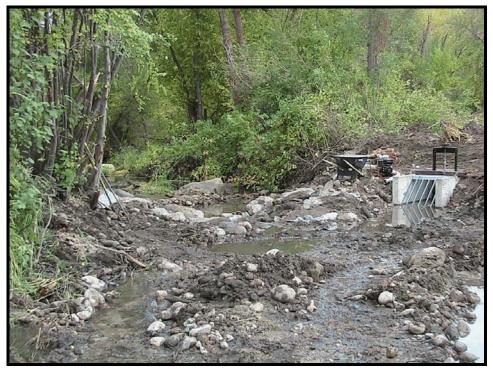
Photo A-10. Looking downstream at Weir No. 1, which has been lined with geotextile and then backfilled. The pipe trench has also been backfilled.

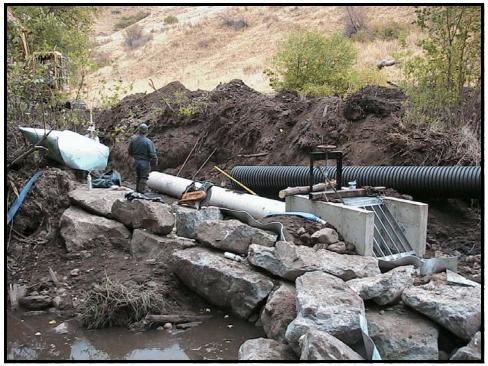
The 18-inch conveyance pipe was also PIP but rated for 63 psi; one 20-foot section was installed from the diversion box into the ditch (photo A-10). After reviewing conditions in the field, the depth of the ditch after the pipe was determined too deep to be safe. Another 20-foot section of pipe was purchased, making the total length of pipe out of the diversion box 40 feet (photo A-10). The second length is 18-inch-diamter, double-wall, HDPE (high density polyethylene) pipe.

Photo A-10. Looking upstream across the right arm of Weir No. 1. The white PVC pipe is attached to the box's "stub." In a field modification to extend the irrigation further down the ditch, the corrugated black HDPE pipe was attached to the PVC pipe.

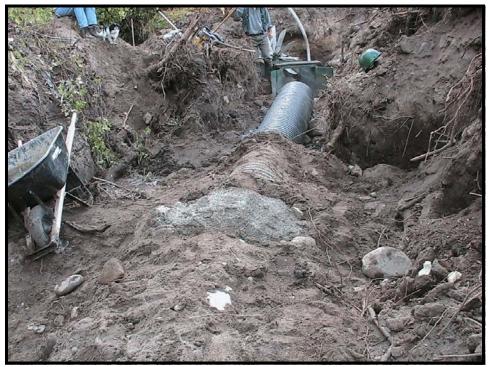
The connection between the two pipe sections was made by cutting lateral slits in the HDPE pipe and forcing it over the PIP pipe (photo A-12). The joint was then covered in concrete to a depth of three inches over the joint. Approximately eight bags of premixed concrete were used. The soils in which the pipe was placed were a sandy-silt with significant number of cobble-sized material. The average depth of fill over the pipe is about 5 feet. All pipe for this project was supplied by Cascade Pipe and Feed Supply of Twisp.

Photo A-12. The concrete protects and weights the transition between the PVC (white) and HDPE (black) irrigation pipes (see photo A-10). The fish screen is in the upper center of the photo, just above the black pipe.

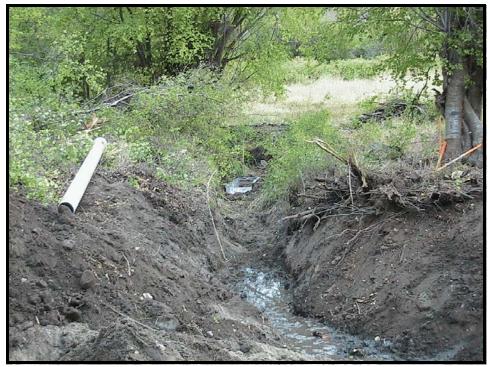
Photo A-13. Along the diversion ditch, just downstream from the fish screen. The new ramp flume is shown near the center of the picture. This portion of the ditch have been cleared of vegetation and deepened.

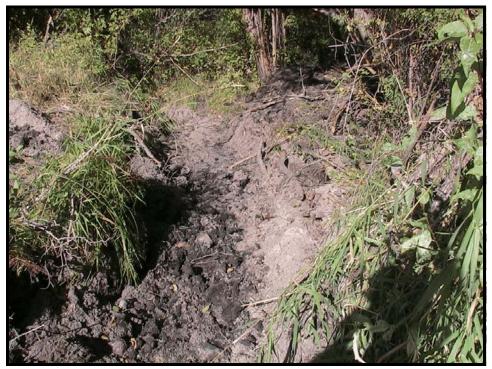
Photo A-14. Downstream of the ramp flume, more cleaned-out ditch.

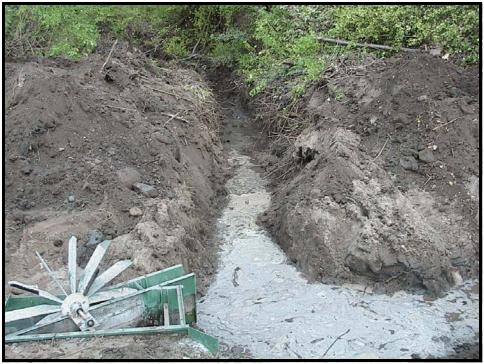
Photo A-15. The fish bypass channel, before installation of the fish bypass return pipe.

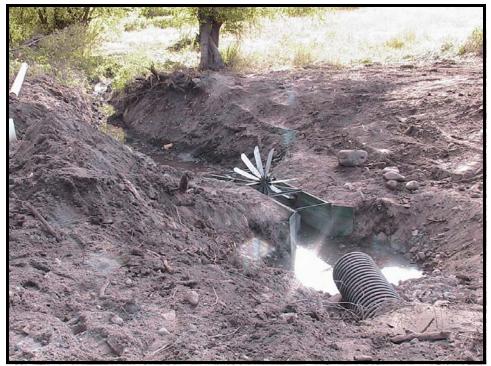
Photo A-16. The diversion pipe extension and the ditch transition at the fish screen. Note the benching of the ditch slopes.

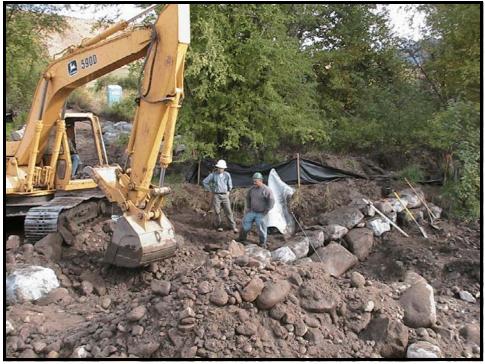
Photo A-17. Looking across Beaver Creek to the left arm of Weir No. 2.

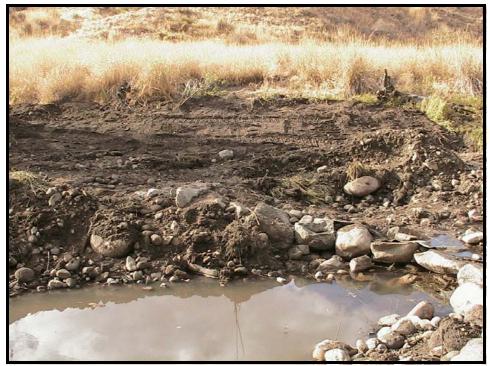
Photo A-18. Looking upstream at Weir No. 2 and the rebuilt stream bank.

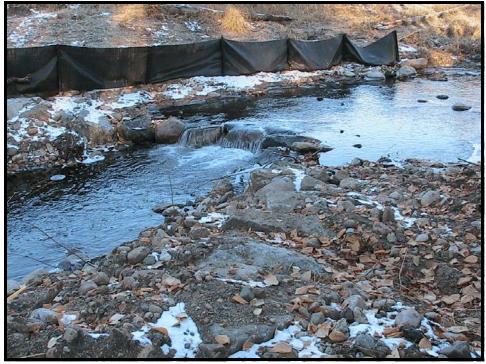
Photo A-19. Weir No. 2 during low flow on November 15, 2003. The silt fence in the background will remain in place until the spring of 2004.

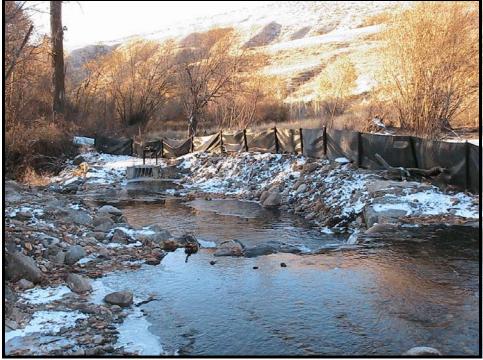
Photo A-20. Looking downstream from above Weir No. 2 on November 20. The upper position of Weir No. 1 is in the left-center of the picture. The headgate has been closed for the winter.

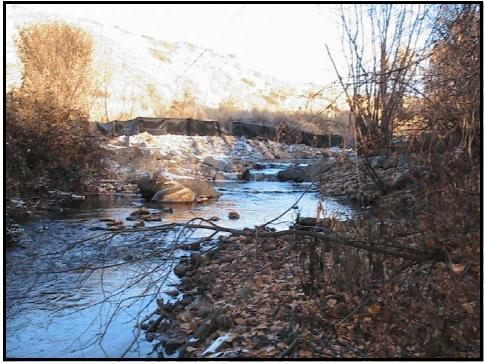
Photo A-21. Looking upstream from the exit of the fish bypass. Weir No. 1 is shown in the center of the picture.

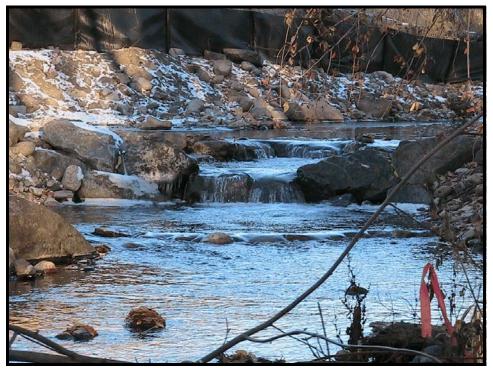
Photo A-22. A closer view of Weir No. 1 on November 15.

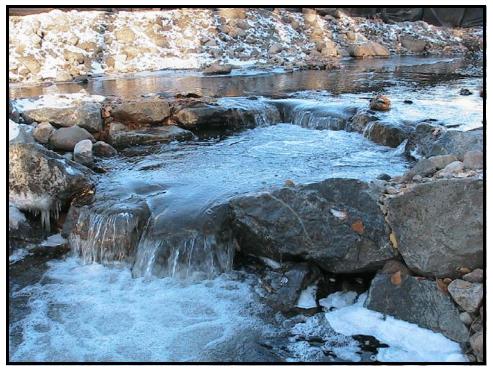
As measured after construction, the downstream drop is actually over 1 foot, mostly as a result of channel restructuring downstream. However, some bedload is expected to drop out of the stream at high flows and accumulate just downstream of the scour hole; this would reduce the drop to the 0.8 foot design standard. If necessary, modifications to the structure or to the streambed downstream of the drop will be made after highwater in the spring of 2004.

Photo A-23. At Weir No. 1, the drop at the downstream portion is greater than designed. After highwater in 2004, if the bed of the pool has not been built up by deposited gravels, the drop will be adjusted.

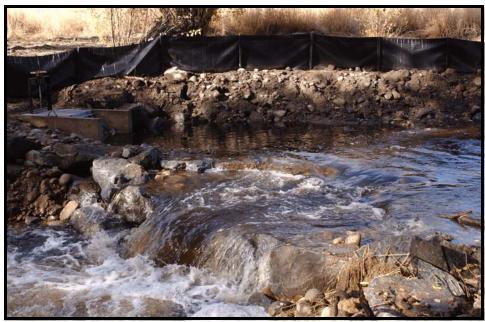
Photo A-24. November high flow over the double-drop Weir No. 1, which is the diversion control structure.

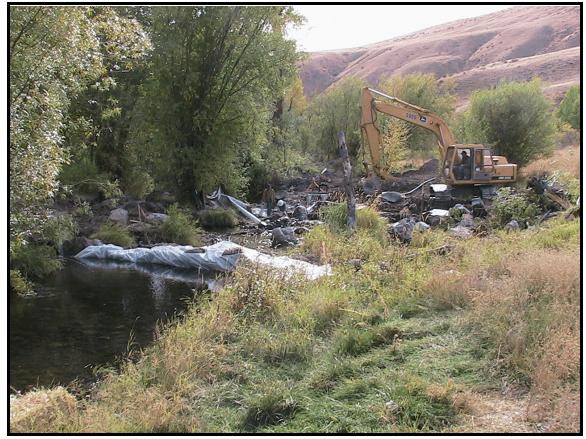
Photo A-25. The Upper Stokes project job site during construction. The cofferdam is at left center.
