**FEDERAL AVIATION ADMINISTRATION  
AIRWORTHINESS DIRECTIVES  
SMALL AIRCRAFT, ROTORCRAFT, GLIDERS,  
BALLOONS, & AIRSHIPS**

**BIWEEKLY 2003-06**

**BELL HELICOPTER TEXTRON CANADA  
AIRWORTHINESS DIRECTIVE  
SMALL AIRCRAFT, ROTORCRAFT, GLIDERS, BALLOONS, & AIRSHIPS**

**2003-05-03 Bell Helicopter Textron Canada:** Amendment 39-13079. Docket No. 2001-SW-53-AD. Supersedes AD 2000-06-10, Docket No. 99-SW-75-AD, Amendment 39-11651.

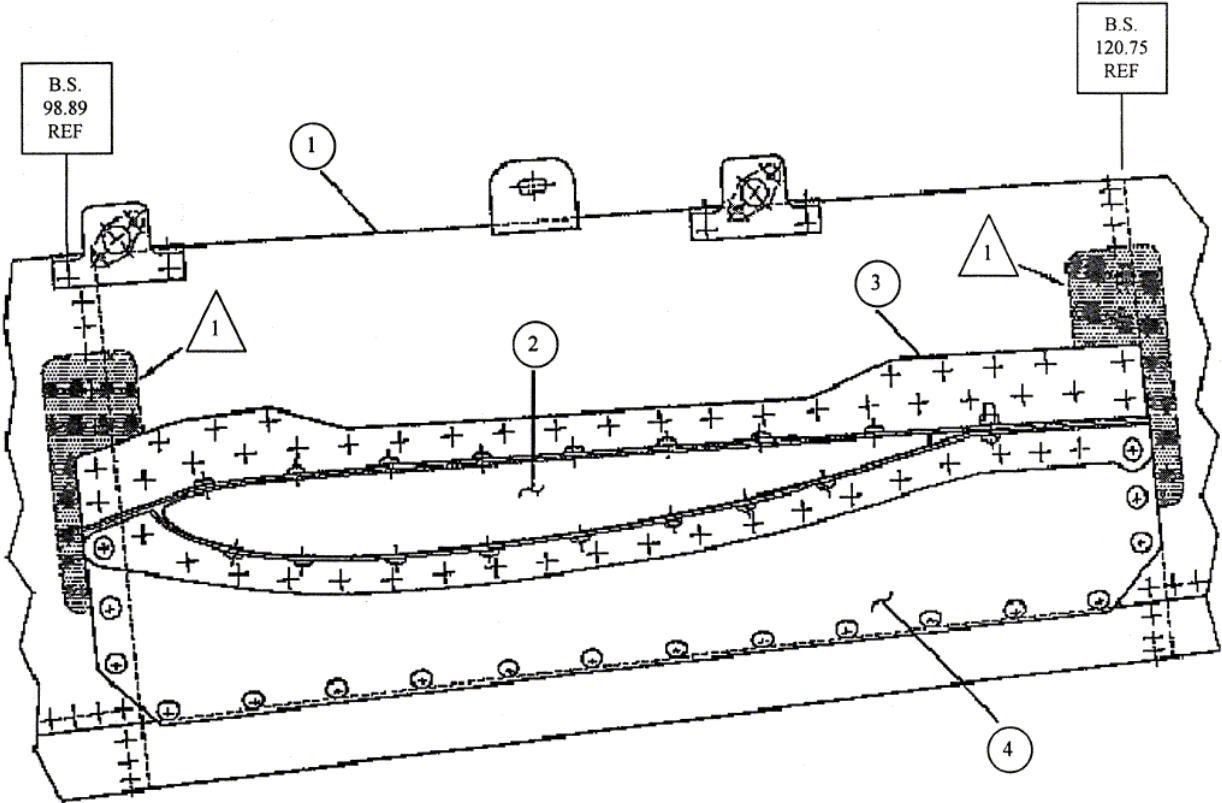
Figure 1. Preflight Check of the Tailboom

To prevent separation of the tailboom and subsequent loss of control of the helicopter, accomplish the following:

- △ 1 Examine these areas for cracks on left side of tailboom only.
- 2. Horizontal stabilizer not shown for clarity.

(f) All applicable part-numbered tailbooms.	Before further flight	If a crack is found, replace the tailboom.	The applicable maintenance manual.

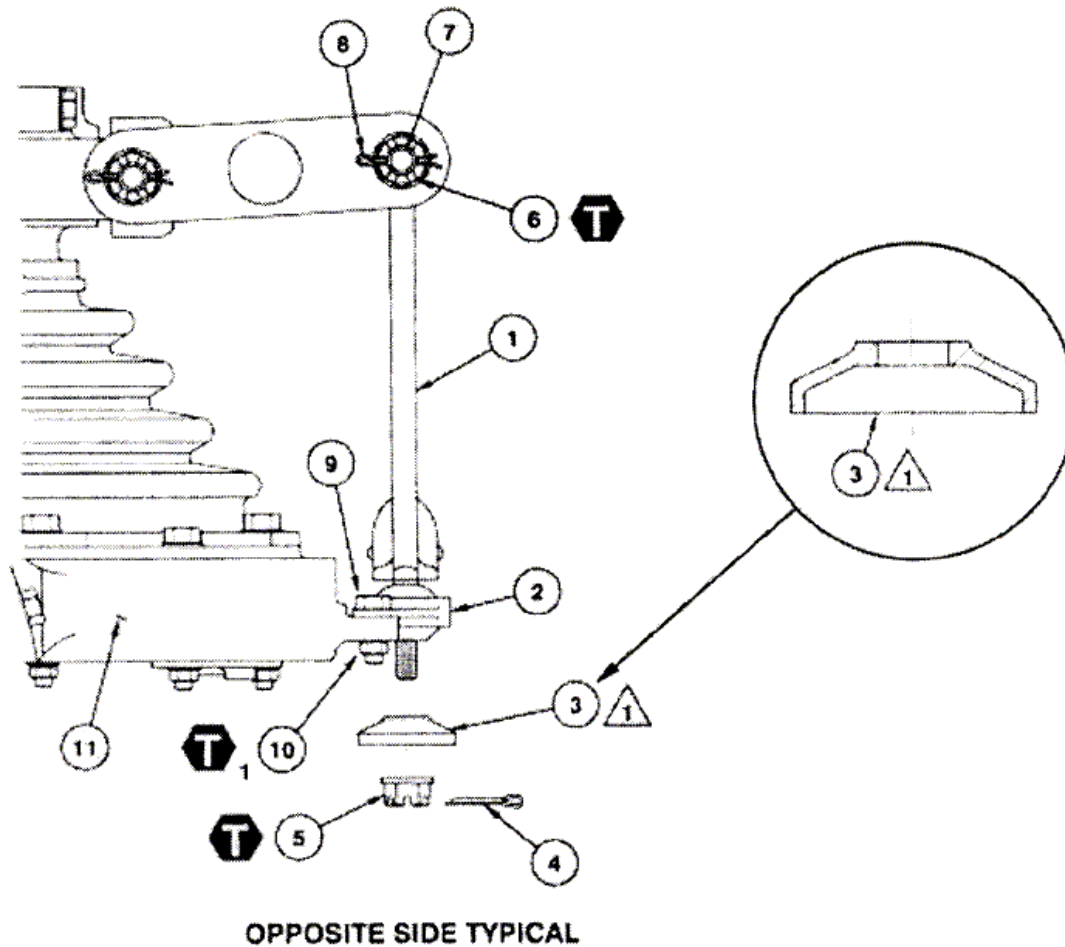
To detect an incorrectly installed swashplate drive link cup washer (cup washer), which could limit the travel of the swashplate outer ring and lead to failure of the stud portion of the swashplate drive link, and subsequent loss of control of the helicopter, accomplish the following:

(a) Visually check both cup washers, part number (P/N) 406-010-412-101, for correct installation in accordance with Figure 1 of this AD. If both cup washers are installed correctly, no further action is required. This visual check may be performed by an owner/operator (pilot) holding at least a private pilot certificate, and must be entered into the aircraft records showing compliance with this paragraph in accordance with sections 43.11 and 91.417(a)(2)(v) of the Federal Aviation Regulations (14 CFR sections 43.11 and 91.417(a)(2)(v)). See the following Figure 1:

(b) If a cup washer is installed incorrectly, remove and replace the swashplate outer ring, each cup washer, bearing and liner, and drive link where the cup washer was installed incorrectly. Replace these parts in accordance with Part II of the Accomplishment Instructions in Bell Helicopter Textron Alert Service Bulletin No. 407-02-55, dated October 29, 2002.
