Integrated Device Technology, Inc.

## HARDWARE FIX FOR 77201 REV. C3 AND REV. D SAR ERRATA

TECHNICAL NOTE TN-29

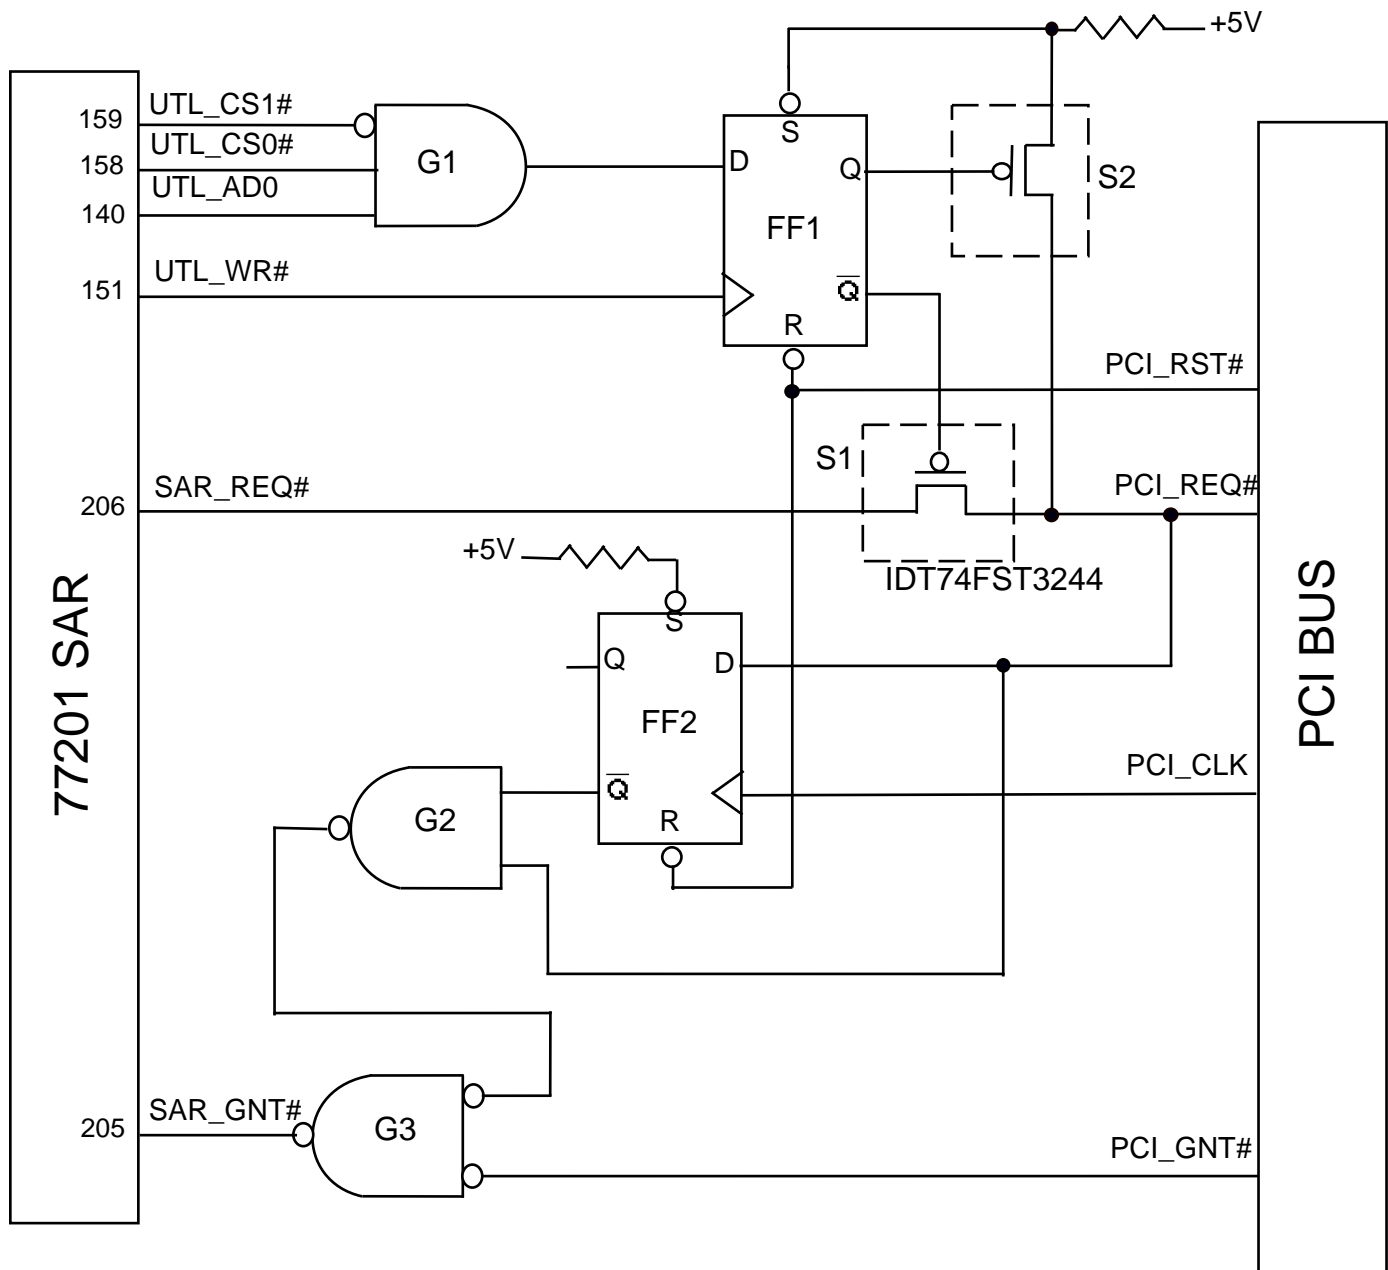
**77201 REV. C3 and D External Hardware Fix**

#### Errata #9: The timer rolls over before the 77201 is initialized.

This situation will cause the 77201 to generate a TSI (Transmit Status Indicator) in the TSQ (Transmit Status Queue). This is accomplished by DMAing the timer rollover indicator into host memory at the TSQ address. If the 77201 is not initialized with a proper TSQBA (Transmit Status Queue Base Address) register with a non-zero value, the 77201 will write the TSI to host memory location zero. This may cause some operating systems to crash.

#### Errata #14: Intolerance of controllers that are non-compliant to the PCI spec.

Some PCI chip sets arbiters do not take away PCI  $\overline{\text{GNT}}$  until one PCI clock after  $\overline{\text{REQ}}$  becomes de-asserted. This delayed de-activation of the  $\overline{\text{GNT}}$  will make the 77201 a park master according to the PCI Spec. To optimize the PCI bus utilization, the 77201 could start a PCI cycle when it is a park master (in the next PCI clock - the same time that the  $\overline{\text{GNT}}$  is being de-activated). Correct operation should allow the 77201 to complete the transfer. Some controllers have been observed to violate this function (e.g. the new low-end versions of the Power Macintosh and the IBM DX4-100 model 330).

The hardware fix requires a Quickswitch to isolate the 77201 PCI bus request line ( $\overline{\text{SAR\_REQ}}$  in the diagram) from the PCI bus at PCI power-up reset. This effectively disables DMAs by the SAR. When the device driver initializes the 77201 (including the TSQBA register), it should enable the  $\overline{\text{SAR\_REQ}}$  signal by writing to the utility bus with  $\text{UTL\_CS1} = 0$ ,  $\text{UTL\_CS0} = 1$ , and  $\text{UTL\_AD0} = 1$ . Also, when the 77201

device driver is un-loaded,  $\overline{\text{SAR\_REQ}}$  can be turned off by writing to the utility bus with  $\text{UTL\_CS1} = 0$ ,  $\text{UTL\_CS0} = 1$ , AND  $\text{UTL\_AD0} = 0$ .

Hardware used in the diagram to accomplish this function is: S1, S2, FF1 and G1.

To allow tolerance to these non-compliant controllers, hardware consisting of an OR-gate to block off  $\overline{\text{GNT}}$  to the 77201 one PCI clock after the  $\overline{\text{REQ}}$  becomes de-asserted (this additional clock is required by the non-compliant PCI chip set to take away  $\overline{\text{GNT}}$ ).

Hardware used in the diagram: FF2, G2 and G3.

Note: all components except the IDT74FST3244, can be put inside a single PLD. An alternate part to IDT74FST3244 is the IDT74FST6800, which combines the S1 and S2 internally to cut down the PCI bus loading.
