Ford Motor Company
P. O. Box 1904
Dearborn, Michigan 48121

January 28, 2008

SUBJECT: **Safety Recall 05S28 - Supplement #14:** 1992-2004 Multiple Vehicle Lines -
Speed Control System Modification

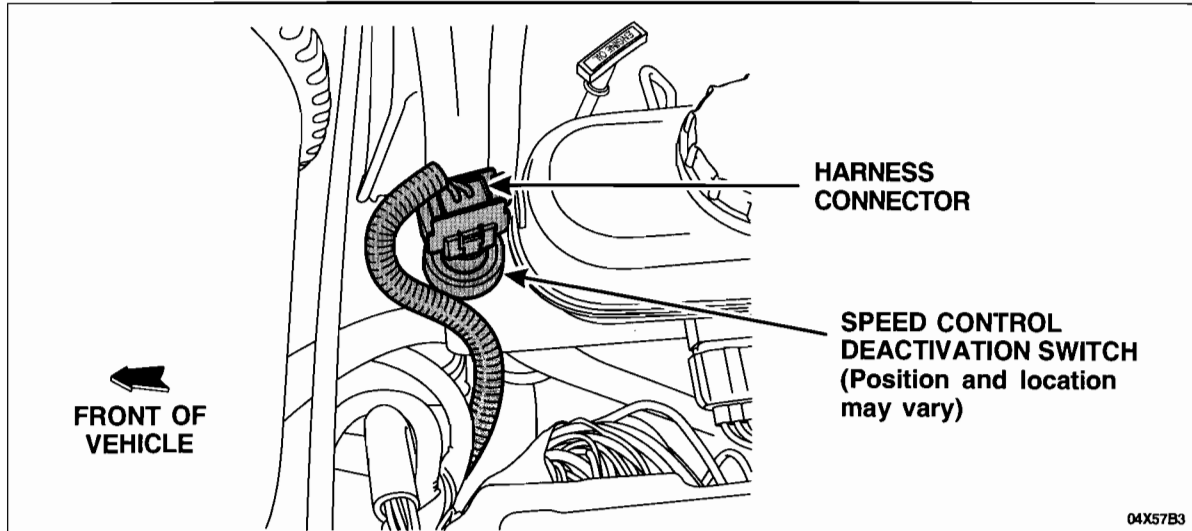
FIGURE 2

Disconnect the SCDS and inspect the harness connector (see Figure 2) for the presence of brake fluid. Refer to the Vehicle Application And Repair Chart on page 5 to identify the correct repair procedure.
