15 - Sewage In Housing

16 - Facility Structure Challenges

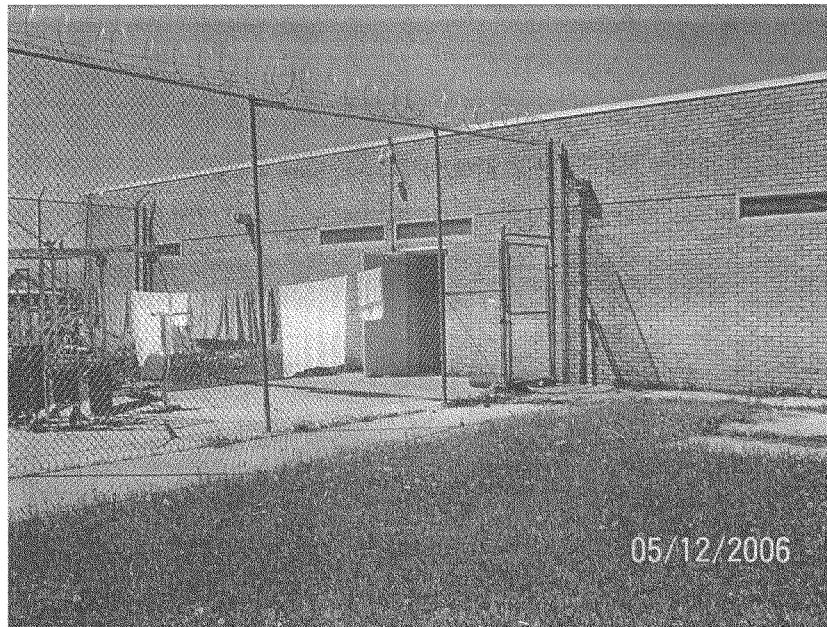
Clothes drying line set up in the recreation yard. Indicative of a lack of working commercial sized clothes dryers

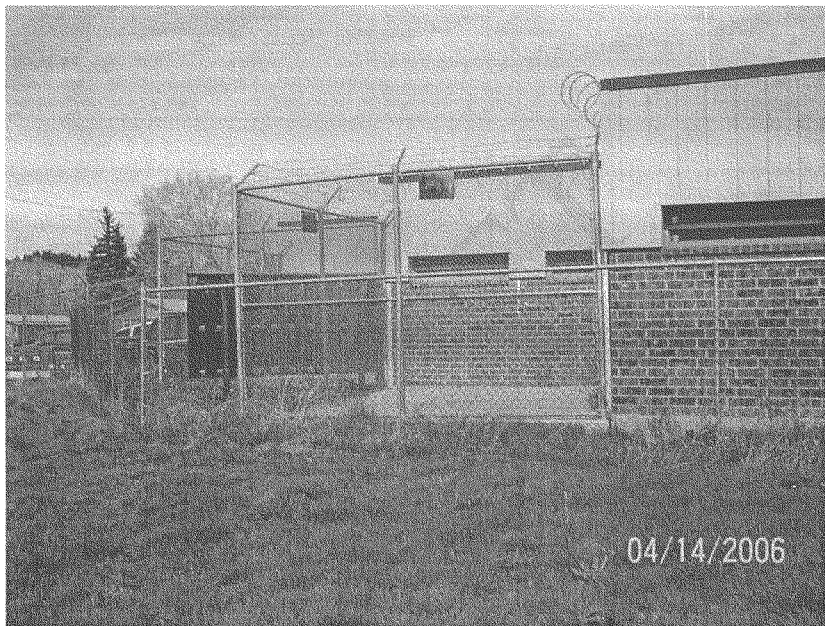
Because of the close vicinity, recreation yards may not be used for emergency evacuation as was stated at this facility

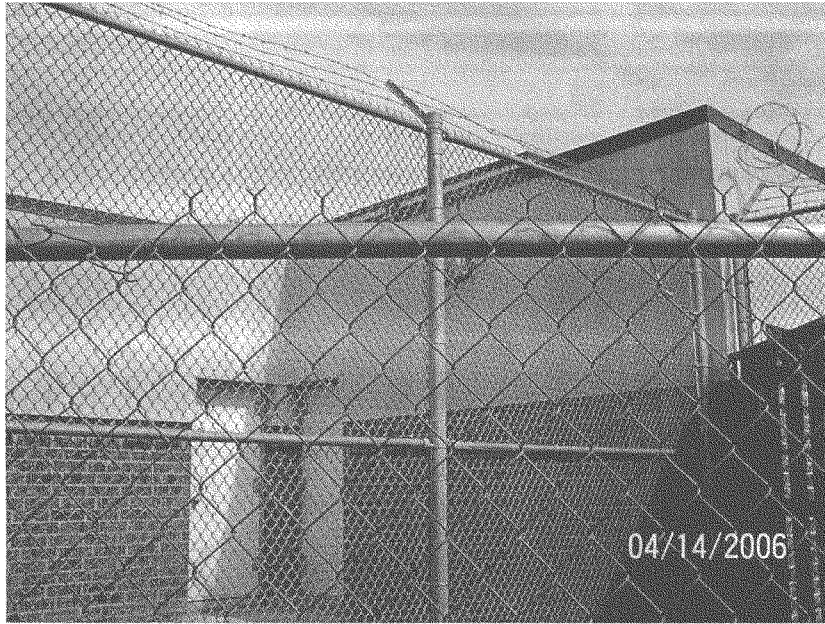
Because of the close vicinity, recreation yards may not be used for emergency evacuation as was stated at this facility

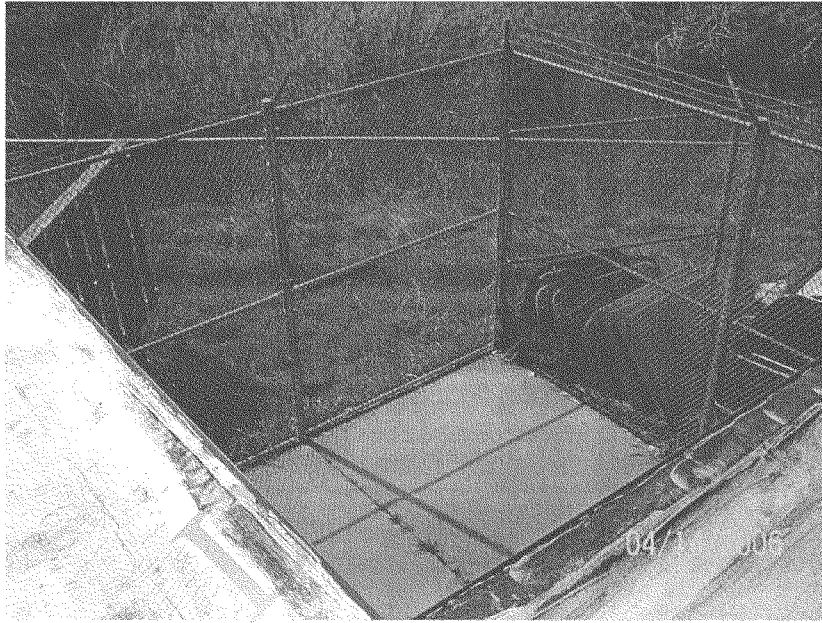
Because of the close vicinity, recreation yards may not be used for emergency evacuation as was stated at this facility

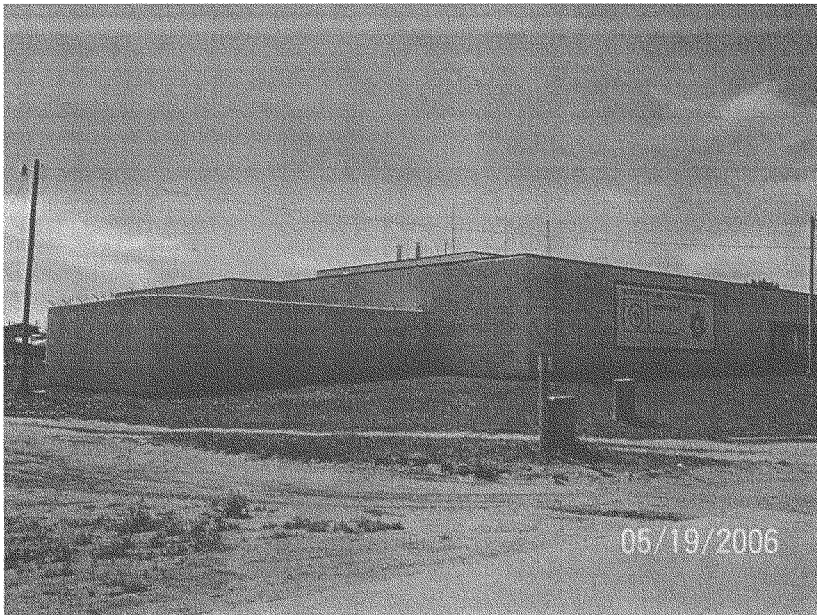
Recreation yard is adjacent to a public road which is used to toss in contraband, for the benefit of the inmates

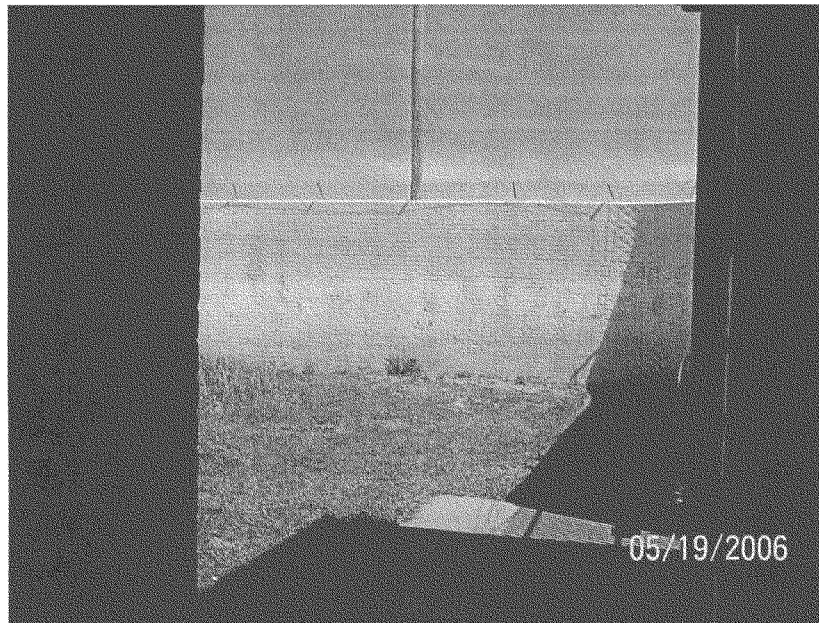
Same insecure recreation yard from the inside

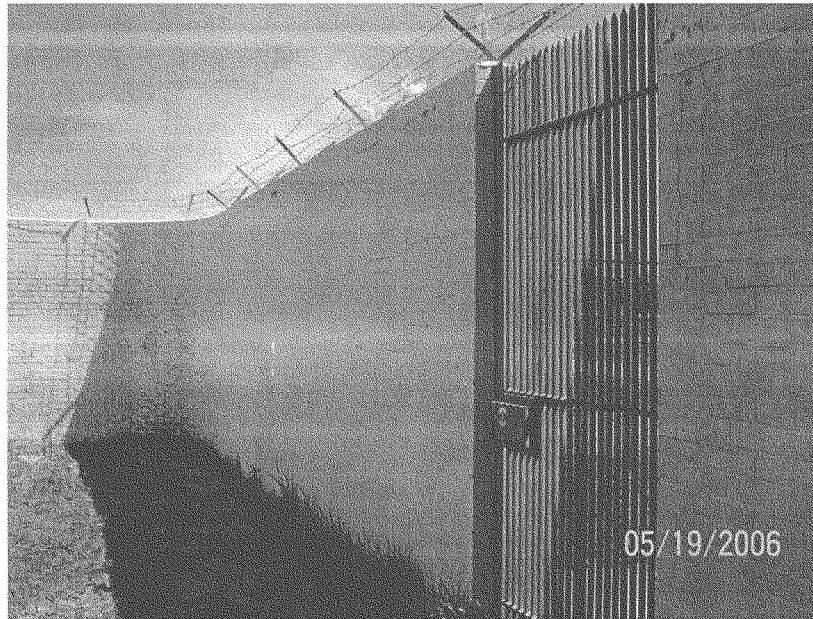
Gate in the recreation yard provides an easy climb-out over the crossbars on the gate. There is no perimeter fence beyond this gate.

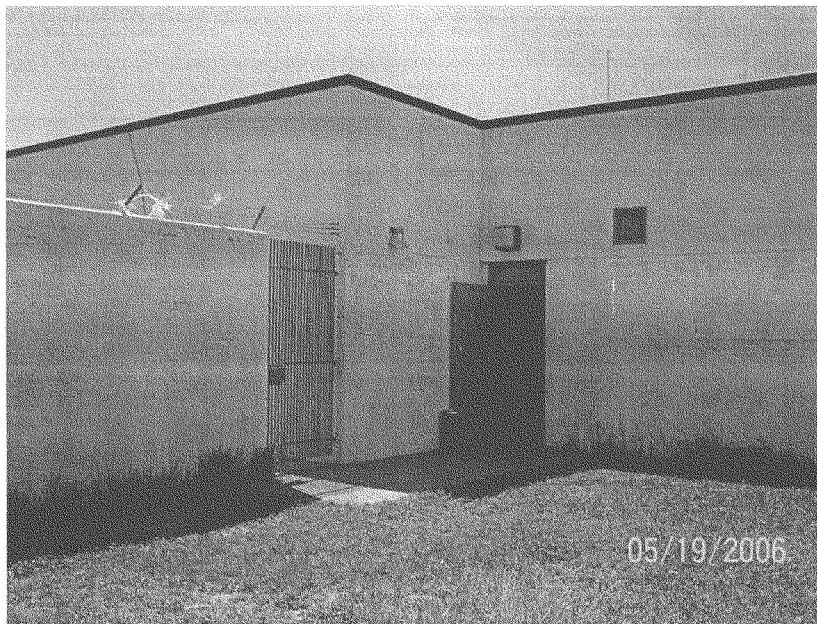
Gate in the recreation yard provides easy climb-out over the crossbars

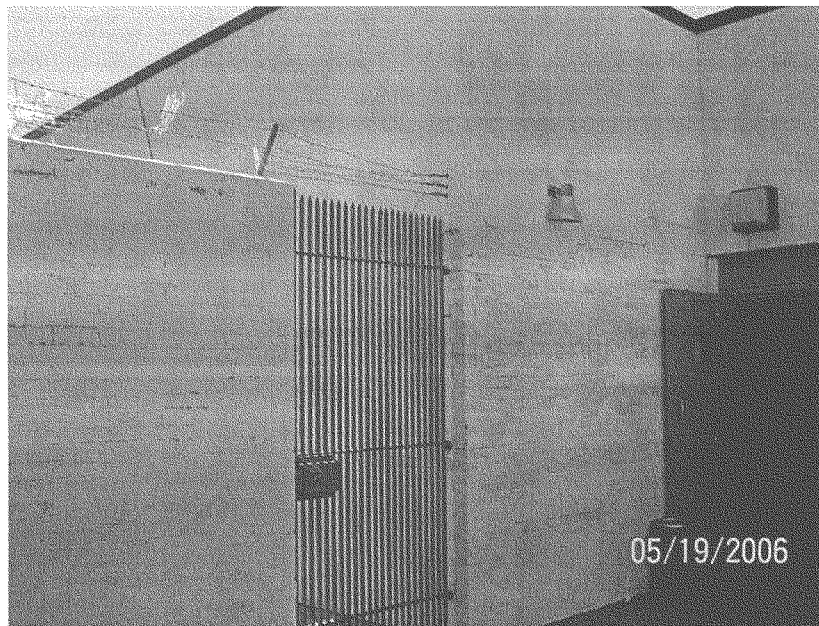
Close-up of the barbed wire above the gate

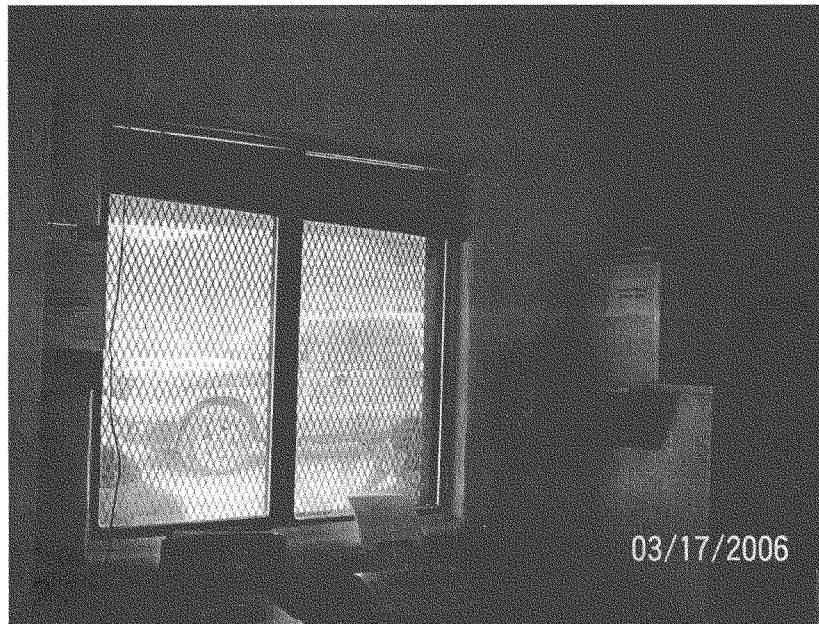
Where no recreation yard exists, inmates are provided a bench outside the facility while the detention officer 'keeps an eye' on the inmates from the Central Control Station and Dispatch from where this picture was taken.

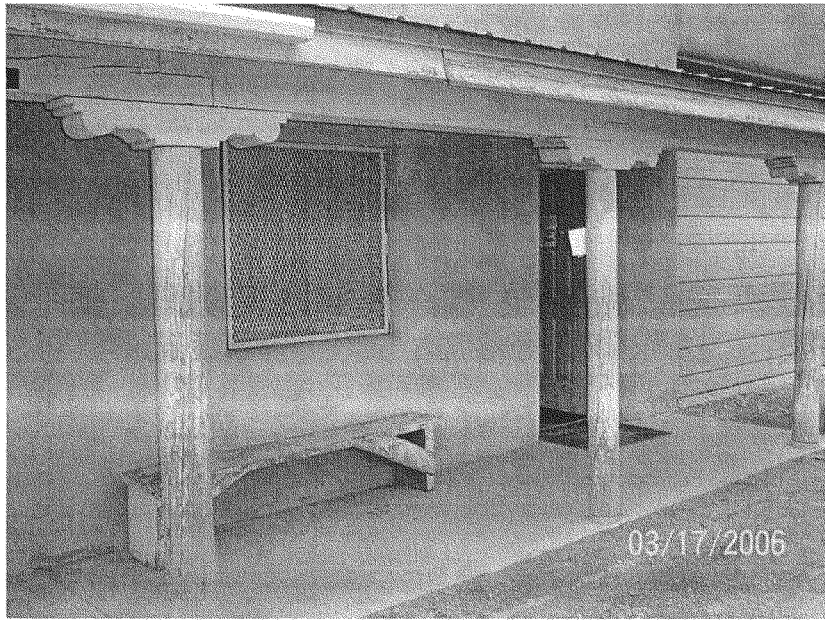
Recreation yard for the picture above

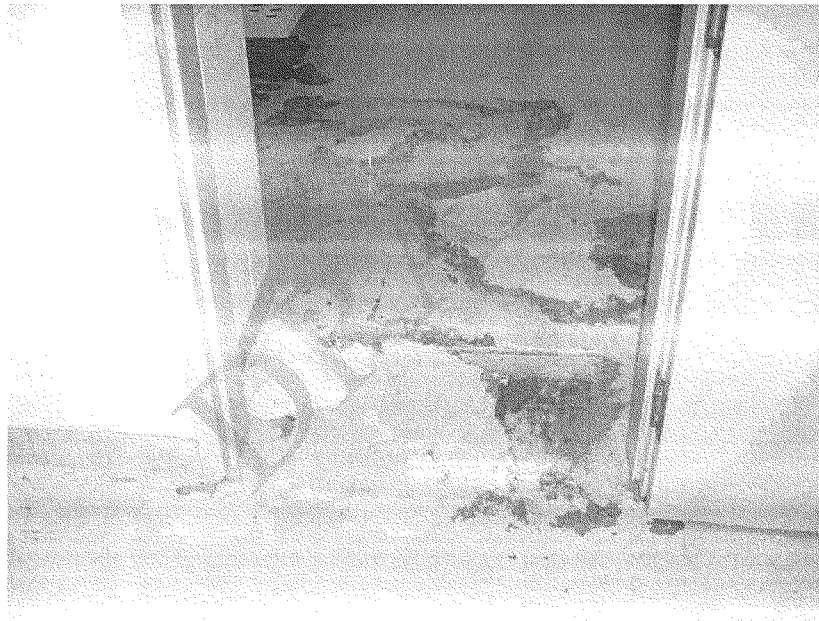
An extension of the plumbing challenges, facilities face challenges with sewage in the housing units as a result of broken connections to sewer lines that have settled lower into the soil over the years, with settling soil conditions

Stains from sewage in the cell, spilled over from the toilet connection at the sink-toilet combination unit

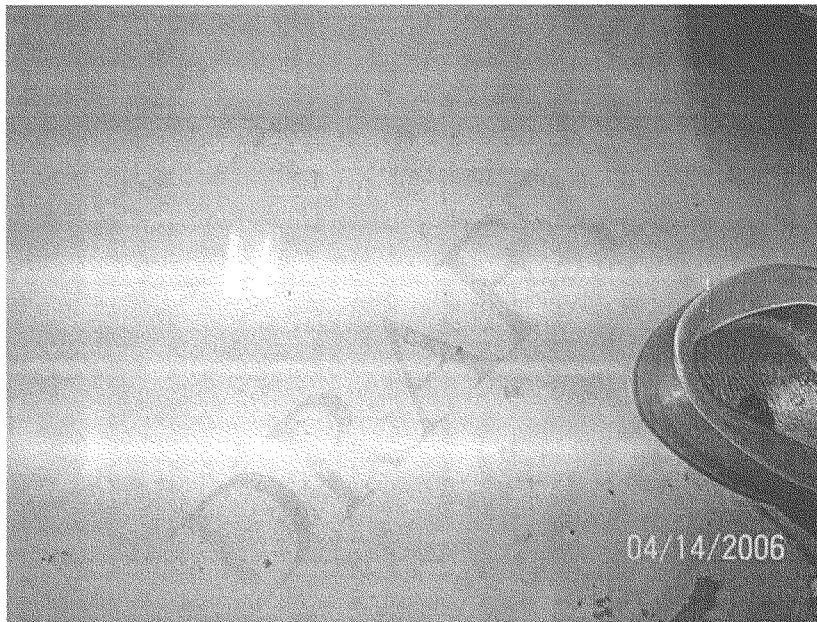
Reflecting lights in the sewage spill over

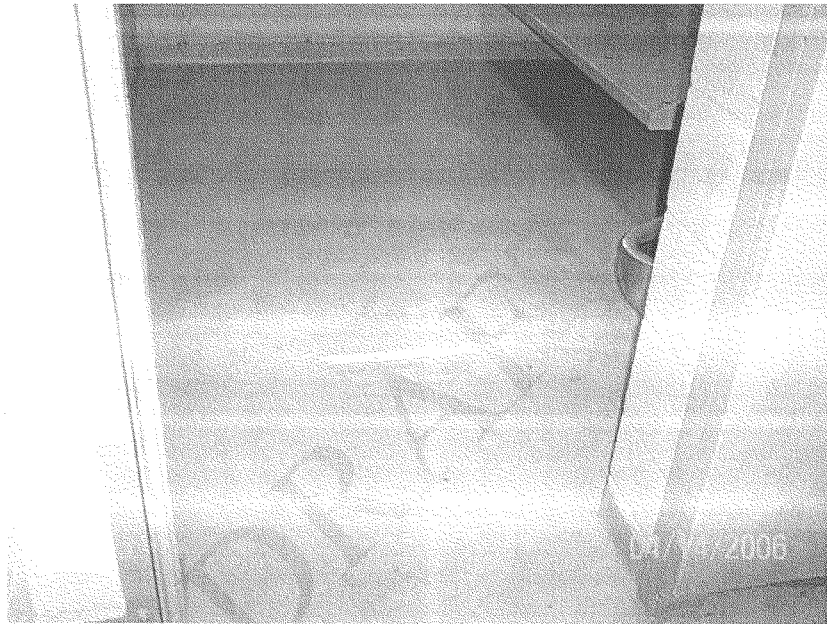
Reflecting lights in the sewage spill over

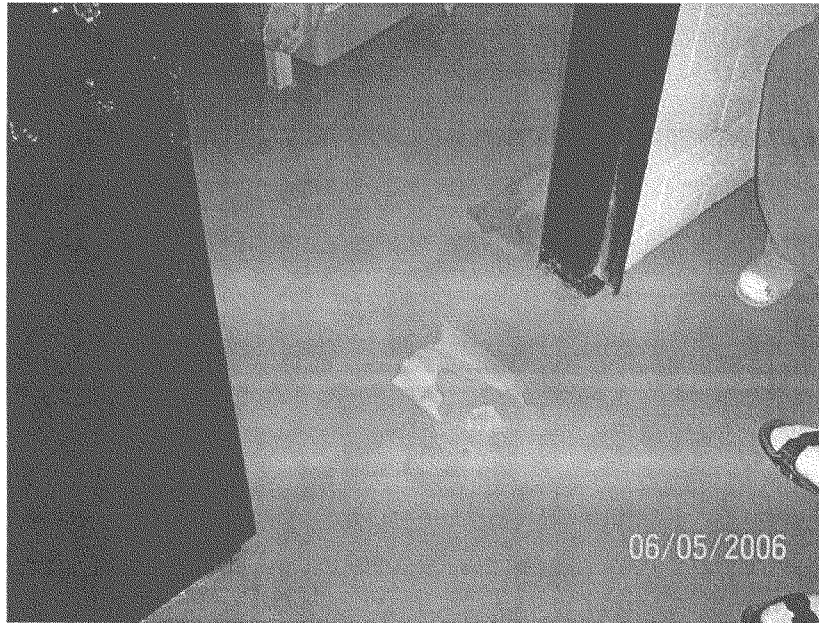
Reflecting lights in the sewage spill over

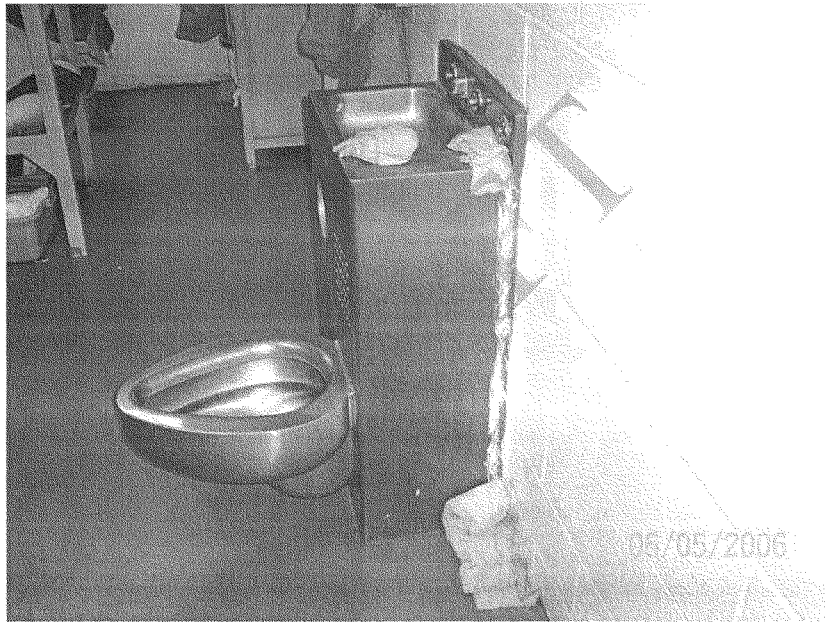
Wadded up towels on the floor to cleanup the sewage spillover

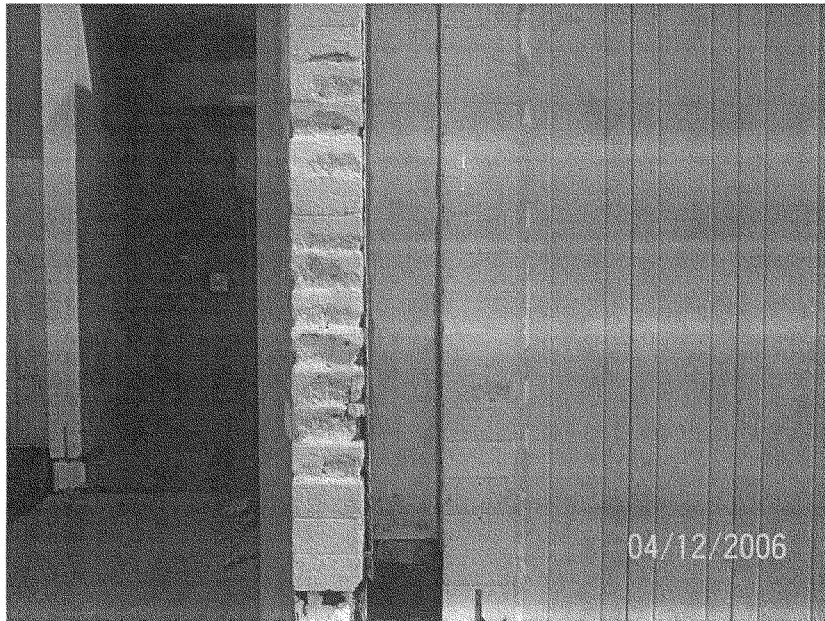
Structure of facilities are deteriorating and in disrepair. Aging structures combined with weathering and the rapid settling of soil has accelerated this deterioration. Average age of existing structures, not counting three year or newer, is 26 years old. The oldest structure in use is 70 years old. Typical life of a structure in normal weather and soil conditions is 40 years.

Weathered and crumbled concrete fins

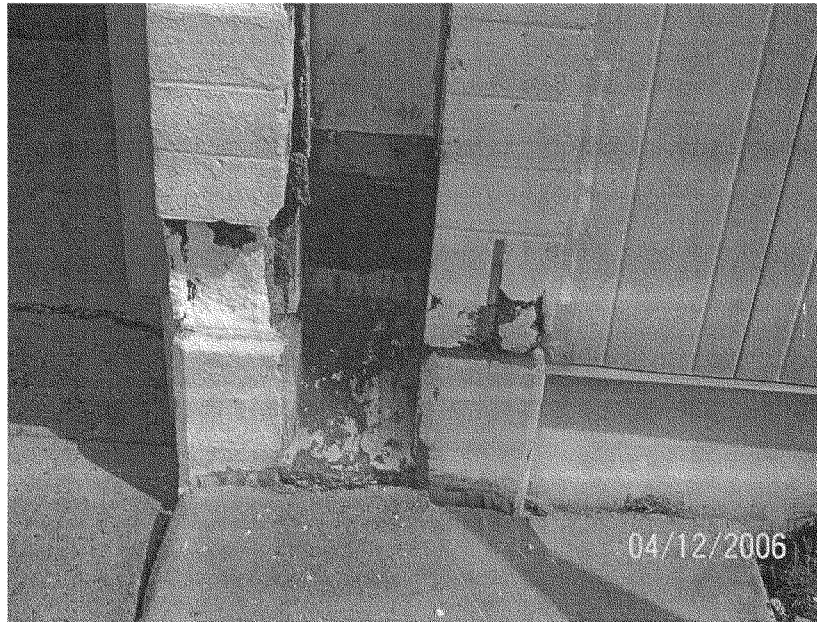
Weathered and crumbled concrete fins

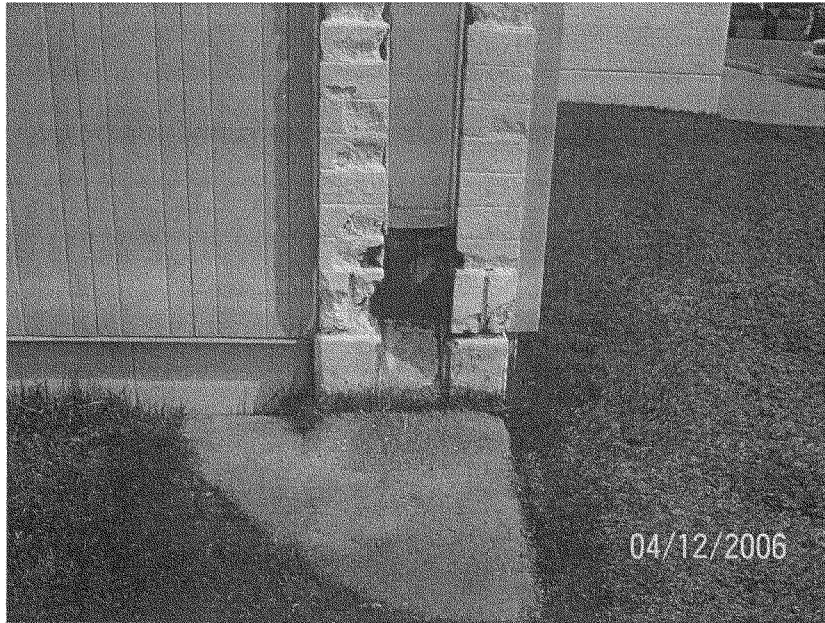
Weathered and crumbled concrete fins

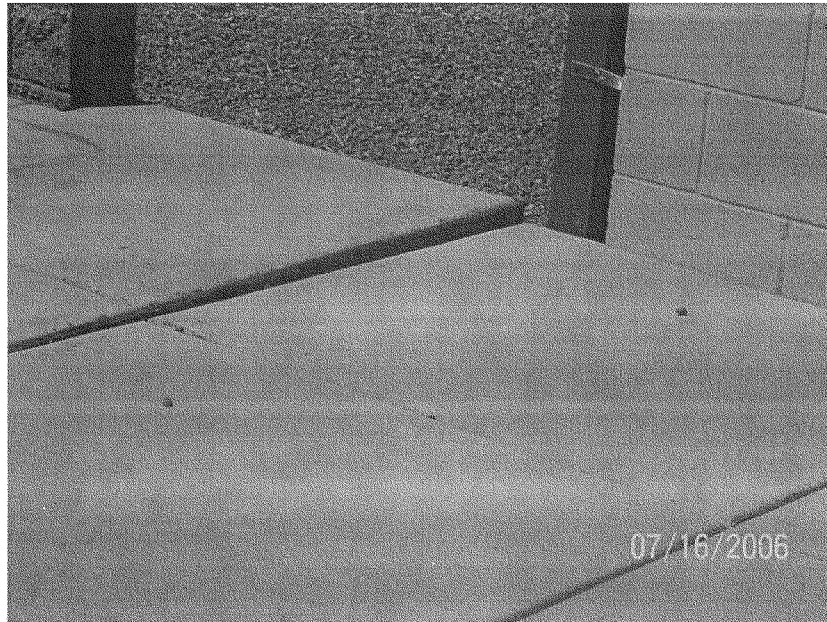
Movement of concrete slab resulting from settling soil

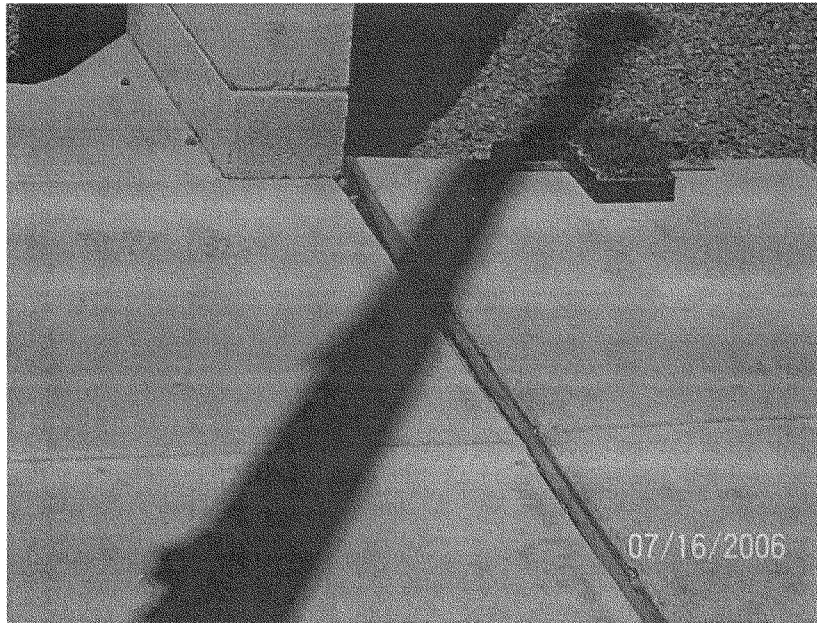
Slab uplifting, approximately 2 inches

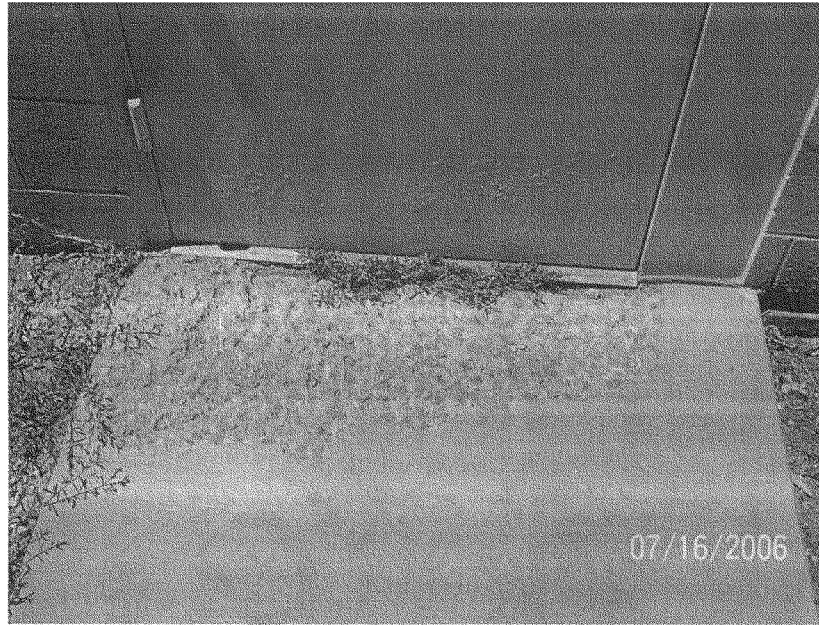
Concrete has to be scraped out to permit opening of the door – which is sinking at a faster rate than the concrete slab outside

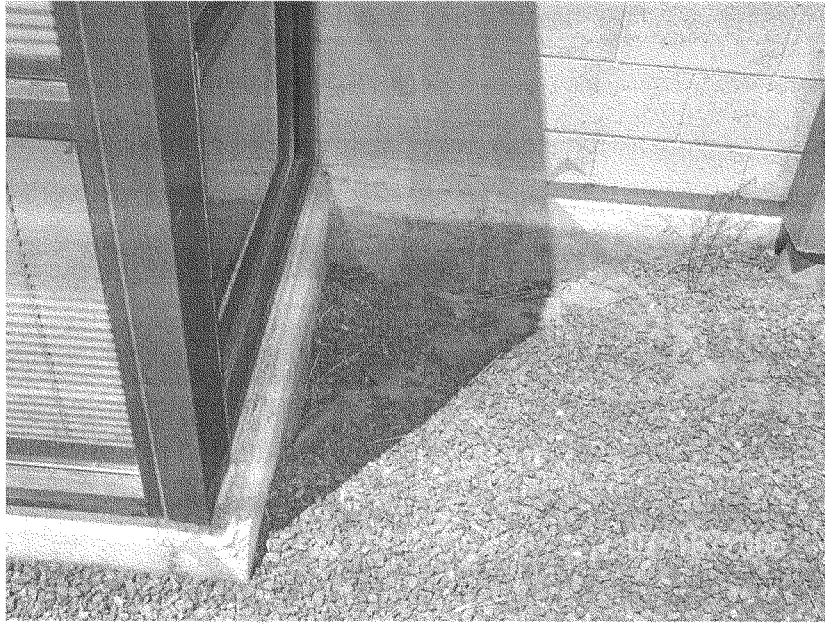
Soil collapse at a corner
