**EMERGENCY ORDER  
NO. 16**

**FEDERAL RAILROAD ADMINISTRATION**

**FRA Emergency Order No. 16**

**Inspection and Repair of Dual Diameter Tank Cars**

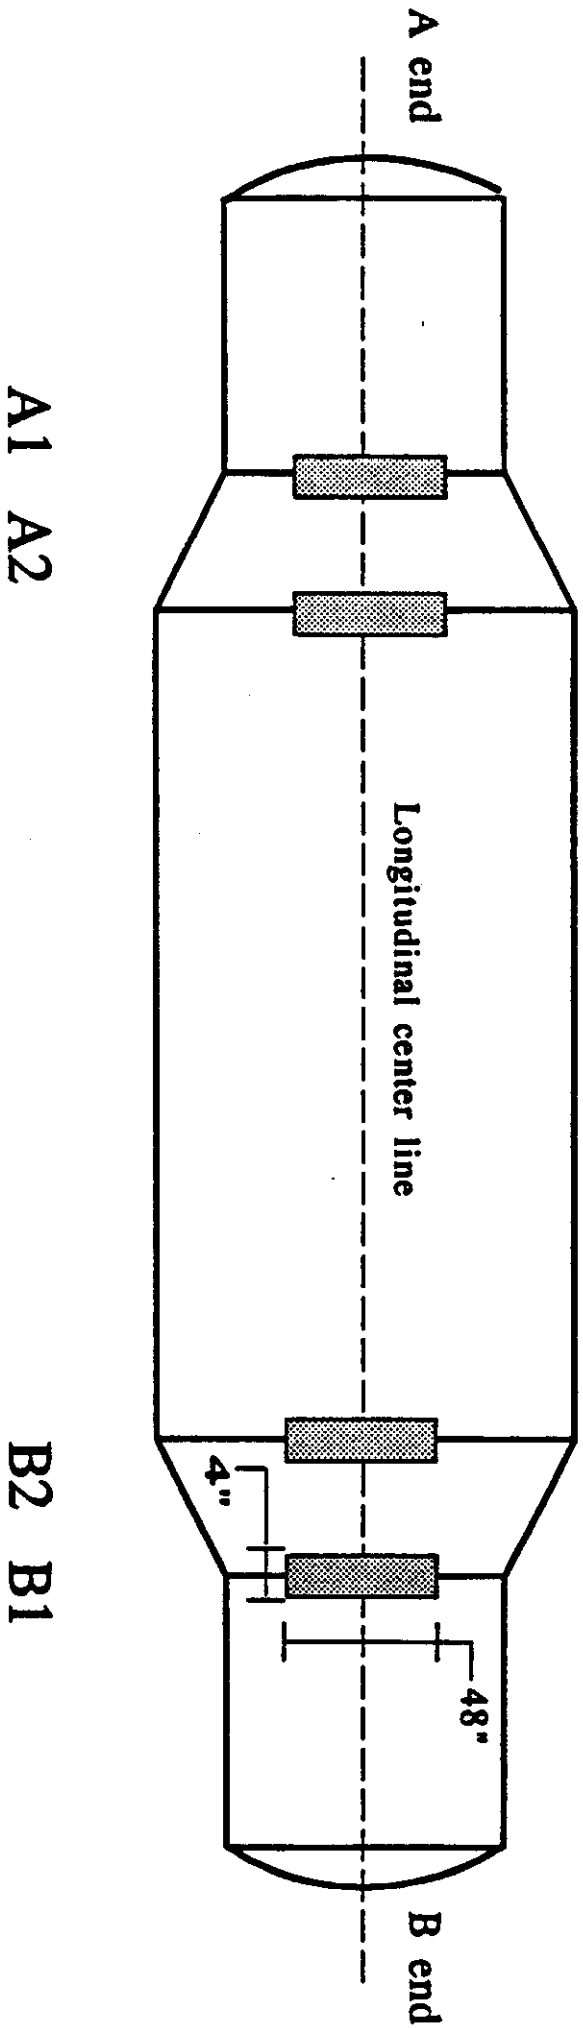
**Figure 1**  
**Radiograph Inspection and Test Zones**

areas at least twenty-four inches on each side of the tank car longitudinal centerline (see Figure 1).

- c. Use a wire brush on all interior and exposed exterior welds and visually inspect for defects.
- d. Radiograph A1, A2, B1, and B2 circumferential weld areas two inches on each side of each weld and at least twenty-four inches on each side of the tank car longitudinal centerline. (See Figure 1)
