High-Frequency Response Functions for Composite Plate Monitoring with Ultrasonic Validation

Engineering Sciences & Applications
Los Alamos National Laboratory
Los Alamos, NM 87545

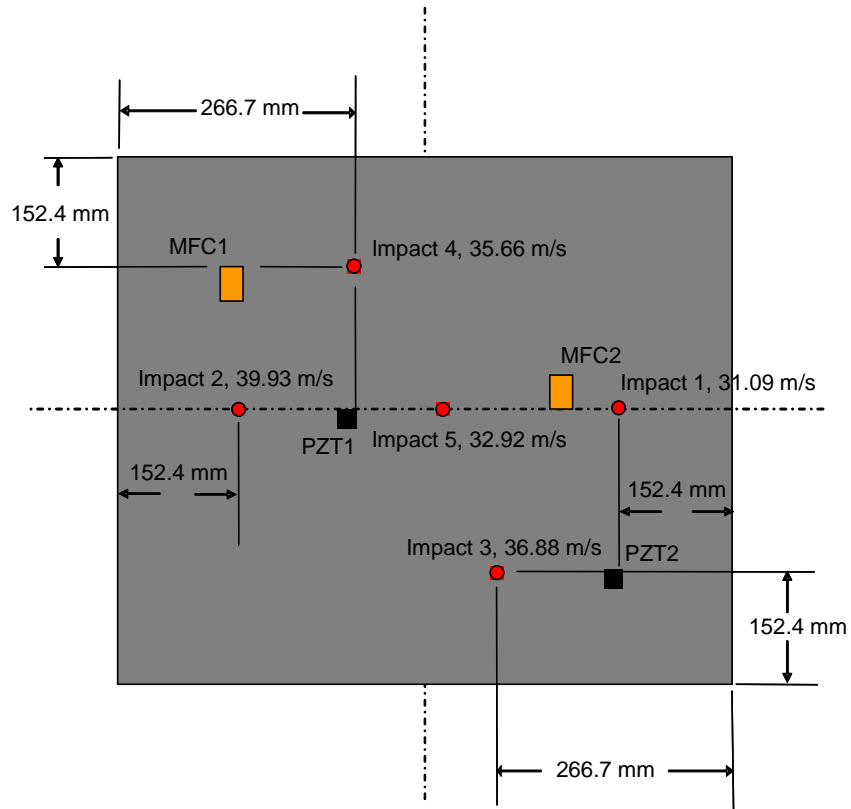
Figure 4: Locations of MFC/PZT and the impact

The impact locations are shown in relation to the MFC and PZT sensors in Figure 4. No physically visible damage was identified during the tests except for Impact 2. Impact 2, with the highest velocity, caused visible damage to the plate, shown in Figure 5. Time-domain data were measured after each impact.

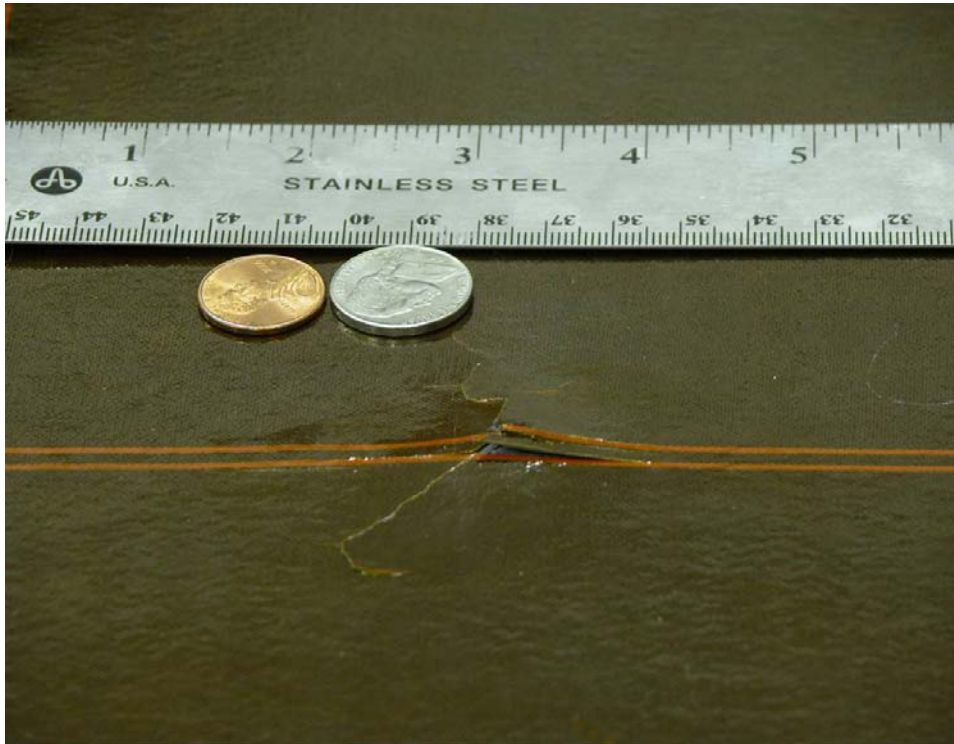
Figure 5: Damage introduced by Impact 2

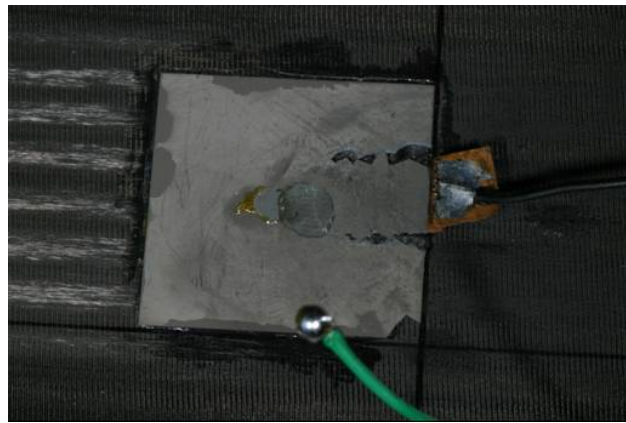
Structural health monitoring sensors/actuators must be rugged to withstand operational environments. Traditional PZT wafers used for active SHM methods are, however, brittle and they are especially vulnerable under impact loadings. After Impact 2, it has been identified that the bonding condition between both PZT and the plate significantly degraded. After Impact 5, it has been visually observed that PZT 1 was broken, as shown in Figure 6. It is important to point out that, even with the degraded bonding condition and until the final visual breakage, the piezoelectric patches were still able to produce sufficient sensing and actuation signals, potentially leading to the false-indication of the structural condition. This type of sensor failure would be especially problematic for most wave propagation approaches because these methods usually require a large number of sensors/actuators for composite plate monitoring.

Figure 6: The failure of PZT 1 after Impact 5

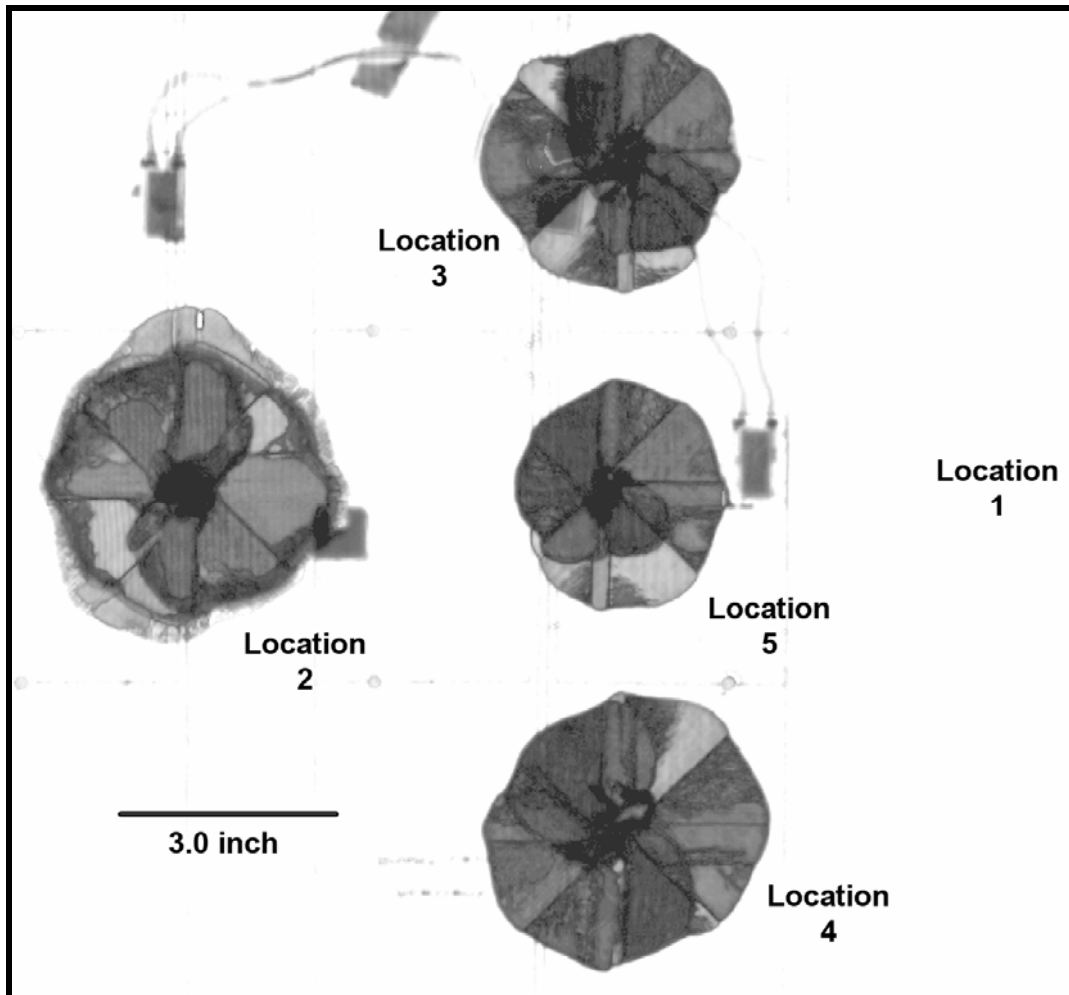
The ultrasonic view of the plate is shown in Figure 15. The white areas represent full amplitude backwall responses. Increasingly dark regions show delamination between different plies, with the darkest areas near the surface of the impact zone. As shown in the Figure, Impact 1 does not introduce any delamination to the plate, as confirmed by the previous analysis. It is speculated that Impact 1 produces minor fiber breakage, and results in minor changes in frequency responses. The other four impacts produce relatively large areas of delamination, which are all detected by the active-sensing FRF based methods.

Figure 15: Ultrasonic view of the plate with induced delamination

Table 2 summarizes the impact velocities versus both delamination areas and corresponding damage metric values. The effective area of observed damage is well correlated to the damage indicator features. The question of the differences in damage metric values between Impact 3 and 4 (Impact 4 has the lower velocity but higher damage metric value in the FRF analysis) is also answered by the ultrasonic testing. Impact 4 obviously produced larger delamination area than Impact 3, which supports the previous FRF analysis.
