Failure Analysis Associates, Inc.  
Engineering and Scientific Services  
149 Commonwealth Drive, P.O. Box 3015  
Menlo Park, California 94025  
(415) 326-9400 Fax (415) 326-8072  
Internet Site: www.fail.com

Faaa-SF-R-96-06-16

## Investigation of the Failure of an SCBA Cylinder

July 2, 1996

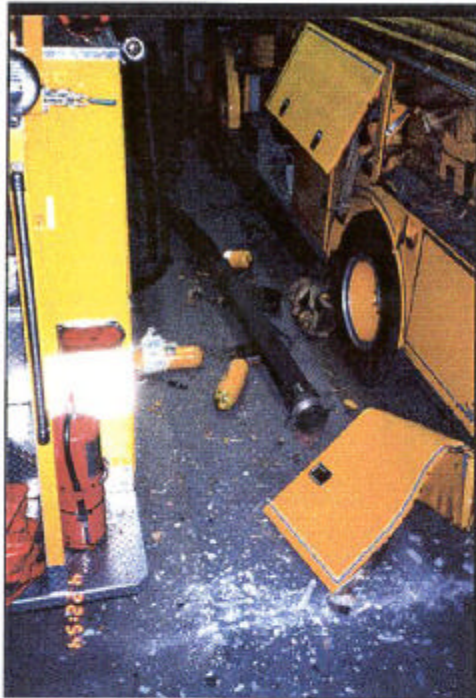
In Figure 1, Engine 1-7 is on the right, and the failed SCBA cylinder is on the floor between the two parked engines. Close-up views of the failed cylinder appear in Figures 2 and 3. The compartment on Engine 1-7, where the cylinder was stored prior to the failure, is visible in Figure 4. The door to this storage compartment was blown off and is on the floor in the foreground of Figure 1. The door to the adjacent storage compartment was blown open and deformed, as shown in Figure 4.

Figure 1. Post-Failure Scene at the Bayview Station of the Humboldt Fire Department

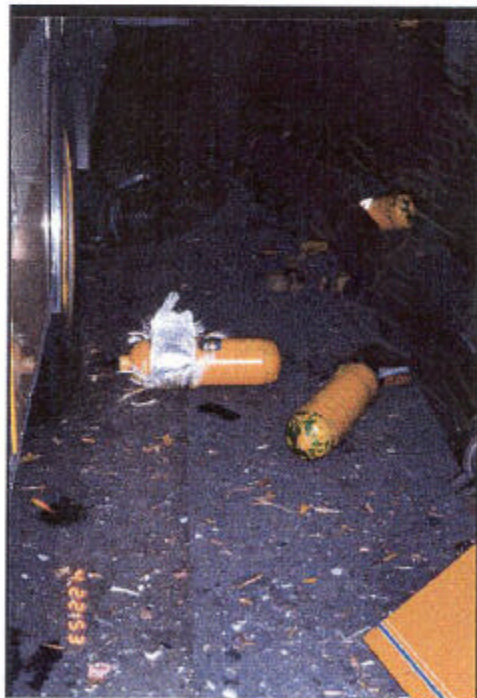
Figure 2. View of Failed Cylinder after Accident

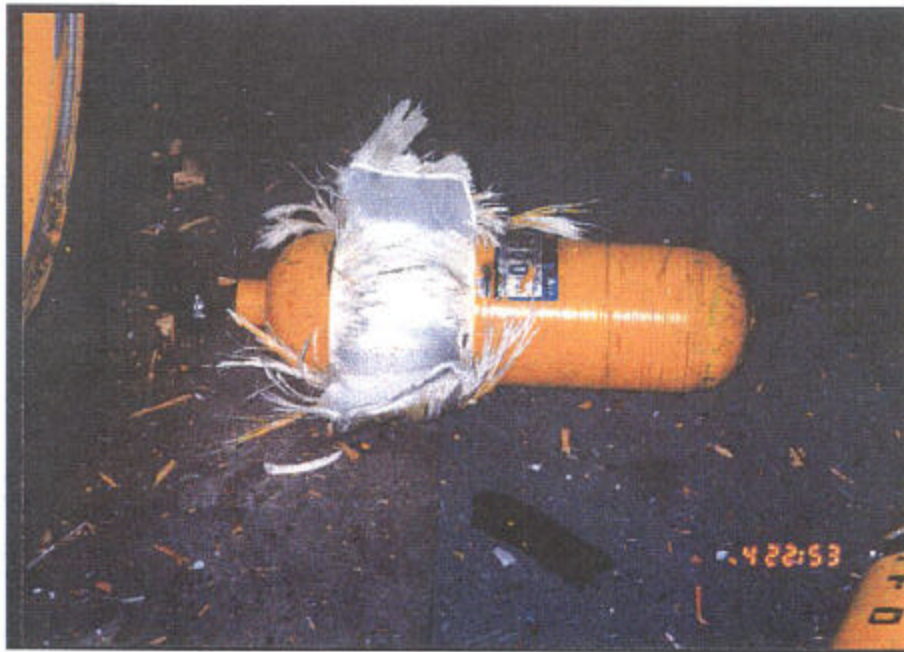
Figure 3. Close-up View of Failed Cylinder after Accident

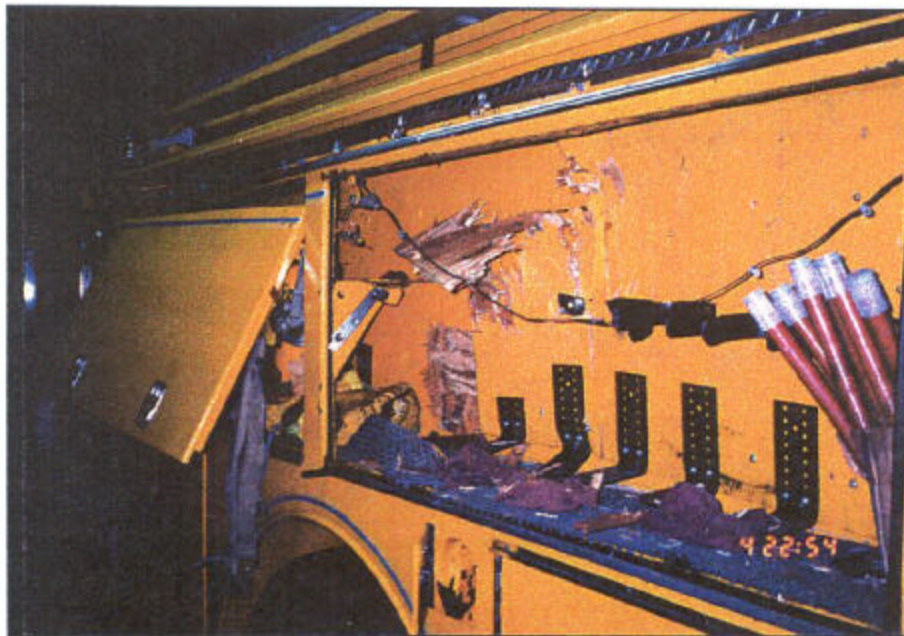
Figure 4. Compartment in Engine 1-7 where the Accident SCBA was Stored

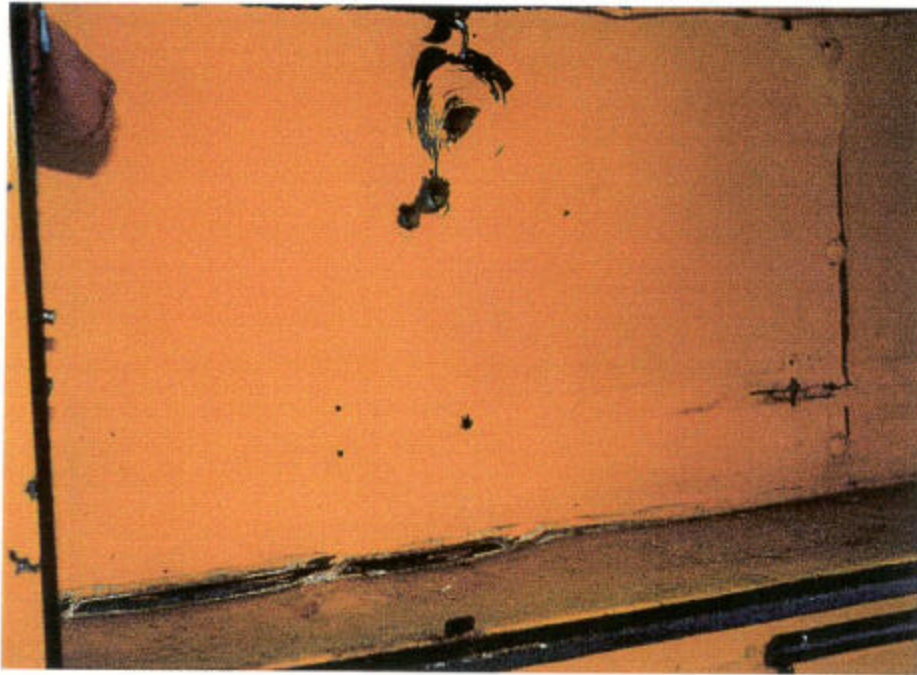
The failed cylinder was transported to FaAA for further examination and testing. The SCBA cylinder storage rack in Engine 1-7, where the failed SCBA cylinder was stored at the time of the failure, was also removed and subsequently sent to FaAA. The interior of the storage compartment following removal of the storage rack is shown in Figure 5. Visible in Figure 5 is the dent in the back wall of the compartment, where the cylinder struck the wall, and the gap along the bottom of the storage compartment, where the top of the fire engine was displaced from the bottom.

Figure 5. Interior of SCBA Storage Compartment in Engine 1-7

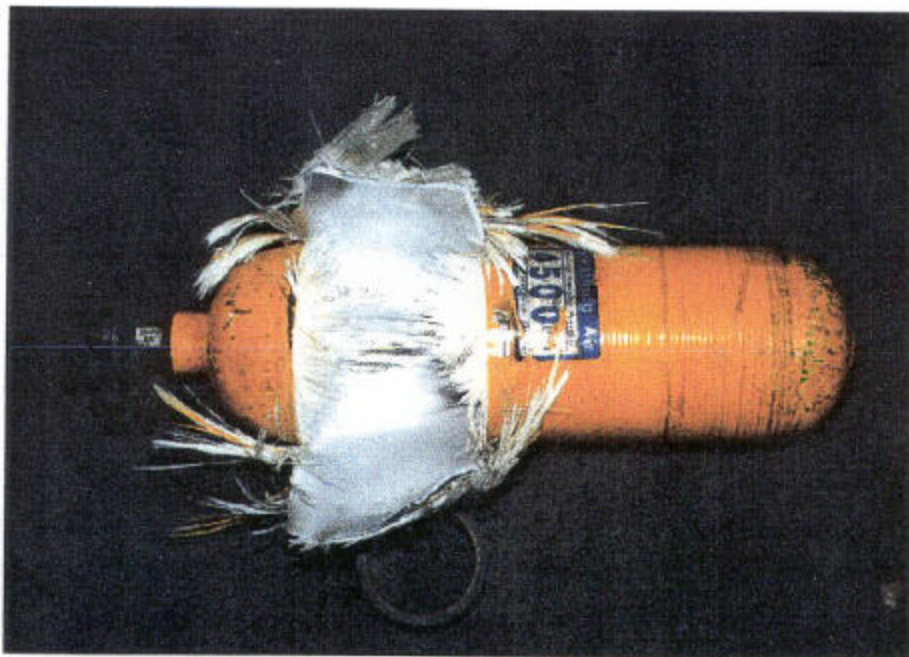
The overall fracture has an "H" shape, as shown in Figure 6, with the horizontal bar of the "H" oriented in the longitudinal direction of the SCBA cylinder and the vertical bars of the "H" oriented in the circumferential direction. Failure of the SCBA cylinder appears to have initiated in the circumferential fibers, near the right hand edge of the label, as viewed with the cylinder vertical and the valve at the top (see Figures 7 and 8).

Figure 6. Failure Region of Accident SCBA Cylinder

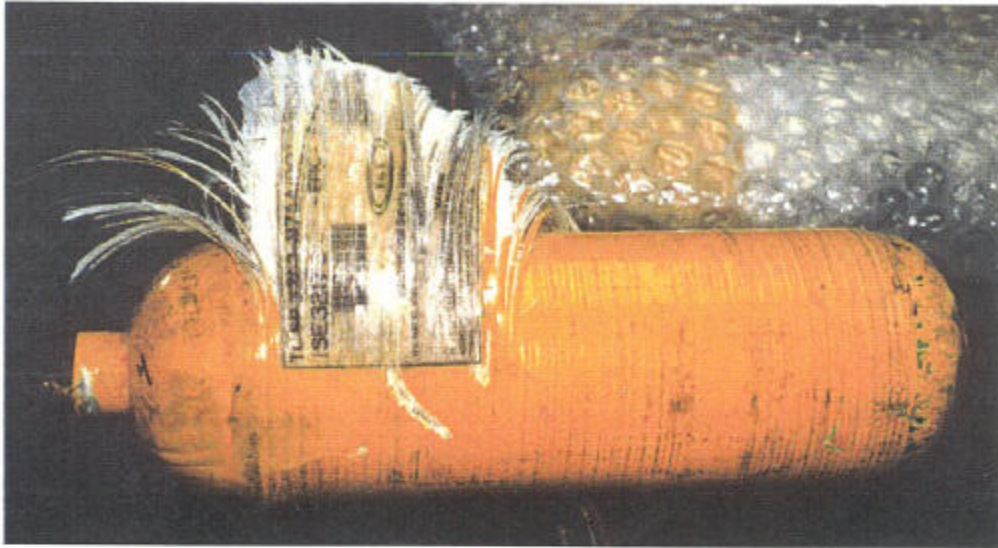
Figure 7. Label of Accident SCBA Cylinder

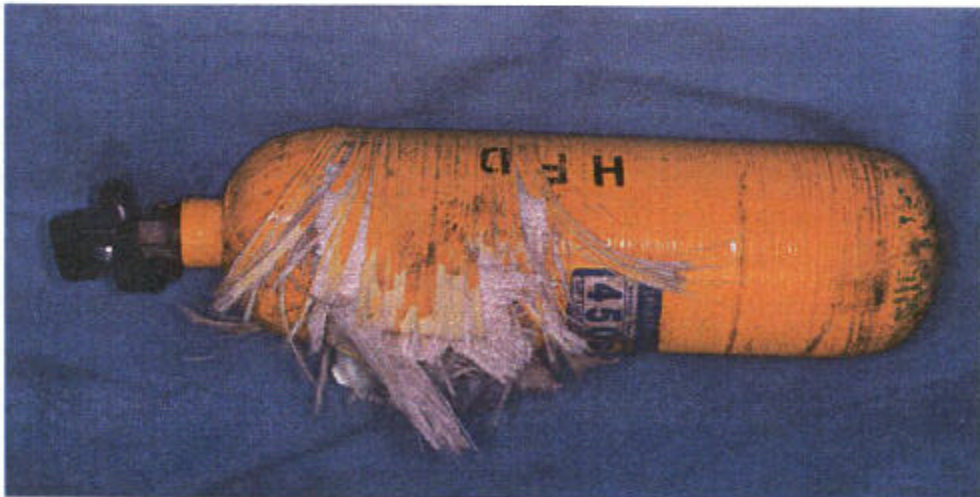
Figure 8. Initial Failure Region of Accident SCBA Cylinder

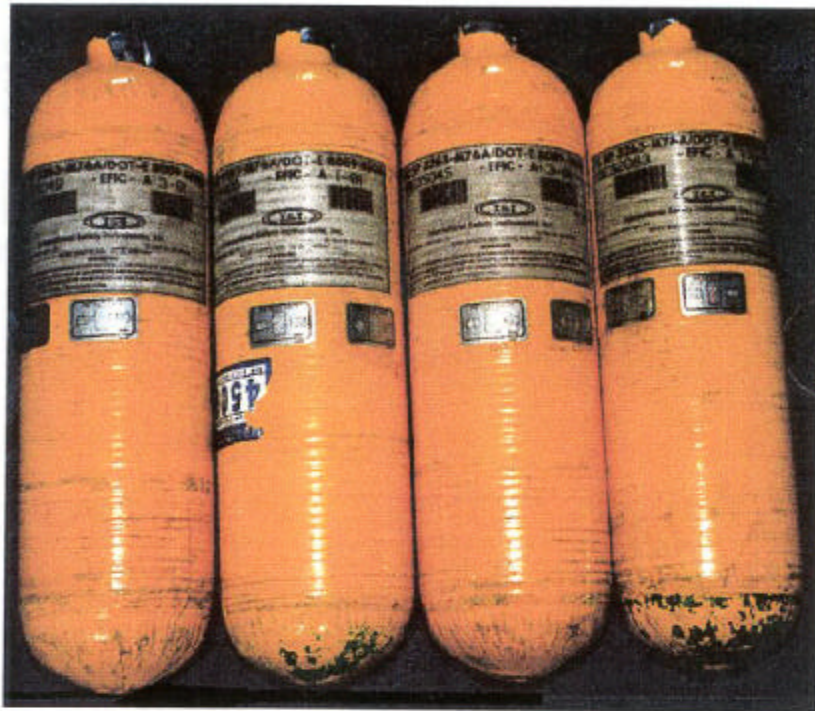
During the inspection, information was obtained on the handling, maintenance, and refilling of the Humboldt Fire Department SCBA cylinders. Other Humboldt Fire Department SCBA cylinders were also examined. In particular, cylinders used in the training exercise and stored on Engine 1-7 at the time of the failure, shown in Figures 9 and 10, were examined for evidence of damage or other unusual surface features. Nothing in the practices of the Humboldt Fire Department or the condition of the other SCBA cylinders provided an explanation for the failure of the SCBA cylinder.

Figure 9. Exemplar Cylinders at Bayview Station (Label Side)

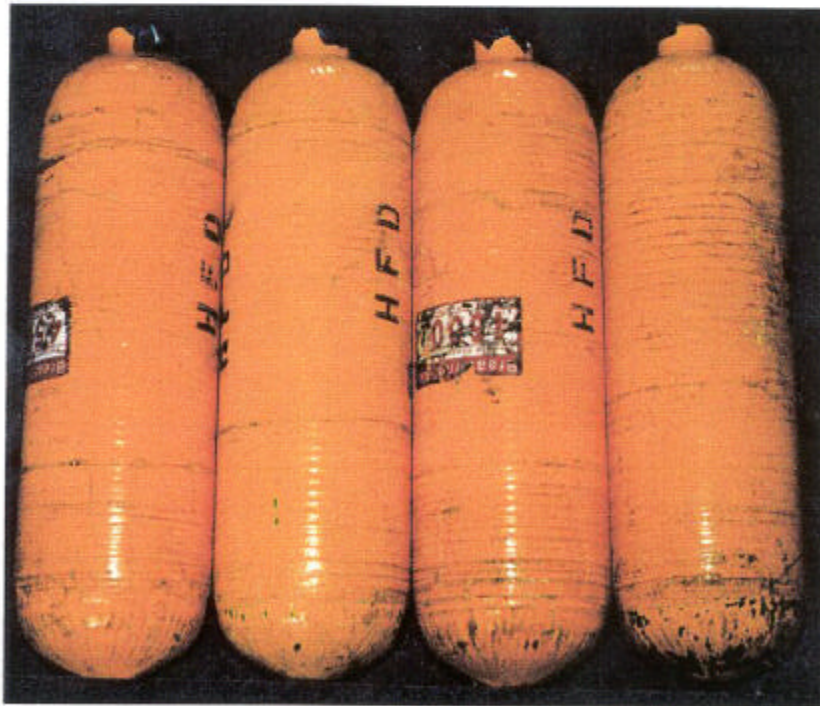
Figure 10. Exemplar Cylinders at Bayview Station (Side Opposite Label)

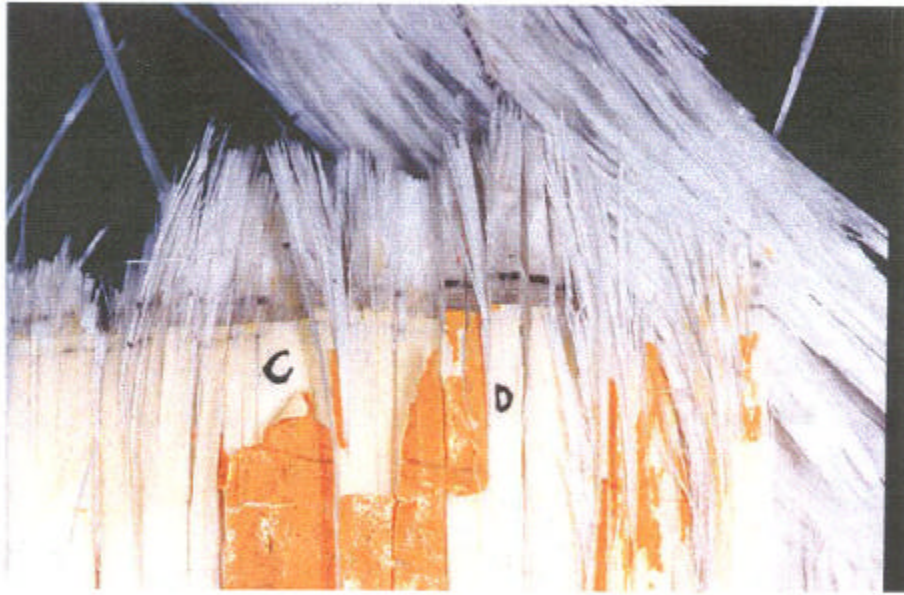
The flat fracture surfaces of the failed fiber bundles are indicative of stress corrosion cracking. The fracture surfaces are perpendicular to the circumferential direction, the direction of maximum stress caused by the internal pressure in the cylinder. The mating fracture surfaces to these circumferential fiber bundles, which were displaced upon failure, also exhibit the flat fracture features. The circumferential bundles appear to be in equi-width segments in the longitudinal direction, which may be associated with autofrettage cracking of the composite during the manufacturing process. This cracking did not contribute to the failure initiation or propagation. The longitudinal fibers that failed above and below the label have a broom or splayed array appearance typical of an overload event in a composite structure. The macro-fractographic features of failed circumferential and longitudinal fiber bundles can be seen in Figures 11 and 12.

Figure 11. Appearance of Failed Circumferential Fibers at Initial Failure Site  
(Letters refer to Test Specimen Locations)

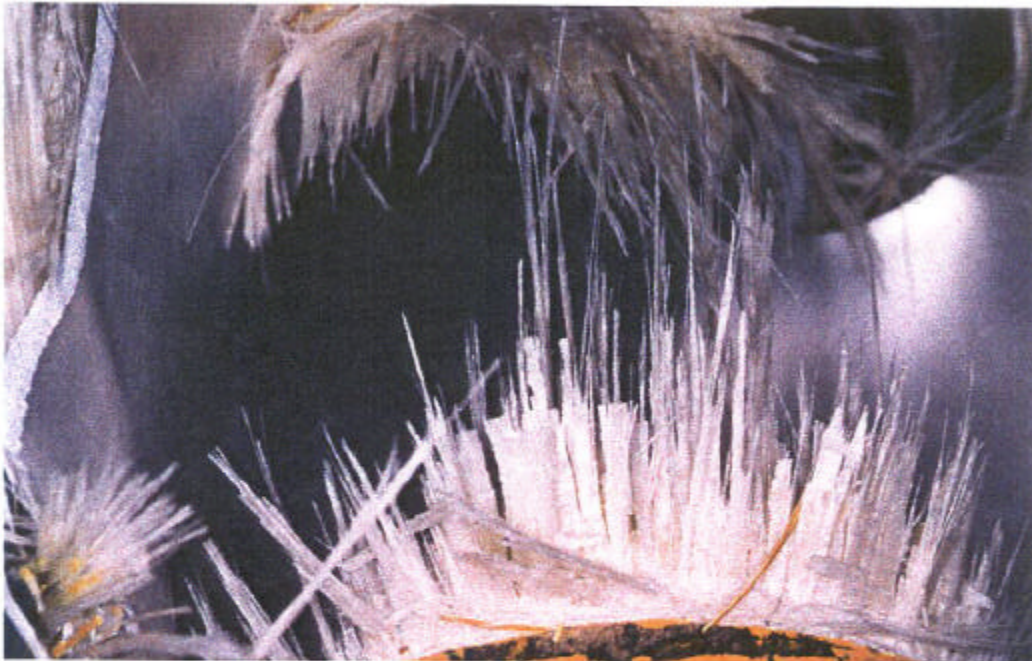
Figure 12. Appearance of Failed Longitudinal Fibers

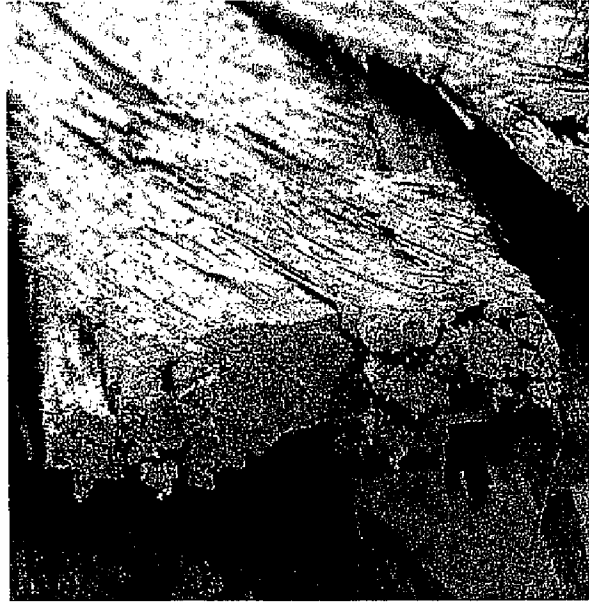
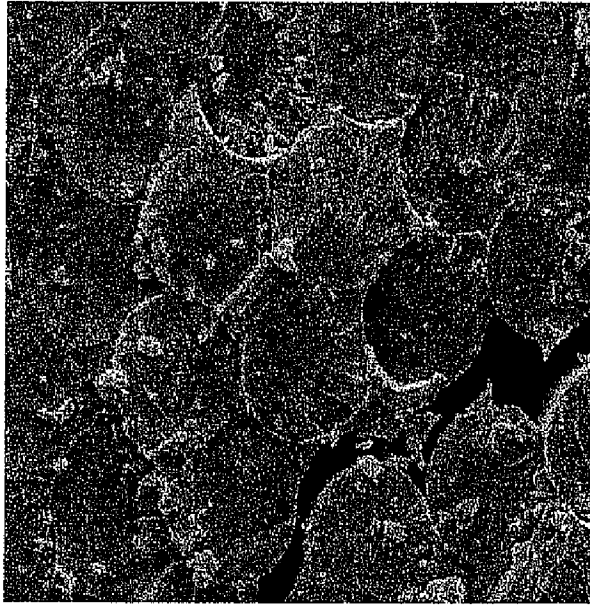
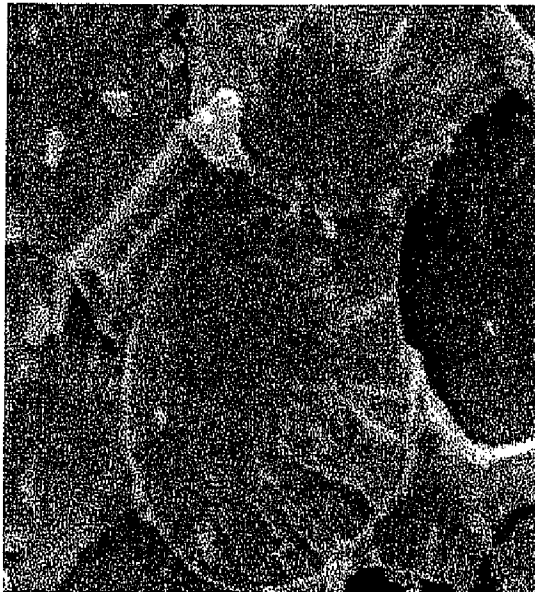
SEM fractography confirmed that the SCBA fracture initiated as a result of stress corrosion cracking. The flat fracture regions observed adjacent to the edge of the label were both macroscopically and microscopically consistent with stress corrosion cracking of fiberglass. Overall and progressively higher magnification photographs of the fracture area from sample D are shown in Figures 15 through 18. Note the characteristic stress corrosion cracking feature of a moon-shaped mirror region on the individual glass fibers followed by the rays or hackle marks radiating outward from the initial crack region. This mirror region is produced as the chemical environment and stress interact to produce initial crack growth. When the crack becomes sufficiently large for the given stress and chemical environment, the crack propagates rapidly through the remaining fiber cross section, resulting in the failure of that fiber. The process continues until the load carrying capacity of the composite and liner combination is reduced below the rupture strength of the SCBA cylinder.

Figure 15. Scanning Electron Micrograph of Circumferential Fibers at Fracture Surface in Sample D - 50x Magnification

Figure 16. Scanning Electron Micrograph of Circumferential Fibers at Fracture Surface in Sample D - 240x Magnification

Figure 17. Scanning Electron Micrograph of Circumferential Fibers at Fracture Surface in Sample D - 2000x Magnification

Figure 18. Scanning Electron Micrograph of Circumferential Fibers at Fracture Surface in Sample D - 4000x Magnification

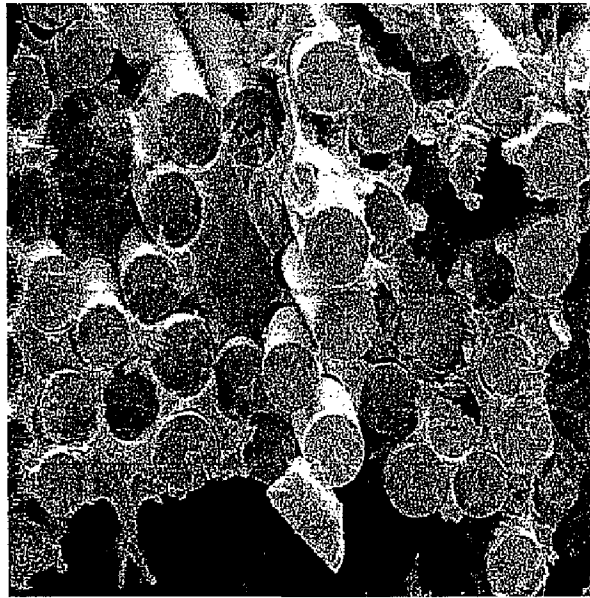
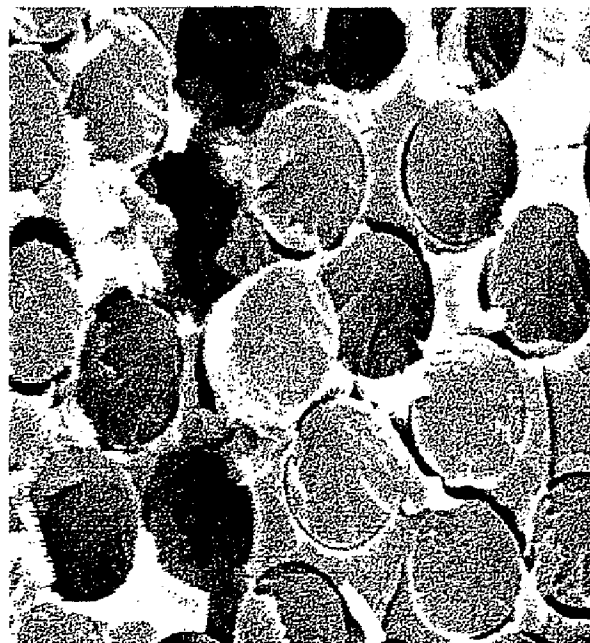
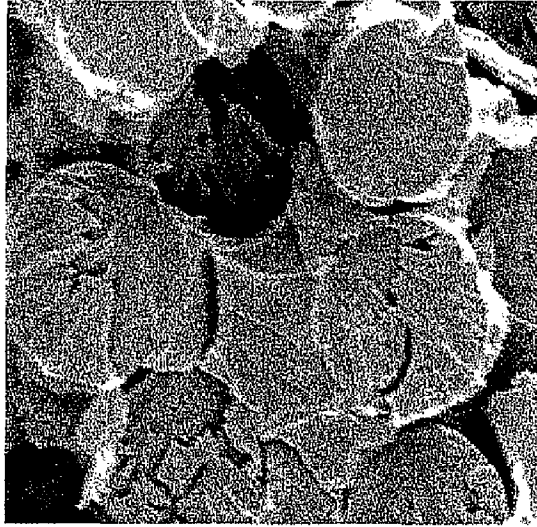
restrained in that position using rubber bands to provide an elevated state of constant strain. The bent sample was then placed into a beaker containing the Alume™ solution. Almost immediately after immersion, cracking of fibers was heard, and the specimens were seen to move and fracture. After less than one minute of exposure, sample F had fractured completely. Sample G remained in solution for several minutes and multiple fiber failures occurred. SEM examination of sample F revealed fractographic evidence of features on the broken fibers very similar to the accident sample D described in Section 2.3. In the photographs of sample F, shown in Figures 19 through 21, note the characteristic mirror region and radiating hackle marks present on the fibers.

Figure 19. Scanning Electron Micrograph of Circumferential Fibers at Fracture Surface in Sample F after Exposure to Alume™ - 1000x Magnification

Figure 20. Scanning Electron Micrograph of Circumferential Fibers Fracture Surface in Sample F after Exposure to Alume™ - 2000x Magnification

Figure 21. Scanning Electron Micrograph of Circumferential Fibers Fracture Surface in Sample F after Exposure to Alume™ - 3500x Magnification

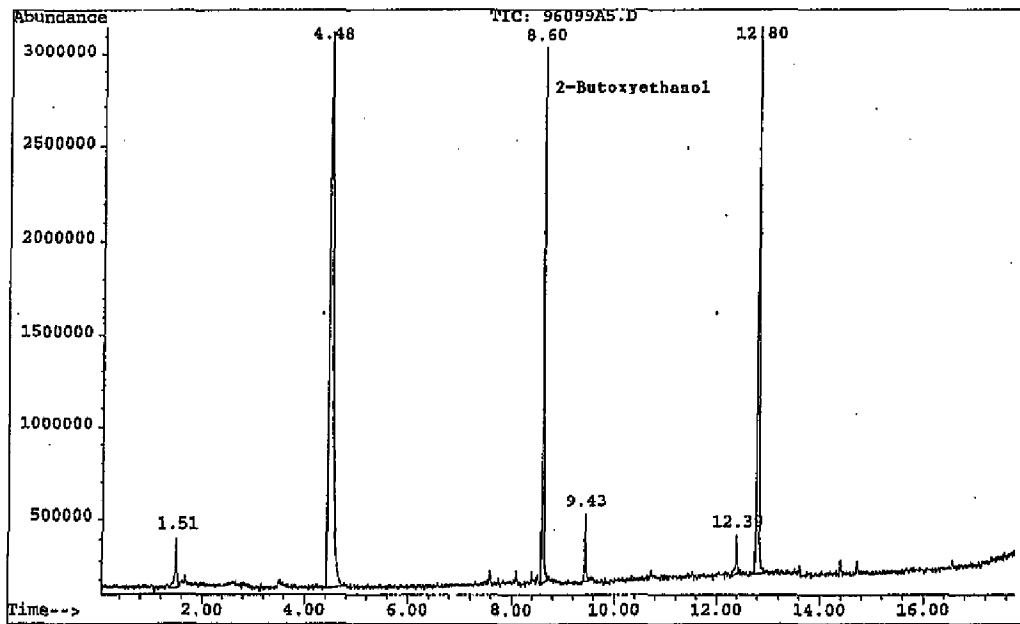
TD-GC-MS results for the total desorbed volatiles for sample G are displayed on the chromatogram shown in Figure 22. Three major, three minor and several trace components in sample G were obtained and identified on the basis of their mass spectra and are summarized in tabular form in Table II. The number of + symbols in the table indicates the relative amount of each component, based on the relative size of peaks in the spectra for sample G. The retention time listed in Table II is the time of elution of each reported component.

Figure 22. TD-GC-MS Chromatogram for Sample G
