# **09/11/91 Britt Airways, Inc., d/b/a Continental Express**

BRITT AIRWAYS, INC., d/b/a CONTINENTAL  
EXPRESS FLIGHT 2574 IN-FLIGHT STRUCTURAL  
BREAKUP EMB-120RT, N33701 EAGLE LAKE,  
TEXAS SEPTEMBER 11, 1991

<b>Accident NTSB ID</b>	92-04
<b>Airline</b>	Britt Airways, Inc., d/b/a Continental Express
<b>Model aircraft</b>	EMB-120, 120-L77
<b>Aircraft manufacturer</b>	Embraer
<b>Engine manufacturer</b>	Pratt & Whitney
<b>Date</b>	09/11/91
<b>Time</b>	1003
<b>Location</b>	Eagle Lake, Texas
<b>Country</b>	USA
<b>IFR or VFR?</b>	VFR
<b>Fatalities</b>	14
<b>Injuries</b>	-
<b>Fire during flight?</b>	Y
<b>Fire on the ground?</b>	Y
<b>Probable cause</b>	The failure of Continental Express maintenance and inspection personnel to adhere to proper maintenance and quality assurance procedures for the airplane's horizontal stabilizer deice boots that led to the sudden in-flight loss of the partially secured left horizontal stabilizer leading edge and the immediate severe nose-down pitchover and breakup of the airplane.
<b>Contributing causes</b>	The failure of the continental Express management to ensure compliance with the approved maintenance procedures, and the failure of FAA surveillance

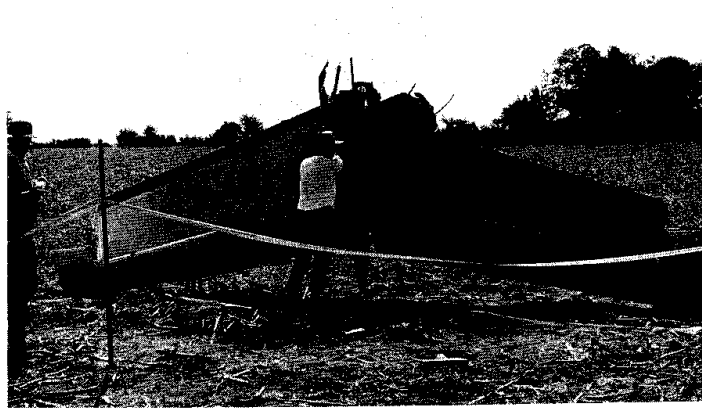
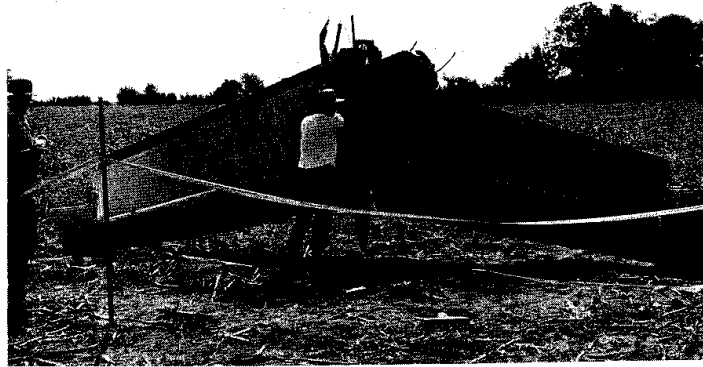
Figure 1a.--View of horizontal stabilizer from underside.

During the Safety Board's examination of the wreckage, none of the 47 screws that would have attached the upper surface of the leading edge assembly for the left side of the horizontal stabilizer was found. There was no evidence of distress in the upper attachment holes for the left side leading edge assembly or indication that the attaching screws were installed when the left side leading edge assembly separated from the horizontal stabilizer. In addition, a "lip" was formed on the forwardmost frame on the left lower side of the horizontal stabilizer spar cap. That frame (spar cap), with receptor holes for the lower attaching screws, was the area into which the screws mounted the underside of the left side leading edge assembly to the stabilizer. This lower frame area showed signs of distress. [Figure 1a](#), [figure 1b](#), [figure 1c](#), [figure 1d](#) show the condition of the left horizontal stabilizer leading edge.

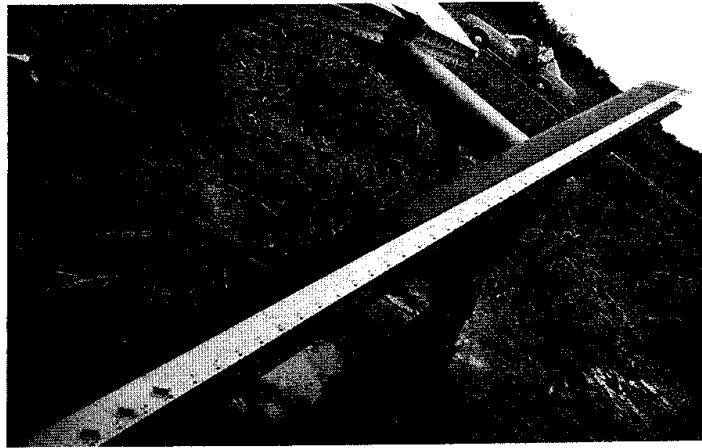
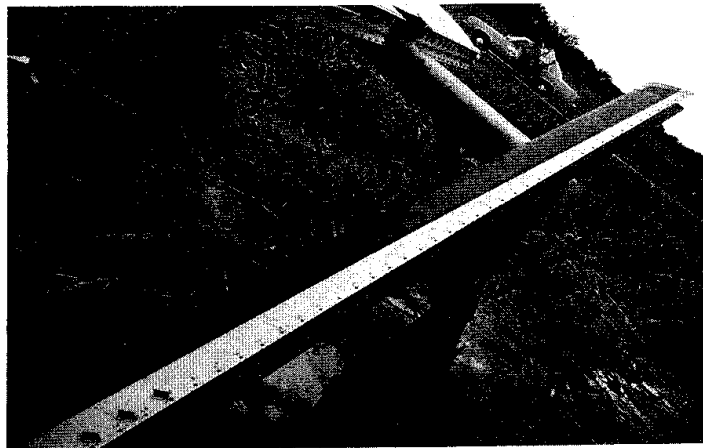
Figure 1b.--Leading edge assembly and outboard portion of left side of horizontal stabilizer.

The lower attachment screws remained installed, but the leading edge assembly had separated from the stabilizer, with the exception of a small portion of composite structure remaining below the two farthest inboard screw heads. The spar cap on the lower left side of the horizontal stabilizer showed evidence of being pulled down so that it would project into the wind stream along with the leading edge. This pulling damage is consistent with the left side leading edge assembly having been ripped down and away from the lower attaching screws as it separated from the horizontal stabilizer. This evidence was consistent with screws missing on the top side of the left leading edge assembly, and the lower attaching screws holding fast, pulling down the frame (spar cap) on the lower side of the stabilizer, and thereby forming the lip.

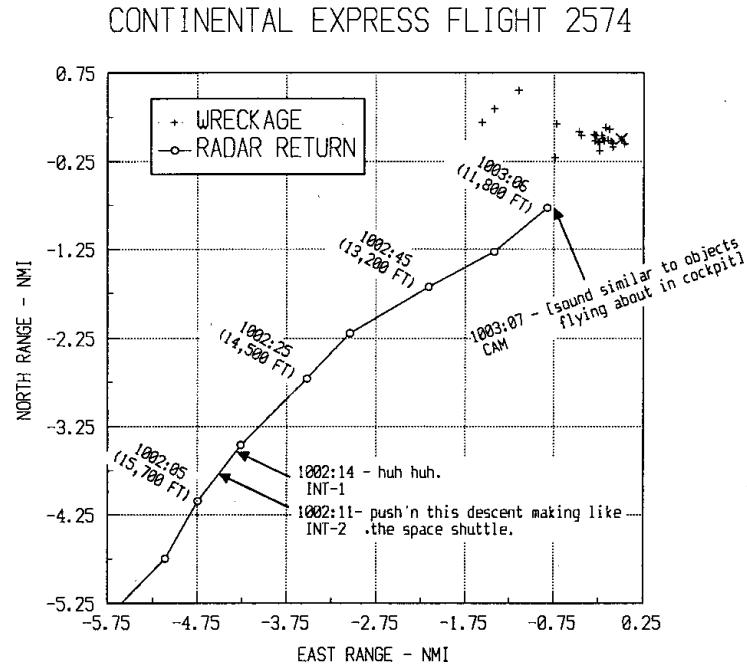
**Figure 2.--Radar-derived ground track, CVR sounds, and wreckage distribution.**

The airplane was flying to the northeast on a 44-degree heading at the time radar contact was lost at 1003:06 CDT. [Figure 2](#) shows the radar-derived ground track of flight 2574, selected sounds from the CVR, and the wreckage distribution.

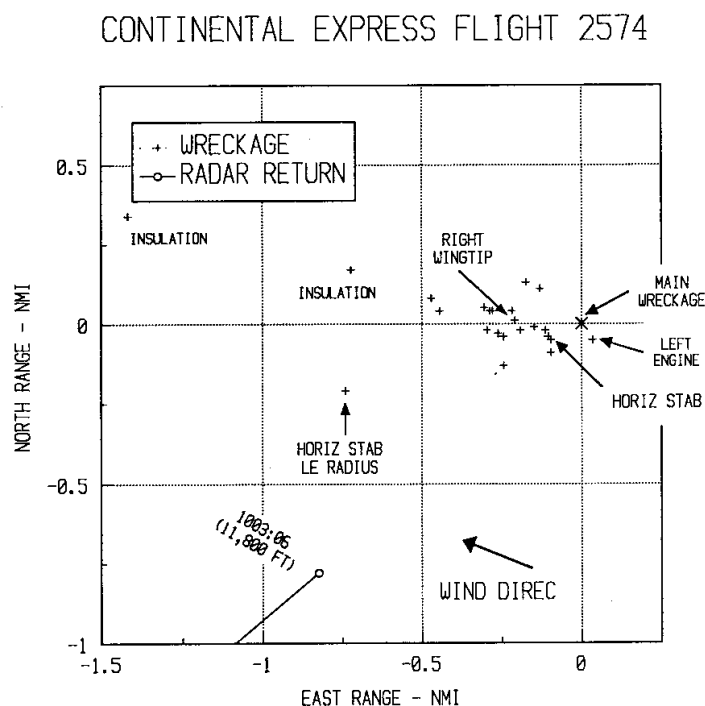
**Figure 3.--Closeup view of part of ground track and wreckage distribution.**

[Figure 3](#) provides a closeup view of part of the ground track and wreckage distribution. The piece of airplane structure farthest from the main wreckage was the left side leading edge (LE) of the horizontal stabilizer. The LE was the first piece of structure along the flight's northeasterly ground track, preceding the next piece by roughly 1/2 of a nautical mile.

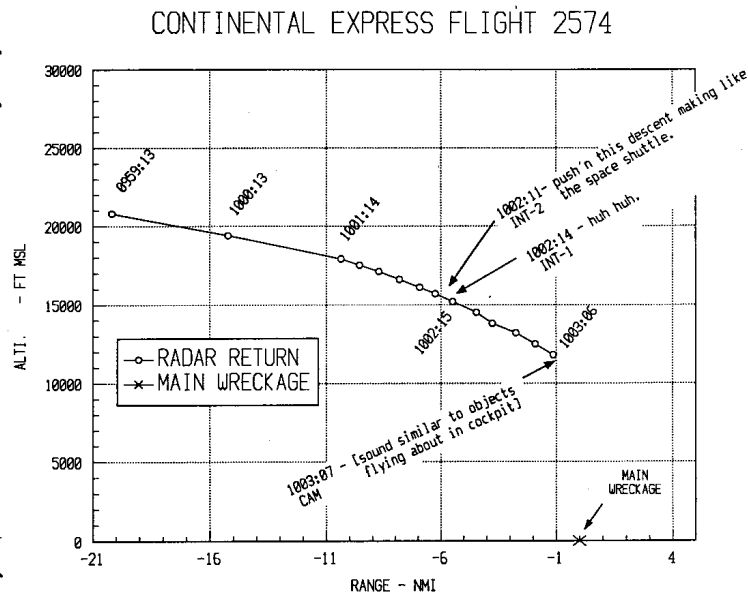
**Figure 4.--Radar-derived descent profile.**

Figure 4 shows the radar-derived descent profile. The last radar contact occurred as flight 2574 was descending through 11,800 feet. The radar-derived rate of descent during the final minute was approximately 4,000 feet-per-minute, which is consistent with FDR data from the airplane.

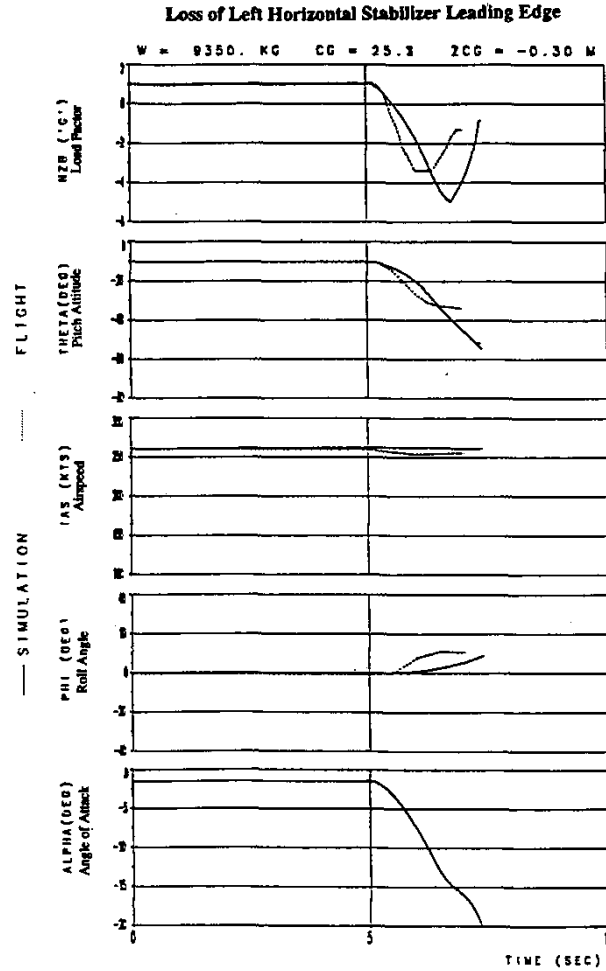
Loss of Left Horizontal Stabilizer Leading Edge

Despite the limitations of flight dynamics predictions, airplane movements during the first 6 1/2 seconds after the upset were consistent with the forces expected following a loss of the left side horizontal stabilizer leading edge. The FDR recorded a nose-left heading change and lateral acceleration that are consistent with an airplane sideslip caused by a drag imbalance between the left (higher drag) and right sides of the airplane. The higher drag on the left side of the airplane was most likely because of the missing leading edge of the left horizontal stabilizer spar. The airplane also reached and maintained 10 degrees to 15 degrees of right roll during the 6 1/2 second interval after upset. The flight dynamics
