Egyptian Delegation Presentation

# Flight MS 990 Accident

April 28, 2000

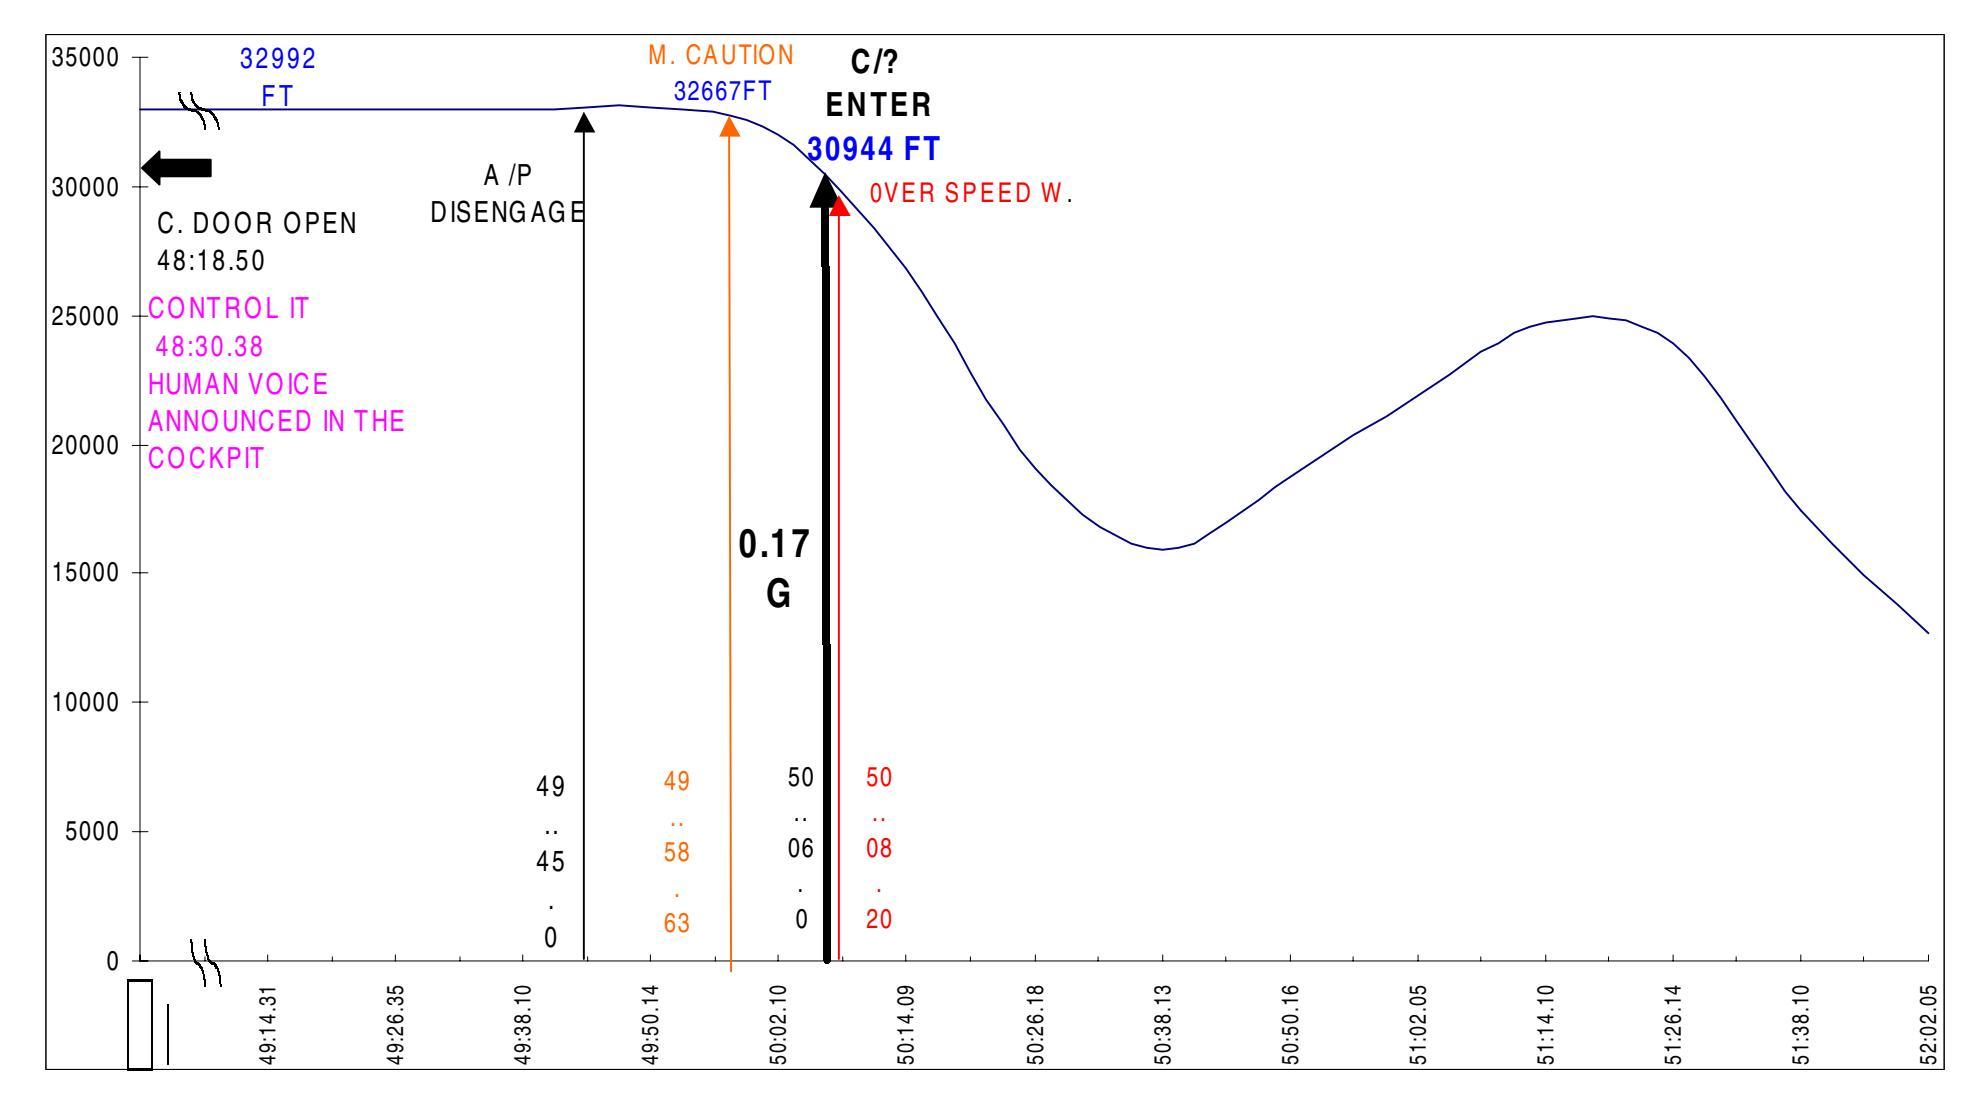
#### FDR 1-A Captain returned to cockpit very early in the event when the aircraft was about 31000 ft.

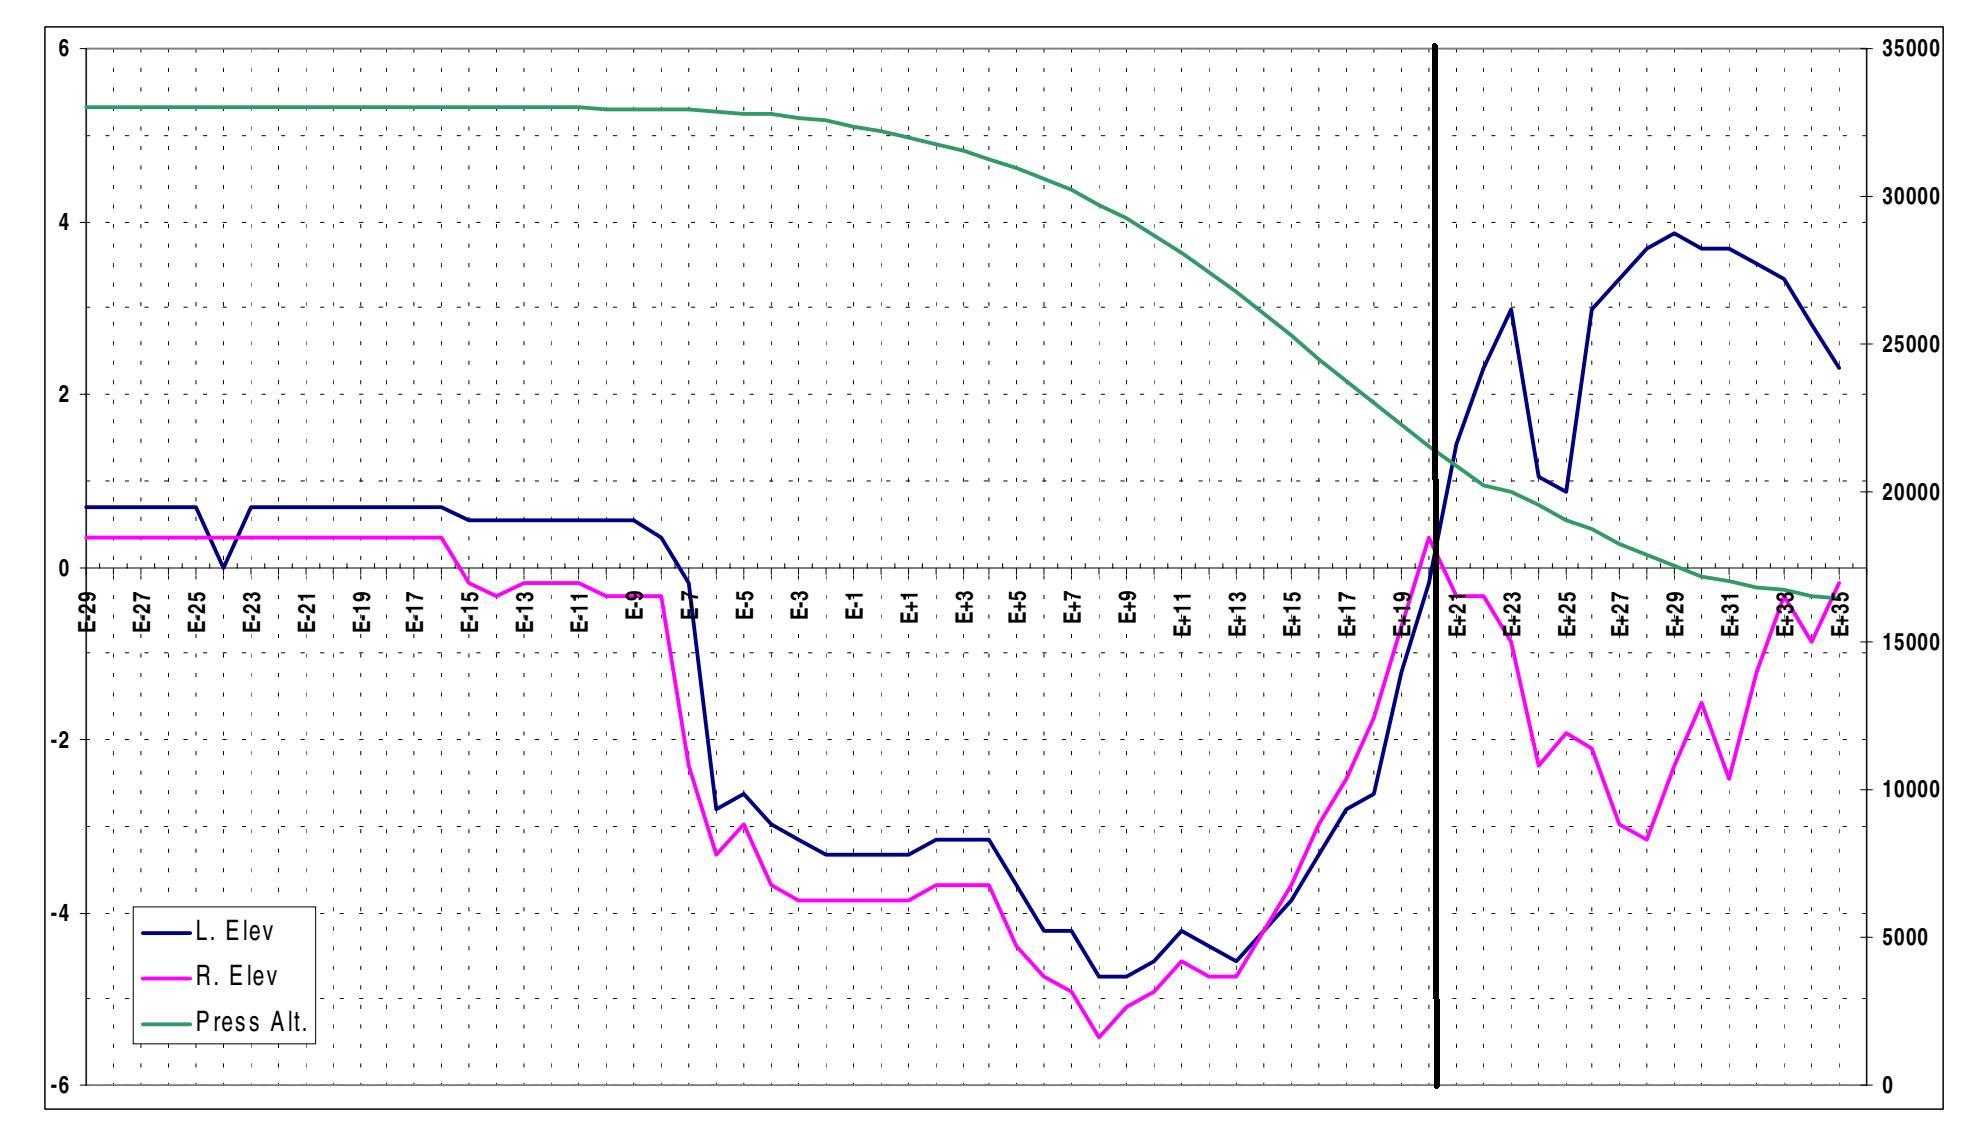
#### FDR 2-Both the elevators were moving simultaneously for the 1st 28 seconds of the dive

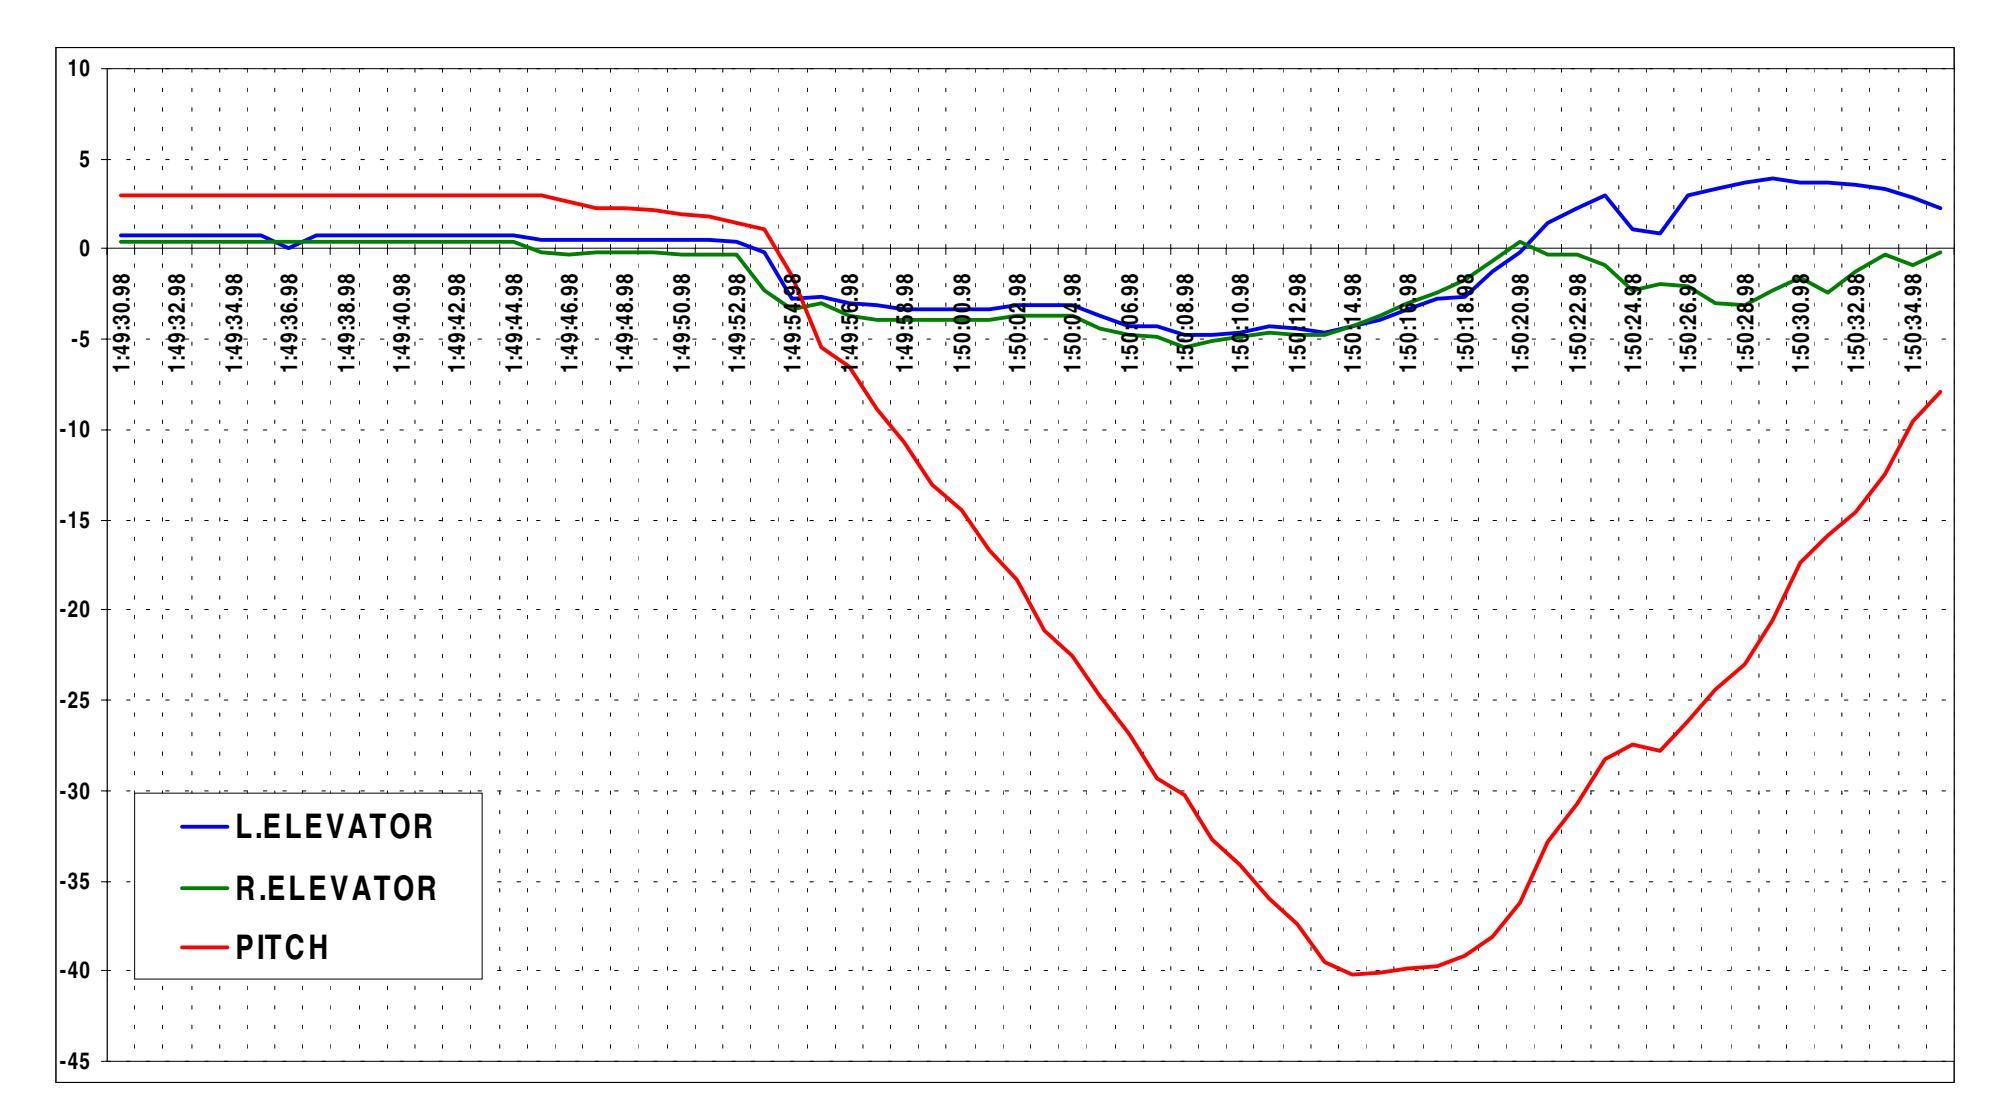
4-The elevators moved together as the nose came up, the dive was stopped, and aircraft control appeared to begin

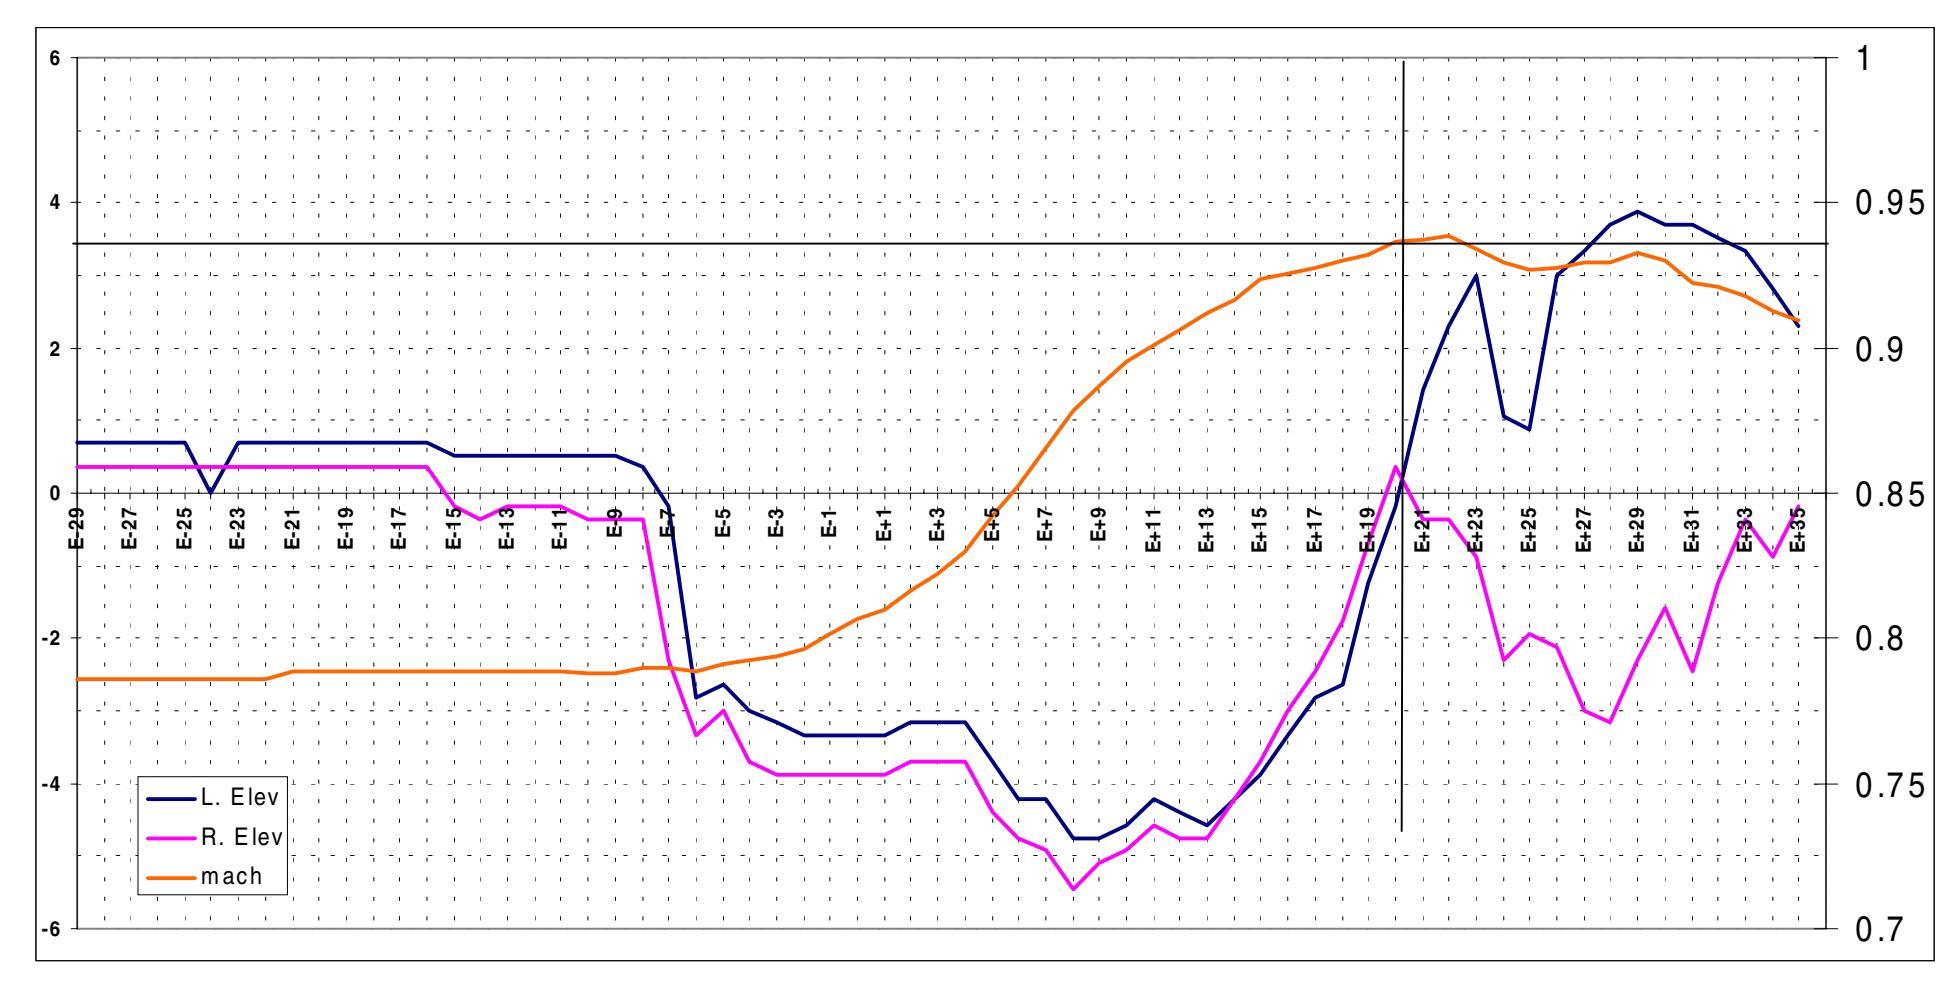
5-The elevator split does not appear until the last 15 seconds of the FDR data when the airplane was above 0.93 Mach. The airplane characteristics above Mach=0.91 is not available from manufacturer

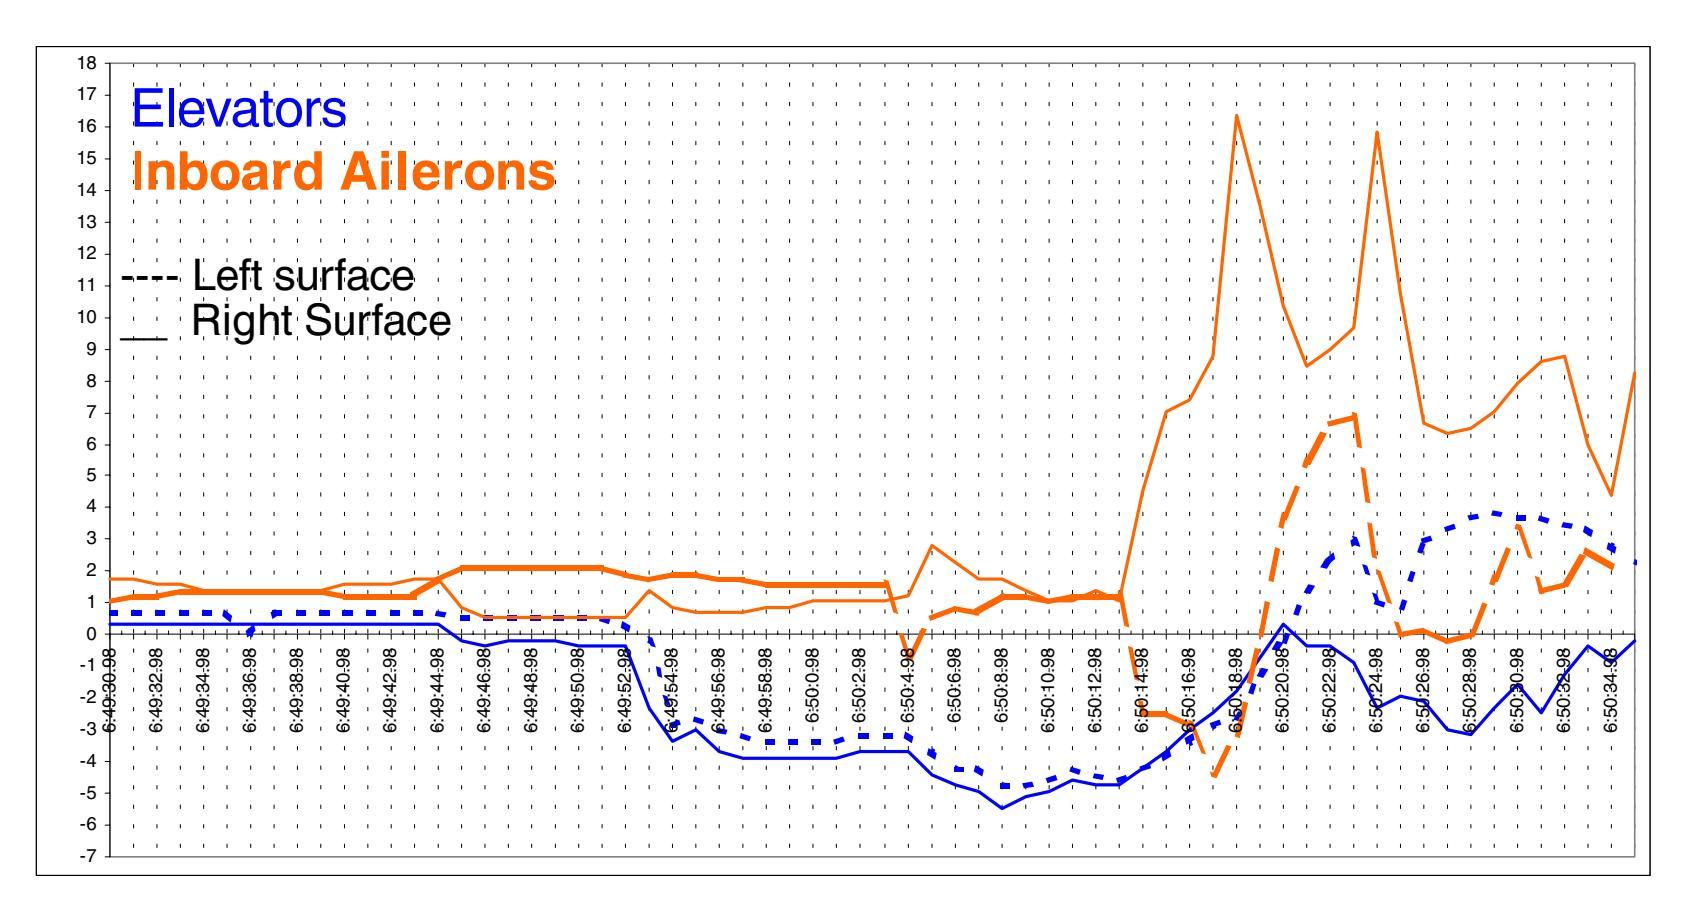
6-The elevator split at the end of the dive was incorrectly interpreted as a fight between the cockpit crew, at about the same time the elevators "split", the aileron surfaces showed similar unexplained movement, again questioning the validity of the A/C performance in this Mach range

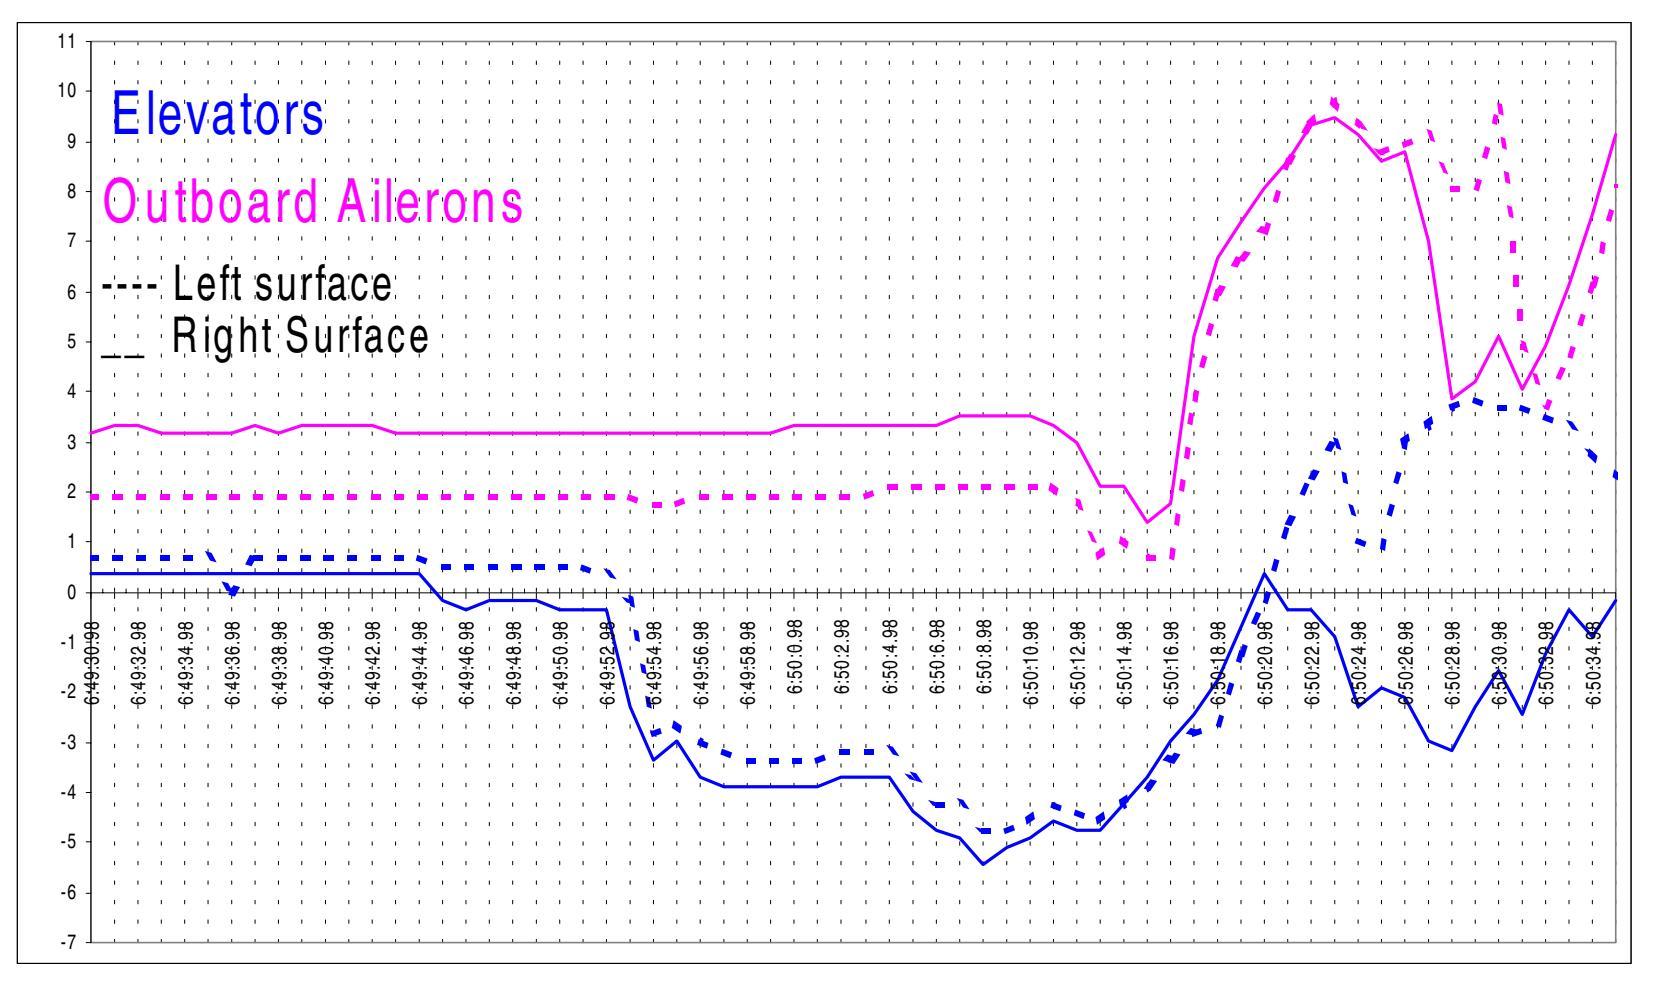
7-The elevator split at the end of the dive was incorrectly interpreted as a fight between the cockpit crew, at about the same time the elevators "split", the aileron surfaces showed similar unexplained movement, again questioning the validity of the A/C performance in this Mach range

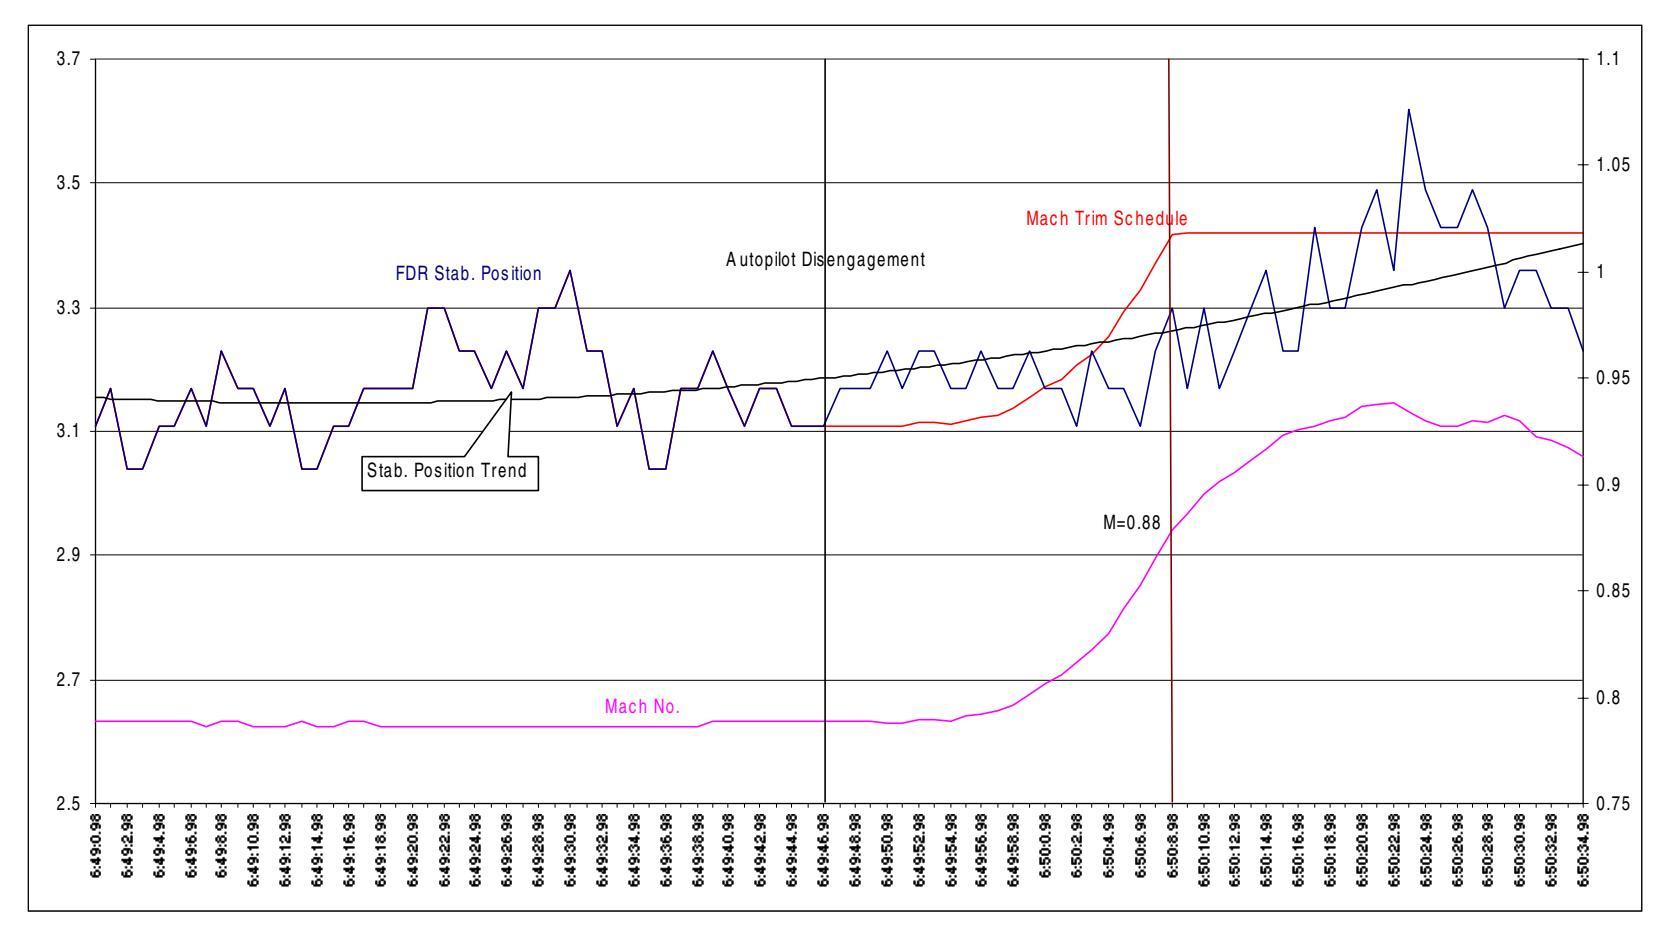
According to FDR data, stabilizer did not show significant movement to correct for the dive Stabilizer should have moved under the command of the Mach trim to pitch up the A/C. FDR data did not show this movement.Mach trim operation analysis is ongoing

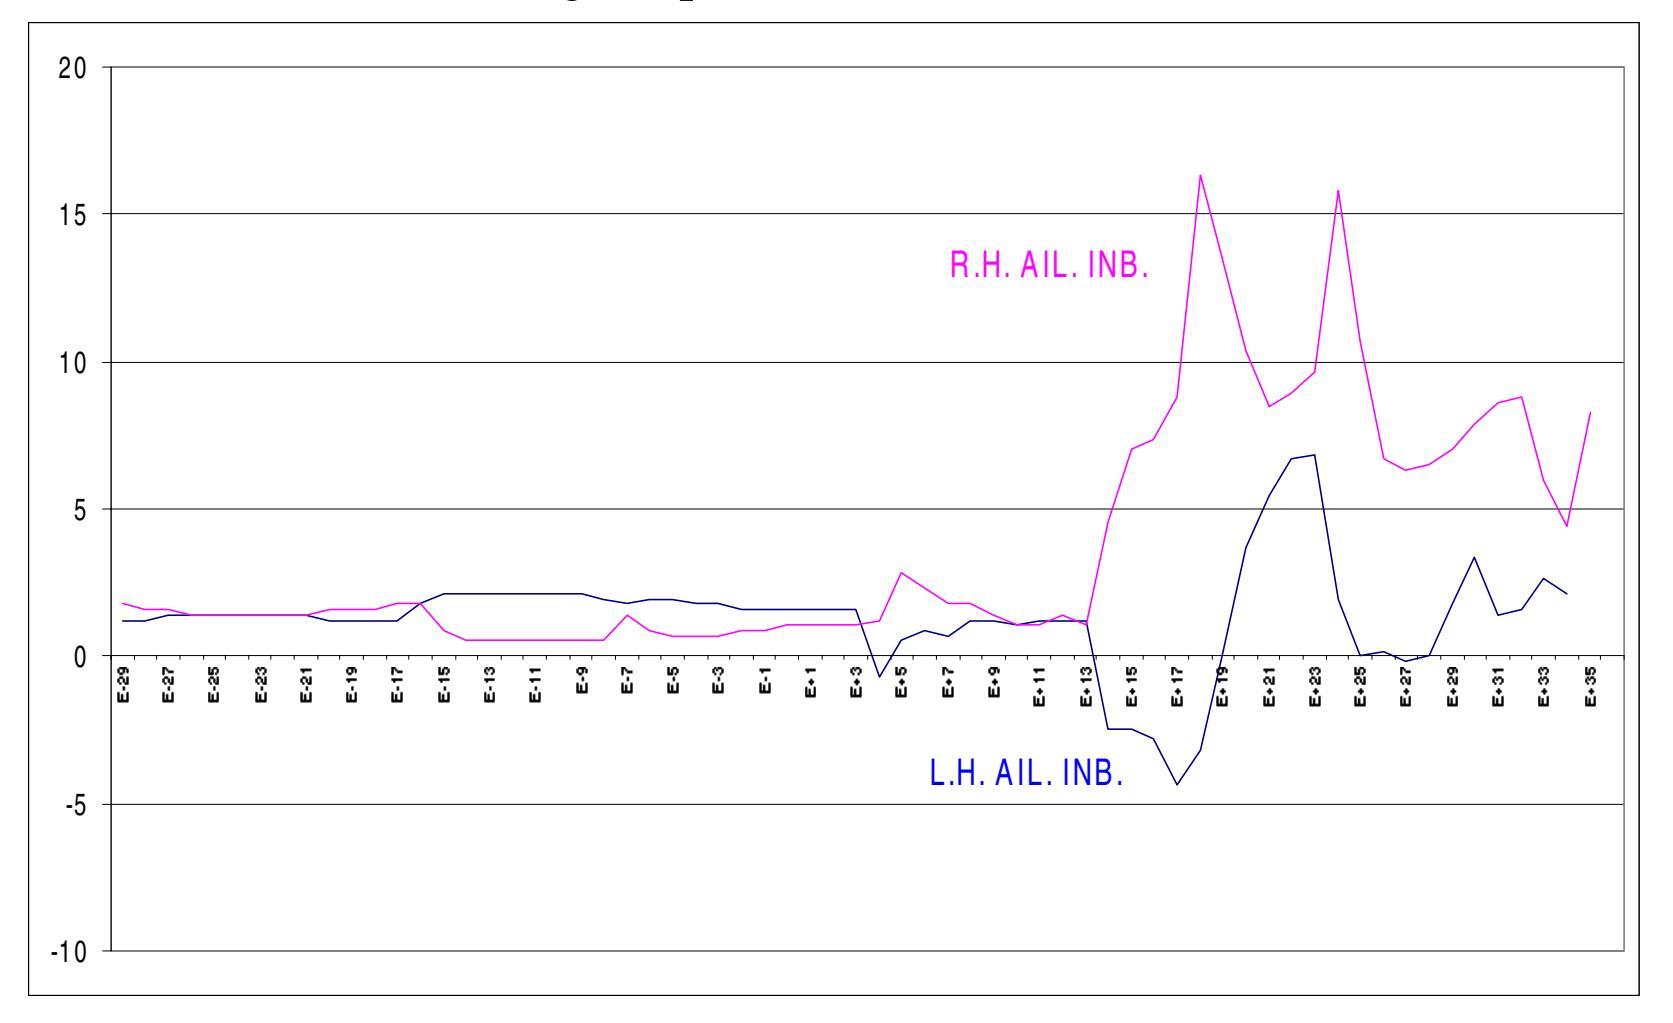
Both inboard ailerons moved significantly upward and then showed noticeable differential deflection (similar to what happened with the elevators). Upward movement of the inboard ailerons would result in significant pitch down movement (acting as speed brakes)

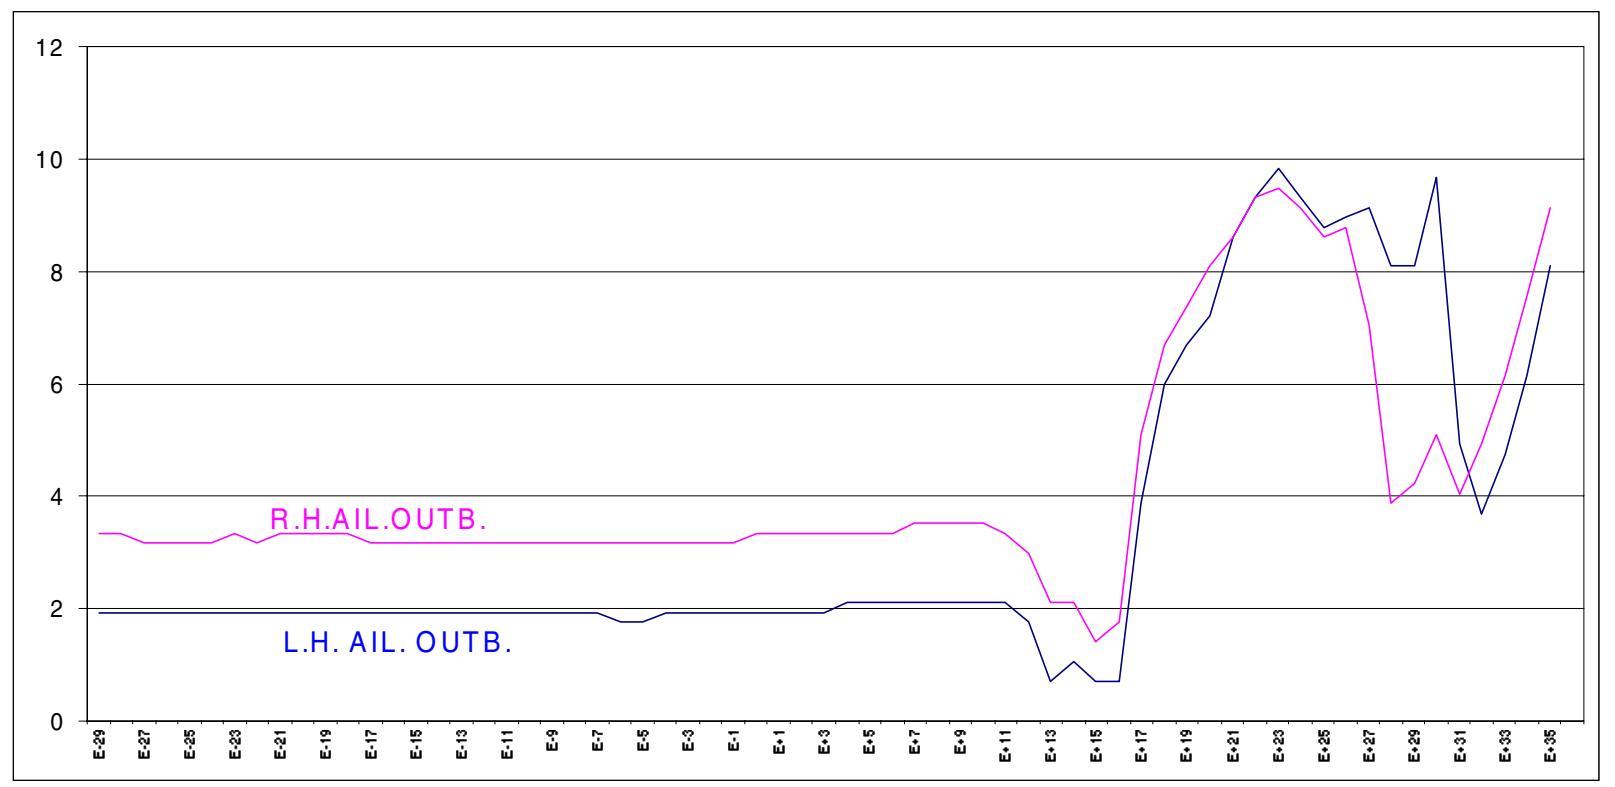
Both ailerons showed slight movements before the dive Both outboard ailerons(which are supposed to be locked during flight) moved significantly upward and then differentially(similar to what happened with the elevators). Upward movement of the outboard ailerons would result in significant pitch down movement (acting as speed brakes)

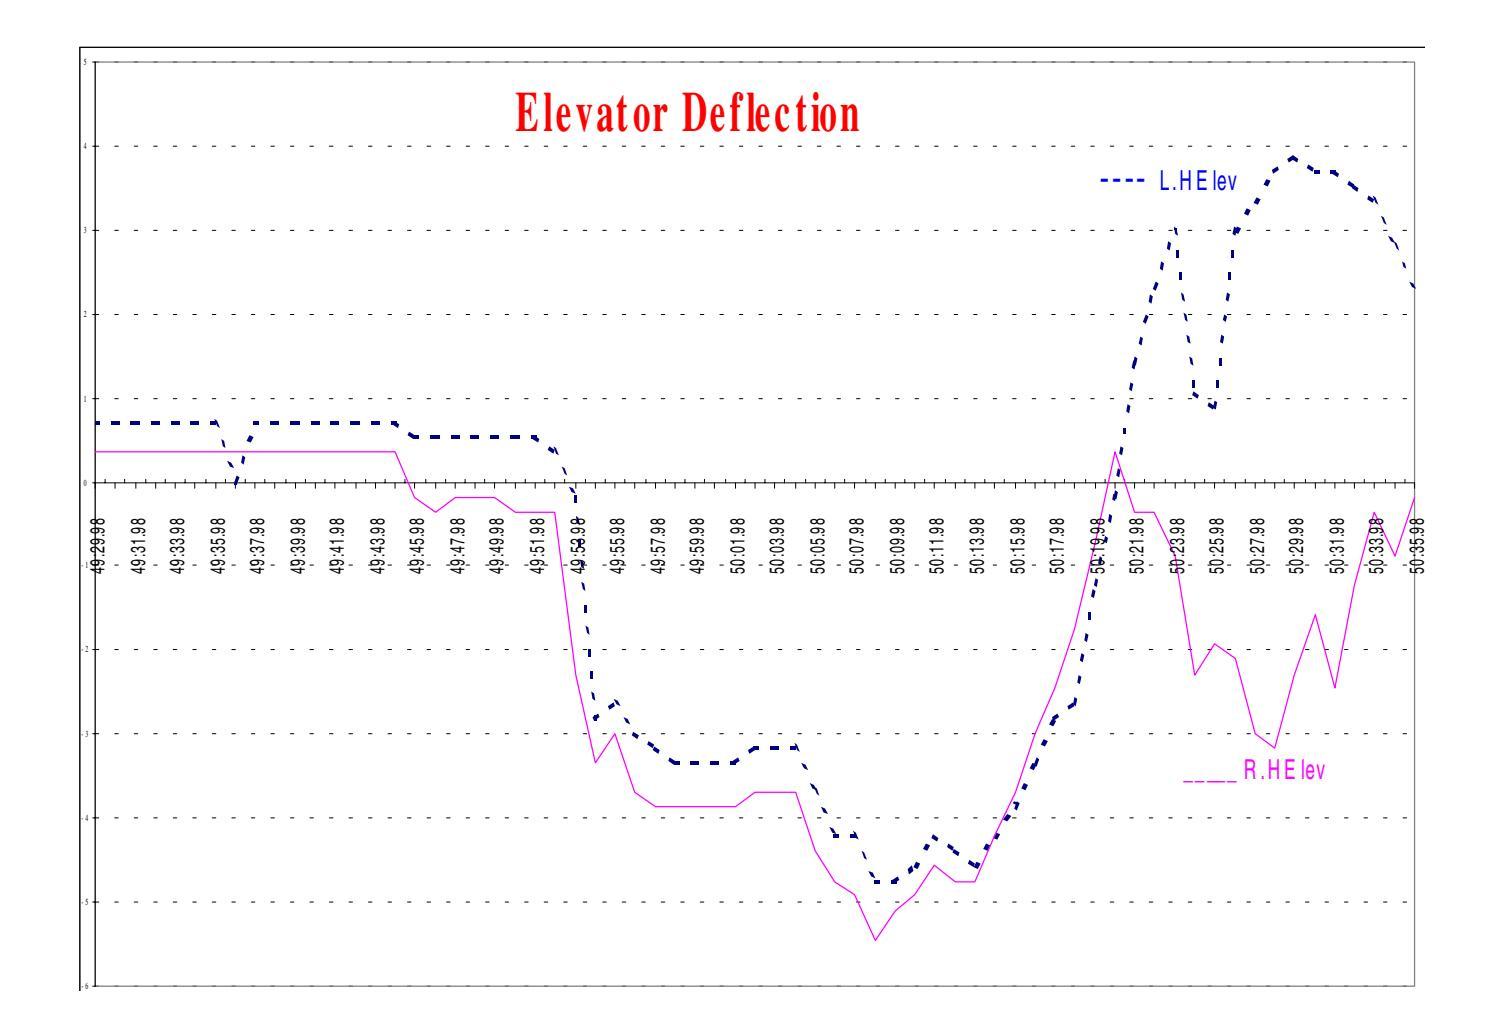
The right elevator showed a sudden movement of 0.5 degree down at 6:48:30 UTC for one second The left elevator showed a sudden movement of 0.8 degree down at 6:49:37 UTC for one second Elevator surfaces started down deflection at 6:49:53 UTC, causing A/C pitch down and dive. Elevators started moving up towards neutral position to recover the A/C from the dive at 6:50:09 UTC Elevators moved differentially(Elevators Split) at 6:50:21 UTC for about 3 seconds, then the left elevator started to follow the right elevator followed by another split for 3 seconds, then both elevators started to move towards the neutral position.

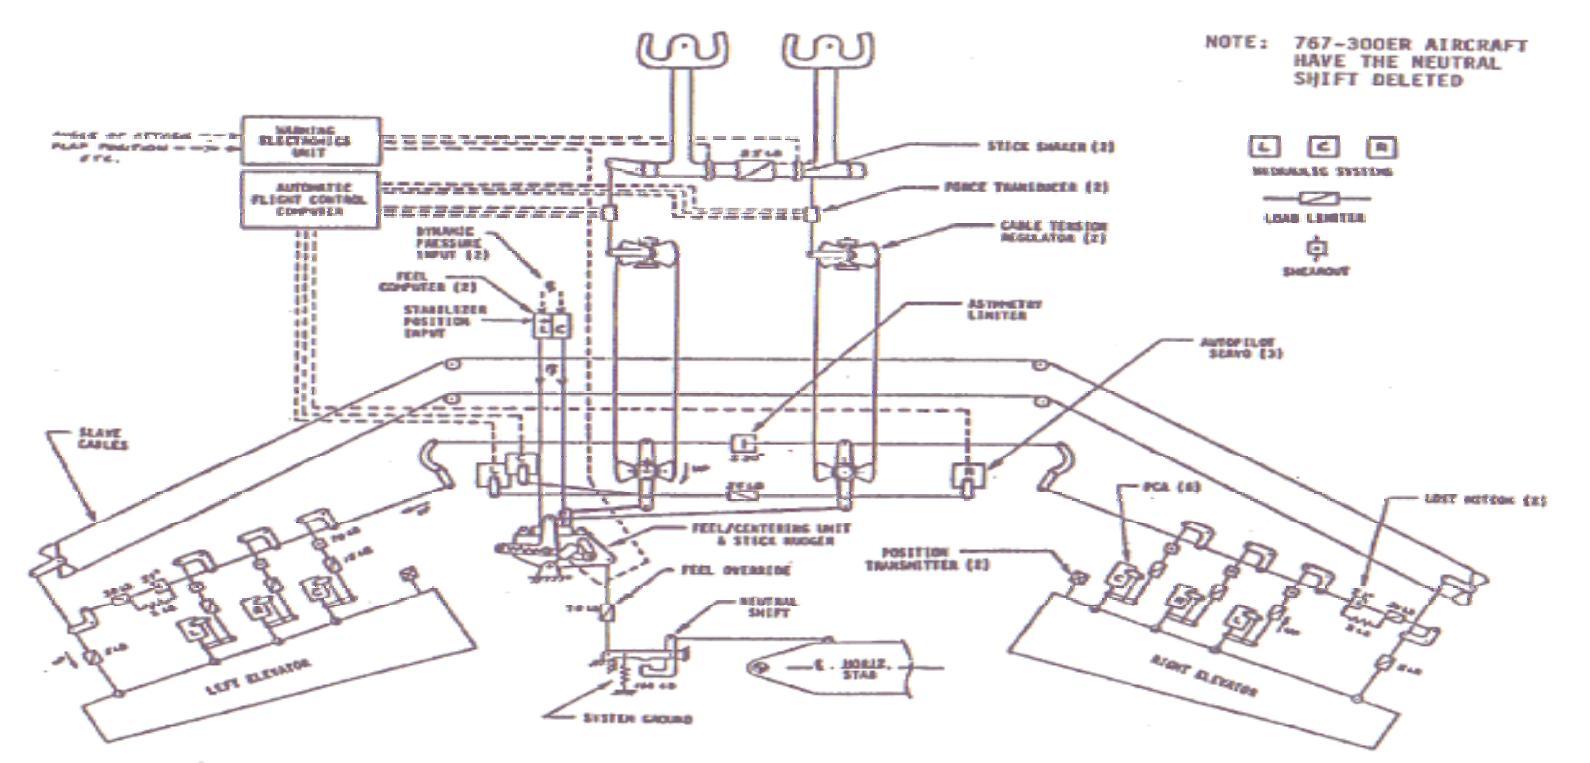
Figure 3.1-3. Elevator Control Schematic

-L.H. Elevator is controllable from the R.H. column at a force 30 lb higher than the normal force at this speed, until column force reaches 100 lb. At this point the two columns are disconnected, the F/O will have no control on the L.H. Elevator

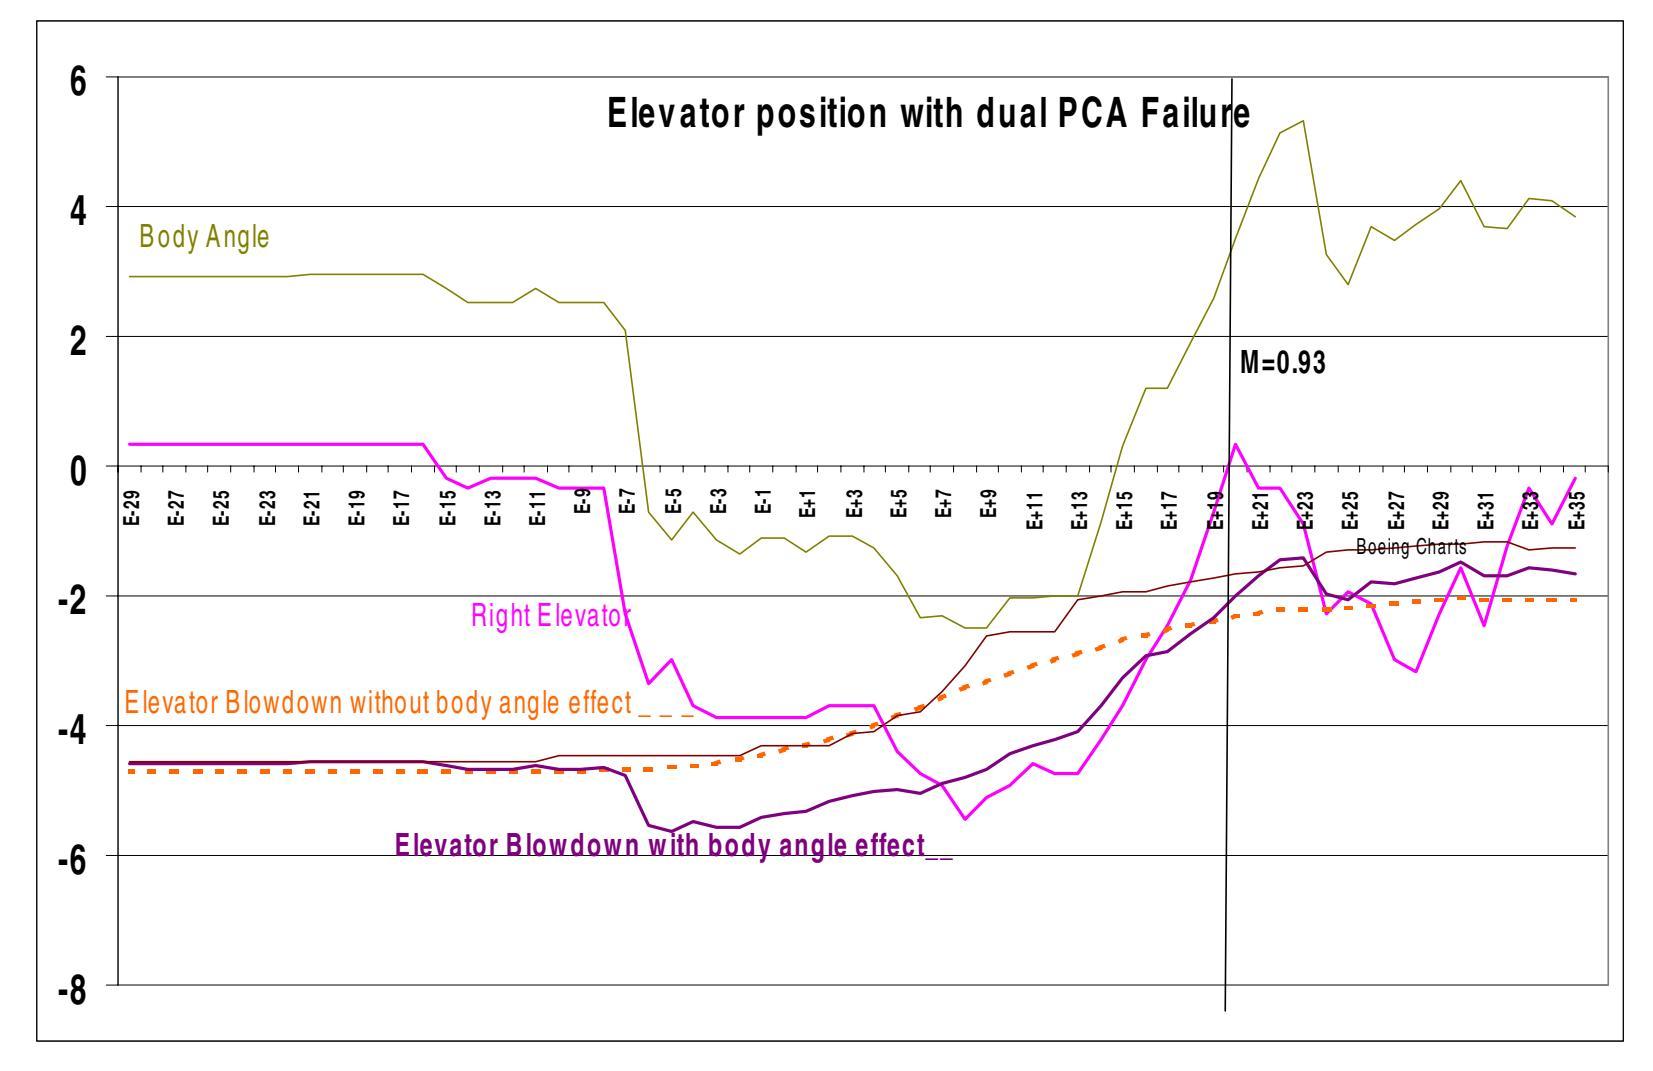
-The results obtained by the three means are not similar and lies within a band of a thickness reaching about 2 degrees -This band is very close to R.H elevator deflection as shown by FDR data
