Egyptian Delegation Presentation

# Flight MS 990 Accident

April 28, 2000

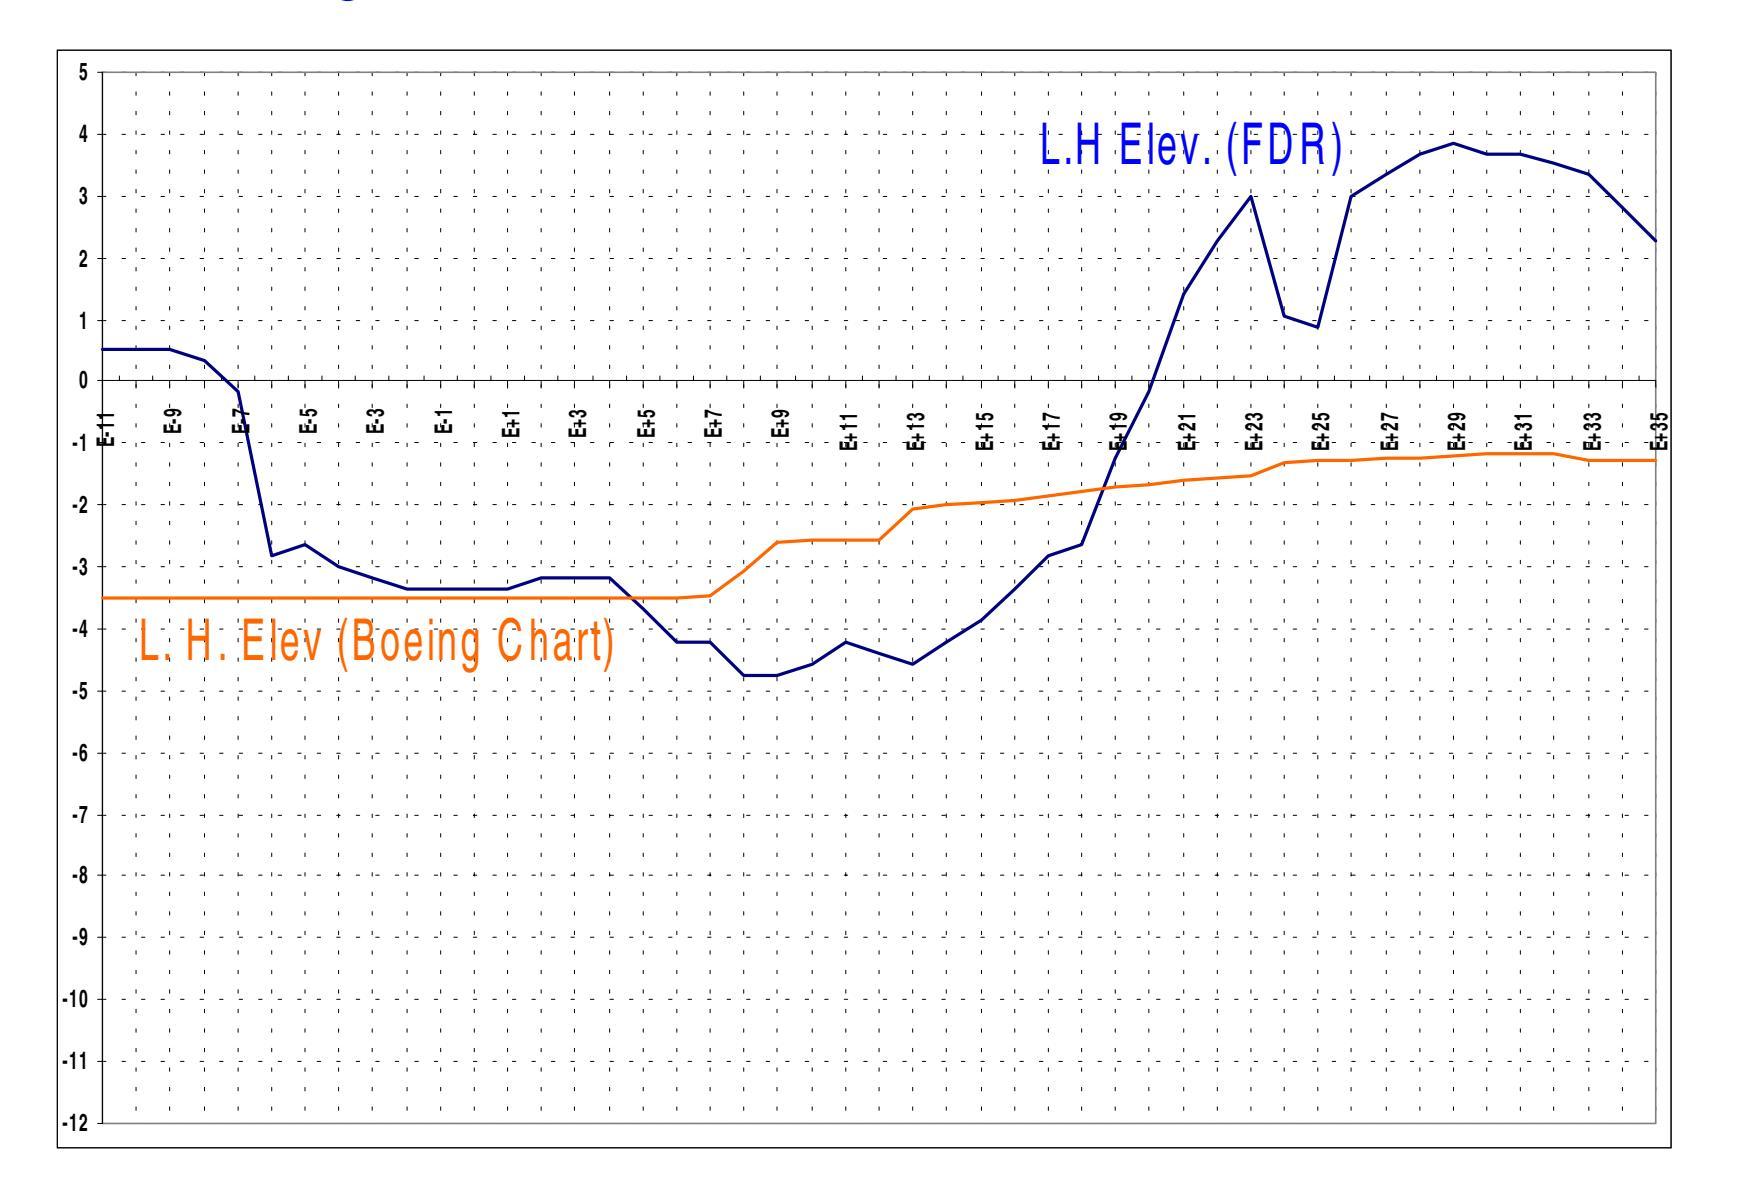
Analysis results as obtained from Boeing Force vs deflection Chart, considering effect of Mach no increase

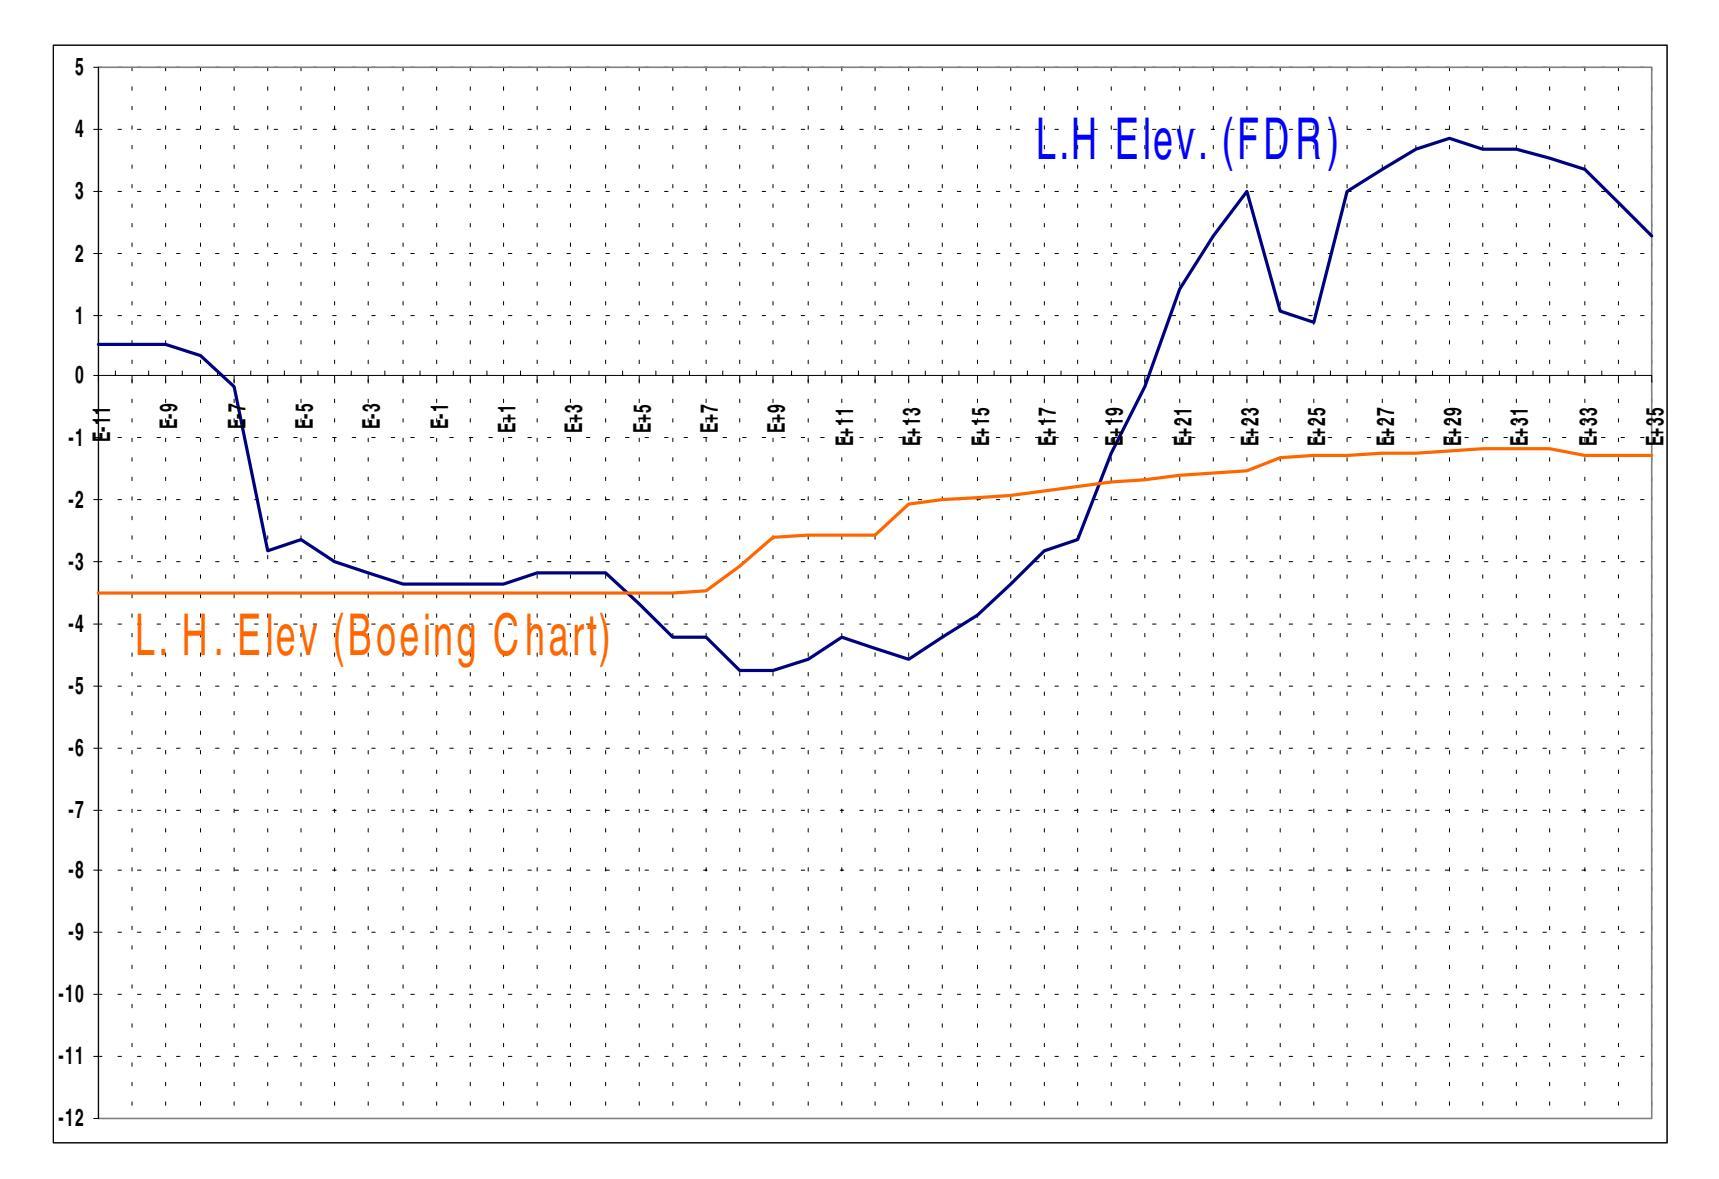
#### L. H. Elevator Note: The left elevator is still under control, pulling the control column aft will result in elevator upward movement

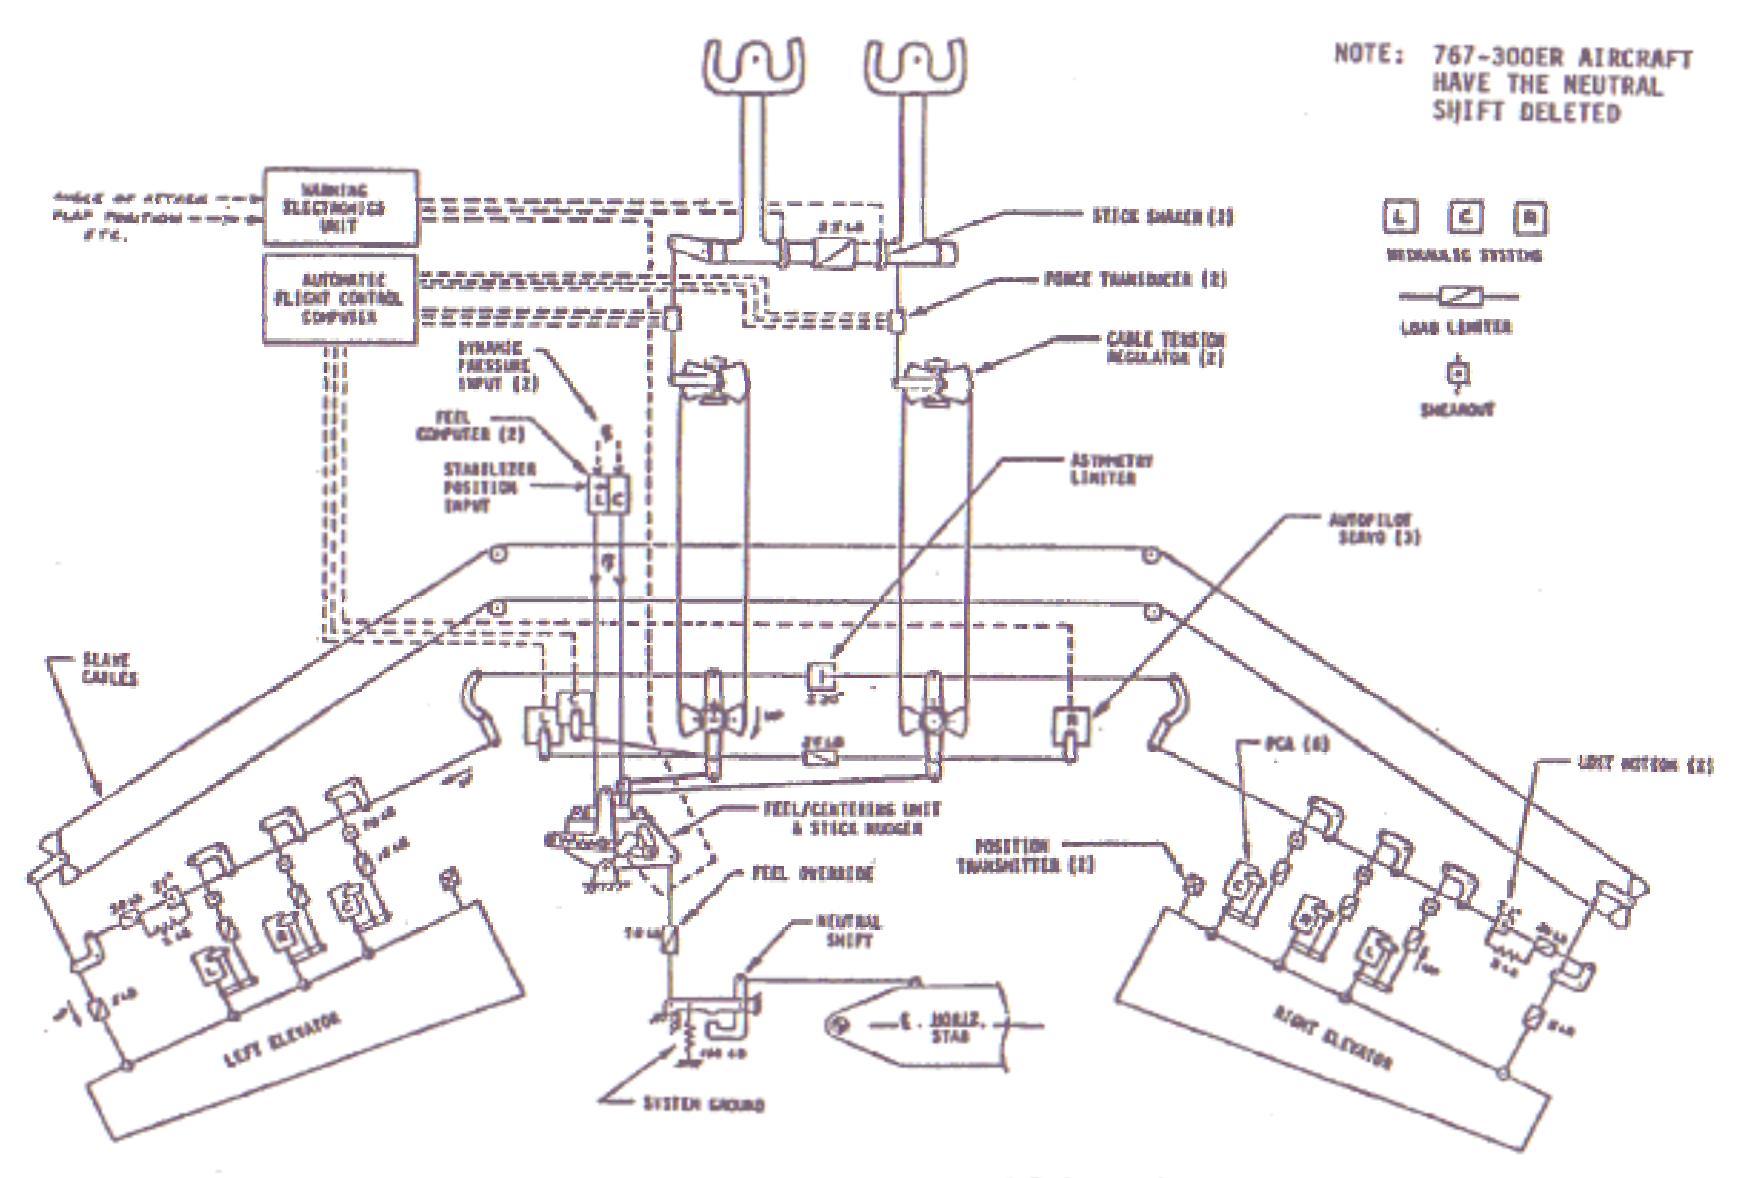
•The internal slide spring cap was found separated from the slide in the servo valve for the right elevator outboard PCA through the rolled rivet. This was the only servo valve in which this cap was found separated.

•The right elevator outboard and center PCA bell crank linkage were sheared as if the bell crank arms were moving to a lower relative angle, while the other three bell cranks (the inboard of the right elevator and two of the left elevator) were sheared as if the bell crank arms were moving to a higher relative angle.

- •Require a cockpit indication in the Boeing 767 that will alert the flight crew to a condition of abnormal PCA operation where in a single fault in the elevator could result in uncommanded elevator movement. Until such a cockpit indication is installed require operators of B767 airplanes to perform daily check of the elevator system as now performed in the 400 hr inspection to isolate faults in the elevator system

- Review the B767 elevator control system design and conduct further examination of the causes of the reported discrepancies found in the elevator actuator bell crank, and

- In conjunction with the Boeing Company develops cockpit crew procedure that will aid the crew during flight in identifying, isolating and negating an uncommanded elevator hard over condition
