Five Year Review Report Northwest Pipe & Casing Clackamas, Oregon

Northwest Pipe and Casing

ORD 980988307 Clackamas, Oregon

September 2006

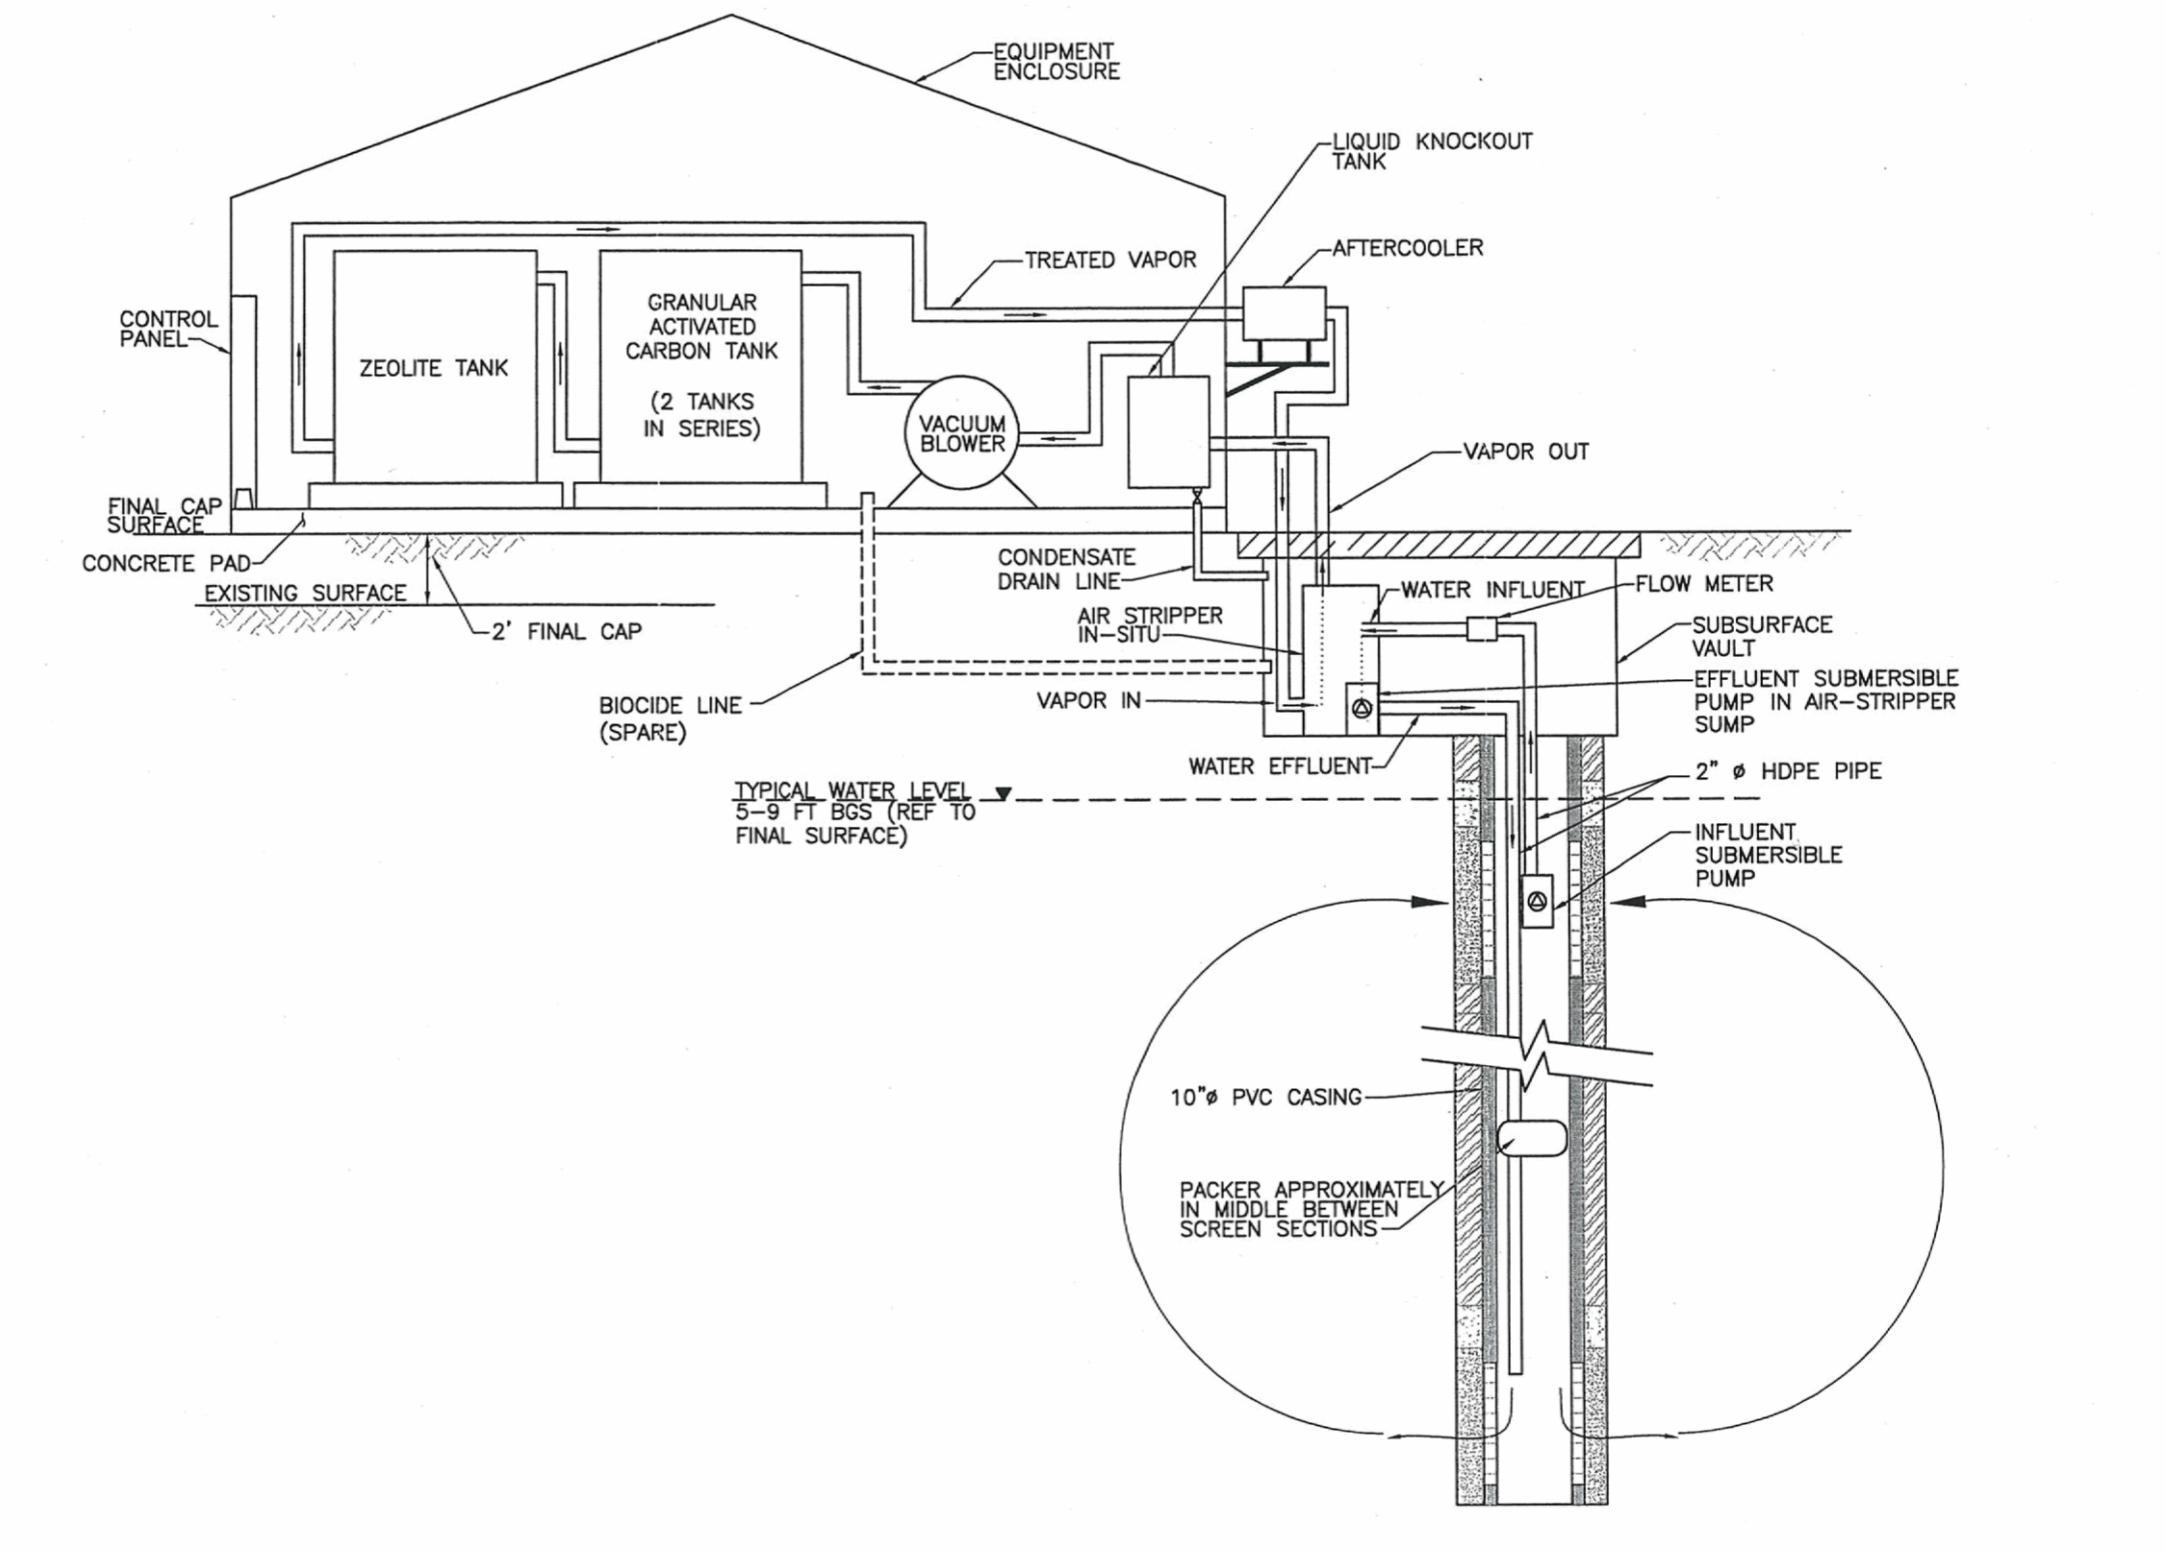
GCW-15 treatment well was determined to be inoperable in July 2005. An inspection revealed the GCW-15 well casing and screen was compromised at a depth of approximately 30 feet bgs due to the failure of the well's inflatable packer (Parametrix 2006b). GCW-15R was constructed in February 2006 to replace GCW-15, and was activated in April 2006.

- The integrity of GCW-15 was compromised due to failure of the well's inflatable packer in July 2005. Review of well construction details and inflatable packer

pressure and placement suggest that the PVC well casing near a threaded joint may have cracked due to pressure induced by the packer. GCW-15 was replaced by GCW-15R in February 2006.
