Completion Report

Squaw Creek Culvert Fish Passage Improvement Project

Squaw Creek, Little Salmon River Subbasin North Central Idaho

February 2008

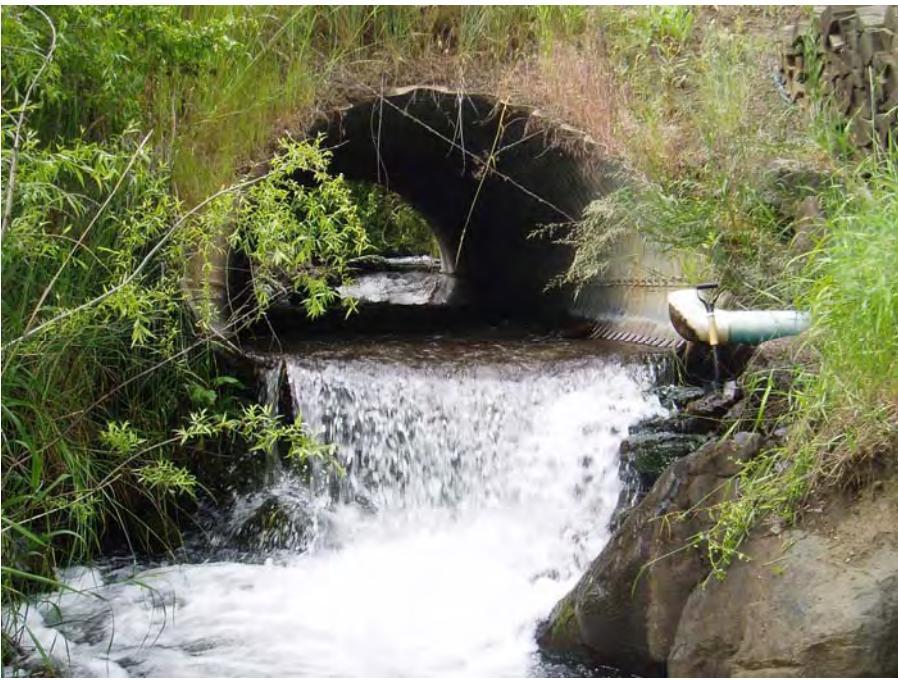
Photograph 1. Squaw Creek culvert downstream side north bank before project construction. Photo by: D. Weigel, Reclamation.

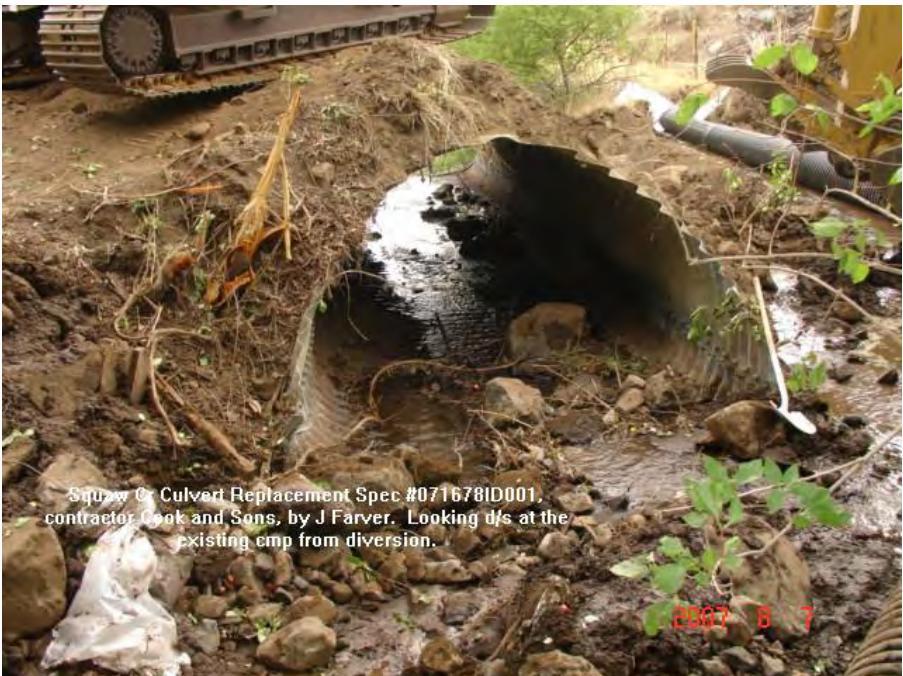
The Squaw Creek diversion is located at stream mile 2.0, and has been in place for an unknown length of time. The existing culvert was a corrugated metal pipe-arch culvert that was 8 feet wide by 6 feet high. The slope in the culvert was approximately 2.6 percent and the culvert was perched 3.5 feet on boulders and other fill material. The existing culvert was replaced with a bottomless arch culvert that will pass the 100-year flood event, sediment, and fish maintaining connected stream habitats for aquatic species. The slope of the streambed invert is approximately 8 percent, constructed with 4-foot diameter boulders and a subsequent well-graded material as part of the streambed matrix. Boulder clusters were added to Papoose Creek to provide fish passage during periods of time water flows in the creek. A concrete retaining wall was constructed on the downstream adjacent landowner's property to block the property from large flood events. The upstream adjacent landowner received a rock retaining wall to retain material from the property's driveway. The rock retaining wall will greatly reduce the amount of material entering the creek. New asphalt was laid to complete the road construction and guardrails were installed to protect automobile traffic over the bottomless arch culvert.

Photograph No. 5. Looking downstream at the existing corrugated metal pipe. Photo by J. Farver.

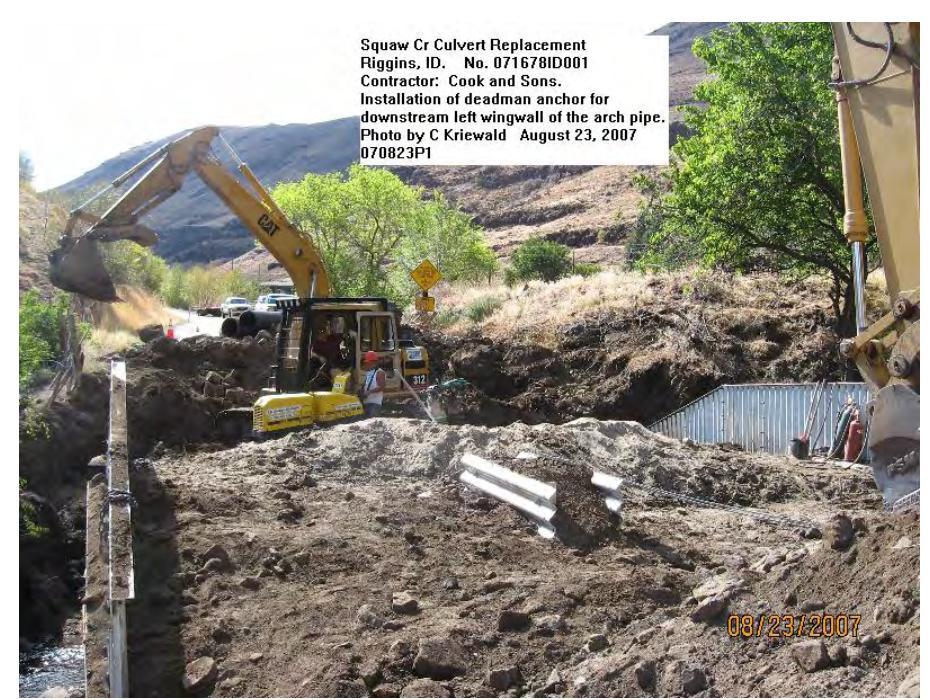
Photograph No. 8. Installation of deadman anchor for downstream left wingwall of arch pipe. Photo by C. Kriewald.

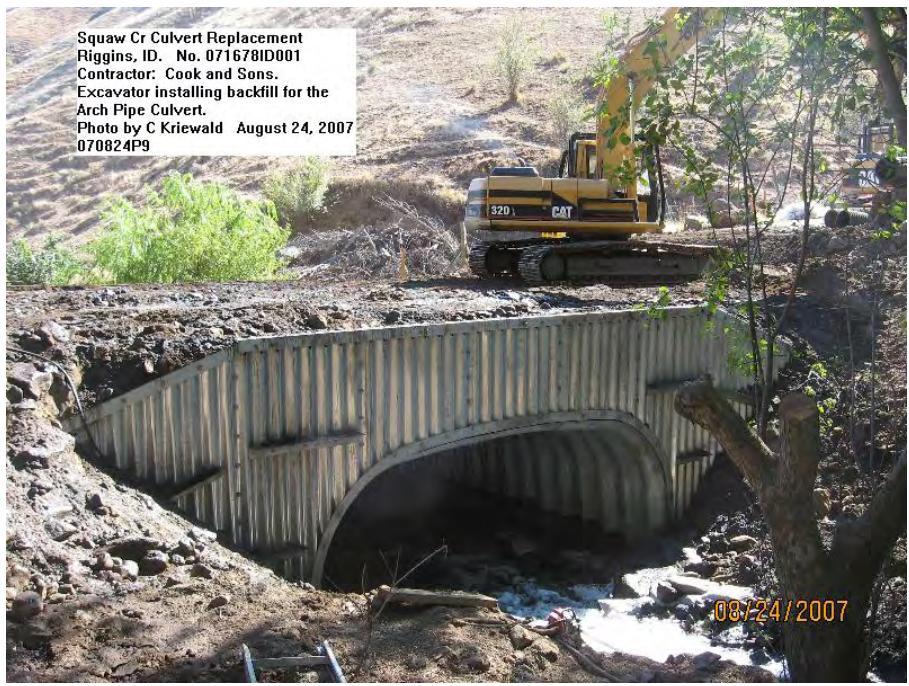
Photograph No. 10. Bottomless arch culvert with wingwalls installed. Photo by C. Kriewald.

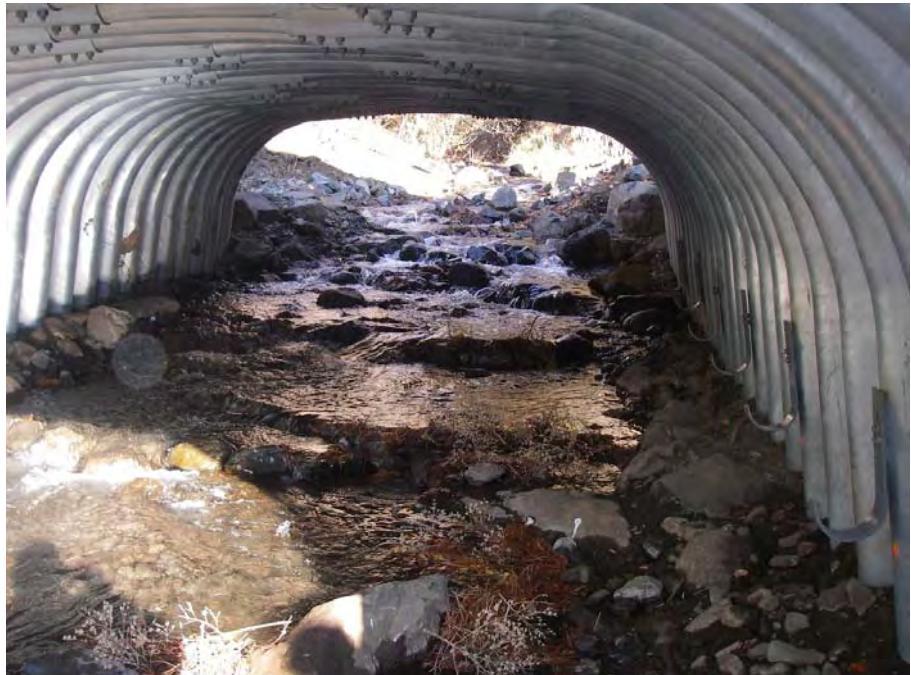
Photograph No. 11. Creek bed inside of the bottomless arch culvert. Photo by J. Chan, Reclamation.

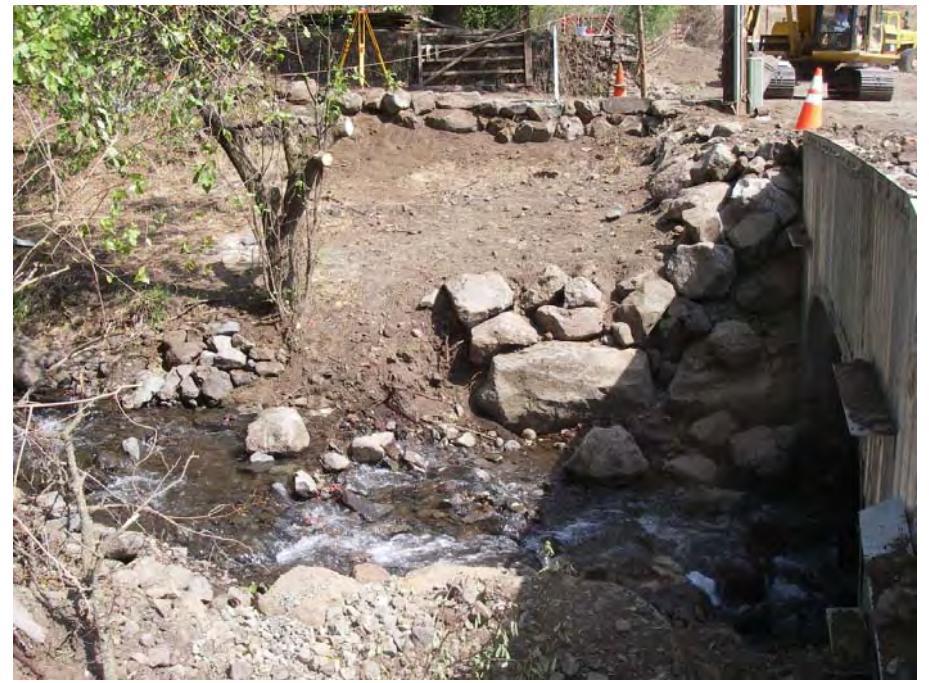
Photograph No. 12. Looking at the upstream side of the bottomless arch culvert showing retaining wall and riprap on creek bank. Property owner's driveway is accessed thru open gate at the top and center of photograph. Photo by J. Chan, Reclamation.

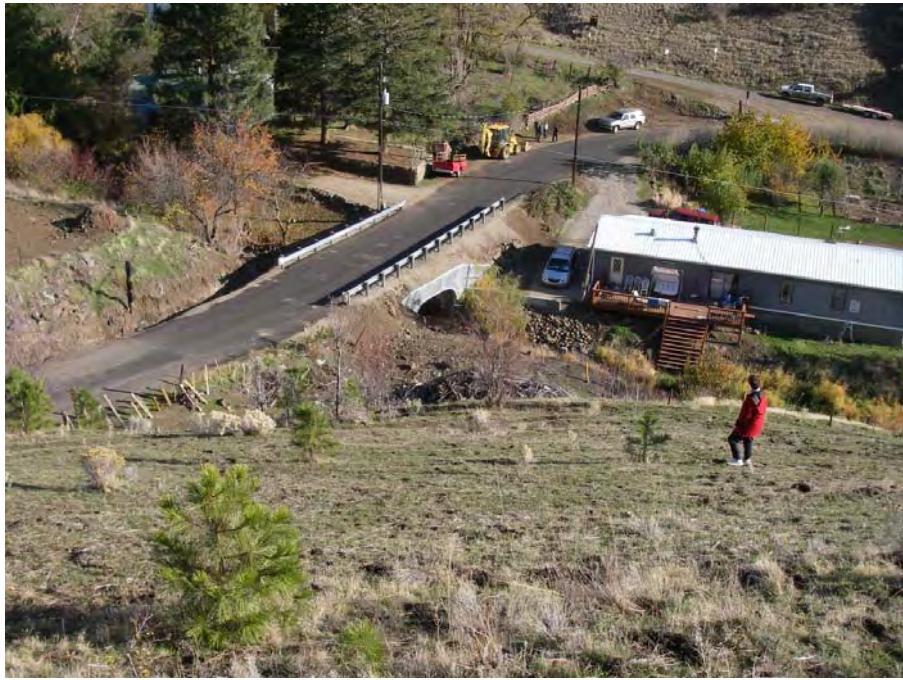
Photograph No. 13. Completion of the project site showing curbing and guardrails installed along the road bed, the bottomless arch culvert covered with road fill and the road re-paved with asphalt. Photo by J. Chan, Reclamation.
