Five Year Review Former Sacramento Army Depot Sacramento, California

Final

December 2001

U.S. Army Corps of Engineers

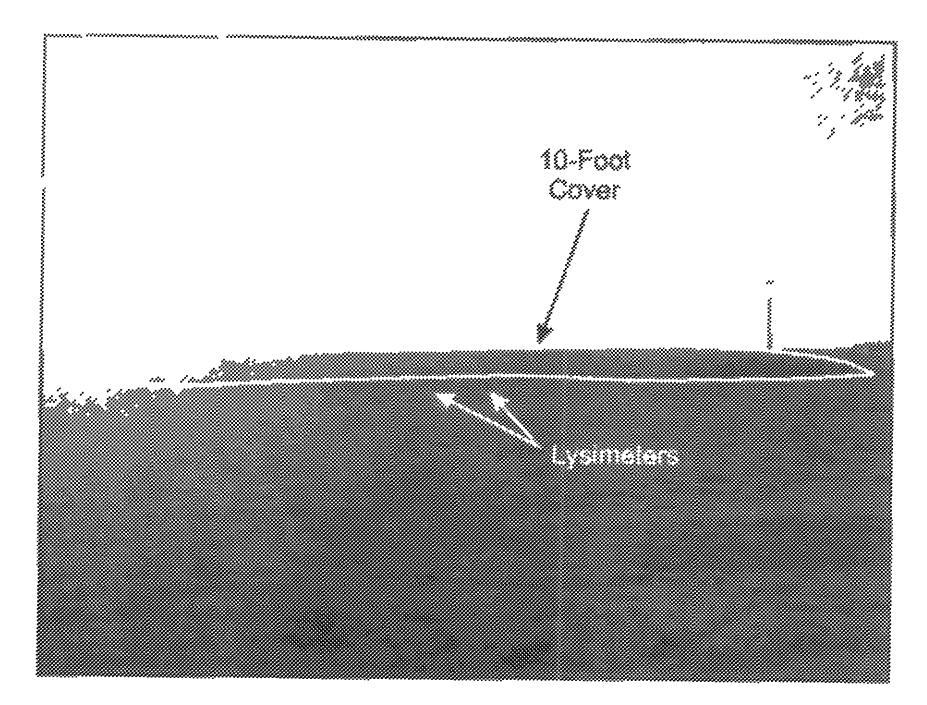
Figure A-1. Previous Location of the South Post Burn Pits and Current Location of Stabilized Material Excavation and Lysimeters
