**BIOLOGICAL ASSESSMENT**  
**APPENDIX II**  
**QUARRY SITE PHOTOS AND DATA FORMS**

## Lower Colorado River Quarries Site Investigation Report

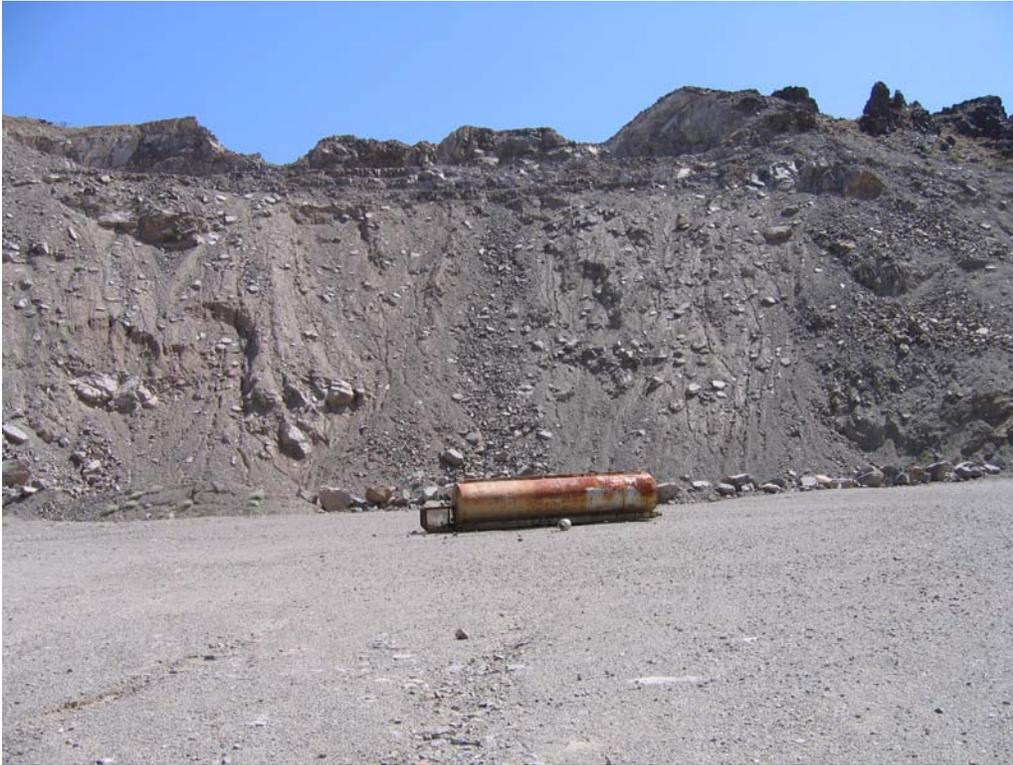
Debris/Vehicles/Hazmat dumping indicators: some dumping along road in + 1 large AST @ quarry site

Agnes Wilson Quarry looking south towards quarry site (Abandoned water tank in foreground)

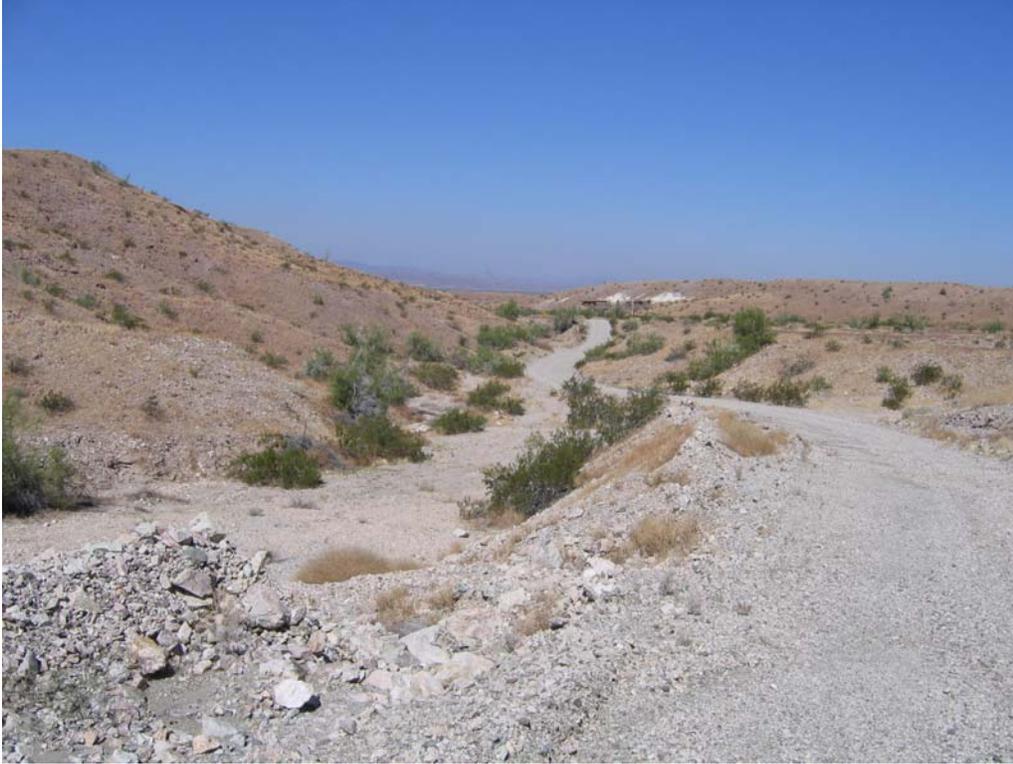
Access Road condition (paved/gravel/dirt/4WD and quality): 4wd, rough gravel, washed out in a few spots  
access not restricted

Cibola (Hart Mine No. 1) wash on west end draining towards west and ROwest

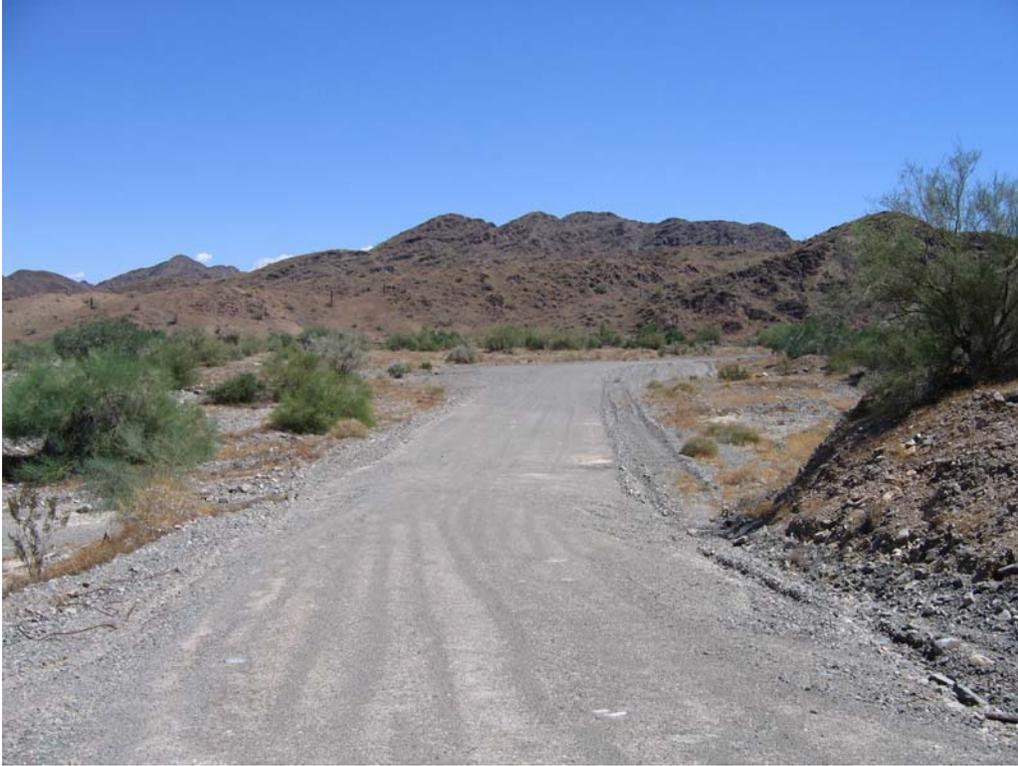
Debris/Vehicles/Hazmat dumping indicators: none @ quarry; tires in wash outside quarry

Ehrenberg Quarry looking east at wash crossing at Right of Way

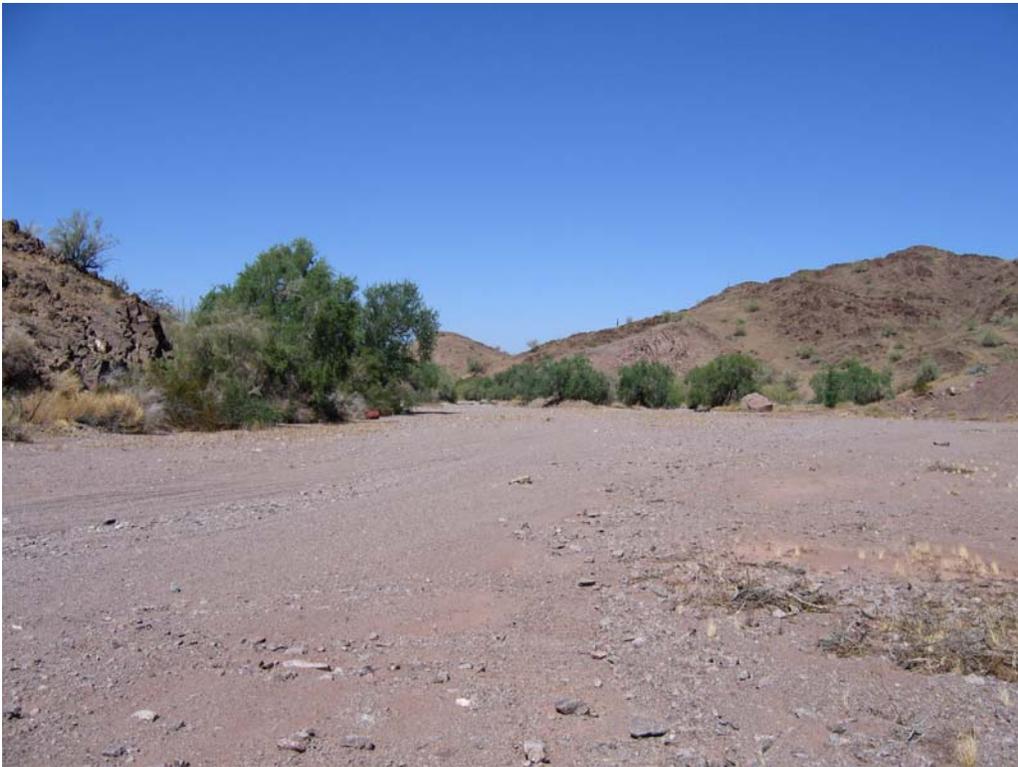
Debris/Vehicles/Hazmat dumping indicators: 1 55 gallon drum in wash adjacent to  
quarry (between E+W Quarries)

La Paz East Quarry looking west towards wash with rusted 55 gallon drum

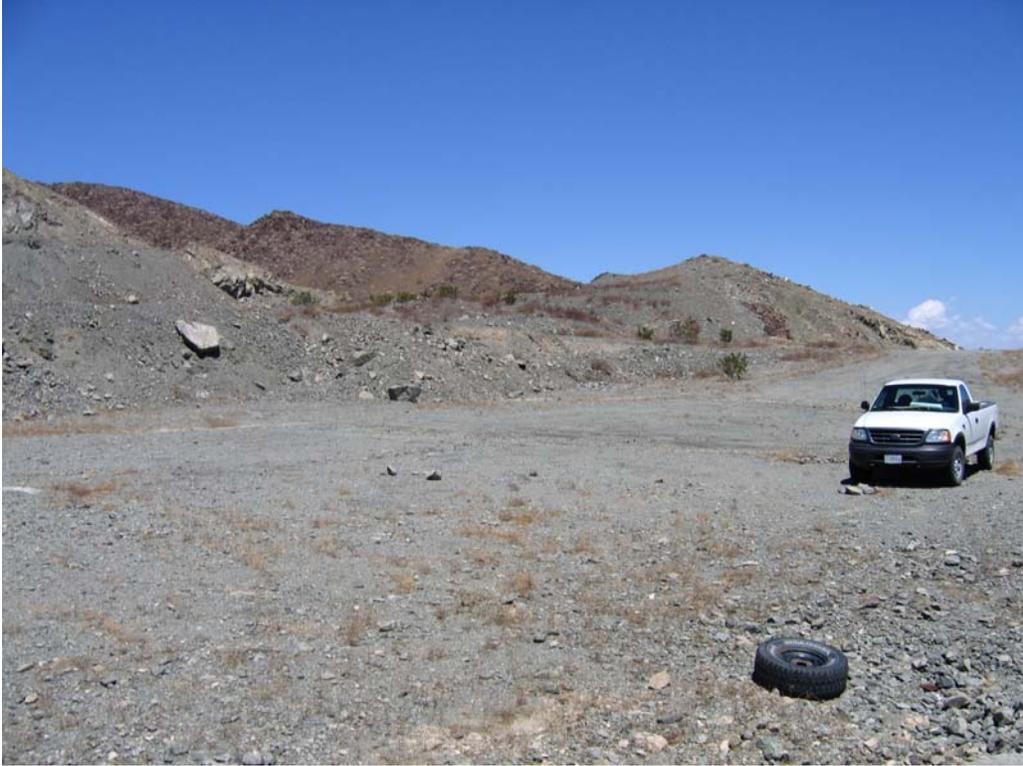
Debris/Vehicles/Hazmat dumping indicators: tires dumped/left @ quarry site  
vehicle + debris

Ripley Quarry east side with debris

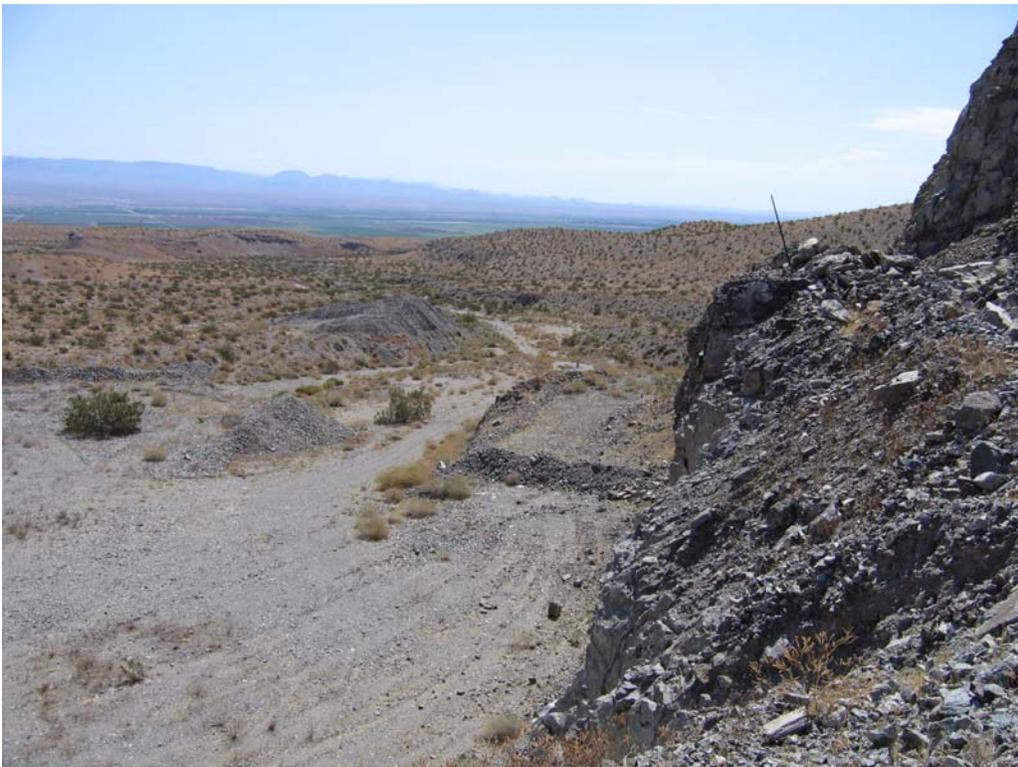
Debris/Vehicles/Hazmat dumping indicators: none @ quarry; abandoned vehicle in wash in ROW

Section 7 looking southeast at wash and ROWest
