Against the Odds—Hottai Ki

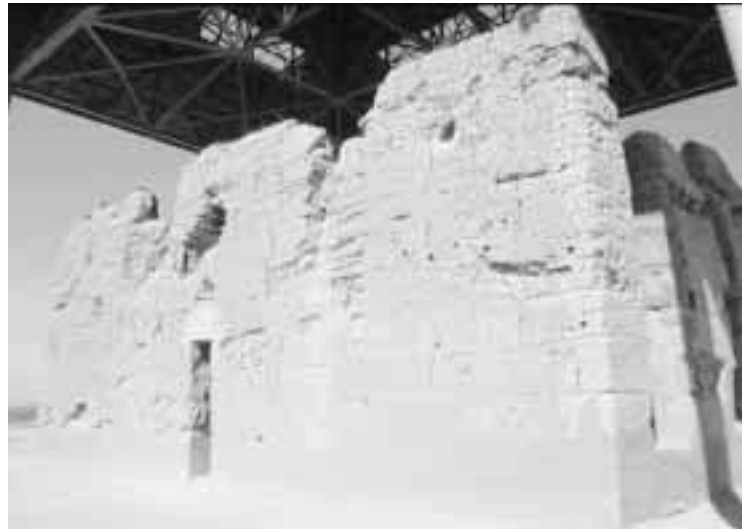
*West elevation,
The Great
House, Casa
Grande ruins.*

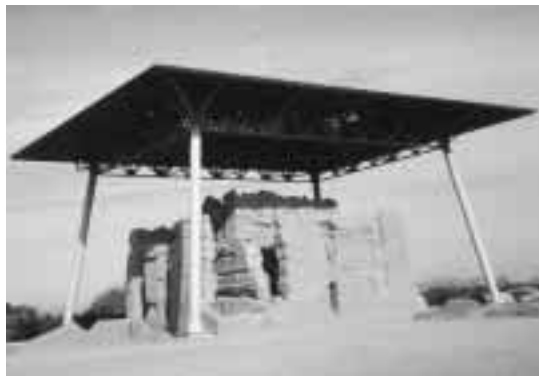
*East elevation,
The Great
House, Casa
Grande ruins.*

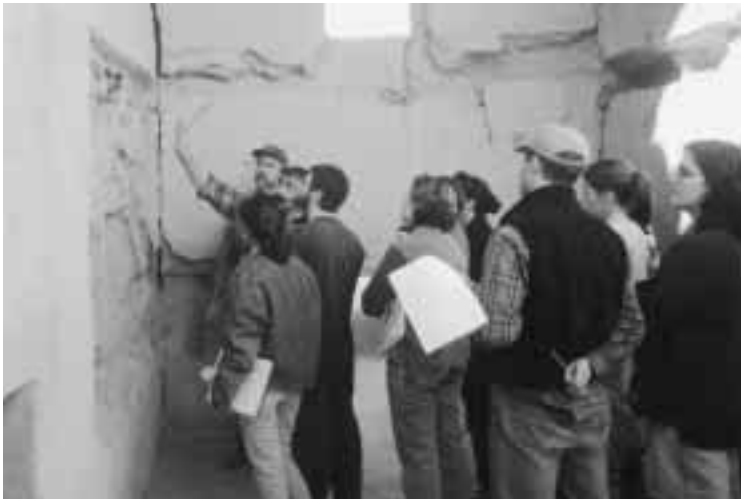
University of
Pennsylvania
1998 Field
School survey-
ing interior walls.

At Casa Grande two concurrent winter field schools documented, surveyed, and assessed conditions evident from surface observations. Students mapped details of conditions across the surfaces, a complete 100%-coverage photo-documentation was accomplished, and an engineering assessment was made. Throughout these campaigns the Arizona State Historic Preservation Officer and staff participated in planning. Analysis sessions were periodically held at the park and at the University; during these forums, participants stood in front of scaled digitized color annotated elevations considering patterns, clues, and other information pertinent to the ruin's condition. Two graduate students undertook thesis topics that involved researching fundamental questions about material, architecture, and deterioration mechanisms. Engineers simultaneously engaged in assessing the structure. In addition, seismic evaluations of the structure in relation to potential earth tremors were made.
