# Materials Solutions for Hydrogen Delivery in Pipelines

Doug Stalheim  
Presenting on Behalf of  
Secat, Inc.  
June 11, 2008

Project ID: PD18

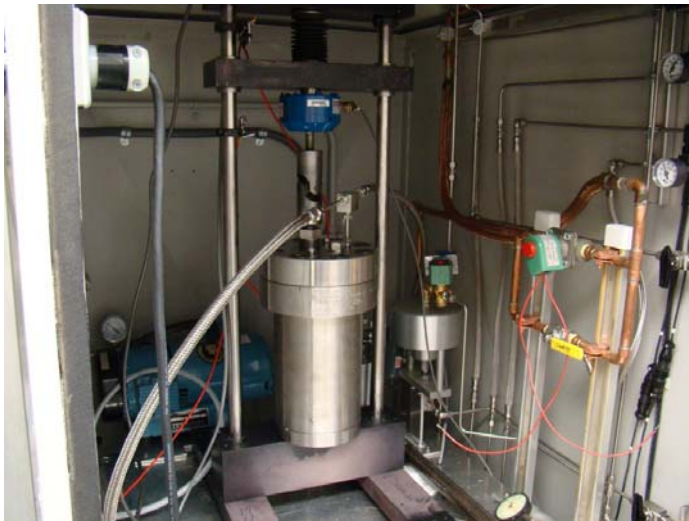
# System for *in-situ* Testing in High Pressure Hydrogen is Now Fully Functional at ORNL

## Key features

- Room temperature gas pressures up to 4800 psi
- Strain rates down to  $1\text{E-}6/\text{sec}$
- Test loads up to 4000 lbs
- Flexible specimen geometry
- Computer-controlled valves and data acquisition

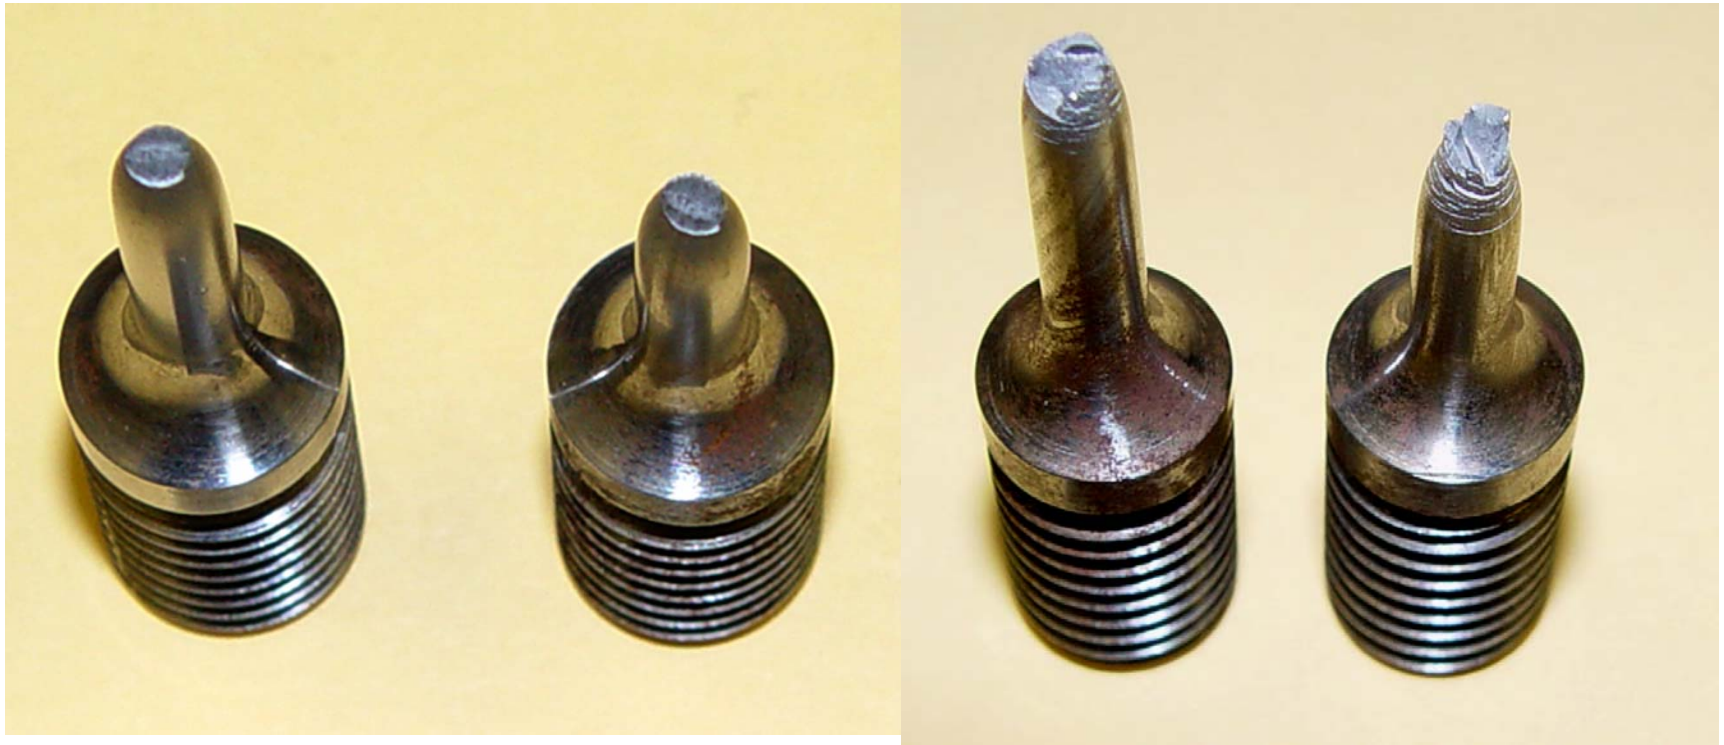
# Fracture Mode of Steel A Changes in the Presence of Hydrogen

**Helium**

Ductile cup and cone fracture

**Hydrogen**

Faceted fracture surface with evidence for multiple secondary cracking

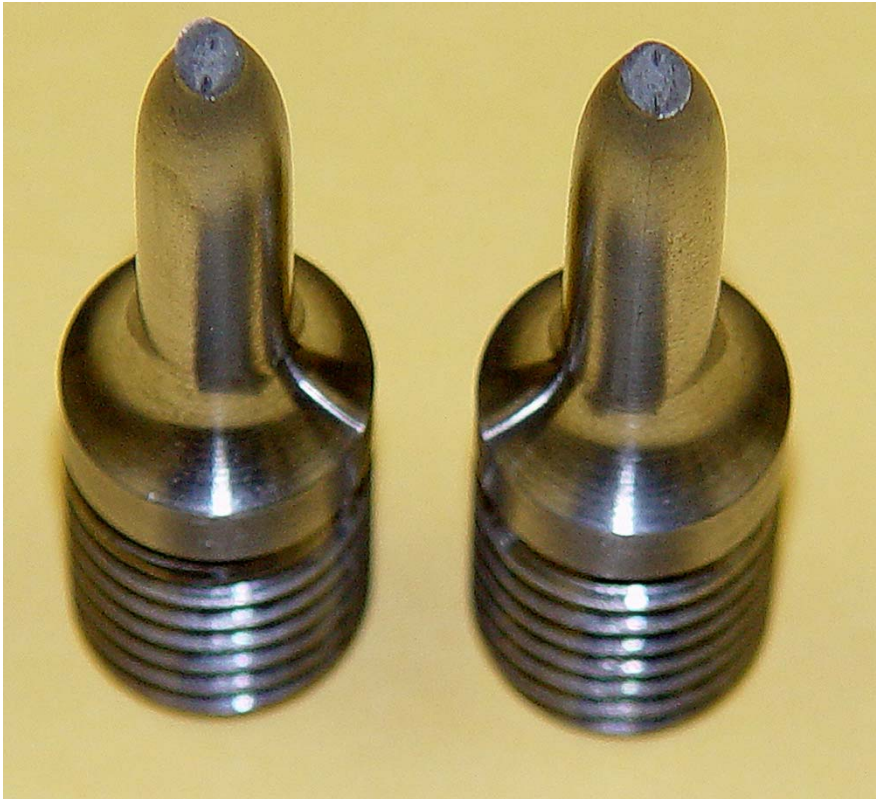
# Fracture Mode of Steel C Also Changes in the Presence of Hydrogen

**Helium**

Ductile cup and cone fracture

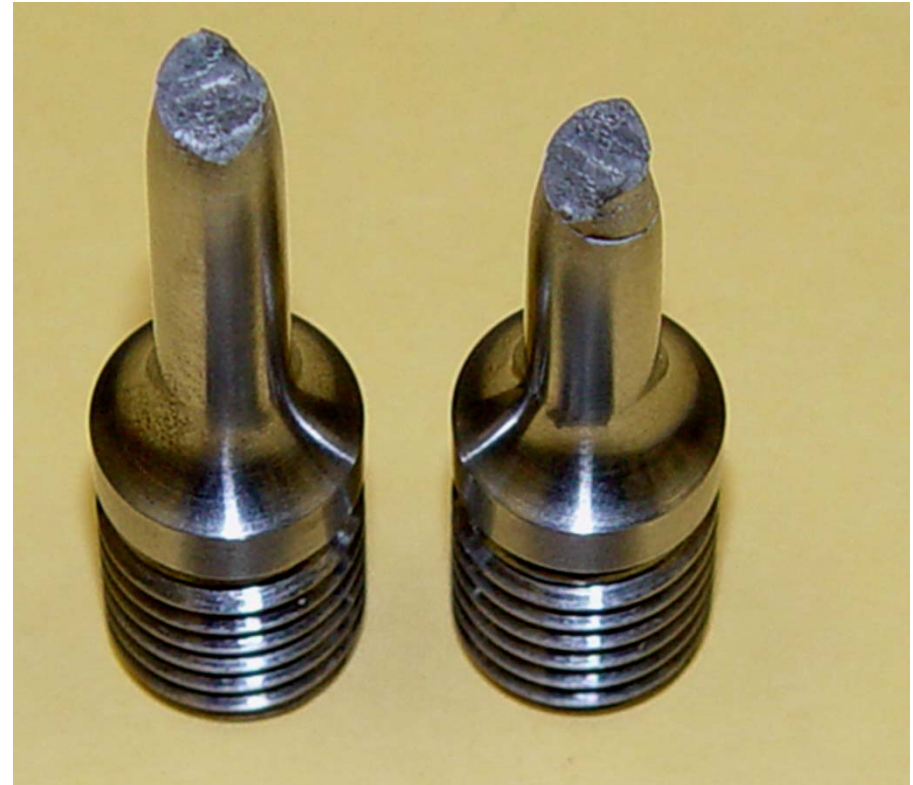
**Hydrogen**

Faceted fracture surface with visible secondary cracking
