# Experimental Results of Structural Health Monitoring of Wind Turbine Blades<sup>\*</sup>

**A 9 meter TX-100 wind turbine blade, developed under a Sandia National Laboratories R&D program, was recently fatigue tested to blade failure at the National Renewable Energy Laboratories, National Wind Technology Center. The fatigue test provided an opportunity to exercise a number of structural health monitoring (SHM) techniques and nondestructive testing (NDT) systems. The SHM systems were provided by teams from NASA Kennedy Space Center, Purdue University and Virginia Tech (VT). The NASA and VT impedance-based SHM systems used separate but similar arrays of Smart Material macro-fiber composite actuators and sensors. Their actuator activation techniques were different. The Purdue SHM setup consisted of several arrays of PCB accelerometers and exercised a variety of passive and active SHM techniques, including virtual and restoring force methods. A commercial off-the-shelf Physical Acoustics Corporation acoustic emission (AE) NDT system gathered blade AE data throughout the test. At a fatigue cycle rate around 1.2 Hertz, and after more than 4,000,000 fatigue cycles, the blade was diagnos

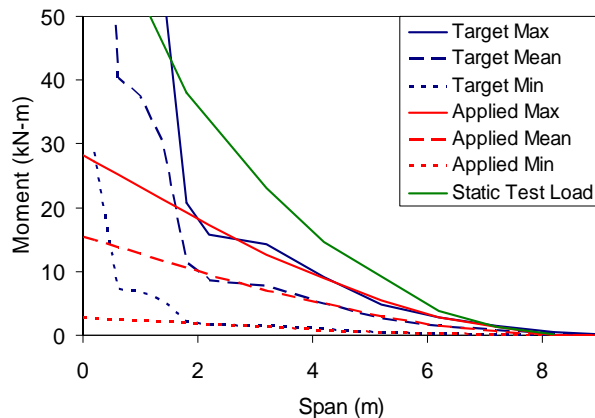
**Figure 3** – Calculated UREX fit of 4-million-cycle target load for TX-100 fatigue test.

31% of that which caused failure in the static test. This load level was predicted to cause failure in 4 million cycles. Starting at 1 million cycles, the load was increased in 10% increments and every 500k cycles thereafter. The target and applied test loads for the first load step and the applied test load for the static test are shown in Figure 3.

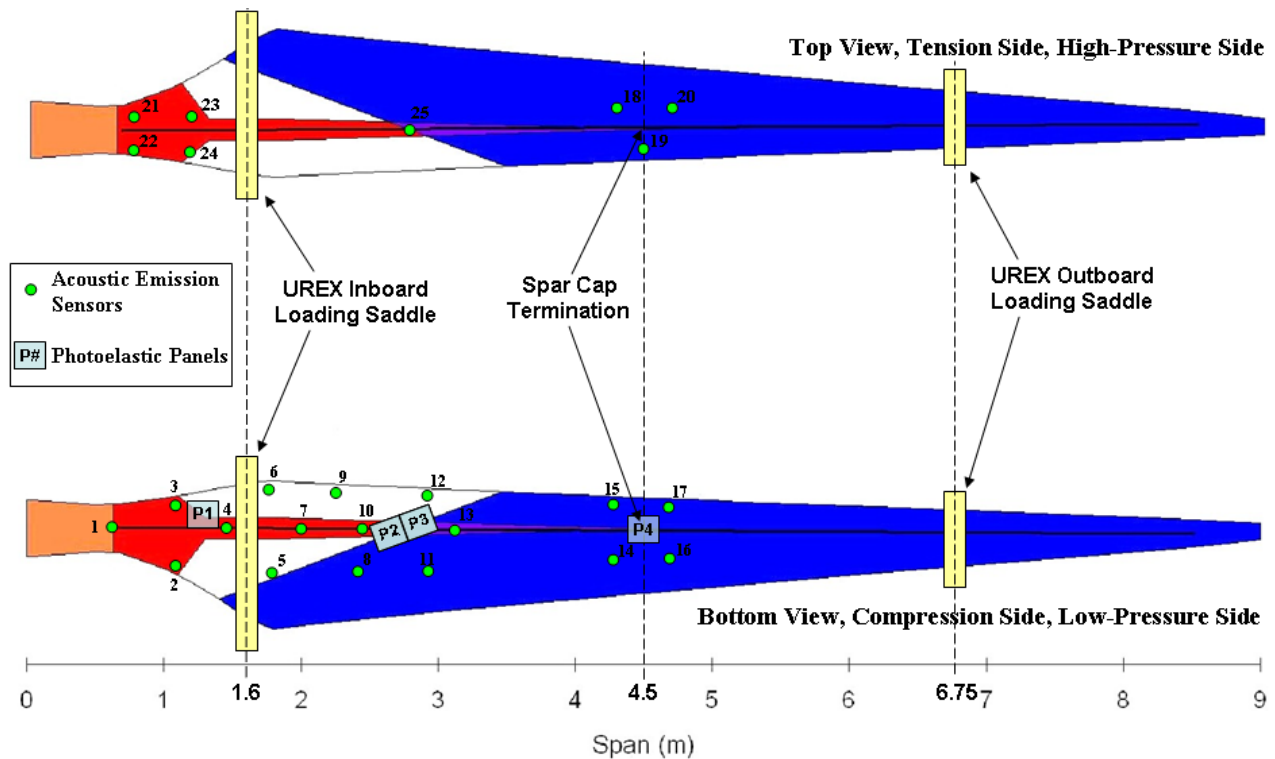
**Figure 5** – Layout of the acoustic emission NDT sensors and photoelastic panels.

Twenty-four PAC Model R6I AE sensors were mounted on the blade over critical areas and interfaces inside the blade. Because of the diverse material characteristics, orientations and interfaces of the internal components in the blade the acoustic velocity was very anisotropic. The sensor layout shown in Figure 5 was determined on site after the acoustic characteristics had been measured. (Sensor #25 was not used during the fatigue test.)

Four 8-inch by 8-inch photoelastic panels were applied on the blade surface over key locations in the blade as shown in Figure 5. Three of the four photoelastic panels are visible in the photos shown in Figure 10. The photoelastic panels were used to provide a qualitative evaluation of the load/strain paths.

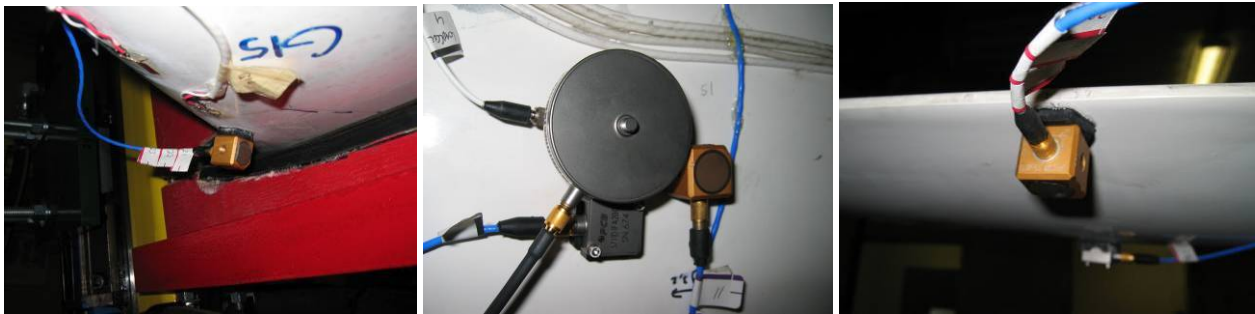
**Figure 7** – Photos of some of the Purdue SHM instrumentation.

Sensor placement was determined ahead of time using the results from pre-testing on a 15-foot cantilevered helicopter rotor blade recently erected at the Herrick Laboratories at Purdue University.<sup>32</sup> An array of high sensitivity triaxial accelerometers, low-frequency capacitive accelerometers, and piezoelectric actuators with force sensors was distributed over the surface of the blade to monitor the loading and blade damage. A triaxial accelerometer at the tip was used to measure the tip deflection in the flap, lead-lag, and root-tip directions throughout the test. Prior to the start of the fatigue test, a modal analysis of the blade in the flap-wise direction was performed. The SHM approach implemented the restoring force method, a passive structural health monitoring algorithm, using 4-each PCB 3711D1FA20G and 4-each PCB 3711D1FA50G triaxial accelerometers. The method of virtual forces, transmissibility and other time-frequency analysis techniques, active structural health monitoring algorithms, was also applied with 4-each PCB 712A02 actuators, 4-each PCB 208C01 force sensors and 4-each PCB 356B18 triaxial accelerometers. The Purdue test team also recorded passive response measurements throughout the test when the blade was at fatigue load. A few photos of the Purdue SHM setup are shown in Figure 7. More details of the Purdue instrumentation setup are given in reference 33.

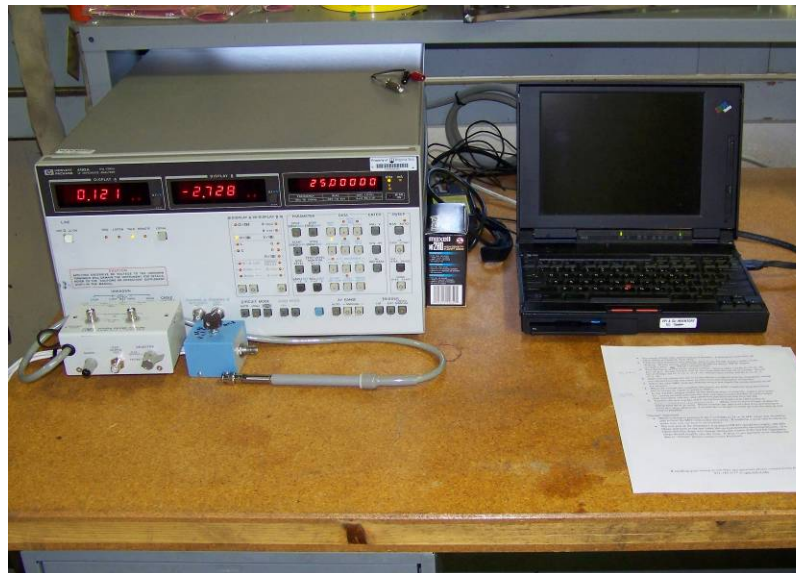
**Figure 8** – Setup of the Virginia Tech SHM instrumentaton.

seen in Figure 8. Initially for this test it was desired to use an Analog Devices, Inc., AD5933 Impedance to Digital Converter integrated circuit to measure the impedance. Unfortunately, problems arose getting the AD5933 to produce acceptable real impedance results so an Agilent HP4192A impedance analyzer was used in its place. Preliminary tests back at VT on a CX-100 wind turbine blade section showed that using MFC sensors on the blade in place of PZTs and mounting the MFCs on the outside of the blade instead of the inside caused less structural information to show up in the impedance, but damage was still detected. The HP4192A was shipped to NWTC for the fatigue test, along with a laptop running Piezoelectric Resonance Analysis Program (PRAP) version 2.1

software to control the impedance analyzer and record data. The switchbox (the blue box shown in Figure 8) was built so that all six MFCs could be connected to the impedance analyzer simultaneously, and then one could be selected at a time to be the input. This greatly simplified the routine for collecting impedance data.

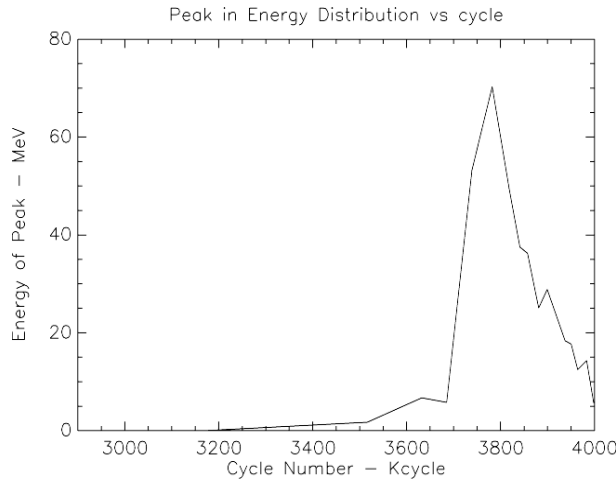
**Figure 13** – Peak acoustic emission energy versus cycle count.

the acoustic energy generation rate in MeV/cycle. For most of the test, this rate was less than 0.01-MeV per cycle. At the point of peak damage, this rate went up to 30 MeV per cycle. See Figure 13 and Figure 14.

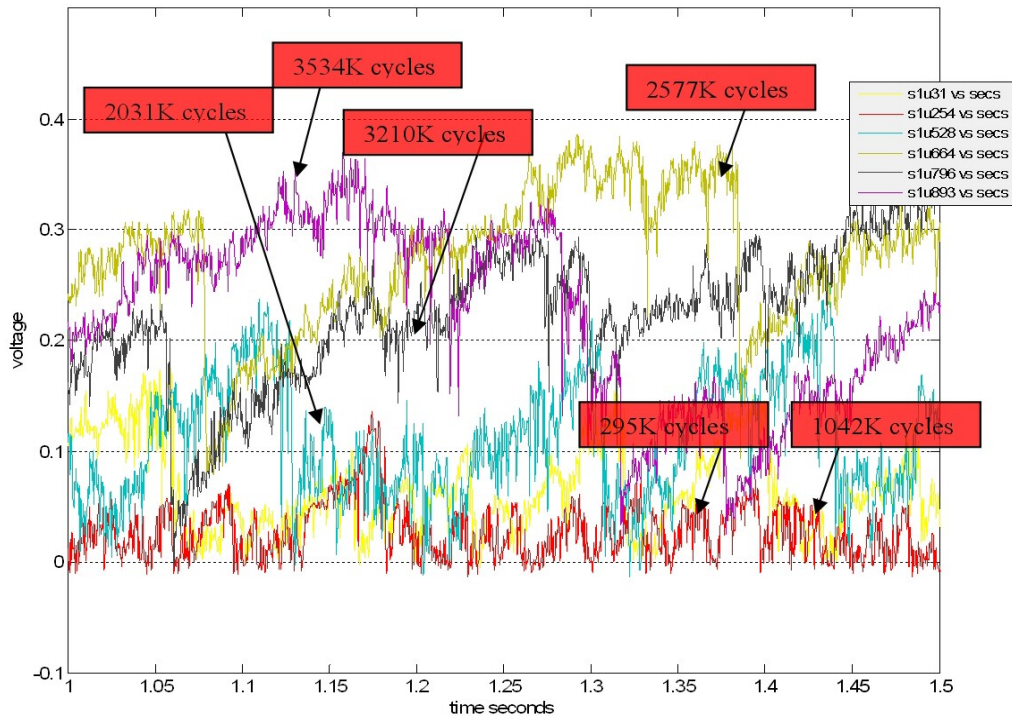
**Figure 15** – Plots showing the increase in CH1 response as the fatigue cycles increased from 295 kilocycles to 3,534 kilocycles.
