CONSTRUCTION OF BRIDGE DECKS WITH PRECAST, PRESTRESSED CONCRETE DECK PLANKS

PHYSICAL RESEARCH REPORT NO. 139
APRIL 2002

Illinois Department of Transportation

**CONSTRUCTION OF
BRIDGE DECKS WITH
PRECAST, PRESTRESSED
CONCRETE
DECK PLANKS**

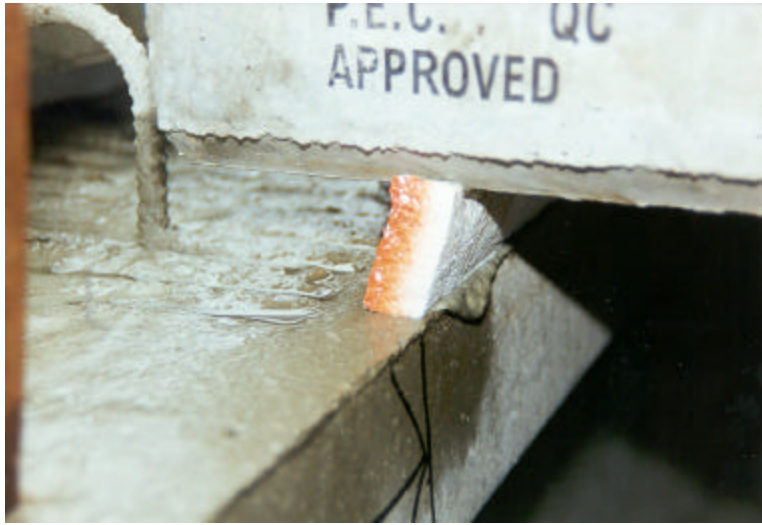
The method of resting the deck planks on the beams also changed. For the 1999 and 2000 construction contracts, leveling jacks were inserted in the plank during fabrication. The leveling screws placed in the jacks allowed the plank to be adjusted to the proper fillet height when planks were seated on the beams. Before planks were seated, polystyrene strips were placed underneath the planks. The polystyrene was to act as a dam for the concrete poured between the planks, which came up underneath the edges of the planks (see Photo 1).

Photo 1. PPC deck plank seated on polystyrene (July 1999 – District 6)

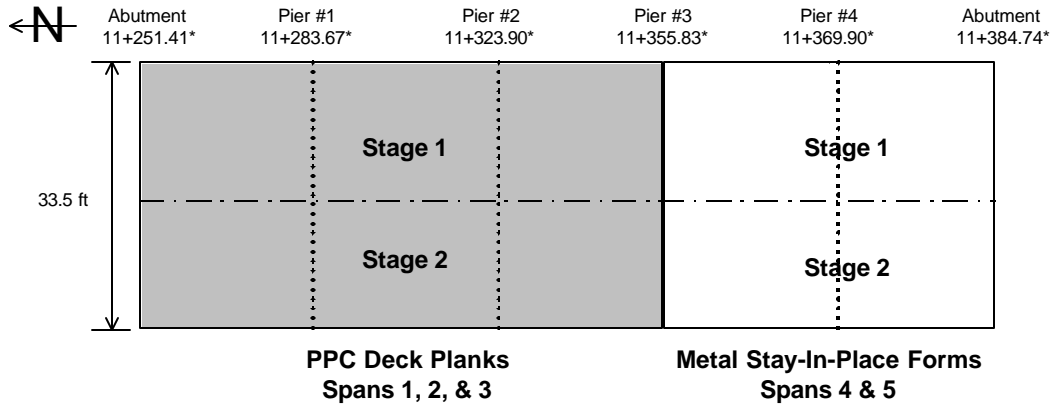
Deck planks were fabricated first for the bridge in District 8. This bridge is located at the Jersey – Greene County line, approximately 6.5 miles south of Eldred, Illinois. The District 8 bridge (Structure No. 042-0009) carries Hillview-Eldred Road over Macoupin Creek. The project involved replacement of the concrete bridge deck, bearing, bridge approach pavements and guardrail, and repairs to the beams and slopewalls. The approach roadways were resurfaced to provide a transition to the new bridge deck and approach pavement. Three spans consist of riveted plate girders and two spans consist of wide flange beams. The new deck incorporated 3-inch thick PPC deck planks in Spans 1, 2 and 3 and metal stay-in-place forms in Spans 4 and 5 (see Figure 1).

Figure 1
District 8 PPC Deck Plank Bridge
 Jersey-Greene County
 Structure No. 042-0009
 (Hillview-Eldred Road over Macoupin Creek)

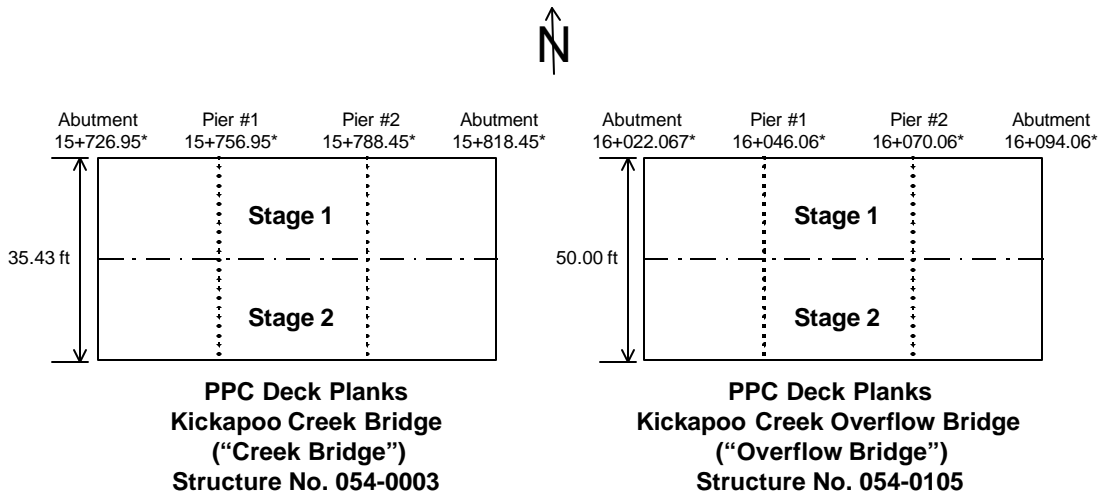
Figure 2
District 6 PPC Deck Plank Bridges
 Logan County
 (IL 10 & 121 over Kickapoo Creek and Kickapoo Creek Overflow)

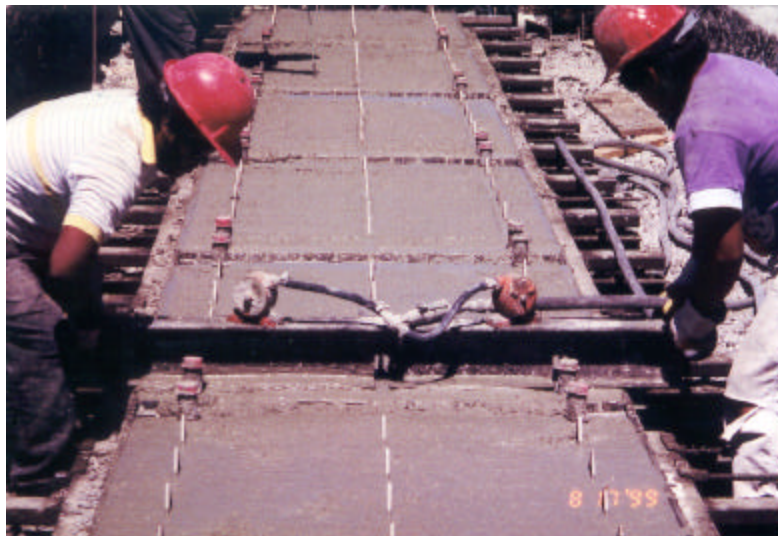
The PPC deck planks for both projects were fabricated at the Prestress Engineering Corporation (PEC) Blackstone production plant. Planks were manufactured according to the applicable requirements of Section 504 of the *Illinois Department of Transportation Standard Specifications for Road and Bridge Construction (January 1997)*, and the contracts' special provisions. Casting beds were set up for a lot size of 8 planks, each 4 feet wide and 5 to 6 feet long. Eleven prestressed strands were placed in headers with slots designed for individual strands. The planks were also reinforced with wire mesh. Leveling jack inserts were imbedded into the planks to allow for fillet height adjustment during deck plank seating. The surface of the plank lot was leveled off with a vibratory screed, as shown in Photo 2. Laborers then hand-finished and tined the surface.

Photo 2. Vibratory Screed

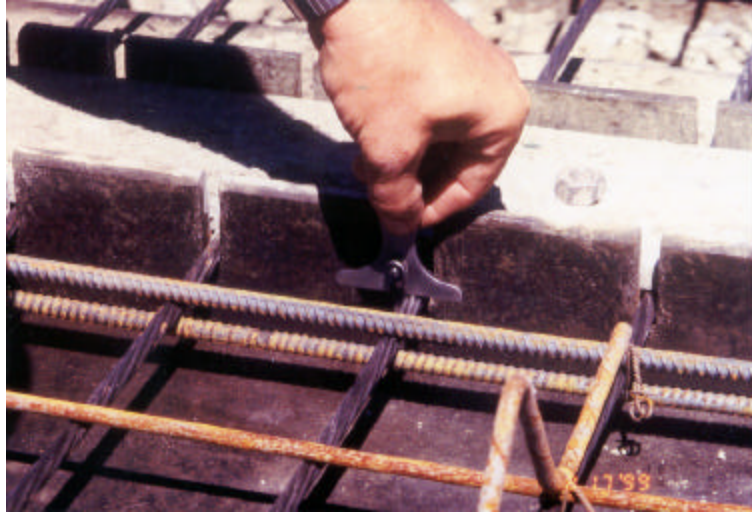
All planks were closely monitored for proper vertical and horizontal locations of the strands. Every strand for every plank was measured on the bed prior to the pour so that it could be adjusted before the pour. If the thickness of the plank was more than $\pm 1/16$ inch from the target, the vertical strand placement was out of tolerance. One deck plank out of every lot (8 planks) was checked for strand slippage, as shown in Photo 3. If the slippage was greater than the allowable measurement, the entire lot of eight planks was rejected.

Photo 3. Checking vertical location of strand with micrometer

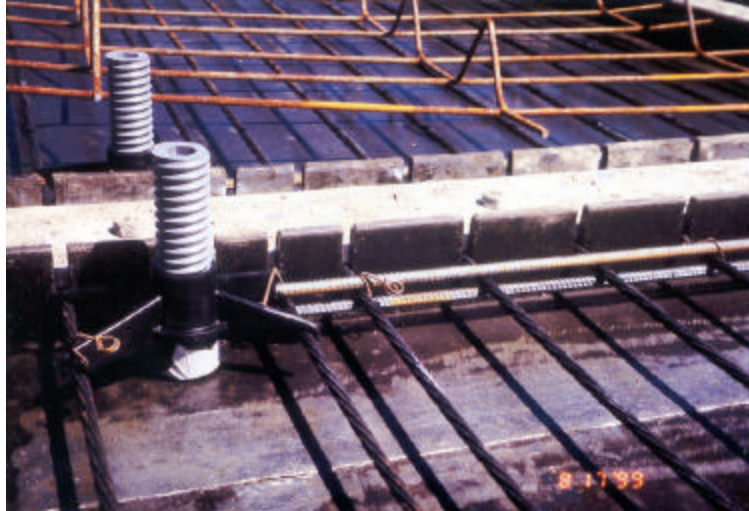
PEC developed a solution to the cracking by adding #3 reinforcing bars above and below the strands, 1.5 inches from each end of the plank, as seen in Photo 4. While the bars reduced a number of the cracks, a great number of planks were still rejected due to hairline cracks.

Photo 4. #3 rebar above and below strands

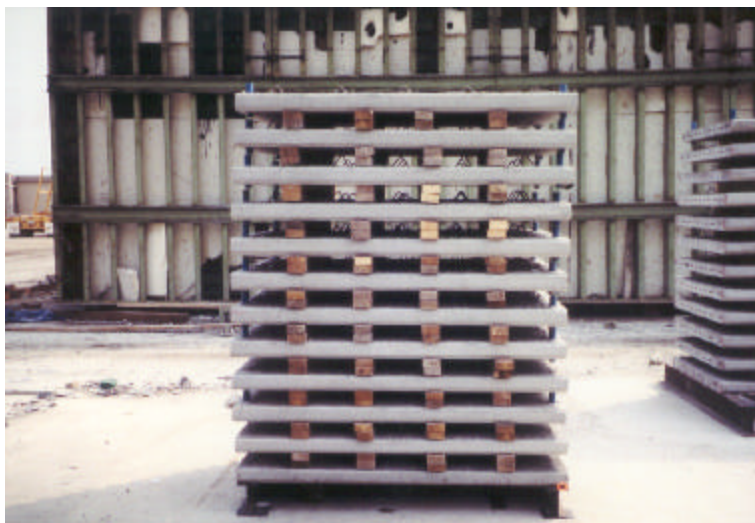
Previously rejected planks were grouped in lots of 10 according to similar cracking patterns. Out of every lot of 10, the IDOT inspector randomly selected one plank as the test plank. All strands on the test plank were cut flush at the ends of the plank. The test planks were set on steel I-beams to ensure flat, straight bearing. Three inches of each edge of the plank rested on the I-beams to simulate the bearing of the structure. The dunnage used on top of the test plank was 2-inch by 4-inch lumber. Two 2-inch by 4-inch pieces were stacked and placed in four locations on top of the test plank. The 2-inch by 4-inch pieces at the ends were placed no less than nine inches from the end of the plank. For the 3-inch thick planks, eleven planks were carefully stacked on top of the test plank with dunnage placed between each of the eleven planks. The eleven planks and dunnage weighed approximately 9900 lb. For the 3.5-inch thick planks, thirteen planks and the dunnage, weighing approximately 11,700 lb., were stacked on the test plank. Photo 5 shows the load test in progress.

Photo 5. Load Test

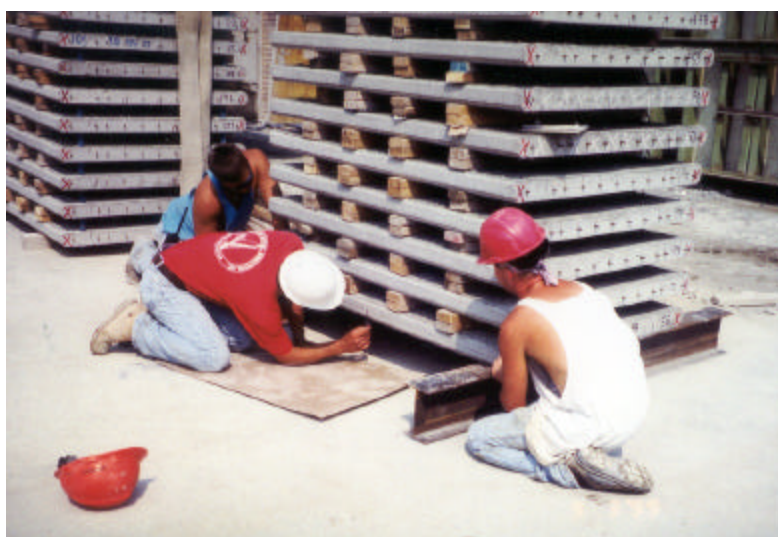
Before loading the test plank, lines were marked on each end of the test plank at mid-depth. The center of the length of the plank was marked with a vertical line. A string line was pulled tight on the mid-depth marks at each end. At the center of the length of the plank, a horizontal line was marked on the vertical line for a straight-line reference. After the test plank was loaded, a string line was held on the end mid-depth lines and pulled tight. The distance from the horizontal line at the center of the plank to the string line was measured and recorded as the deflection, as shown in Photo 6. The load remained in place for 24 hours.

Photo 6. Checking deflection with stringline

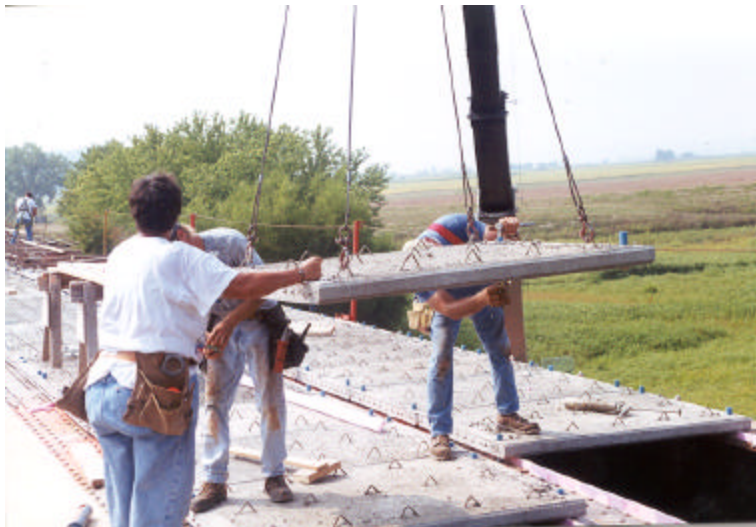
An average of 25 PPC deck planks were seated in a given day on the Jersey-Greene County bridge. Photo 7 shows the seating of the deck planks. On some days, the laborers would finish unloading one truck and could not continue seating planks until another shipment arrived. Eleven working days were used to seat the deck planks. Six days were used for Stage 1 (the northbound lane) and five days were used for Stage 2 (the southbound lane). For Stage 1, the last PPC deck plank was set June 3, 1999; and the Stage 1 pour was twenty-one days later on June 24, 1999. For Stage 2, the last PPC deck plank was set September 10, 1999; and the Stage 2 pour was eighteen days later on September 28, 1999.

Photo 7. Deck plank seating (District 8 – Stage 2, Sept. 2, 1999)

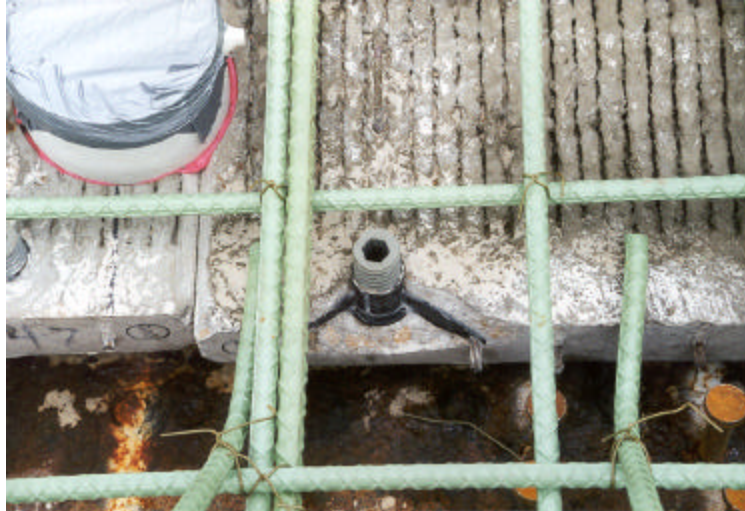
When seating PPC deck planks for Stage 1, the laborers were slowed down while installing the leveling screws. Many of the imbedded inserts were slightly compressed, making screw installation very difficult. Furthermore, several of the planks developed spalls in one or more of the corners after the leveling screws were installed (see Photo 8). This was probably a result of the force applied when the leveling screws were installed.

Photo 8. Spall at leveling insert (District 8 – Stage 1, June 24, 1999)

PEC began installing the screws during fabrication. The laborers only had to adjust the screws during the seating process. This solution greatly reduced the time and effort required for seating the deck planks.

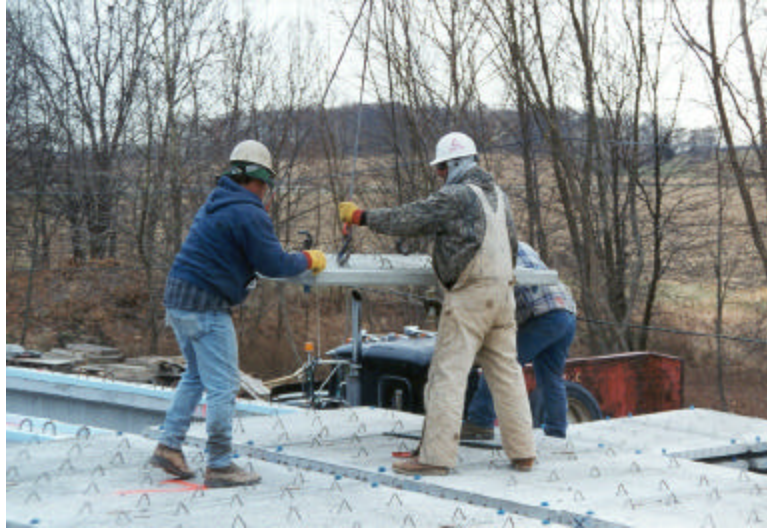
Photo 9. Deck plank seating (District 6 – Stage 2, Dec. 1, 1999)

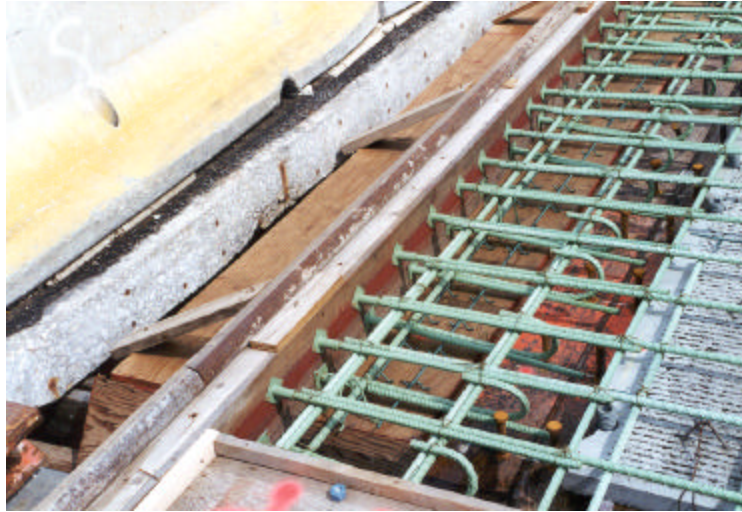
Because of the deck planks, reinforcement bars had to be modified in some places. Splice bars had to be cut three to four inches shorter, because they were too long to accommodate the deck planks (see Photo 10). Some of the vertical bars for the parapet wall had to be cut shorter, since they had to rest on the deck planks (see Photo 11).

Photo 10. Bottom splice bars cut short
(District 8 – Stage 1, June 24, 1999)

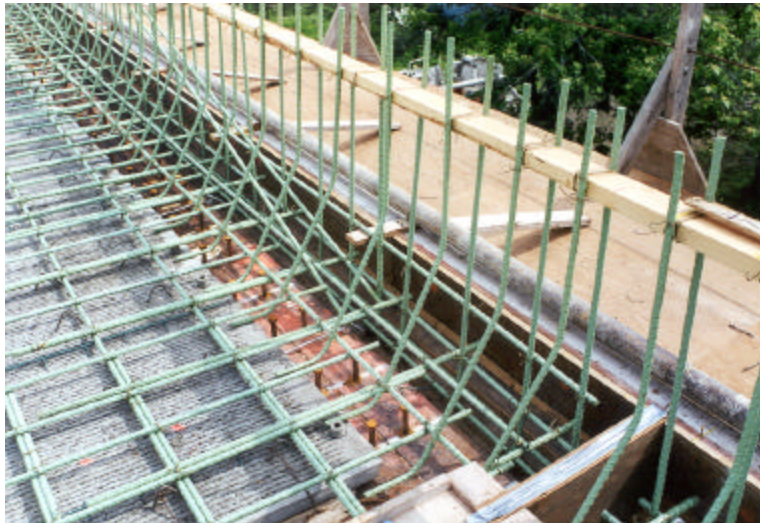
Photo 11. Inside parapet wall bars resting on plank
(District 8 – Stage 1, June 24, 1999)

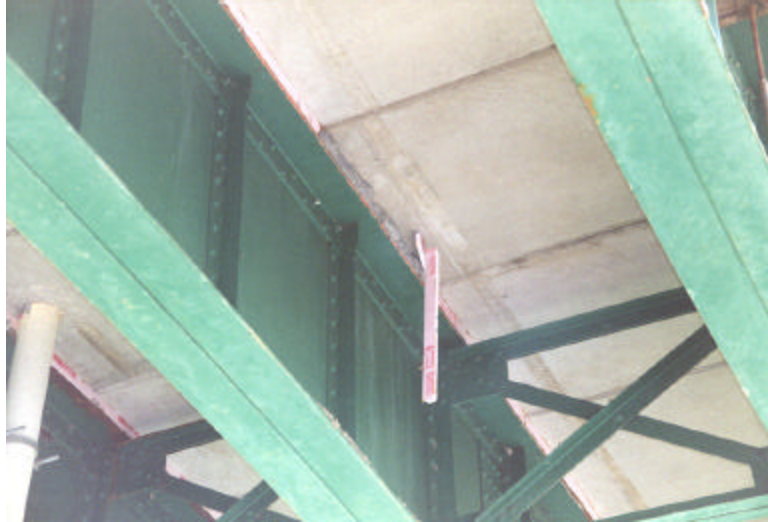
During Stage I paving, several “blow-outs” were reported. A blow-out occurs when the concrete either pushes out or breaks some sections of polystyrene, as shown in Photo 12. Without the polystyrene there to act as a dam, some concrete was lost in those areas. ASTM C 578 Type IV extruded polystyrene was used for both Stage I and 2. The movement and vibration of the bridge from the traffic may have caused the caulking bond to weaken between the polystyrene and the beams.

Photo 12. Blowout (District 8 - Stage I, June 28, 1999)

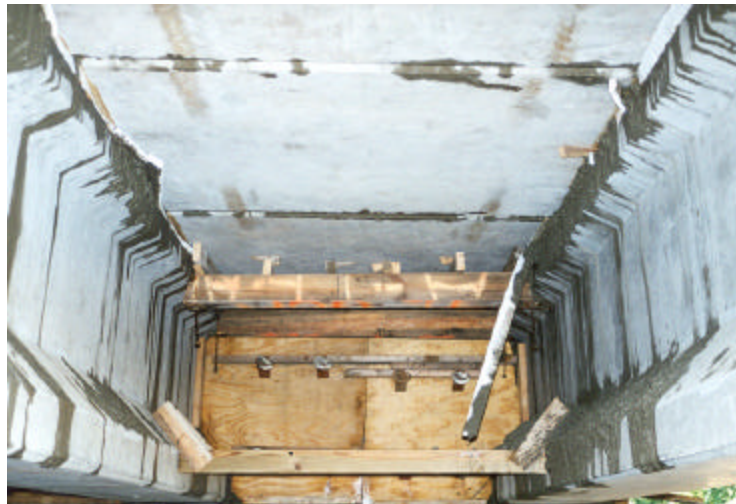
District 6 had even more blowouts during both Stage I and Stage II construction than District 8 (see Photo 13). The grade of polystyrene for the Stage II construction was changed to reduce the blowouts. For Stage 1, expanded polystyrene was used. ASTM C 578 Type IV extruded polystyrene was used for Stage 2. The extruded polystyrene did not appear to help in reducing the blowouts during the Stage II pour (see Photo 14).

Photo 13. Blowouts (District 6 – Stage 1, August 16, 1999)

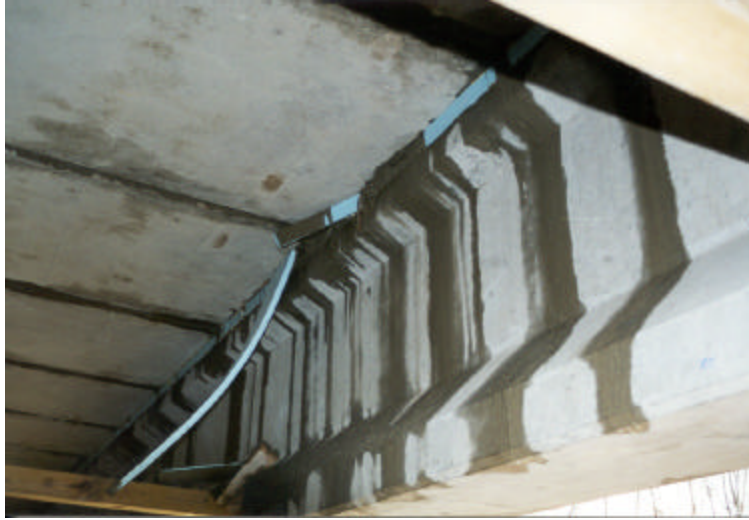
Photo 14. Blowouts (District 6 – Stage 2, March 13, 2000)

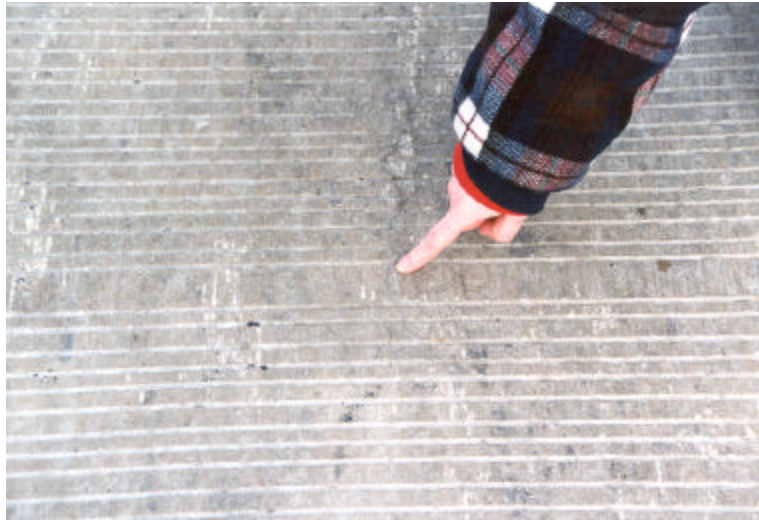
On December 1, 1999, a distress survey was performed on the Jersey-Greene county bridge. Numerous transverse cracks were found in Stage 1 (the northbound lane). The transverse cracks extended across at least 50 percent of the lane and were typically spaced 3.5 to 5.0 feet apart. The majority of the cracks were hairline, as shown in Photo 15. Stage 2 (the southbound lane) looked better than Stage 1. Only two transverse cracks and no longitudinal cracks were found.

Photo 15. Longitudinal Crack (District 8 – Stage 1, Dec. 1, 1999)

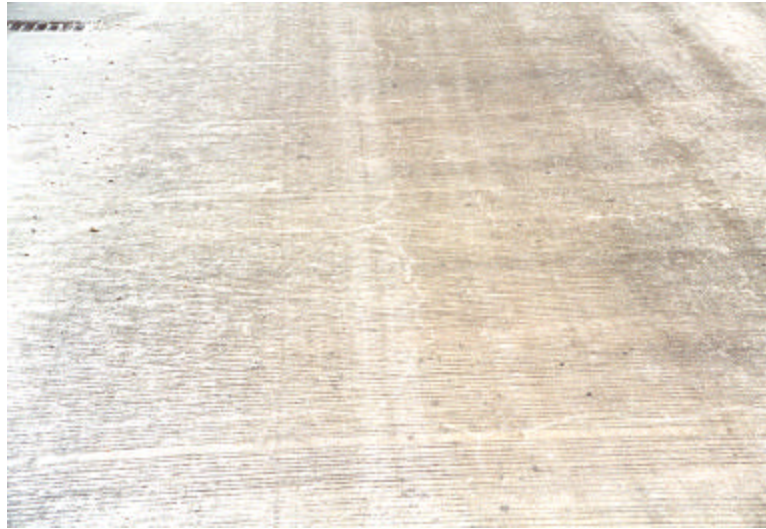
Approximately two months later, on January 28, 2000, a quick survey was performed on the Jersey-Greene County bridge. In Stage 1, several longitudinal cracks were observed. In fact, a single longitudinal crack, mostly above the first interior girder, ran along at least 50 percent of the northbound lane. In this survey, cracks were possibly more visible due to salt residue covering the bridge deck surface. Several transverse cracks were also seen in

Stage 1 (see Photo 16). Like the December survey, no longitudinal cracks and only two transverse cracks were found in Stage 2.

Photo 16. Longitudinal Crack (District 8 – Stage 1, January 28, 2000)

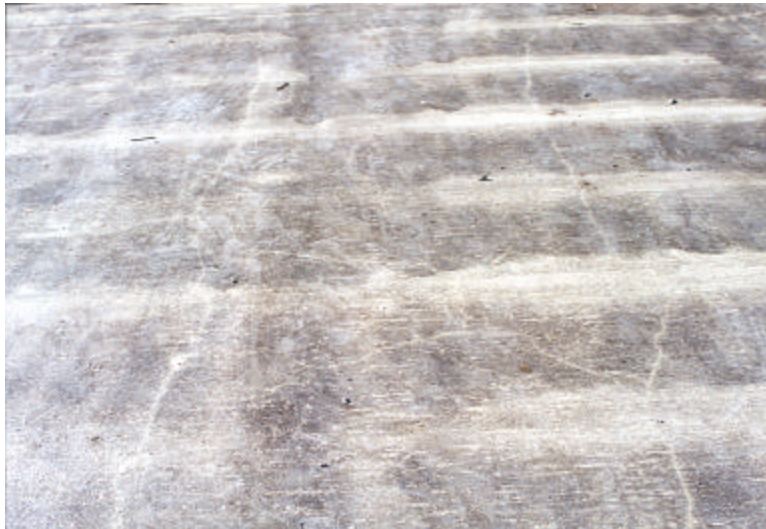
Photo 17. Longitudinal, transverse, & diagonal cracks before traffic loading
(District 6 – Stage 1 “overflow” bridge, August 30, 1999)

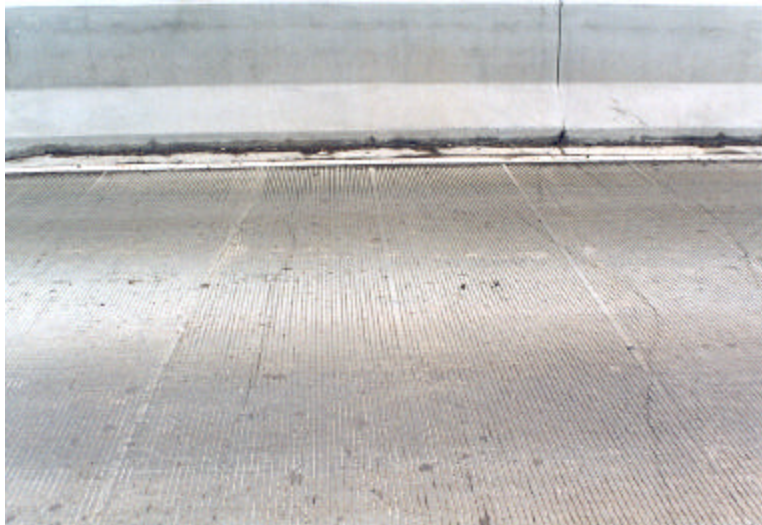
The more severe and visible transverse cracks were located directly above the piers. Two cracks in an hourglass shape were located above Pier #1 in Stage 1 of the “creek” bridge (see Photo 18) Two fairly straight transverse cracks were located above Pier #2. The survey notes for the 1999 PPC deck plank bridges previously surveyed indicate that similar cracks were located over most of the piers.

Photo 18. Transverse cracks above Pier #2
(District 6 – Stage 1 “creek” bridge, March 13, 2000)

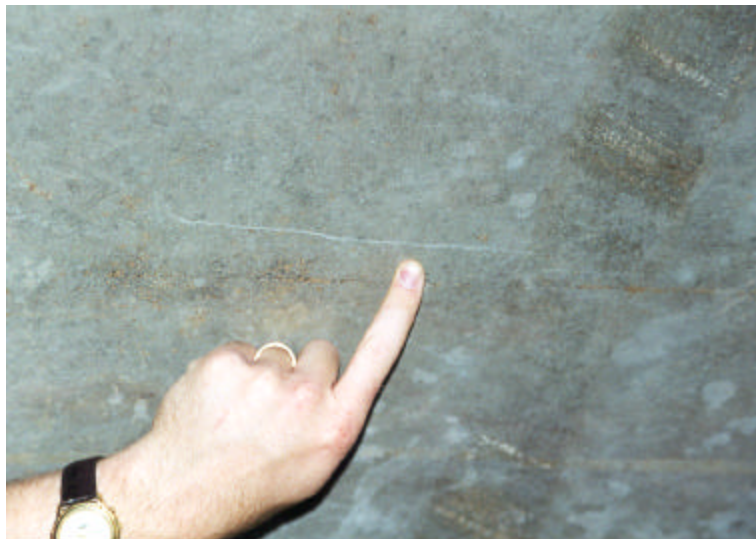
The surveyors examined the underside of both bridges. While they were able to look at all three spans of the “overflow” bridge, they were only able to look at one span of the “creek” bridge due to the water level. They found only one plank in the “overflow” bridge that appeared to have some cracking (see Photo 19). Even the cracking they saw was minor. The rest of the planks appeared to be in good condition.

Photo 19. Crack on underside of PPC deck plank
(District 6 – “overflow” bridge, May 30, 2000)

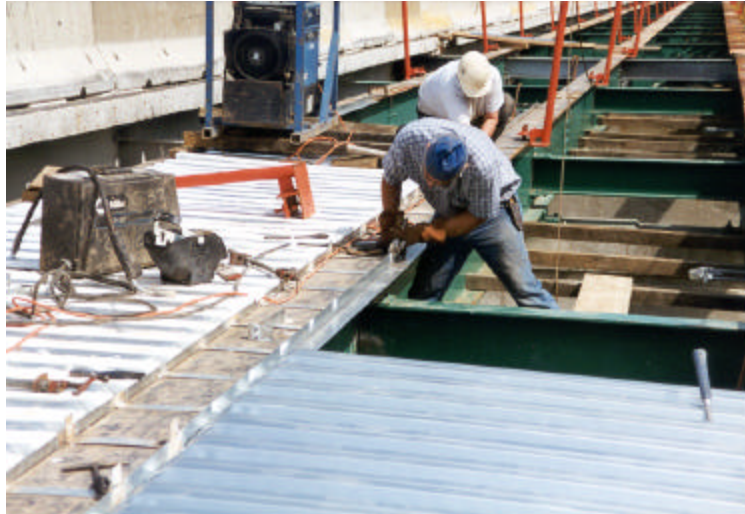
Metal stay-in-place forms were incorporated into two spans of the Jersey-Greene county bridge in District 8. The permanent metal deck forms were placed between the exterior girders in spans 4 & 5 (see page 7 and Photos 20 and 21).

Photo 20. Seating metal stay-in-place forms (District 8 – May 1999)

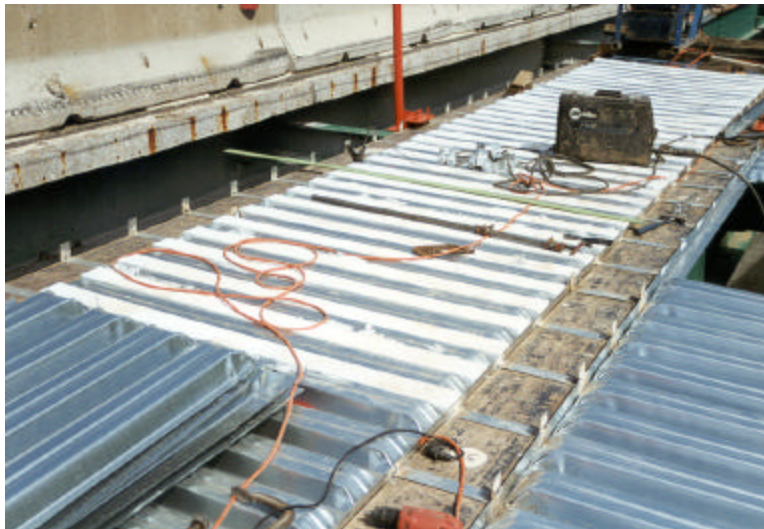
Photo 21. Polystyrene fillers in metal stay-in-place forms (District 8 – May 1999)
