SESSION FOUR: DECK SAFETY

USE OF OPERATING HAZARD ANALYSIS TO REVIEW ON-DECK PROCEDURES IN COMMERCIAL CRAB FISHING

PRACTICAL DECK SAFETY FOR CRAB FISHERS

AN EXPERIMENTAL COMPARISON OF MARINE VESSEL DECK MATERIALS AND FOOTWEAR SLIP RESISTANCE UNDER VARYING ENVIRONMENTAL CONDITIONS

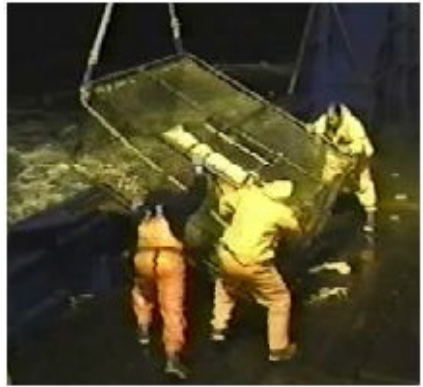
Figure 3. Move pots from on-deck storage stack to launcher

2	Move pots from on-deck storage to launcher	High hand forces and awkward postures	Push/pull pots	Musculoskeletal injury/illness	1	2	3	6	Worker Training
		Caught between pot or other obstruction or struck by pot	Pot moves without worker knowledge Pot moves too fast Pot swings due to boat movement	Crushing/contact trauma injury	2.5	3	2	15	Worker Training Increase communication between worker and crane operator/captain Improve control layout on crane
		Pinch point at feet	Front edge of launcher moves toward deck	Foot caught between launcher and deck, crushing injury	1	3	2	6	Worker Training Identify pinch point area with bright paint Launcher "feet" or "pads" on deck (stumble hazard?)
		Fall from height	Work above deck Slippery work surface	Contact trauma	1	4	1	4	Worker Training Footwear PPE?
		Fall on same level	Slippery work surface	Contact trauma	1	2	2	4	Worker Training Footwear
		Pot fall from overhead	Crane/gear failure Crane operator failure	Contact trauma	1	4	3	12	Crane maintenance Operator training Improve control layout on crane

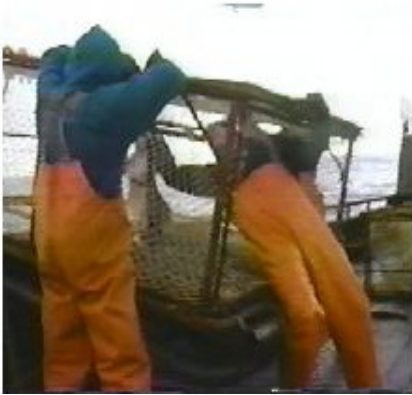
Figure 4: Prepare pot for initial launching

3	Prepare pot for initial launching	High hand forces and awkward postures	Open/close pot door	Musculoskeletal injury/illness	1	2	2	4	Worker Training
		High hand forces and awkward postures	Remove buoys and rope Hang bait	Musculoskeletal injury/illness	1	1	2	2	Worker Training

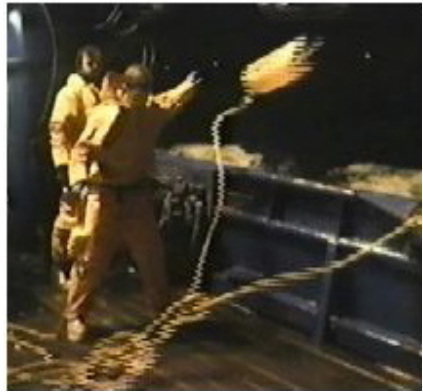
Figure 5: Launch pot and throw out line and buoys

PROCEDURE OR TASK	POTENTIALLY HAZARDOUS CONDITIONS	CAUSE	EFFECT	CONCERN LEVEL			RECOMMENDATIONS	
					FREQ.	SEV	DETECT.		
4	Launch pot and throw out rope and buoys	Awkward postures while throwing	Bulky items	Musculoskeletal injury/illness	1	1	3	3	Worker Training
		Struck by launcher	Launcher movement	Contact trauma	1	1	1	1	N/A
		Moving rope	Uncoiling rope overboard	Man overboard	1	4	2	8	Training Warning sound PPE
5	Throw line, retrieve buoys, connect line to power block, bring in pot	Contact with hook	Hook movement	Contact trauma	1	1	1	1	N/A
		Awkward dynamic movement during throw	Hook weight Throw distance	Musculoskeletal stress at shoulder	1	1	3	3	
		Pull line in, high hand forces and awkward (hands at/above shoulder) postures		Musculoskeletal stress at shoulder	1	1	2	2	Worker Training
		Power block, caught in in-running nip point	Hand too close to in-running nip point Loose clothing	Crushing injury	1	3	2	6	Worker Training Tape sleeves Guarding?

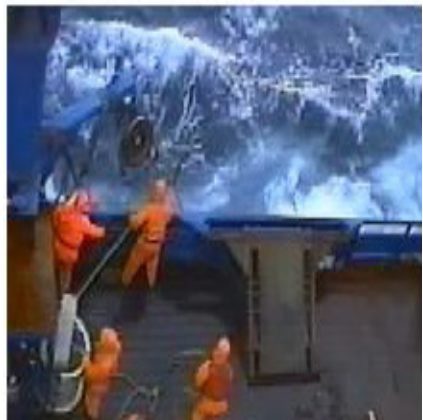
Figure 7: Attach pot to picking boom crane and move pot to launcher

6	Attach pot to picking boom and move pot to launcher, unhook from picking boom	Caught between pot and launcher or other obstruction	Pot moves without worker knowledge Pot moves too fast Pot swings due to boat movement Launcher tilts to deck	Crushing/contact trauma injury	1	3	2	6	Worker Training Increase communication between worker and crane operator/captain Improve control layout on crane
		Pinch point at feet	Front edge of launcher moves toward deck	Foot caught between launcher and deck	1	2	2	4	Worker Training Identify pinch point area with bright paint Launcher "feet" or "pads" on deck (stumble hazard?)
7	Relocate sorting table, transfer catch to table	Caught between table and launcher or other obstruction	Table moves without worker knowledge	Crushing/contact trauma injury	1	2	1	2	Worker Training
		Awkward posture and high repetition during catch transfer	Location of table with respect to pot	Musculoskeletal stress	1	1	2	2	Worker Training

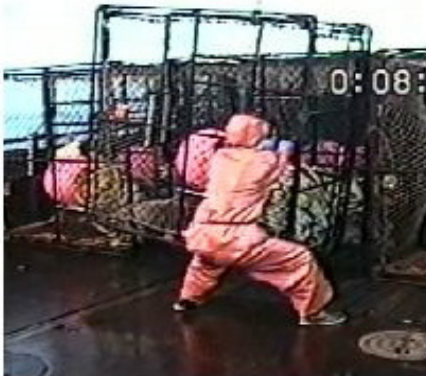
Figure 10: Move pots from launcher to on-deck storage

PROCEDURE OR TASK	POTENTIALLY HAZARDOUS CONDITIONS	CAUSE	EFFECT	FREQ.	SEV.	DETECT.	CONCERN LEVEL	RECOMMENDATIONS
9	Move pots from launcher to on-deck storage	High hand forces and awkward postures	Push/pull pots	Musculoskeletal injury/illness	1	2	3	6	Worker Training
		Caught between pot and other obstruction	Pot moves without worker knowledge Pot moves too fast Pot swings due to boat movement Launcher tilts to deck	Crushing/contact trauma injury	2.5	3	2	15	Worker Training Increase communication between worker and crane operator/captain Improve control layout on crane
		Fall on same level	Slippery work surface	Contact trauma	1	2	2	4	Worker Training Footwear
		Fall from height	Work above deck Slippery work surface	Contact trauma	1	4	1	4	Worker Training Footwear PPE?
		Pot fall from overhead	Crane/gear failure Crane operator failure	Contact trauma	1	4	3	12	Crane maintenance Operator training Improve control layout on crane

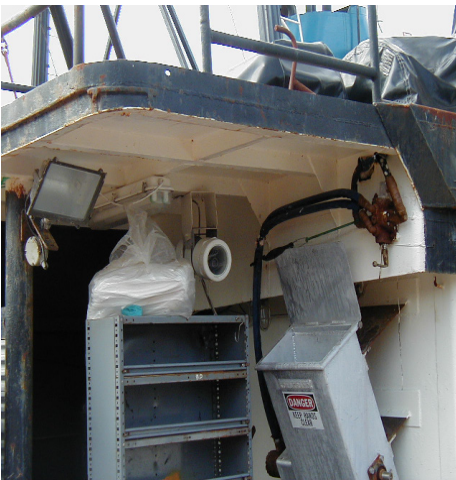
Figure 1: Closed-circuit TV camera (in the round white housing) and extra lighting at bait chopper

1. Install adequate lighting on deck. This increases visibility in dark areas and during night and helps the crew work more safely (Figure 1).
2. Use a closed-circuit TV system on house-forward boats. This helps the skipper see what is happening on deck from the wheelhouse. He or she can then become more easily aware of dangerous conditions and activity on deck (Figure 1).

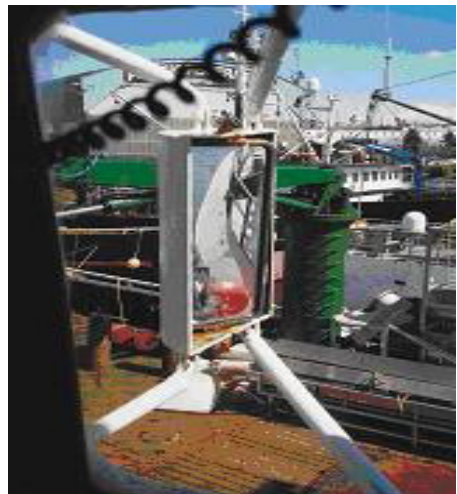
Figure 2: Truck mirror seen from inside wheelhouse

3. Install a truck mirror on the starboard side of the wheelhouse. This helps the skipper see work along the starboard rail and pot launcher (Figure 2).

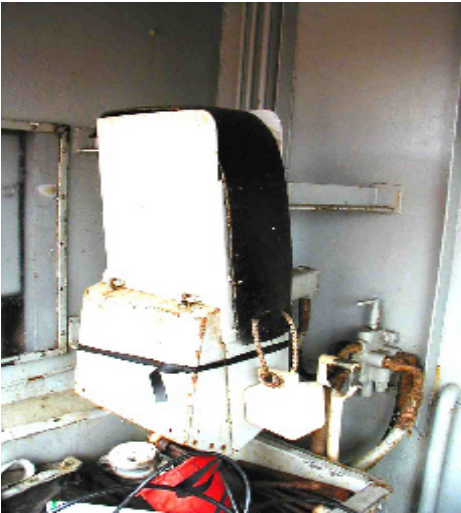
Figure 4: Bait chopper guard made from old conveyor belt material.

10. Install a guard over the bait chopper. This helps prevent the crew from reaching into the chopper box and risking injury (Figure 4).
11. Install an emergency shut-off on the bait chopper. This allows another person to turn off the bait chopper if a fisher either has been injured by the chopper or is about to be injured.

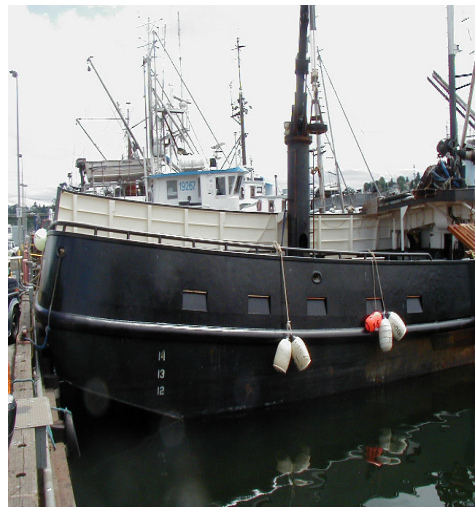
Figure 5: Boat with raised bulwark on port side and raised pipe rail on starboard side
