FINAL REPORT

REMEDIAL INVESTIGATION REPORT

**ASHLAND/NORTHERN STATES POWER
LAKEFRONT SUPERFUND SITE**

August 31, 2007

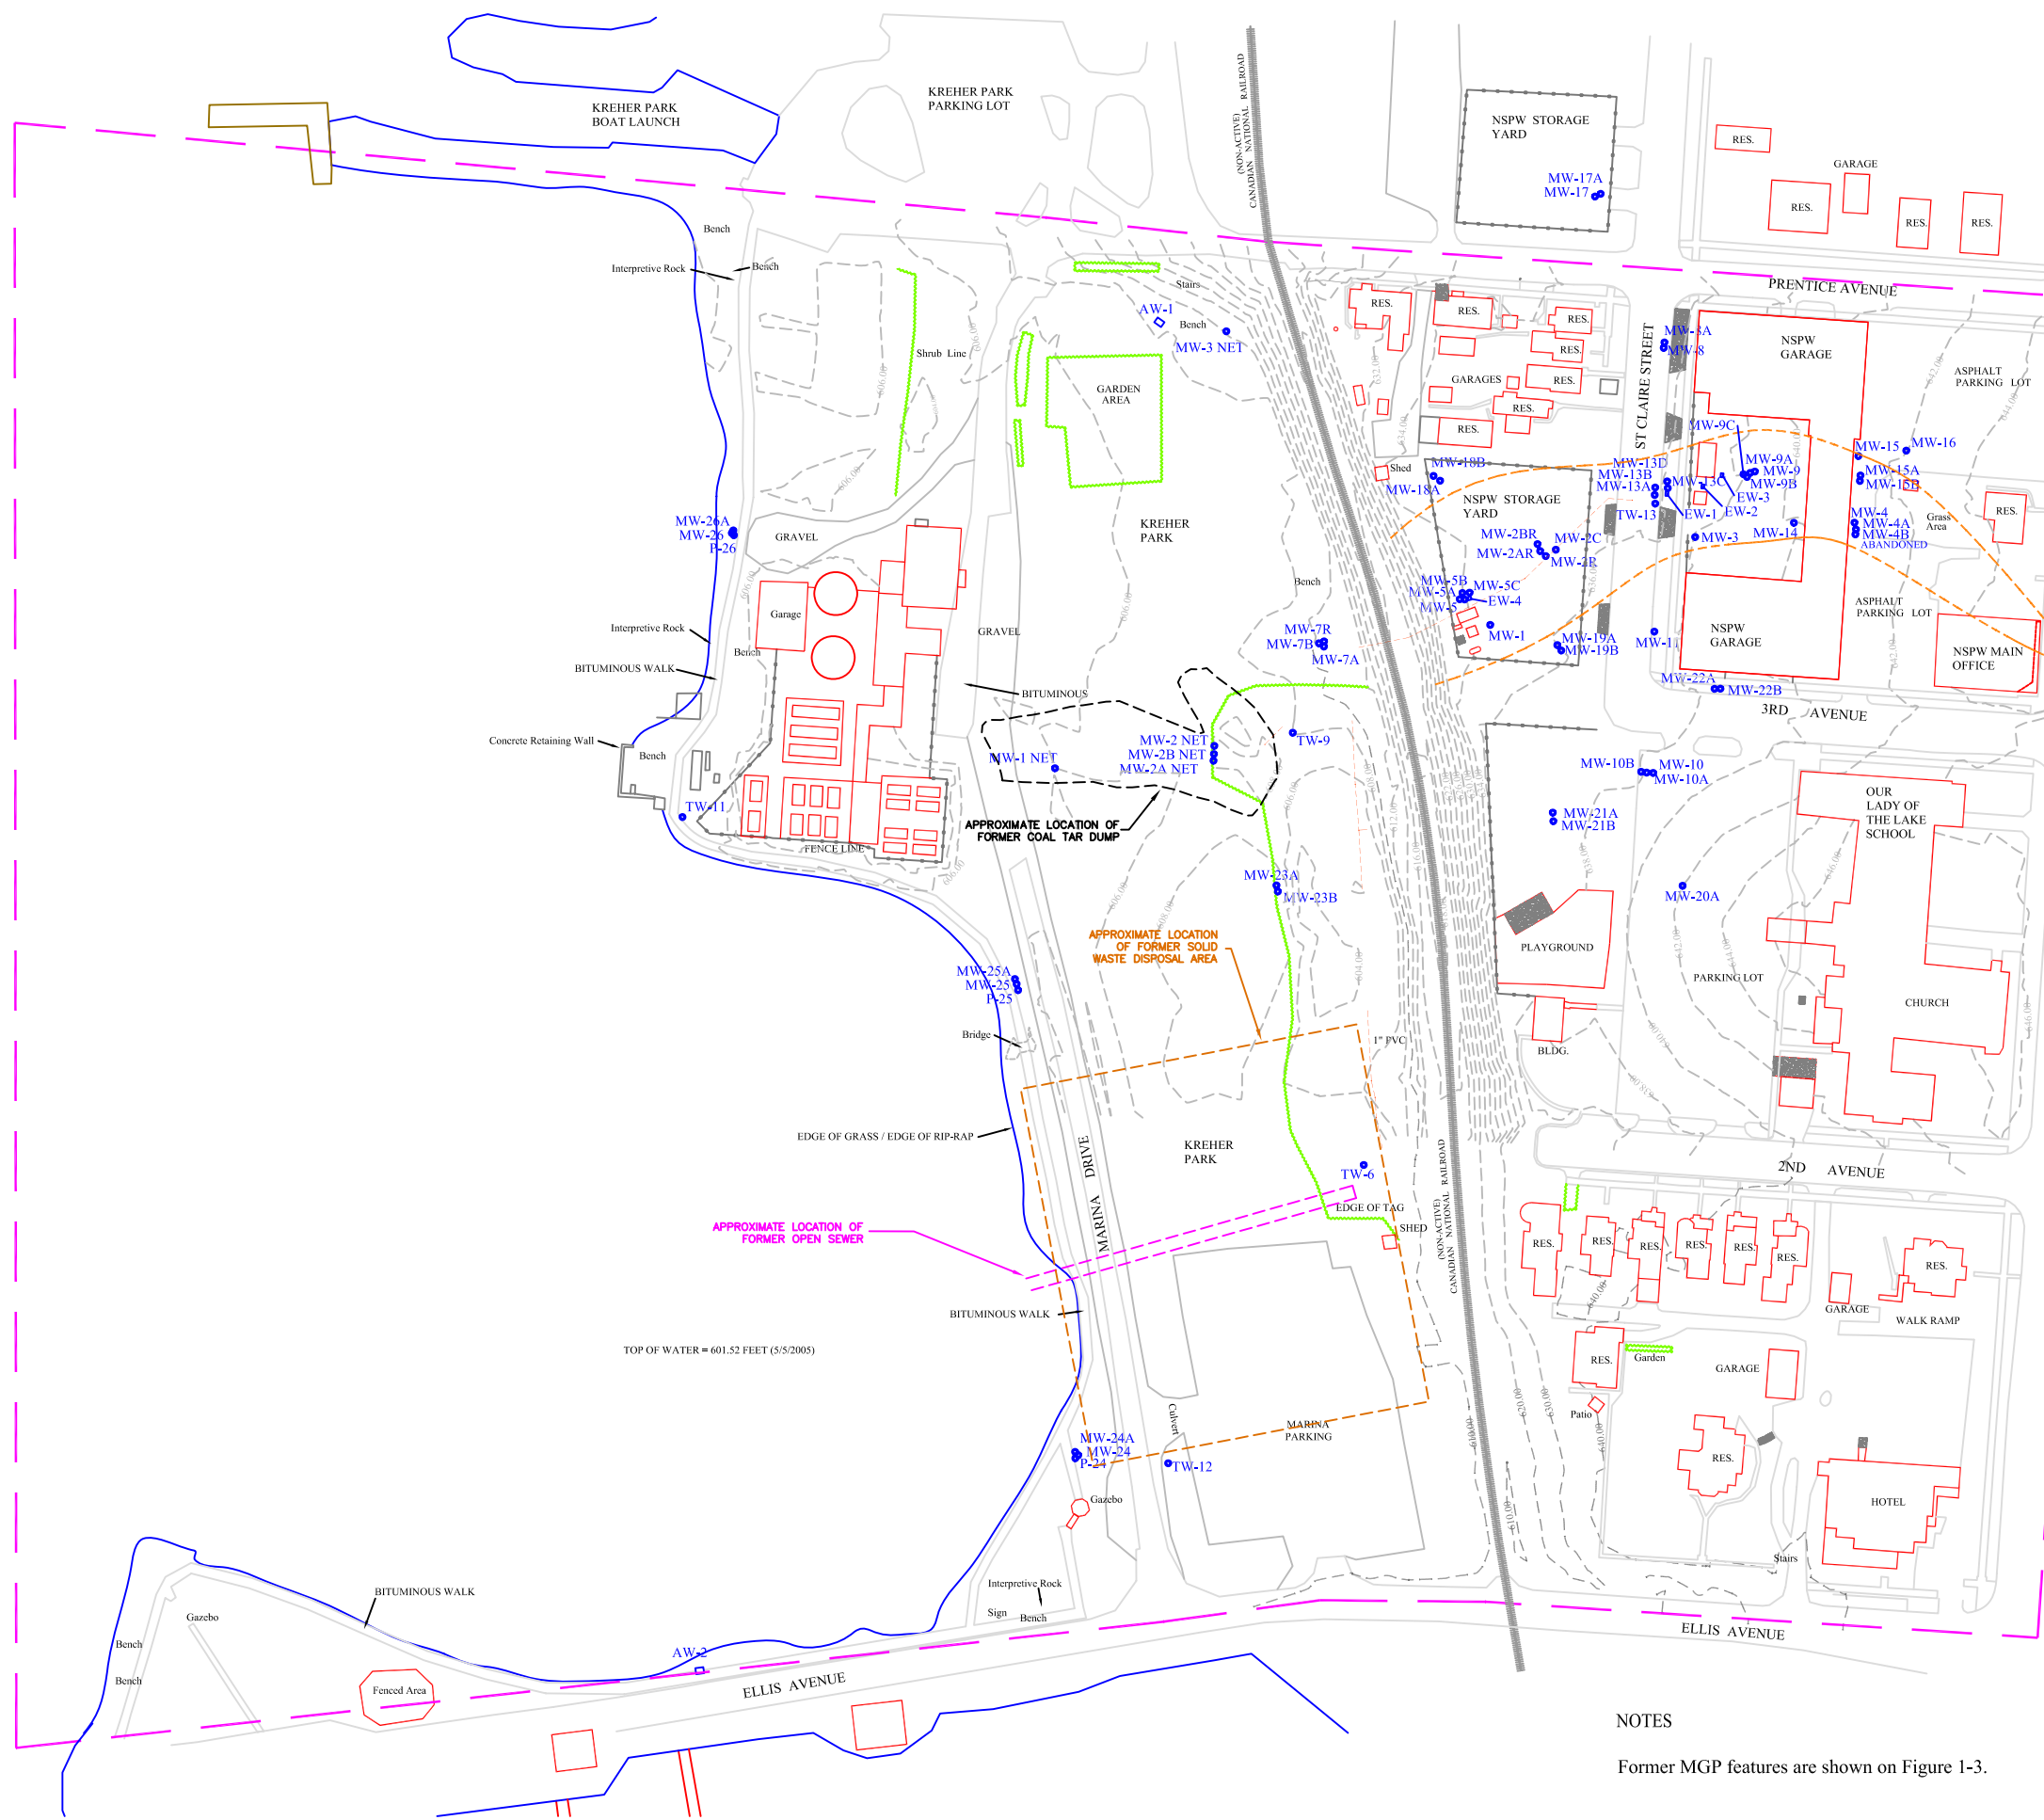
PROJECT: ASHLAND/NSP LAKEFRONT SITE ASHLAND, WISCONSIN			
TITLE: FIGURE 1-2 SITE FEATURES			
DRAWN BY: DDZ	SCALE: 1" = 150'	PROJECT: 25688375	
CHECKED BY: PJS	DATE: 30.JULY.2007	SHEET: 1-2	
APPROVED BY: DPT			
URS		10200 INNOVATION DRIVE, SUITE 500 MILWAUKEE, WISCONSIN 53226 414-831-4100

- LEGEND
- NPL SITE BOUNDARY
 - SURFACE CONTOUR MAJOR
 - SURFACE CONTOUR MINOR
 - FENCE LINE
 - TREE/SHRUB LINE
 - FILLED RAVINE EXTENT (APPROXIMATE)
 - UNDERGROUND CLAY TILE PIPE REMNANTS

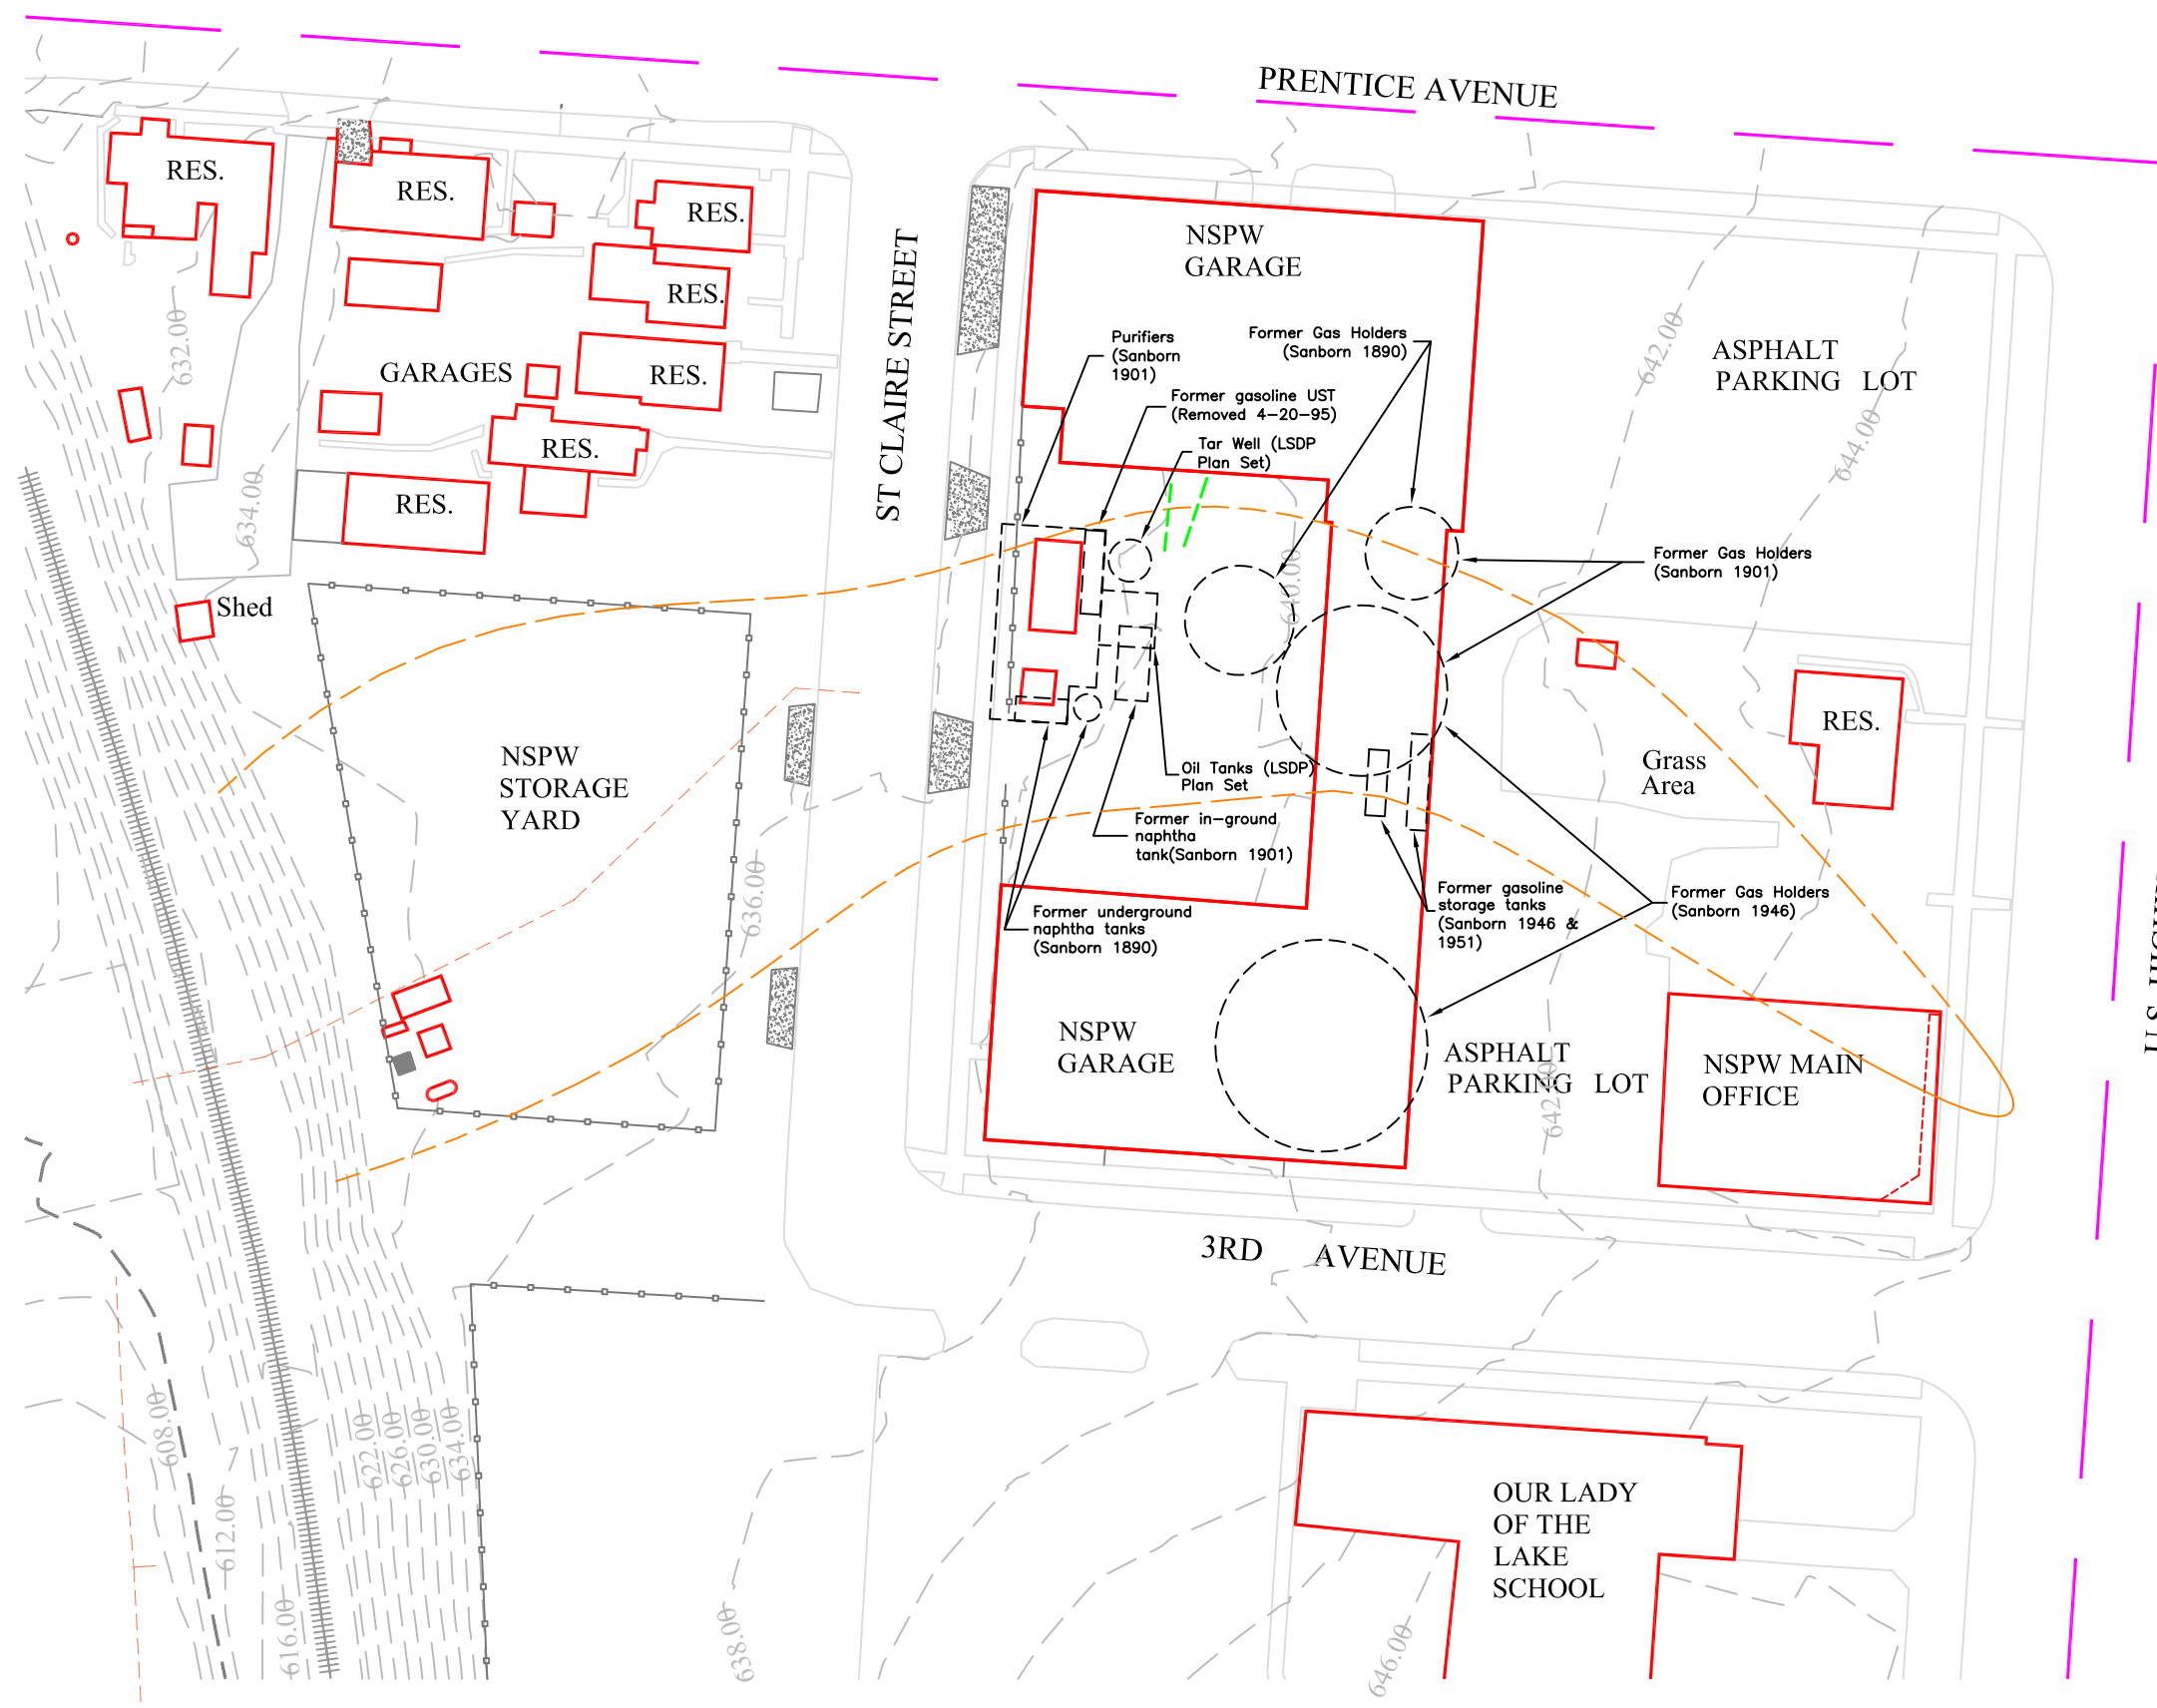
PROJECT: ASHLAND/NSP LAKEFRONT SITE ASHLAND, WISCONSIN			
TITLE: FIGURE 1-3 FORMER MGP FEATURES			
DRAWN BY: DDZ	SCALE: 1" = 60'	PROJECT: 25688375	
CHECKED BY: PJS	DATE: 30.JULY.2007	SHEET: 1-3	
APPROVED BY: DPT			
URS		10200 INNOVATION DRIVE, SUITE 500 MILWAUKEE, WISCONSIN 53226 414-831-4100

- NPL SITE BOUNDARY
- SURFACE CONTOUR MAJOR
- SURFACE CONTOUR MINOR
- FENCE LINE
- FILLED RAVINE EXTENT (APPROXIMATE)
- UNDERGROUND PIPE REMNANTS
- UNDERGROUND CLAY TILE PIPE REMNANTS

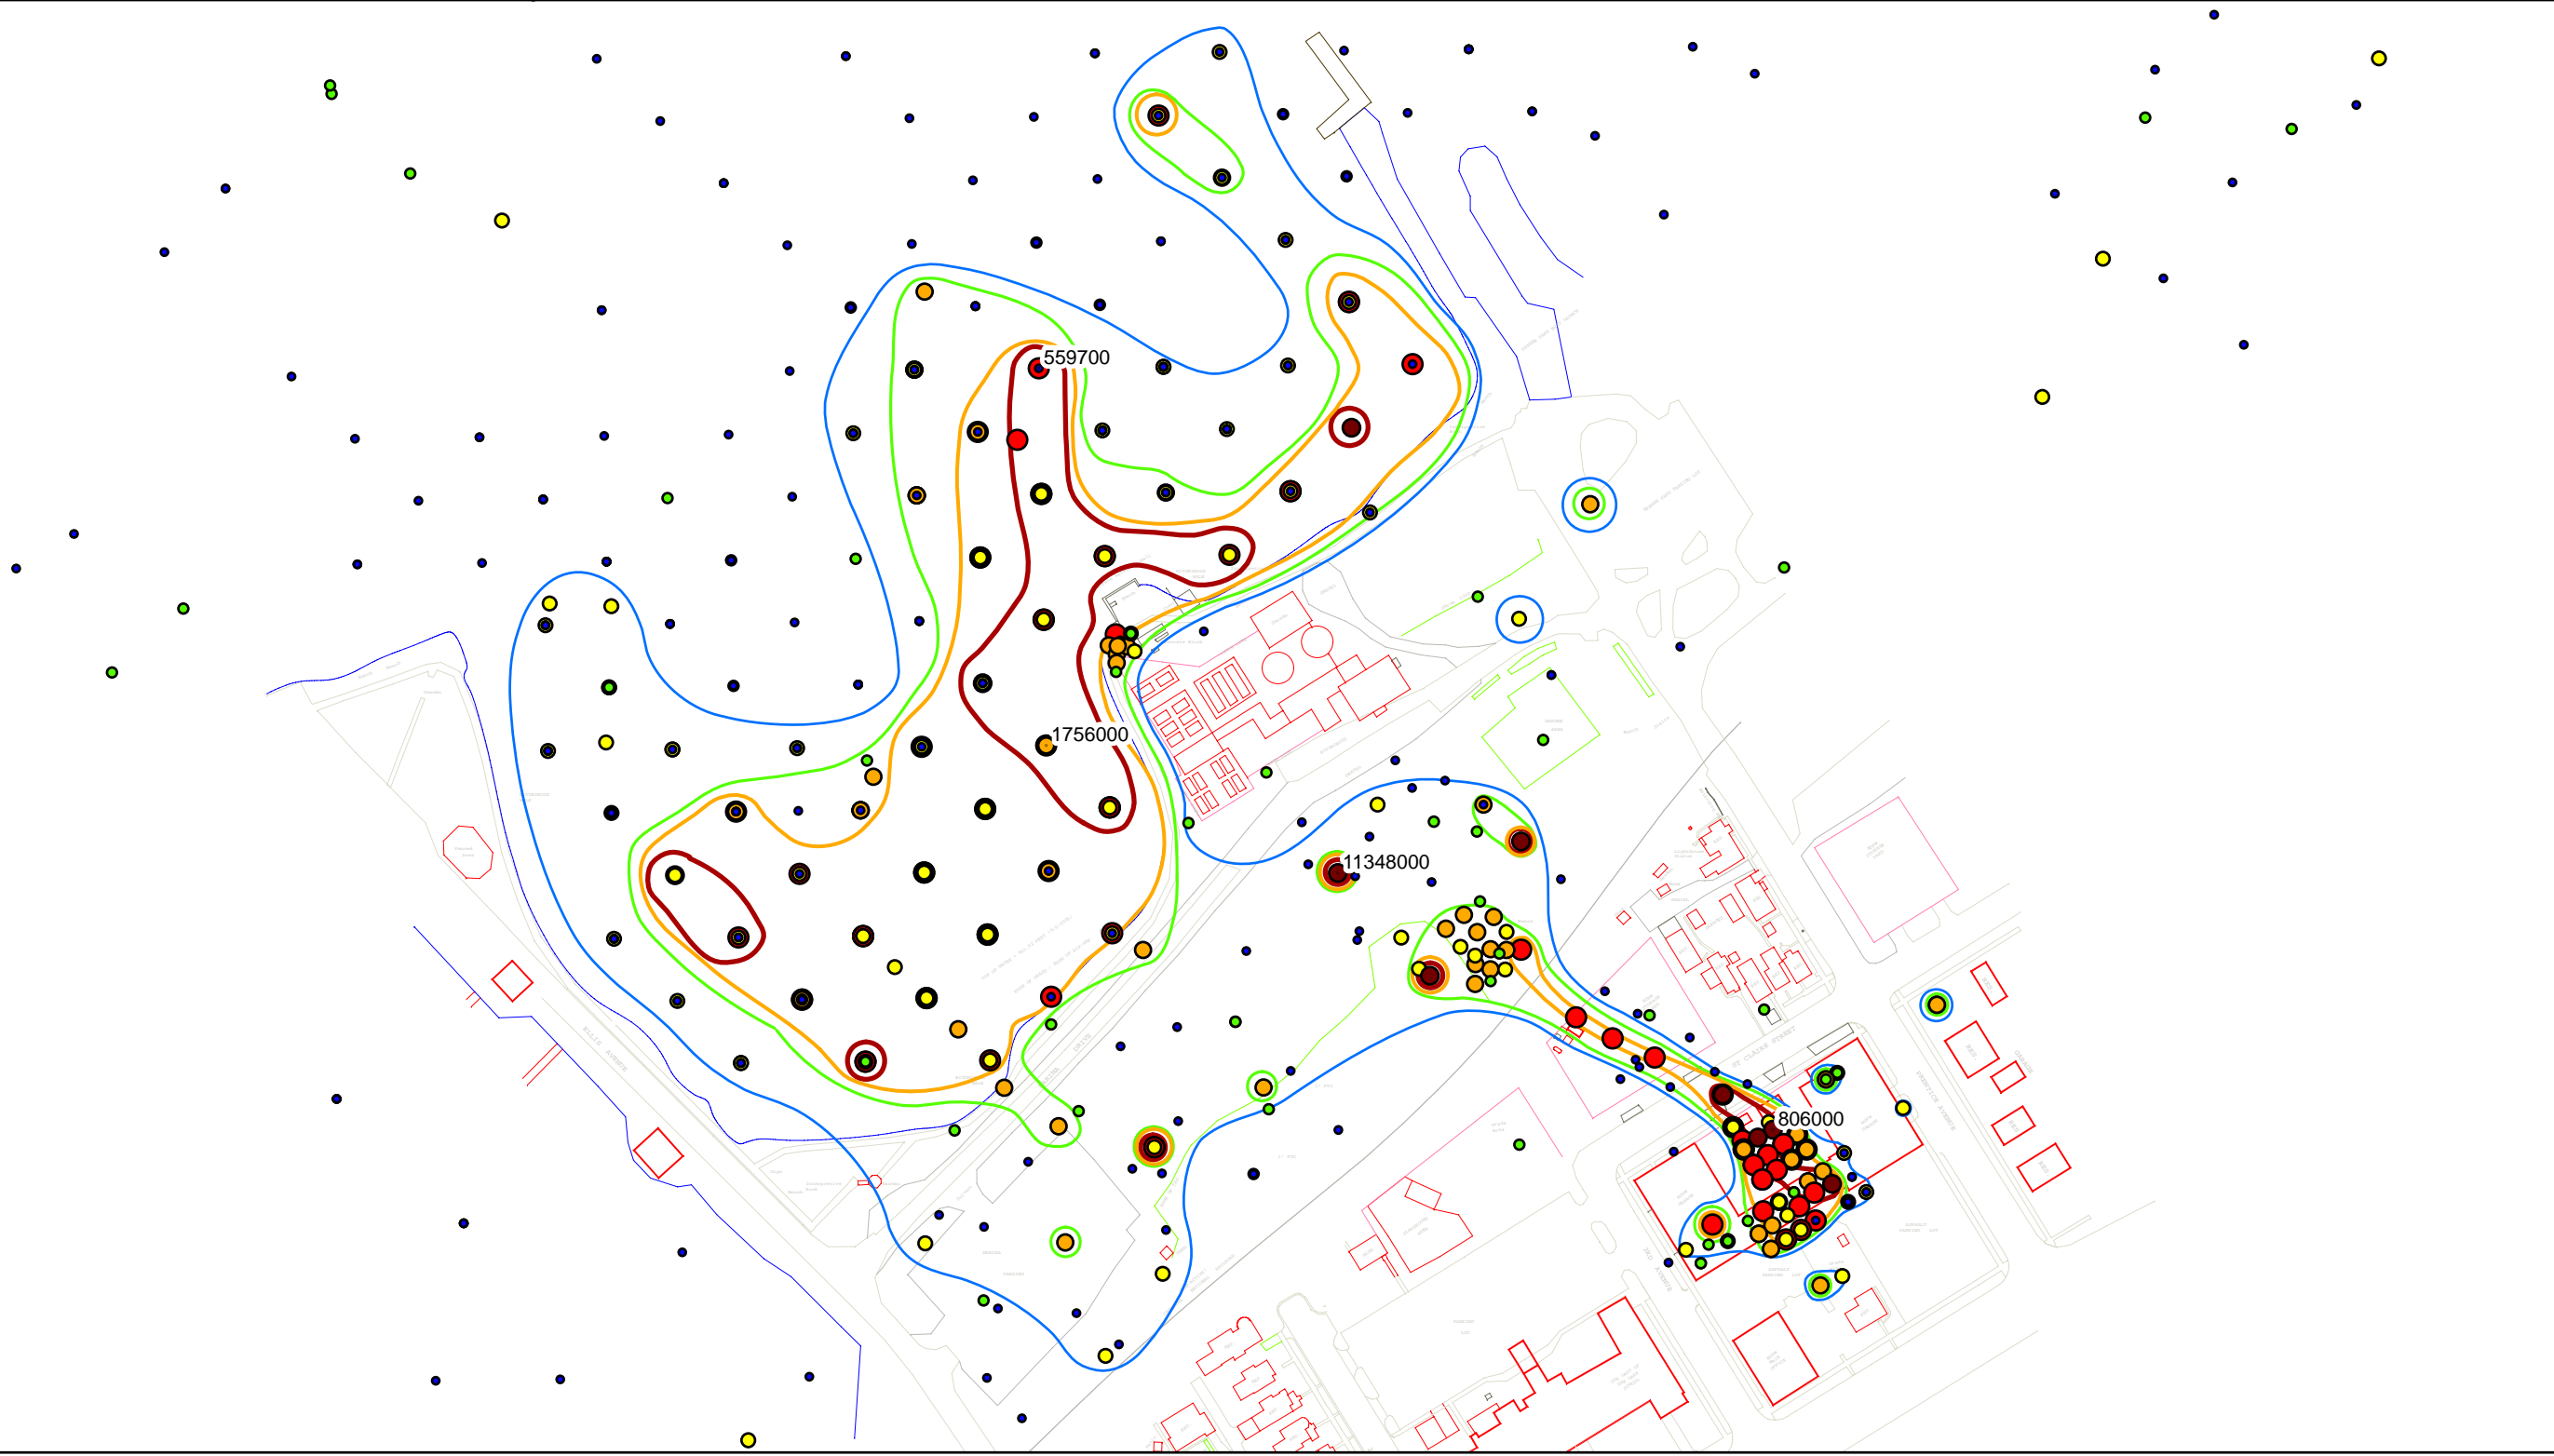
Total VOCs include benzene, ethylbenzene, styrene, toluene, total xylenes, and 1,2,3-, 1,2,4-, and 1,3,5-trimethylbenzene.

The highest levels of VOC contaminants at the Kreher Park are found at areas corresponding to free product zones. These are comparable with levels near other free-product zones at the upper bluff/filled ravine and Copper Falls aquifers. The levels are consistent for both soil and groundwater. Because of the high mobility and high solubility of the VOCs, the high permeability/flat horizontal groundwater gradient has led to widespread VOC contamination in groundwater at Kreher Park. However, these levels are generally an order of magnitude lower than samples collected near the free-product (DNAPL) areas.

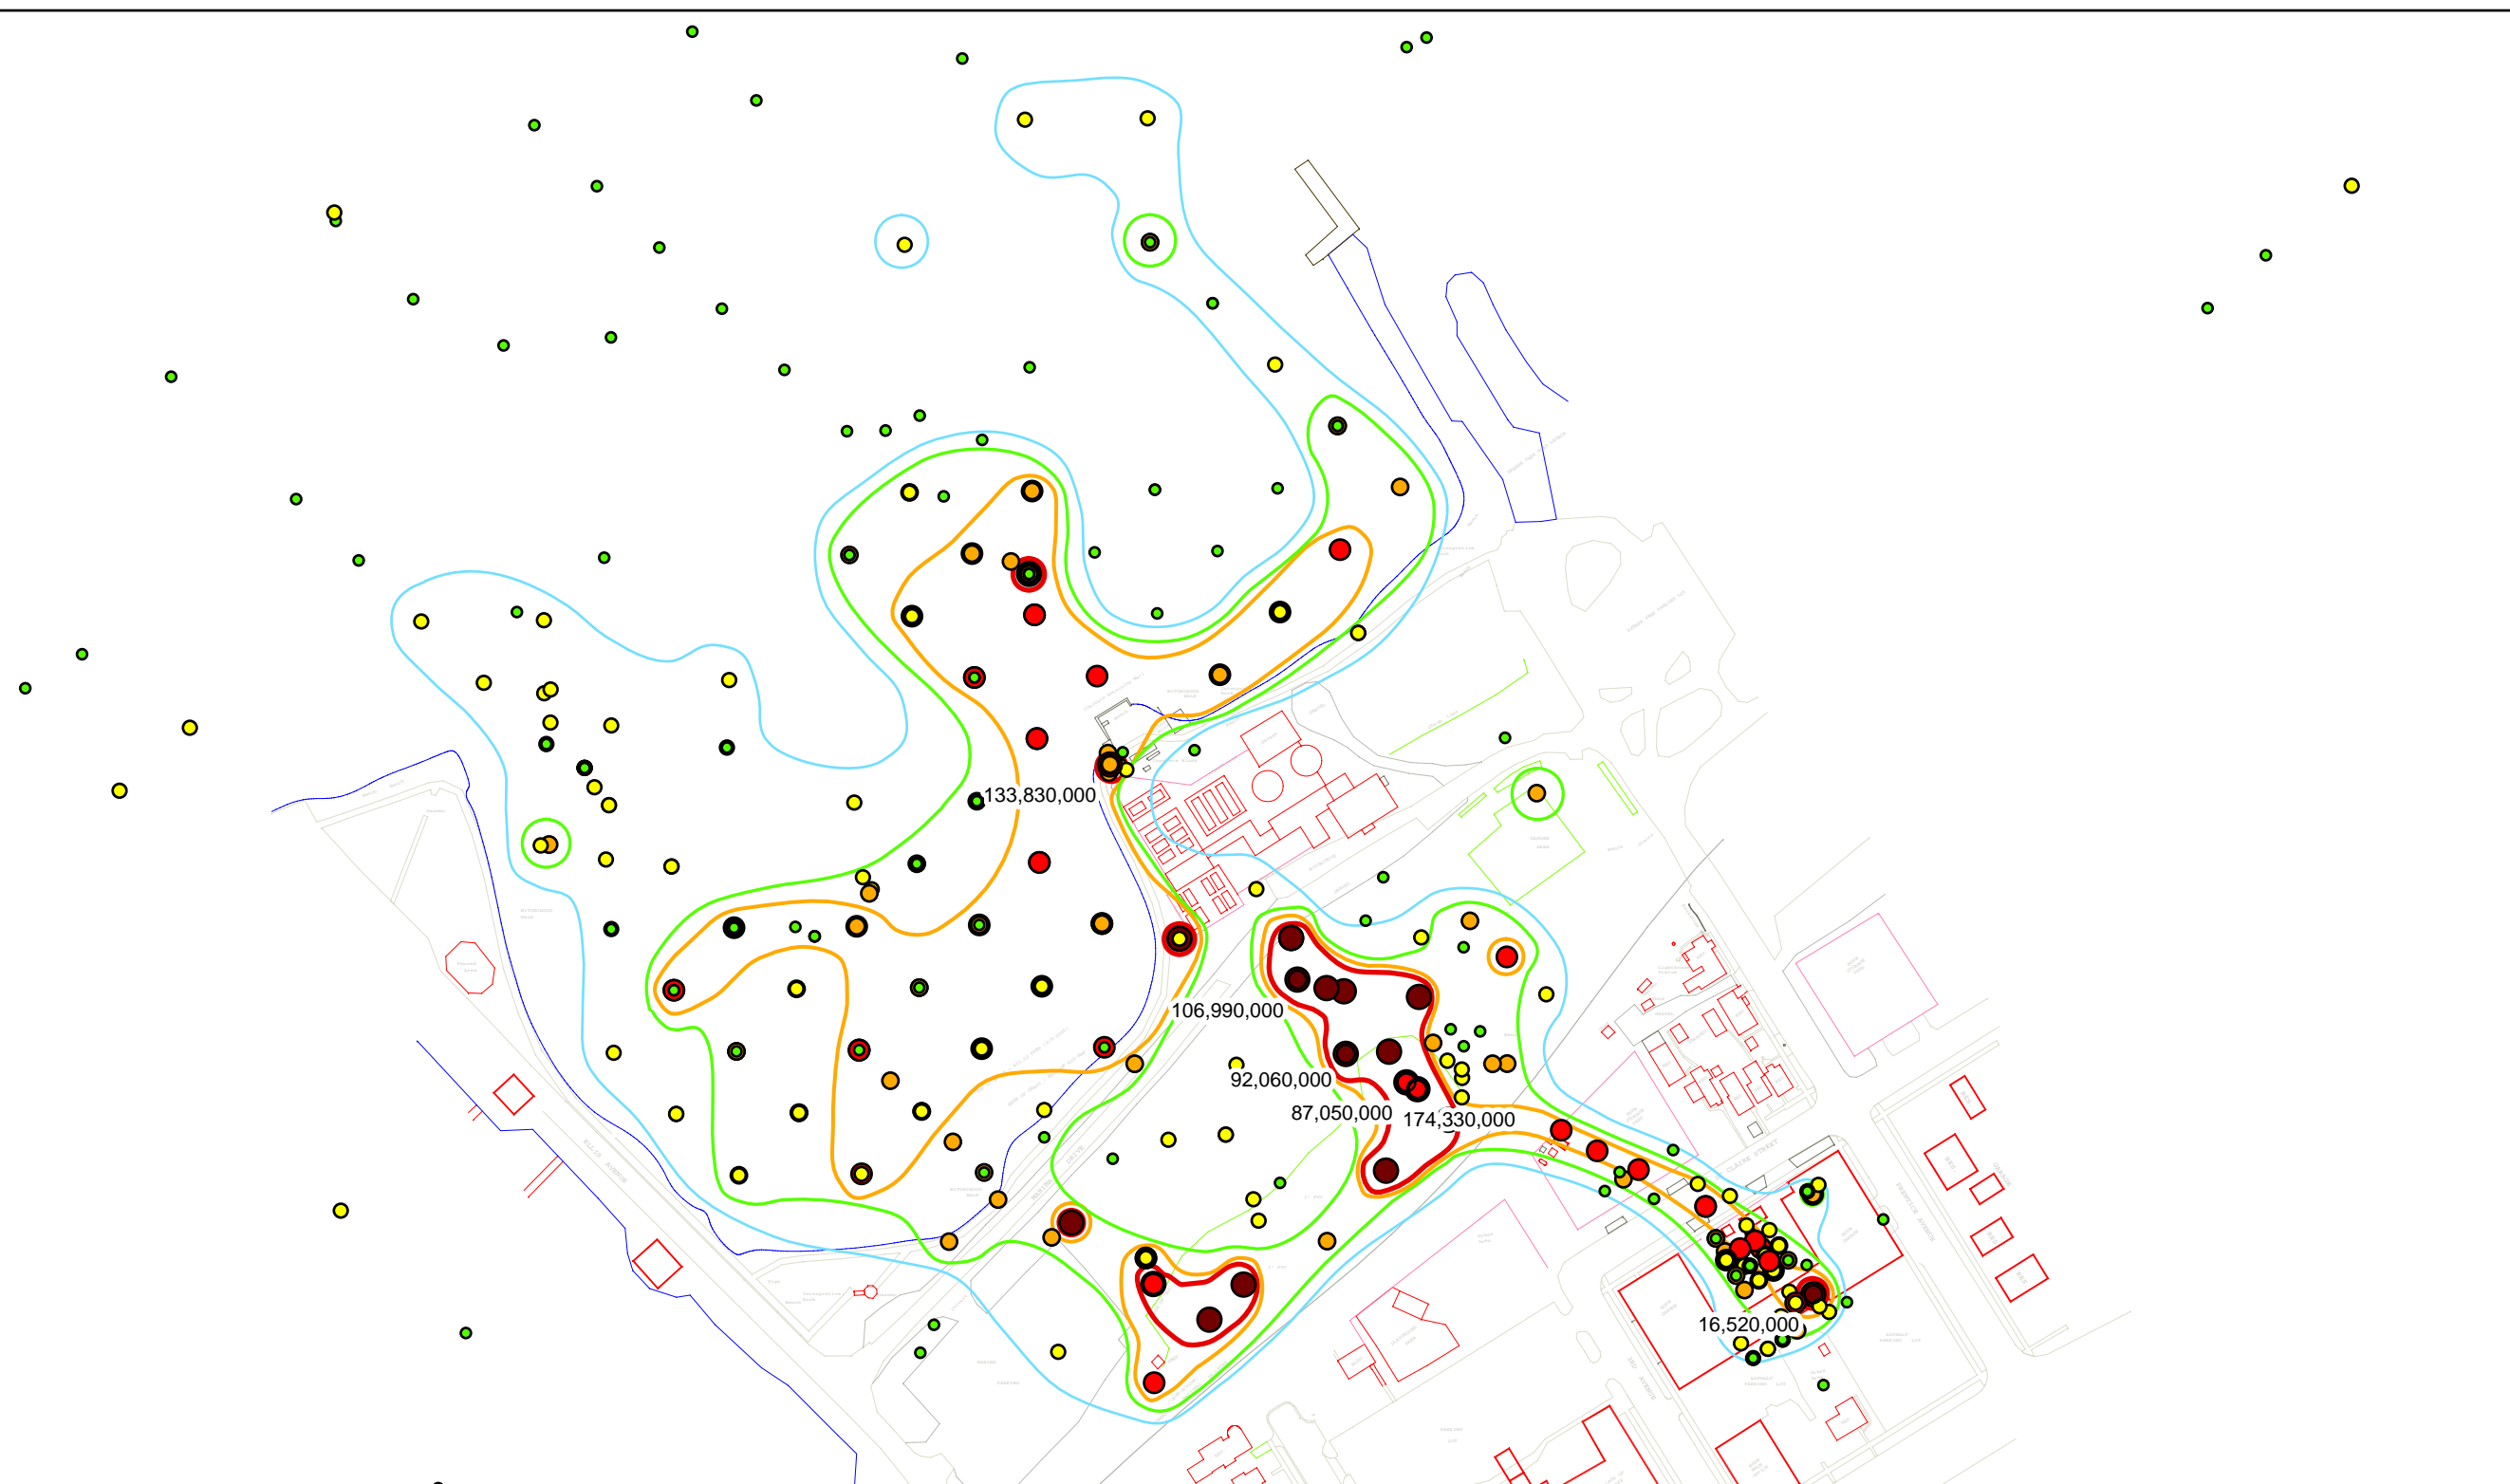
RI MAX Total PAHs Sediment & Soil TPAH ug/kg	TPAH soil isocontour TPAH ug/kg
● 0 - 1000	— 10,000
● 1001 - 10,000	— 100,000
● 10,001 - 100,000	— 1,000,000
● 100,001 - 1,000,000	— 10,000,000
● 1,000,001 - 10,000,000	
● >10,000,000

In contrast, the soil data from Kreher Park show the opposite relationship regarding PAHs, with an order of magnitude increase in PAH levels across the majority of the Park compared to the upper bluff/filled ravine. The PAHs are less mobile and less soluble compared to the VOCs, degrading more slowly. This chemical behavior combined with the physical characteristics in the fill material have created conditions for the PAHs to remain present and at similar levels in the fill since they were first released. The highest levels are most pronounced in the area of the former coal tar dump. The high levels of PAHs likely originated from the off-loading of fuel feedstocks and other raw materials to support the MGP and possibly other lakefront industrial activities.
