# **Cold Testing of a Russian Pulsating Mixer Pump at the Oak Ridge National Laboratory, Oak Ridge, Tennessee**

**January 2002**

Prepared by  
B. E Lewis  
J. D. Randolph

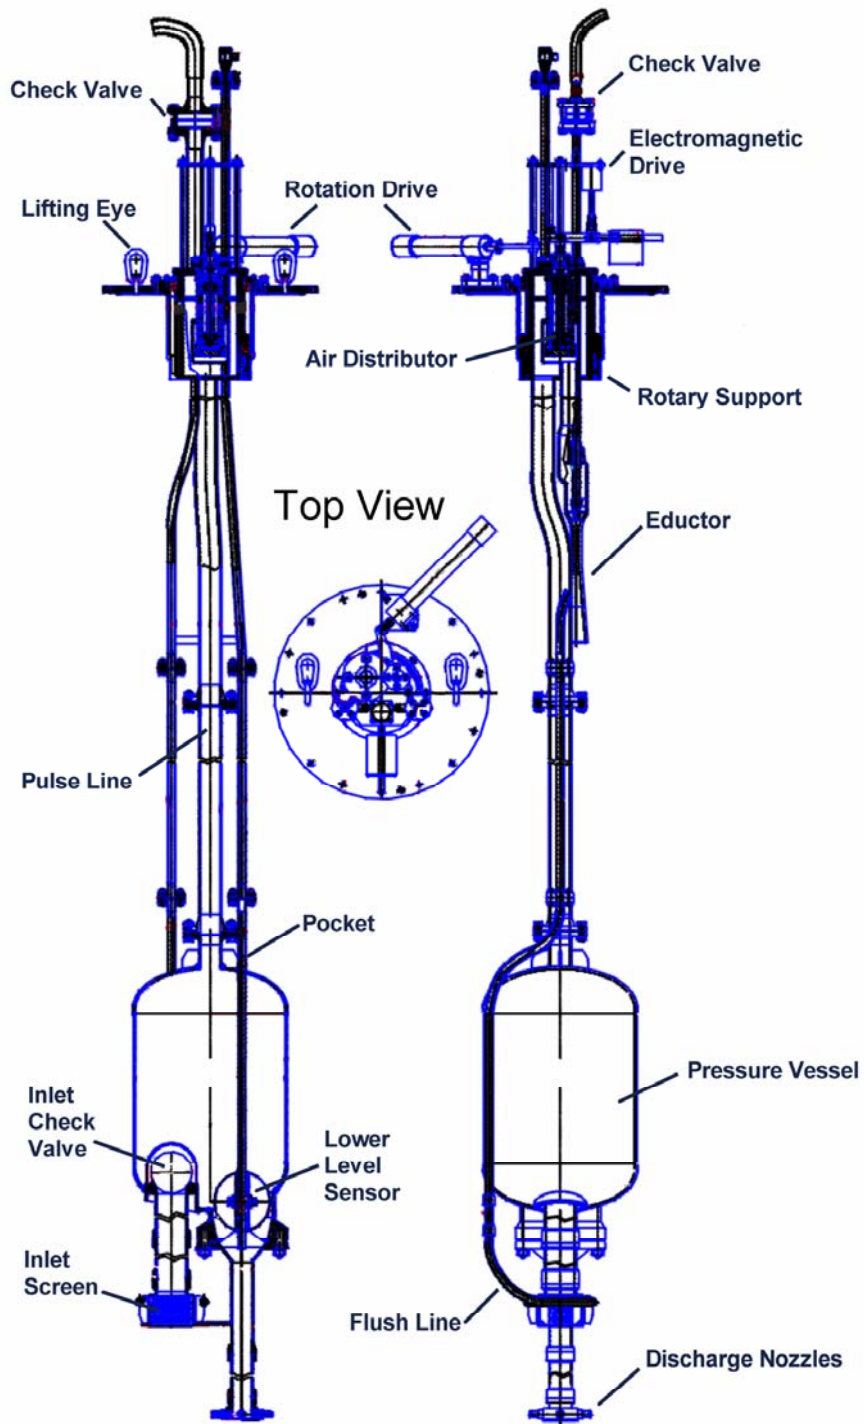
**Fig. 1. Russian pulsating mixer pump for use in the Gunite and Associated Tanks remediation.**

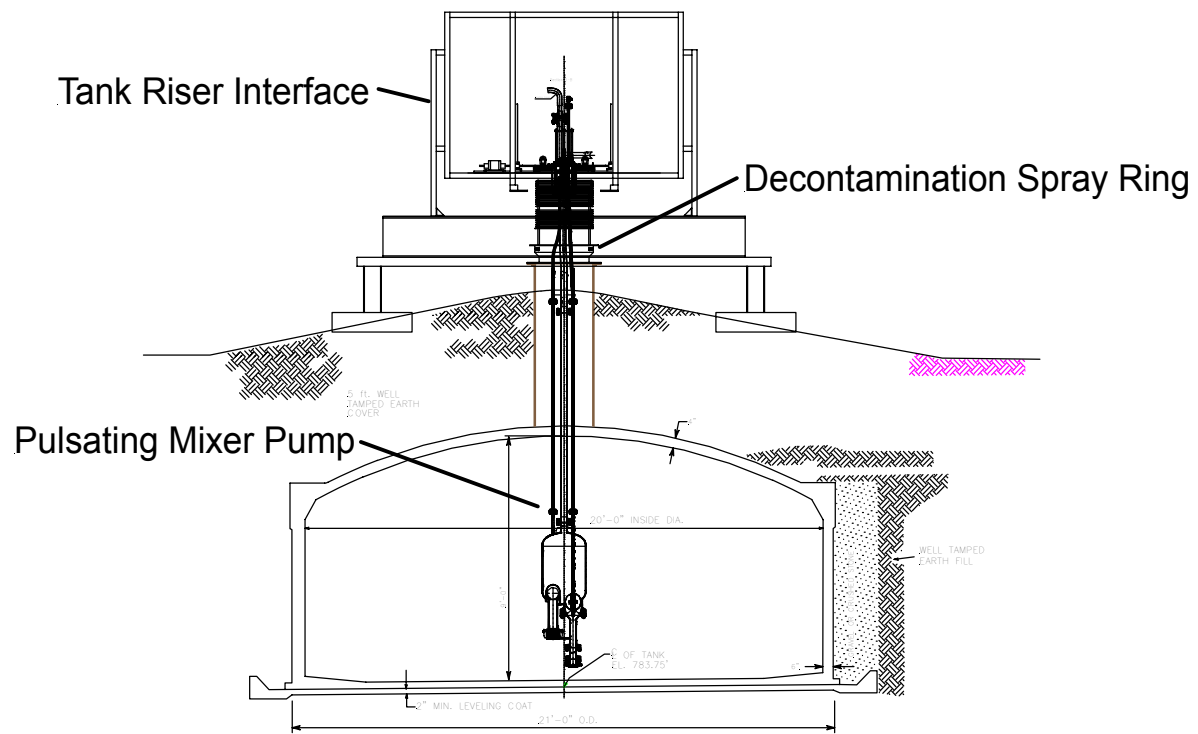
**Fig. 2. Sketch of Russian pulsating mixer pump in GAAT TH-4.**

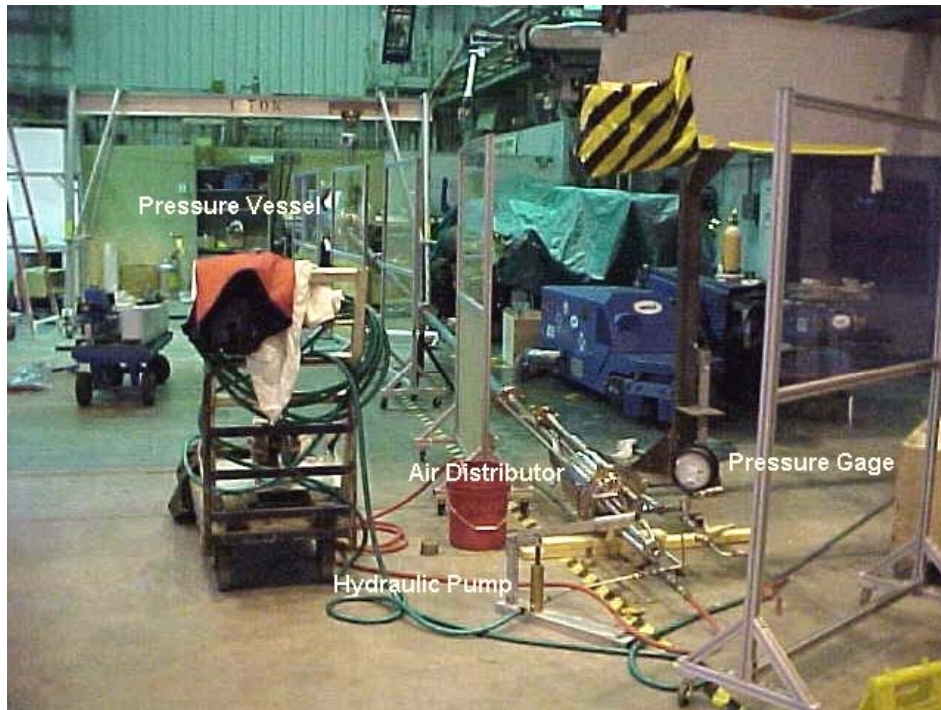
Each of the PMPs was hydrostatically tested by the ORNL QE&I department in accordance with established test procedures. The setup for these tests is shown in Fig. 5.

**Fig. 5. Russian PMP hydrostatic test setup.**

Design specifications for the PMP indicated the maximum allowable working pressure of 230 psi. ASME B&PV code requires PVs to be tested to 1.5 times the listed maximum allowable working pressure and that the pressure be maintained for a period of 10 min without leakage. The test pressure for the PMP was 345 psi. Calibrated pressure gages were installed at each end of the PMP and used to measure the applied hydrostatic pressure. The pressure was increased in ~50 to 100 psi increments. The pressure was held at each increment while the system was checked for leakage. After the test pressure of 345 psi was attained, the system was allowed to sit undisturbed for the required 10 min while the pressure gages at

each end of the unit were monitored. Each of the three PMPs successfully underwent independent hydrostatic pressure testing and was able to hold the required pressure for at least 10 min.

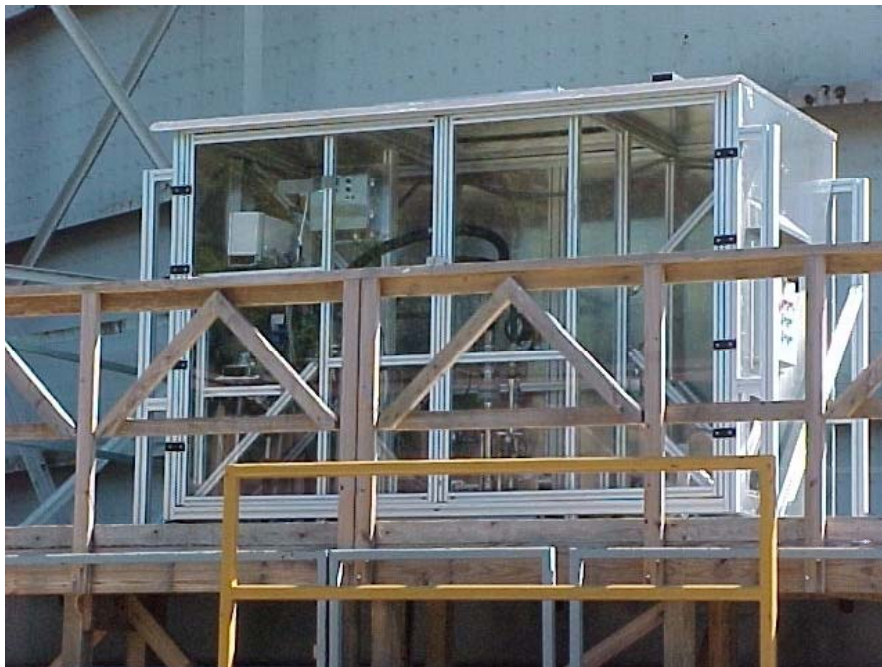
the drive table assembly. The Plexiglas panels were later replaced with 1/8-in. aluminum sheeting. Fig. 6 is a view of the modified TRI at the TTCTF.

**Fig. 6. TRI at the TTCTF after modification.**

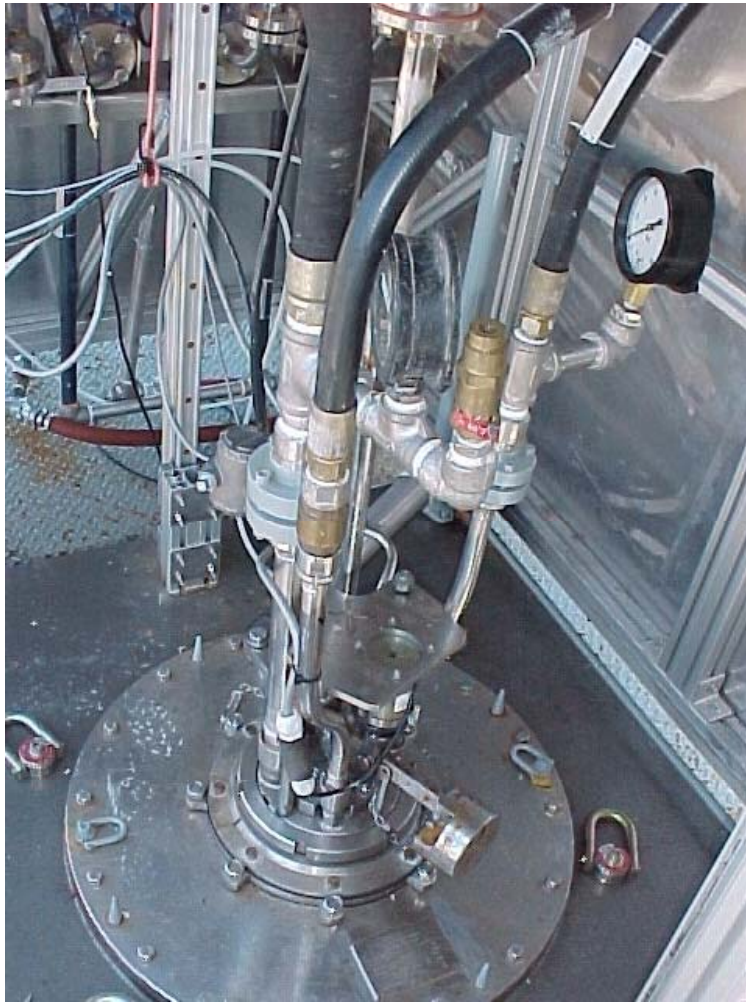
relocated to the more rigid support table, which was constructed of 0.5-in.-thick carbon steel plate. A structural engineer evaluated the use of the support table as a lift point for the PMP and TRI and determined that relocation of the lift points to the support table would bring the design into compliance with the applicable codes. The PMP is mounted to the TRI support table assembly and held in place by a series of 16 bolts. The support table is securely mounted to the TRI's aluminum framework. The top of the PMP and two of the four lift rings are shown in Fig. 7.

**Fig. 7. View of the top of the PMP and drive table inside the TRI.**

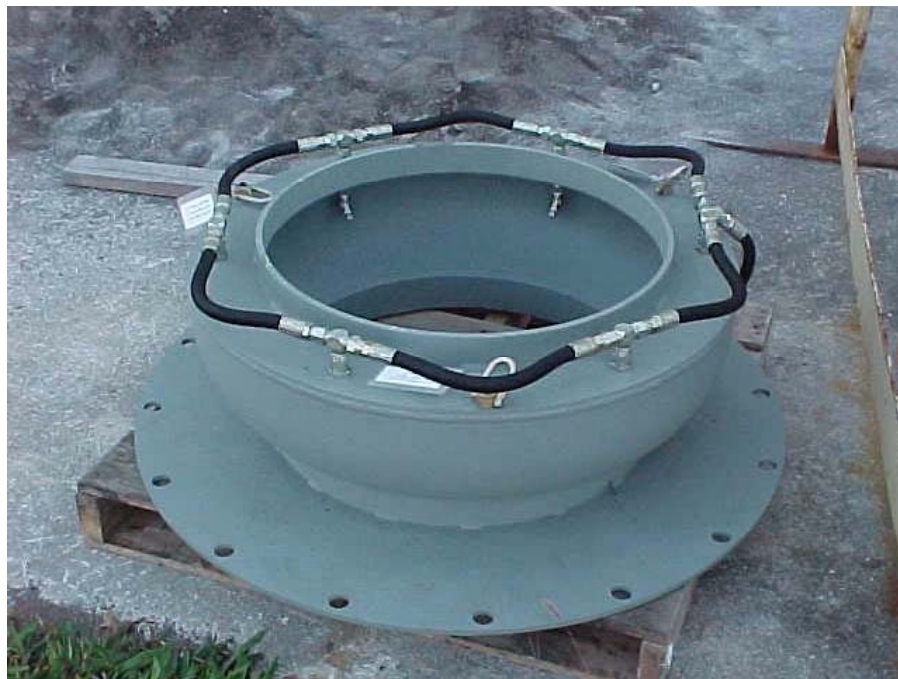
**Fig. 8. DSR at the TTCTF prior to installation for cold testing.**

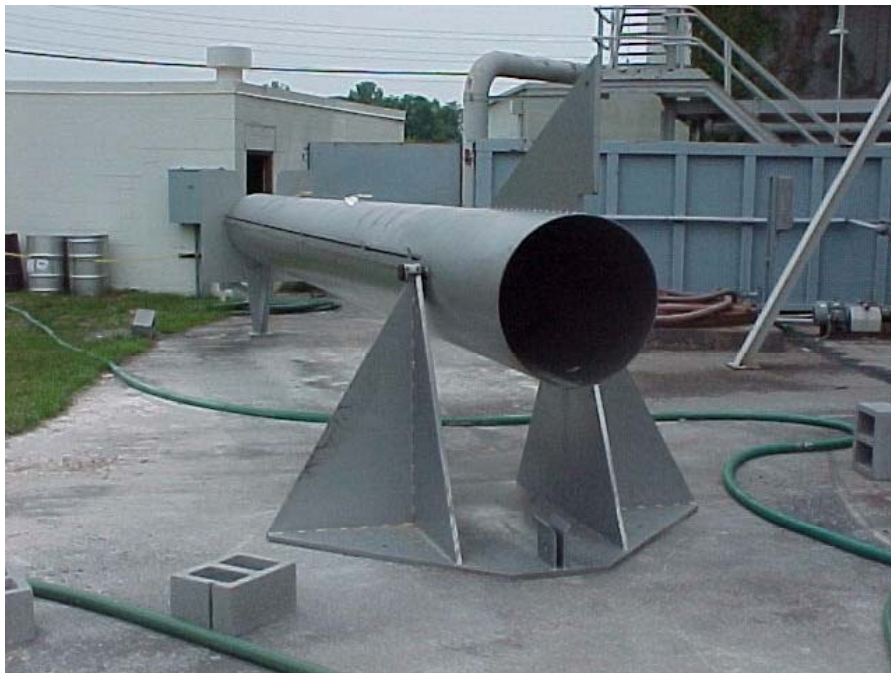
The transport cradle (TC) is a long cylindrical tube (~26 in. diam) that is ~25 ft in length and has a hinged base. The base is designed to be bolted to a concrete pad. The top section of the TC has a flange with guide pins for receiving the TRI/PMP. Fig. 9 is a view of the TC at the TTCTF.

**Fig. 9. TC at the TTCTF.**

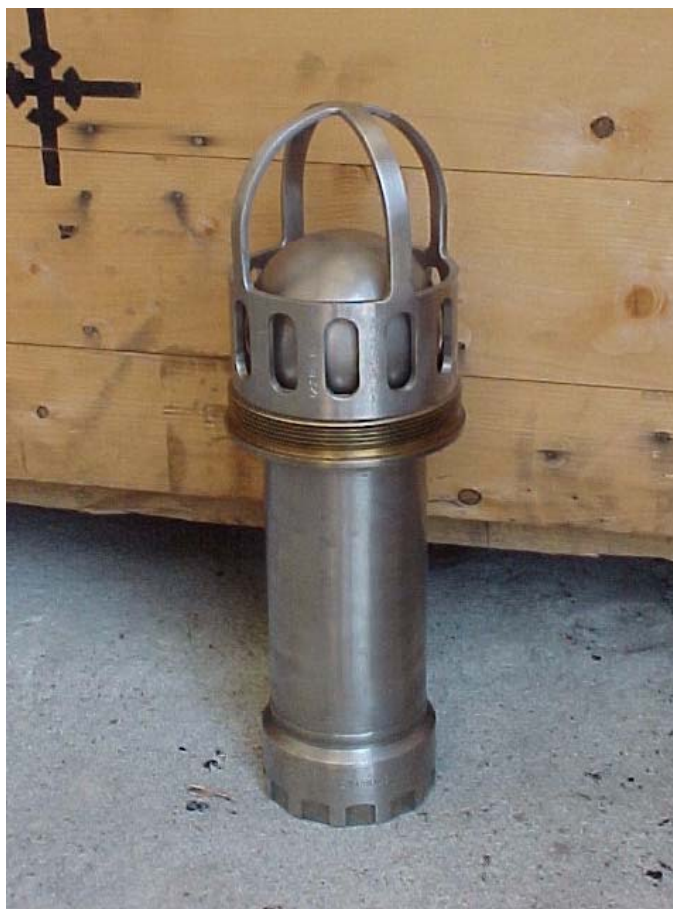
completely full. It is speculated that the low-frequency vibration may be associated with oscillation of the ~4-in diam solid titanium ball check valve inside the retaining cage as the PV is filled. Fig. 10 is a view of the check valve and retaining cage before installation in the bottom of the PMP PV. As the PV is filled, the ball check is moved upward above the inlet pipe opening by the flow of incoming material. Fluctuations in the incoming flow may allow the ball check to oscillate inside the retaining cage. The results of the vibration measurements confirmed the belief that the observations made during the MCC acceptance inspection were caused by the interactions of the discharged jet stream with the walls of the test tank and not a result of an inherent design condition of the PMP.

**Fig. 10. Check valve assembly before installation in the bottom of the PMP PV.**

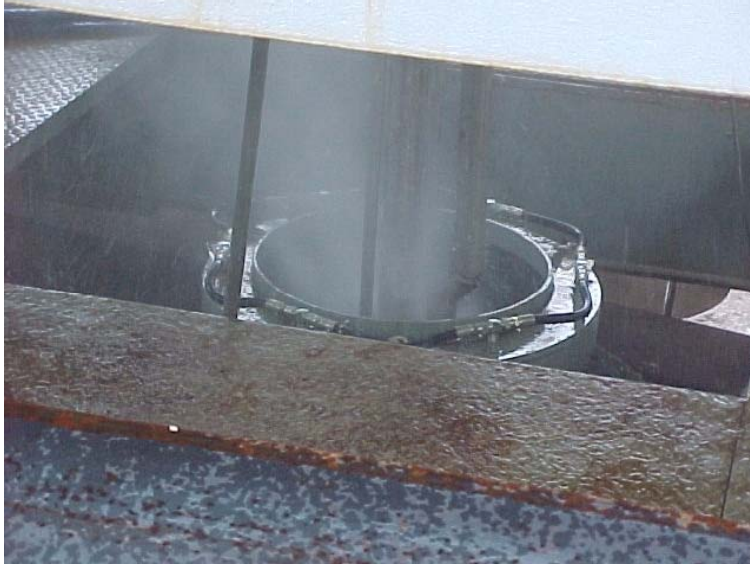
**Fig. 11. Mist above DSR operating at the TTCTF.**

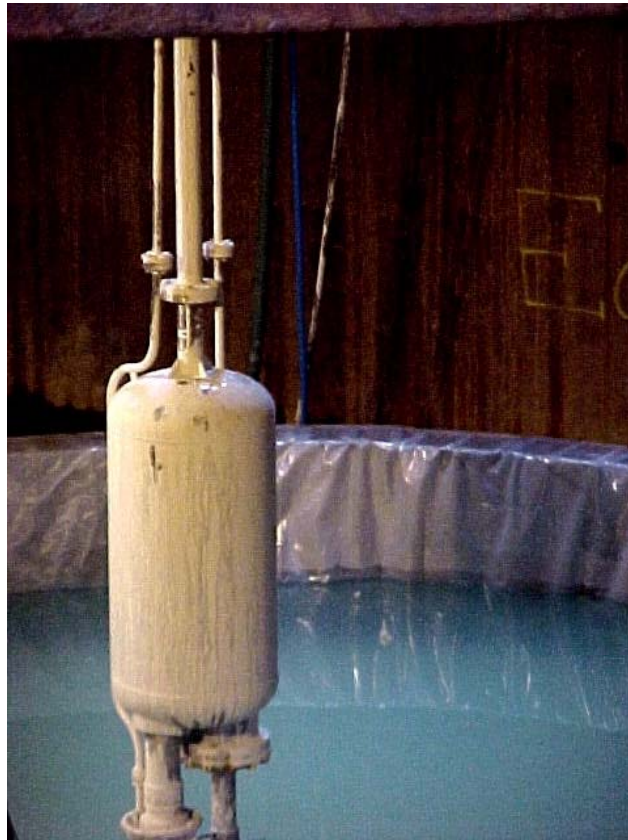
**Fig. 14. View of waste simulant on the PMP PV at the TTCTF.**

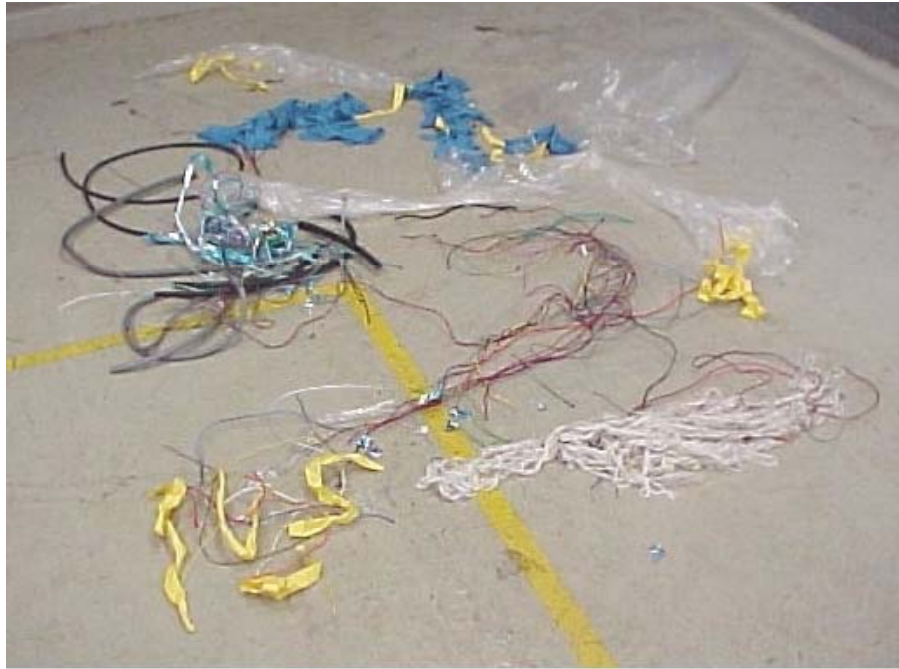
**Fig. 15. Debris used in cold testing of the PMP.**

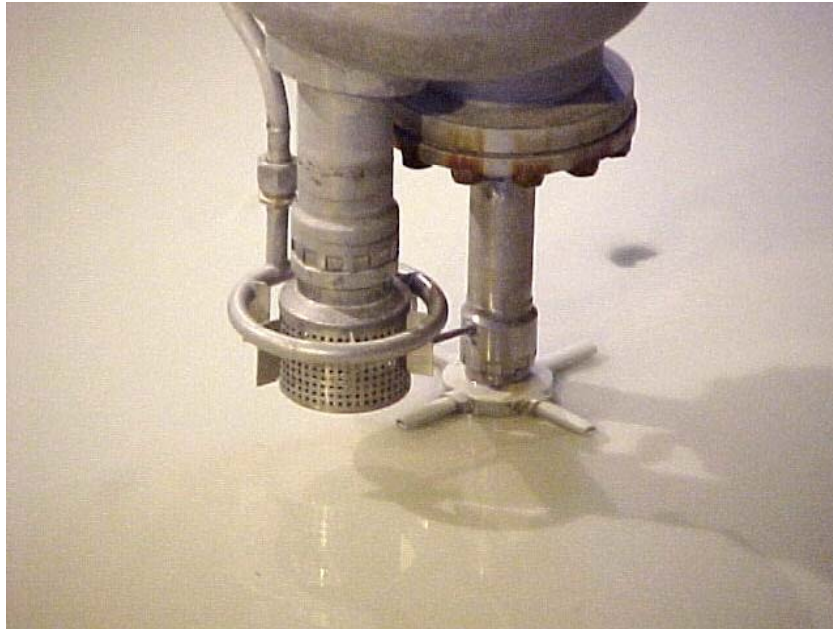
Additionally, a perforated metal screen was used to limit the size of material that could be drawn into the PV through the inlet port. The screen is ~6 in. diam and ~4 in. high and is constructed of perforated (~0.25-in.-diam holes) metal plate (Fig. 17). No material became caught in the perforations during cold testing.

**Fig. 17. View of the bottom of PMP showing the orientation of the screened inlet port relative to the discharge nozzles.**

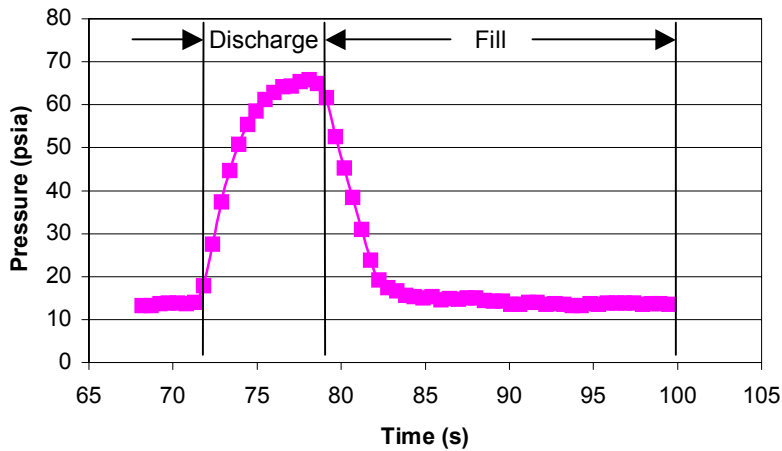
Fig. 18 is a representative absolute pressure-time curve for a typical fill and discharge cycle for the PMP operating with a 90-psig air supply pressure.

**Fig. 18. Typical pressure time curve for the fill/discharge cycle using a 90 psig air supply.**

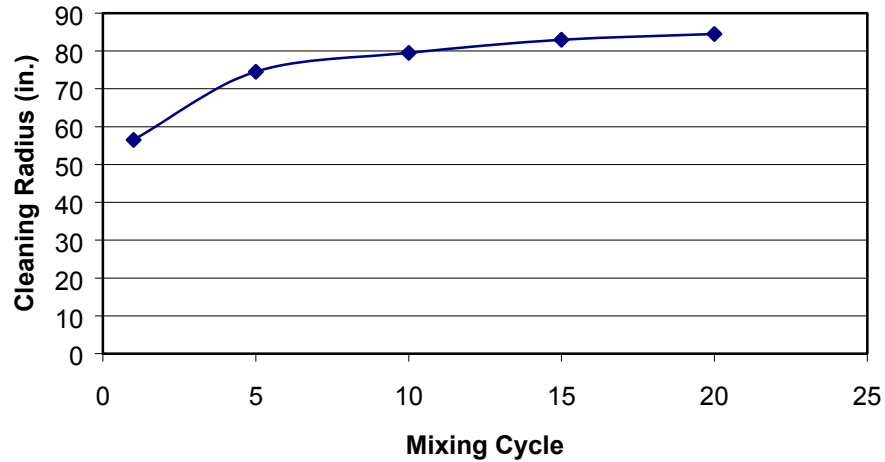
**Fig. 20. Minimum cleaning radius growth for 16 mm diameter nozzles.**

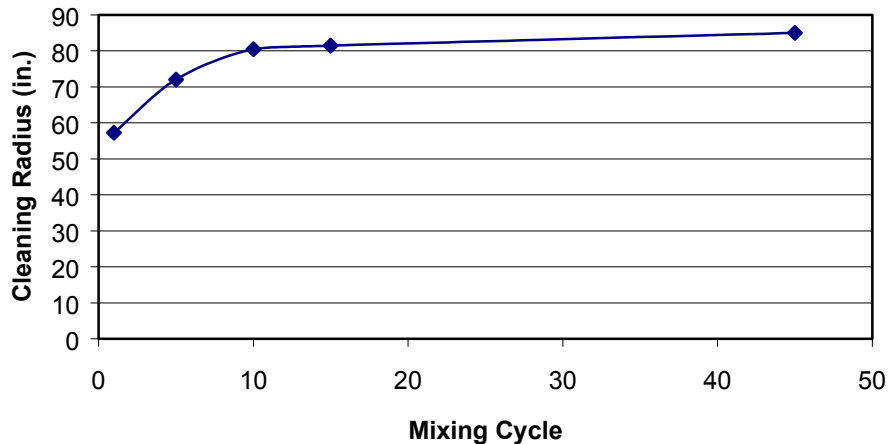
These tests began with an ~2-in.-deep layer of sand on the bottom of the mock tank. Fig. 22 shows the growth of the static minimum cleaning radius for the 10-mm-diam nozzles with a maximum of 85 in. after 45 operating cycles.

**Fig. 22. Minimum cleaning radius growth for 10-mm-diam nozzles.**

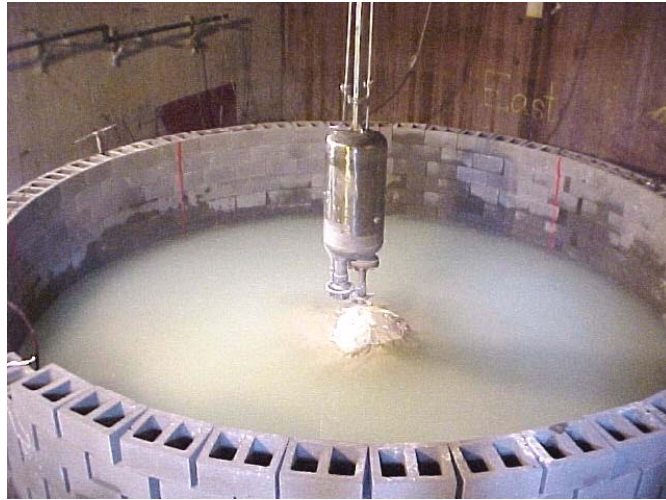
**Fig. 28. View of clay-sand mound before mixing and filling of mock-tank.**

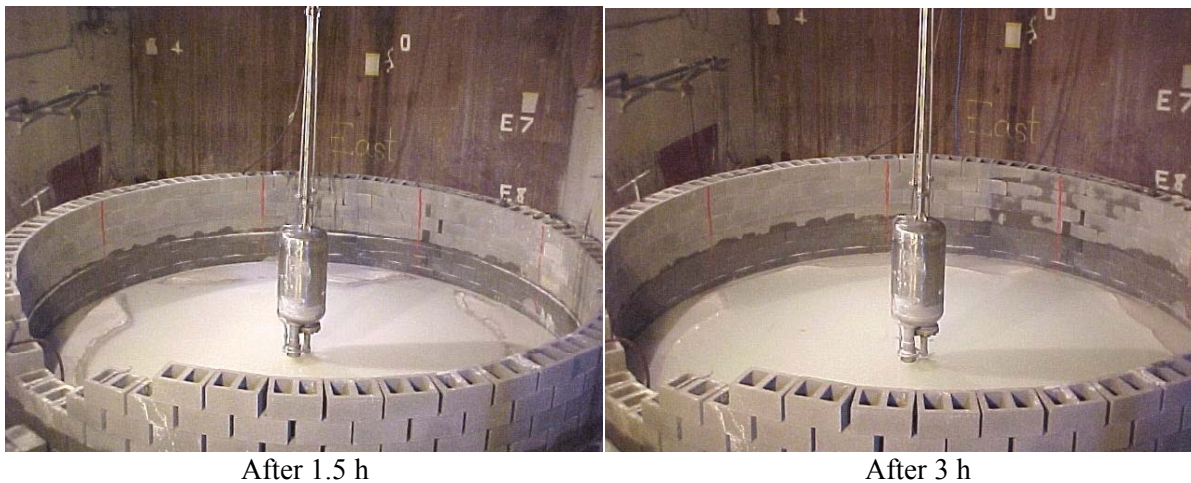
The test was resumed the following day by refilling the test pit to the initial water level and continuing the operation of the PMP with the discharge nozzles  $\sim 1$  in. off the floor of the mock tank. The system was operated for an additional 1.5 h before it was shut down and clay-sand displacement measurement taken. At the end of this operating period, the PMP had been operated for a total of 3 h. The minimum effective cleaning radius at the end of the 3 h cumulative operating period was  $94.1 \pm 1.9$  in, which was within 0.5 in. of the value after 1.5 h but with significantly less variation. The amount of clay-sand near the mock tank wall varied from 4 to 6 in. and had an average depth of  $5.2 \pm 1$  in. This clay-sand depth indicates that essentially all the sludge surrogate had been displaced to the outside wall of the tank during the test. Fig. 29 shows views of the mock tank after mixing.

**Fig. 29. View of mock-tank after mixing a single in-line clay-sand mound.**

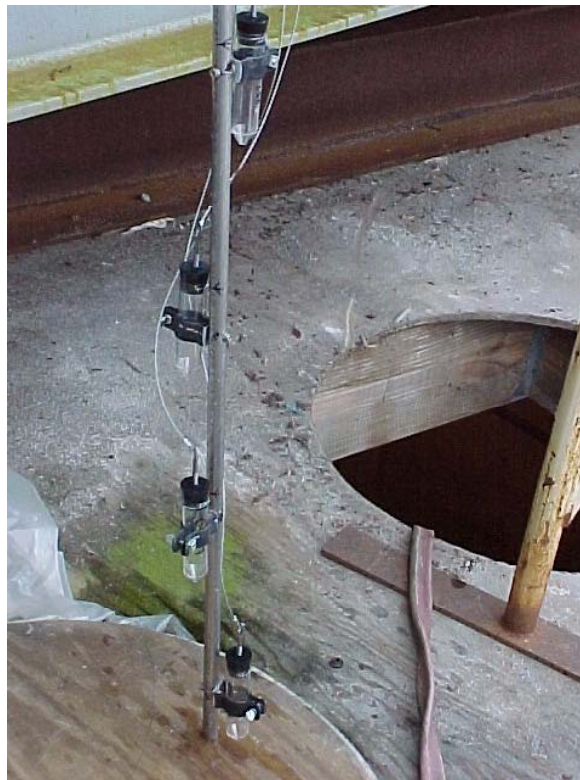
**Fig. 30. End of long-pole sampling tool, showing sample collection vials.**

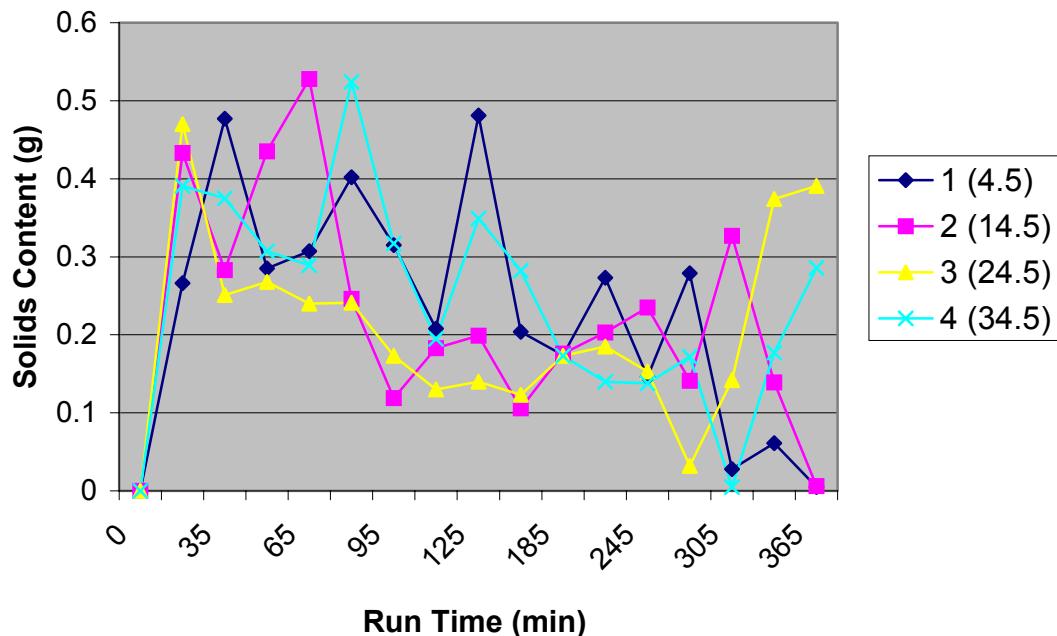
**Fig. 31. Raw sample data from mixing test on August 15, 2000 where curve 1 is for the sample position nearest the floor of the mock tank, and curve 4 is for the sample position farthest from the floor (numbers in parentheses indicate height from floor of mock tank).**

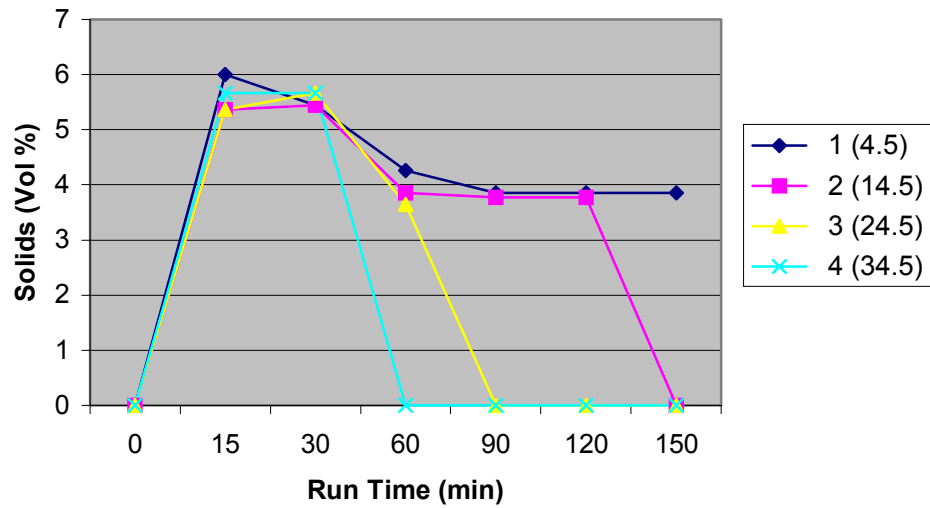
**Fig. 32. Solids mixing profile during simulant retrieval where curve 1 is for the sample position nearest the floor of the mock tank, and curve 4 is for the sample position farthest from the floor (numbers in parentheses indicate height from floor of mock tank)**

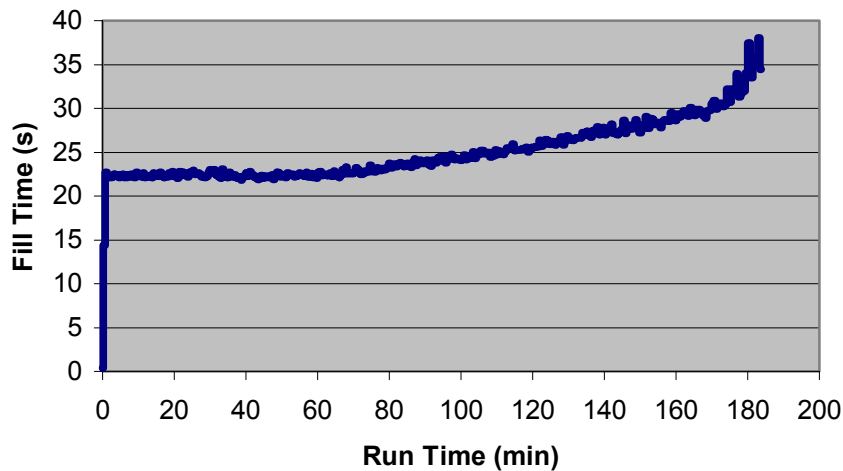
As expected, the fill time increased as the mock tank was depleted of material, which resulted in a decrease in head pressure from the fluid surrounding the PMP. The fill time was observed to vary from  $\sim 22.7$  to  $34.5$  s and is shown in Fig. 33. The discharge time remained reasonably constant throughout the test at  $6.43 \pm 0.31$  s. The variation in fill time resulted in a decrease in the discharge/refill frequency from  $\sim 2.1$  to  $\sim 1.5$  cycles per minute from the beginning to the end of the test, respectively.

**Fig. 33. Variation of fill time with run time for the PMP pump down test.**

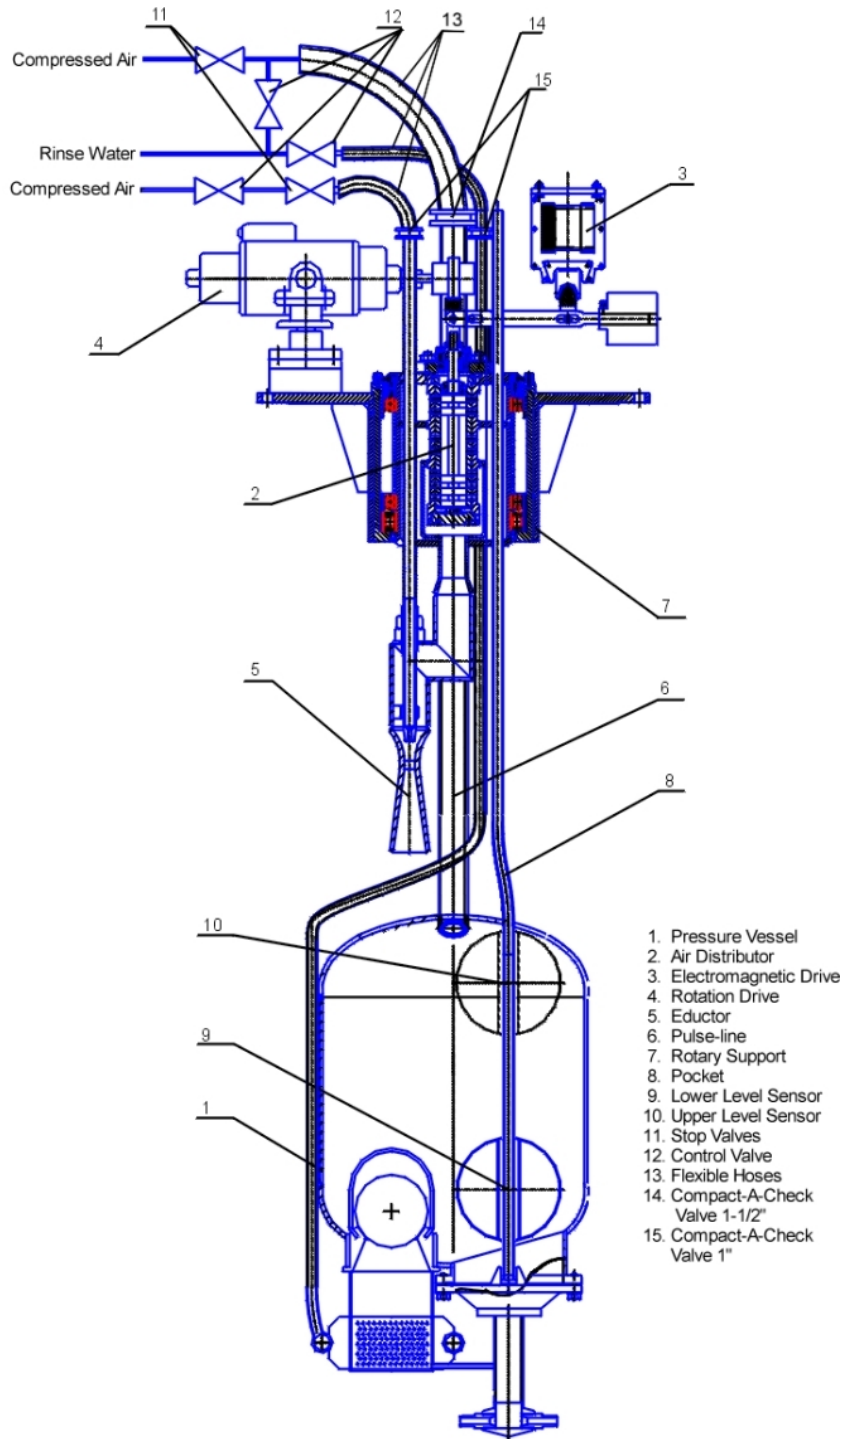
**Fig. B.1. Russian PMP.**
