***Pilot Peat-Bed Treatment System for NPDES Outfall H-12***

**Nancy V. Halverson  
Ralph L. Nichols  
Christopher J. Berry**

**October 22, 2007**

Savannah River National Laboratory  
Washington Savannah River Company  
Savannah River Site  
Aiken, SC 29808

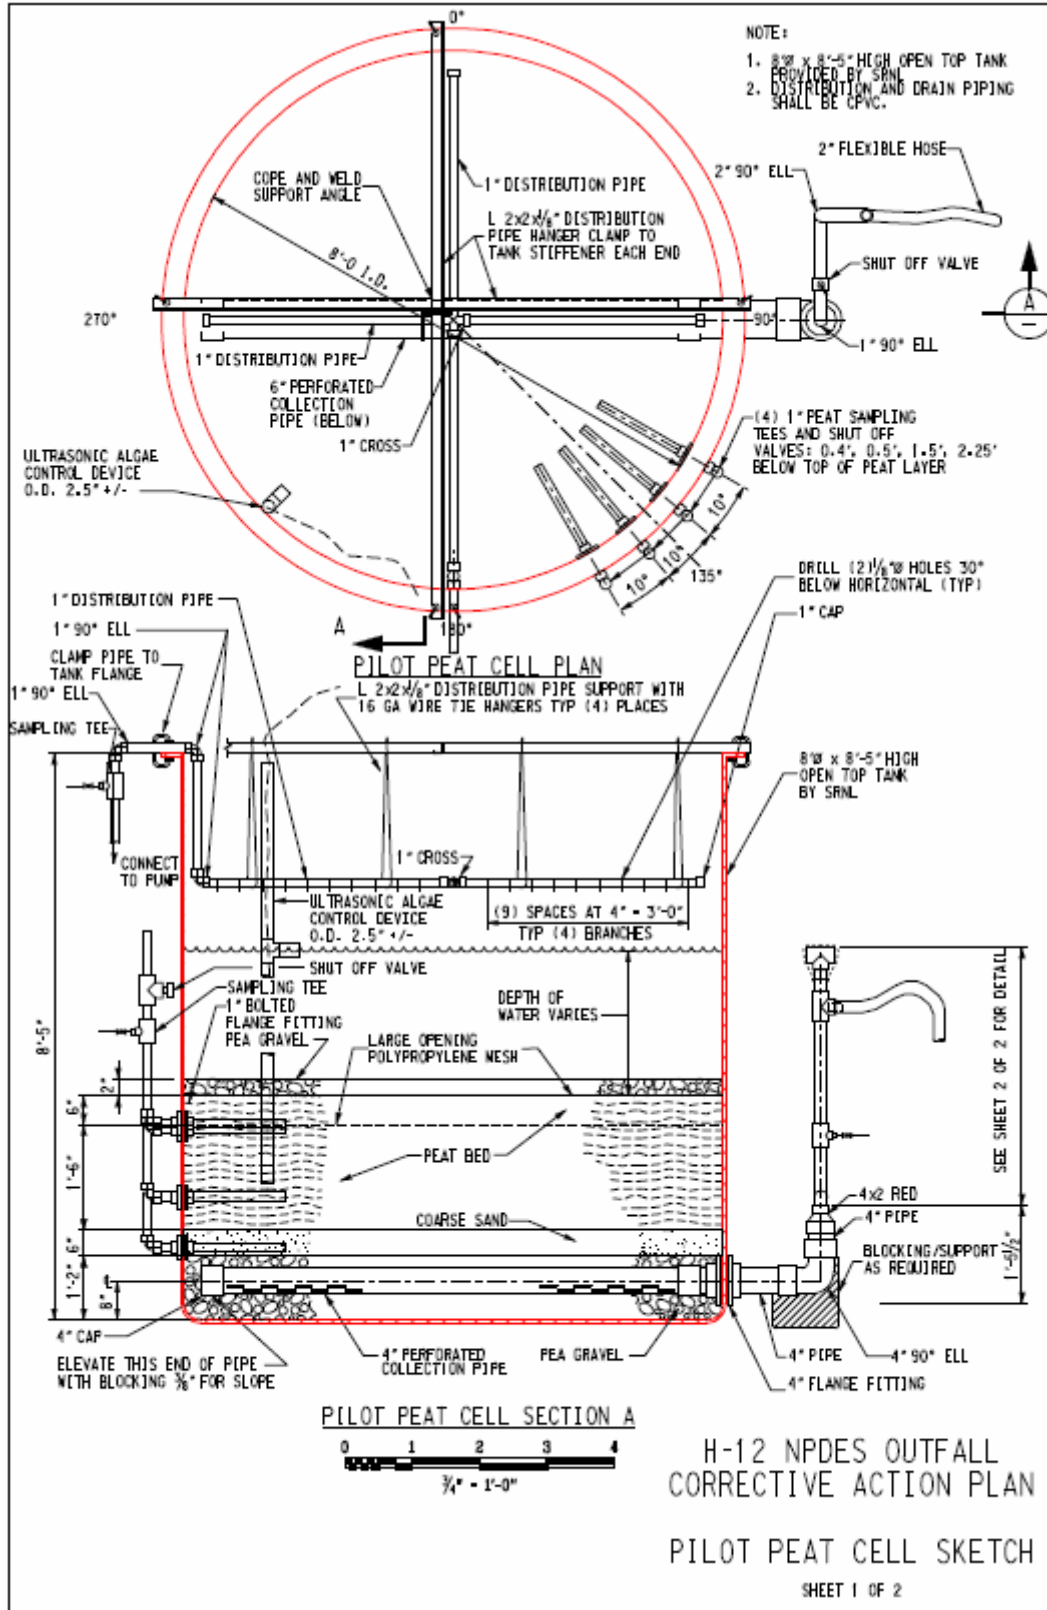
Figure 2. Tank #1 - Premier Pro-Moss TBK Peat Treatment Tank

Tank 1 consisted of the following layers, listed from bottom to top (Figure 2):

- 14" sub-drain layer of washed pea gravel with 4" diameter perforated PVC effluent piping at 0.5% slope
- 6" thick filter layer of coarse washed sand with hydraulic permeability of greater than  $1 \times 10^{-2}$  cm/s (0% passing Number 100 sieve)
- 18" thick layer of Pro-Moss TBK peat (see Appendix 1 for the technical data sheet)
- Separation layer of polypropylene mesh with openings 10.2 x 10.2 per square inch
- 6" thick layer of Pro-Moss TBK peat
- Layer of polypropylene mesh with openings 10.2 x 10.2 per square inch on the top of the peat
- 2" cover layer of washed pea gravel

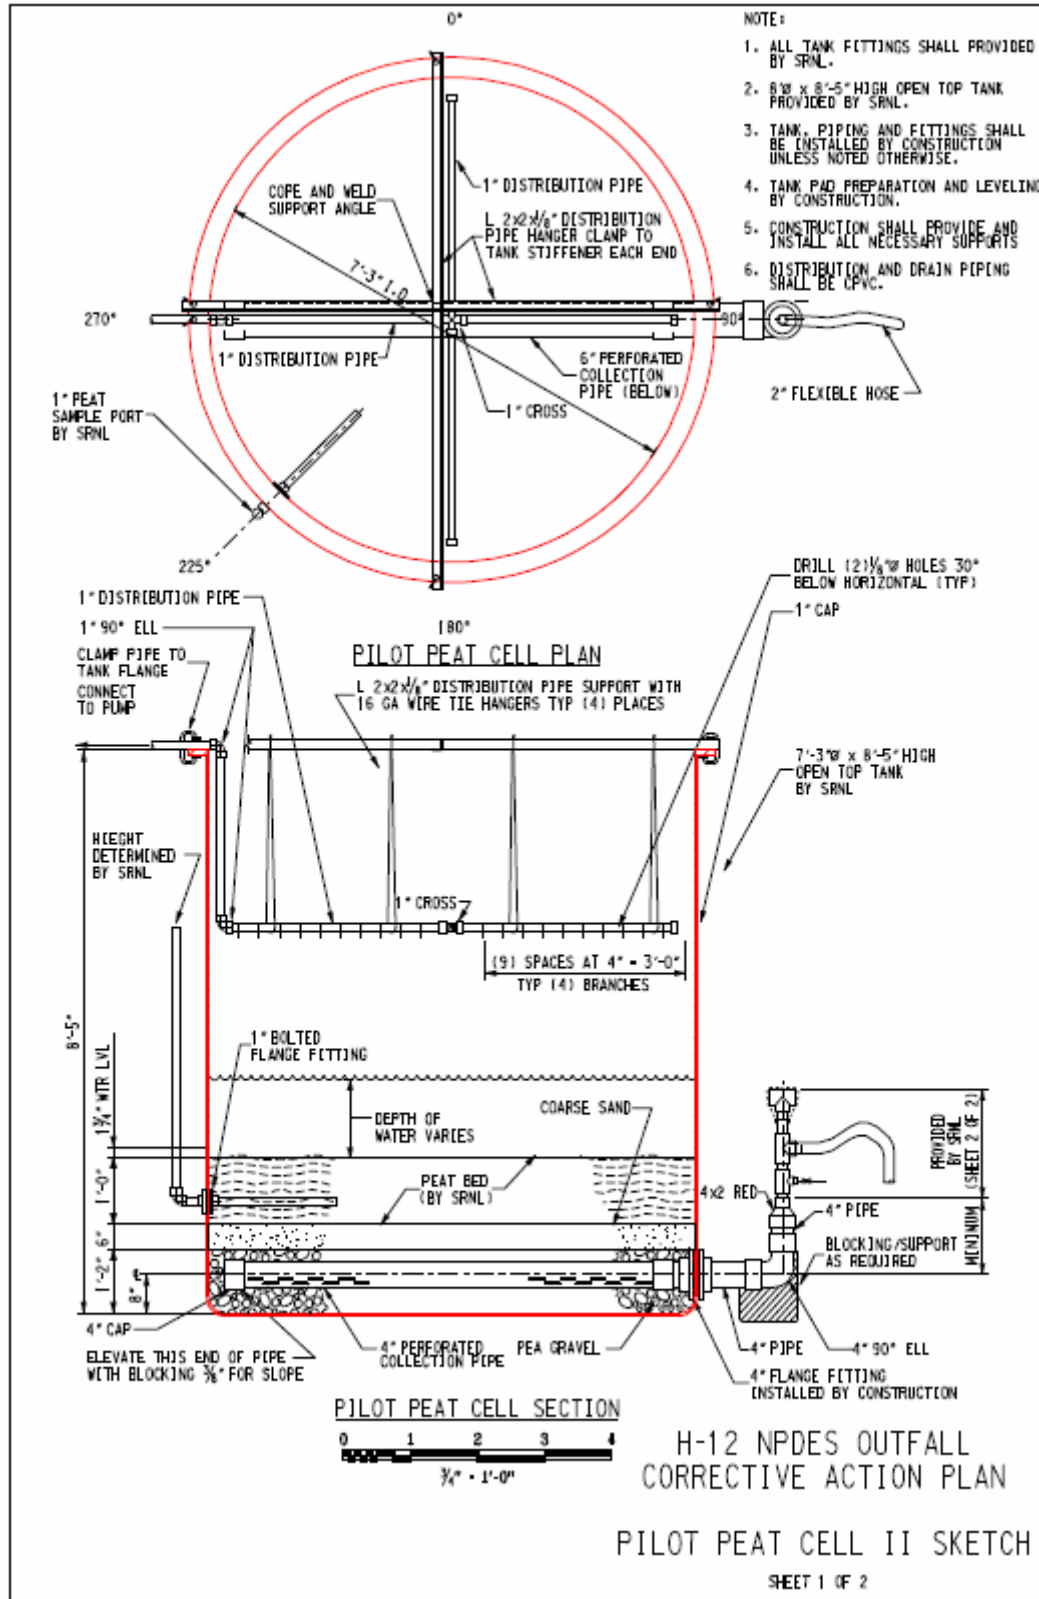
Figure 3. Tank #2 – APTsorb Peat Treatment Tank

Tank 2 was constructed in a similar manner to Tank 1, with the major difference being the layers inside the tank. Tank 2 consisted of the following layers, listed from bottom to top (Figure 3):

- 14" sub-drain layer of washed pea gravel with 4" diameter perforated PVC effluent piping at 0.5% slope
- 6" thick filter layer of coarse washed sand with hydraulic permeability of greater than  $1 \times 10^{-2}$  cm/s (0% passing Number 100 sieve)
- 1' thick layer of APTsorb peat (see Appendix 2 for the specifications).

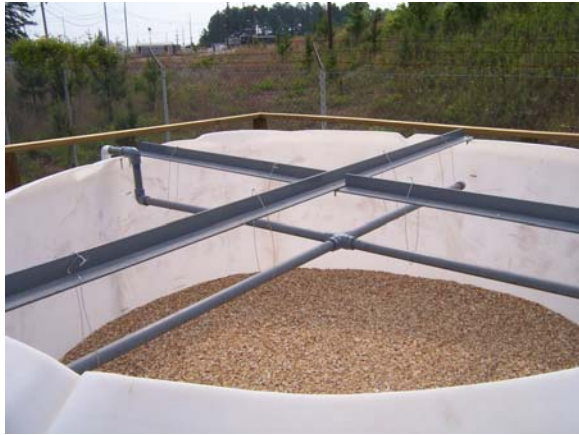
Figure 4. Influent distribution system on Tank 1

The influent distribution system suspended across the top of each tank consisted of 1" PVC piping with  $\frac{1}{8}$ " perforations drilled into the lower sides (Figure 4). The effluent structure for each tank had an adjustable arm to control water level, flow out of the system, and residence time in the system (Figure 5). The effluent control arm was adjusted to maintain a head of a foot or more of water over the peat to prevent the peat from drying. Sample ports through the side of the tank connected to perforated piping installed at various depths in the peat layer and extending 18" into the tank (Figure 6). The sample ports allowed measurement of various parameters and hydraulic head at different depths in the peat and calculation of hydraulic conductivity. An access deck was built around the tanks (Figure 7).

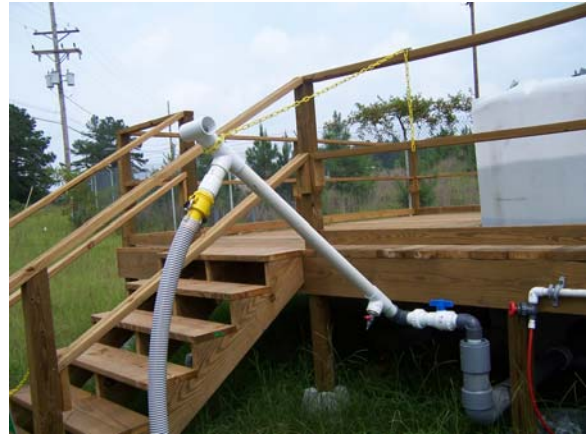
Figure 5. Effluent control arm with discharge tubing

A 2" transparent tube (to allow a visual indicator of flow) collected the peat-bed effluent at the end of each of the adjustable arms (Figure 5) and routed it to a 2" PVC pipe leading back to the wastewater stream, downstream of the sand-bag dam but upstream of the NPDES outfall.

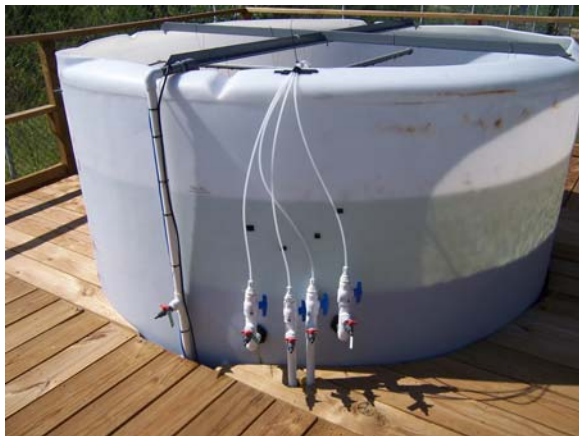
Figure 6. Peat layer sample ports in Tank 1

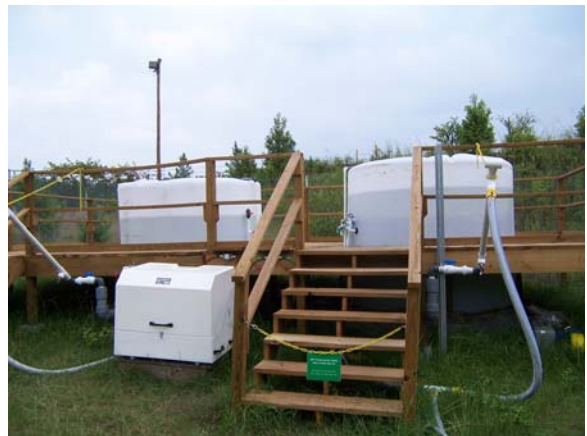
Figure 7. Access deck – Tank 1 on the right and Tank 2 on the left

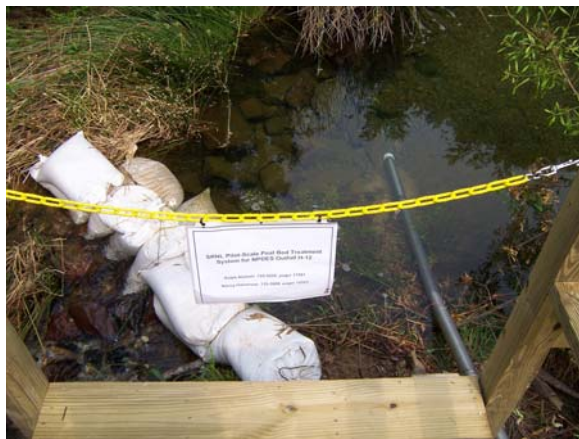
Figure 8. Sand bag dam and influent pipe casing

A low sand-bag dam was placed in the Outfall H-12 stream, upstream of the NPDES sample station, to provide a pool of water during low flow periods (Figure 8). Two-inch stainless steel wire-wrapped 0.010 inch slot well screen and casing were used to construct an intake structure to house a submersible pump used to deliver water to the pilot scale treatment system. The screen and casing armored the pump and prevented particulates down to fine sand in size from entering the pump. Initially, a  $\frac{1}{2}$  hp variable speed Grundfos RediFlo2 pump was used to deliver water to the pilot scale treatment system. The variable speed pump was operated by a variable frequency drive which enabled good flow control. A  $\frac{1}{2}$ " hose connected the pump to the influent distribution piping.

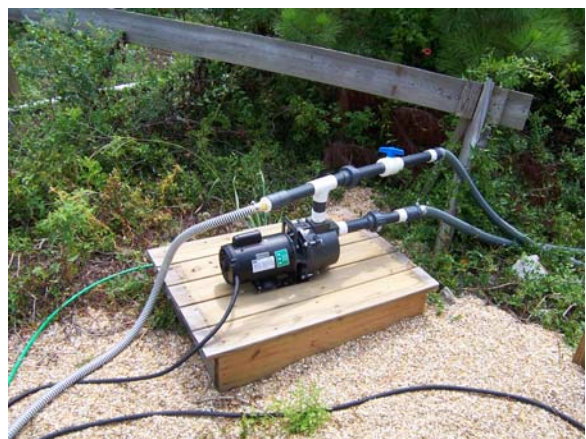
Figure 9. New water supply pump with overflow back to Outfall H-12

After two such pumps failed, a different pump was installed on July 13. The new pump was a  $\frac{3}{4}$  hp Dayton non-submersible centrifugal pump model 2P004. The suction tubing to the pump was inserted into the same stainless steel casing with well screen that was used with the other pumps. Because this was not a variable speed pump, flow to the tanks was controlled by valves installed along the intake piping, and excess water pumped from the Outfall H-12 stream was returned to the stream, bypassing the peat tanks (Figure 9).

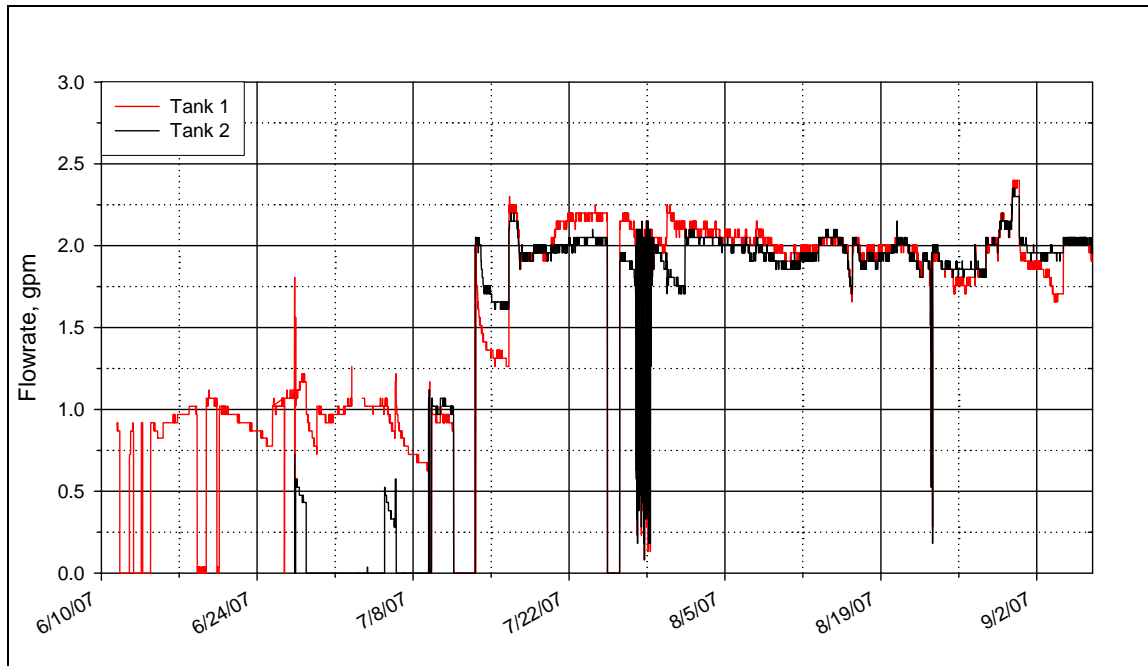
Figure 10. Flow for Tanks 1 and 2

In contrast to the power and water supply concerns, flow through the peat was trouble-free for most of the study period in spite of the algae growth that became apparent in early July. After the first few days of operation, a flow recorder was added to the system to allow continuous monitoring of the peat-bed influent. At the beginning of the study, the pumping rate to each tank was approximately 1 gpm, a rate chosen to mimic the cross-sectional flow rate for the full-sized system and to provide an approximately four hour retention time in the peat. In July, the project team decided to cut the full-size peat beds in half, requiring the design flow per unit area to be doubled. Consequently, the flow to the pilot study tanks was doubled to approximately 2 gpm on July 13. A graph of the flow to the tanks is shown in Figure 10.

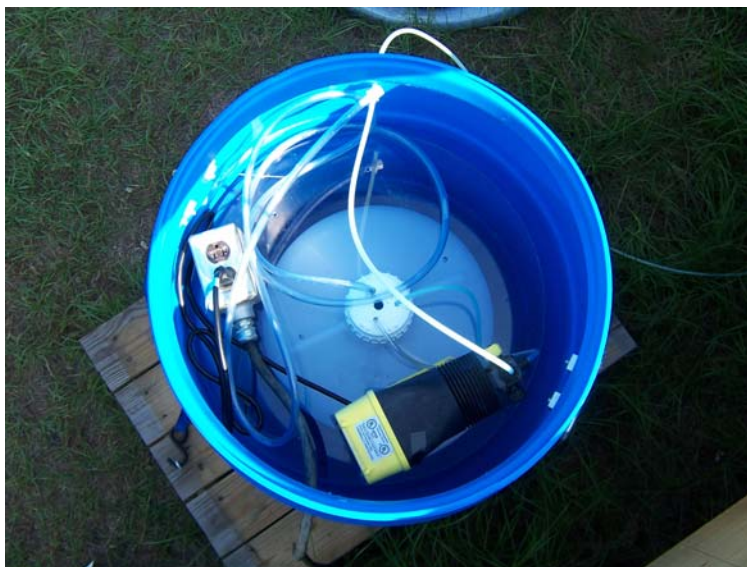
Figure 11. Chemical addition system

carboy (Figure 11) was used to inject the stock solution into the influent line upstream of the manifold that controlled flow to the individual tanks. The injection tubing was made of 1/4" high density polyethylene and was equipped with a check valve to prevent source water from flowing into the stock tank in the event of a pump failure. The copper addition system operated continuously at a nominal flow rate of 6.5 mL/minute except for a few days beginning around September 9 or 10 when the system ran out of  $\text{CuCl}_2$  over a weekend.

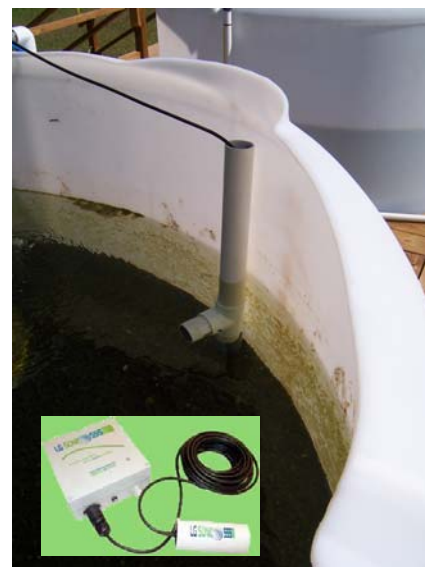
Figure 12. LG Sonic SSS ultrasonic algae controller

Due to concerns over the possibility of the algae eventually causing clogging of the peat bed, a LG Sonic SSS ultrasonic algae control device was installed in Tank 1 on August 20 (Figure 12). A mounting device was constructed for the instrument using PVC pipe. To allow comparison of a treated tank vs. a non-treated tank, no algae control device was put into Tank 2.

Ultrasonic devices control algae by emitting an underwater ultrasonic wave that causes the vacuoles in the algae to resonate and rupture. A device’s effectiveness varies depending on the type of algae present. Product literature indicated that some algae may take several weeks to die off (LG Sound 2007) and another source (Canadianpond.ca Products Limited 2007) indicated some types of algae are not susceptible to the ultrasonic vibrations. The ultrasonic algae controller installed in Tank 1 had not caused noticeable reduction in the algae growing on top of the gravel layer or on walls of the tank at the time of this report. However, there were less algae floating on the top of Tank 1 than Tank 2 after about four weeks of operation of the LG Sonic SSS.

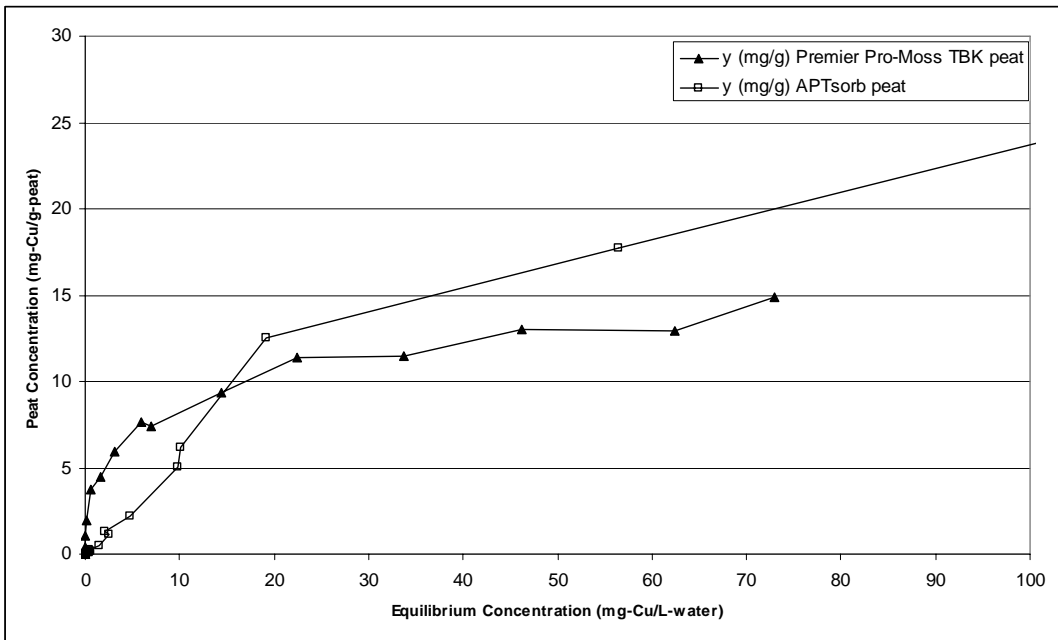
Figure 13. Peat adsorption isotherms of copper

The adsorption isotherms for the Premier Pro-Moss TBK peat and the APTsorb peat are shown in Figure 13. Figure 14 shows the two adsorption isotherms at liquid equilibrium concentrations less than 1 mg/L. The adsorption isotherms plot the equilibrium relationship between the concentration of copper in the fluid phase and the concentration of copper in the peat particles, giving a measurement of the capability of the two types of peat to adsorb copper. The results indicated that the APTsorb peat adsorption capacity and holding capacity for copper were larger than for the Premier peat, but that adsorption by the Premier peat was strongly favorable at copper concentrations likely to be seen at Outfall H-12. The loading of copper on the Premier peat was higher at these lower concentrations compared with the APTsorb peat. The APTsorb peat was favorable only at higher concentrations, > 20 mg/L. More details of this batch testing can be found in Berry (2007 DRAFT).

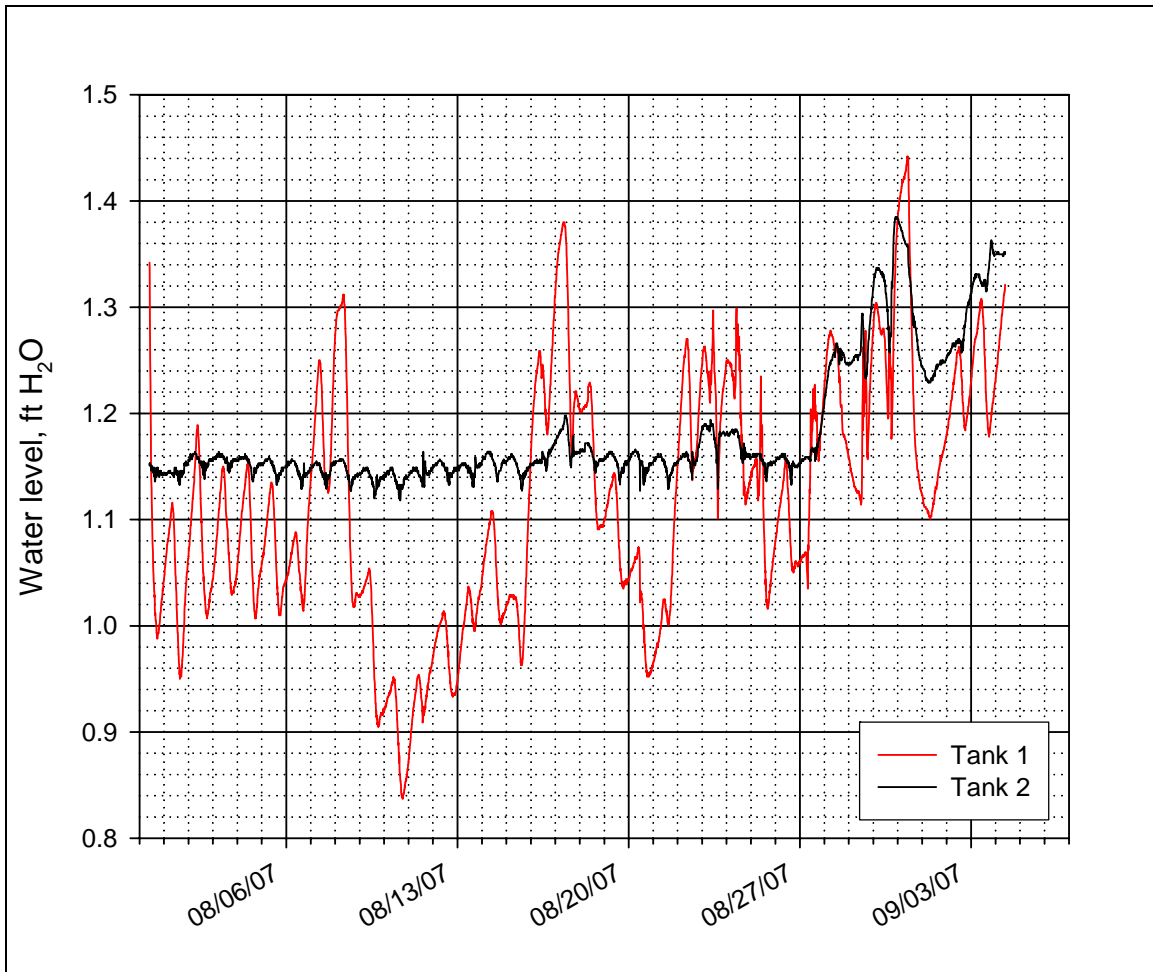
Figure 15. Water levels in Tanks 1 and 2

Transducer measurements in Tank 1 showed that the tank water level had been exhibiting a diurnal swing (Figure 15). Water levels reached a high point each day between 8:00 and 11:00 AM and dropped to a low point between about 3:00 and 7:00 PM, at which time the level would begin to rise again. The inception date of this phenomenon is not certain because the transducers were not installed until the water level variation had been noticed. However, the transducer in Tank 2 was installed before any tank water level variation was visually noted in that tank. Review of the data for Tank 2 showed a similar variation of the water levels, on a much smaller scale and with slightly different peak times. Over time, however, the water level vacillation in Tank 2 appeared to increase, perhaps with the growth of algae on the surface of the substrate (Figure 15). Various explanations have been hypothesized, including expansion of the tank during the heat of the day (which could allow water to short-circuit along the side of the tank), increased activity by the algae, or clogging of the top layer of the peat. The exact cause has not been determined. Design of a full scale peat bed system for Outfall H-12 would need to incorporate sufficient freeboard in the peat beds to account for the daily swing in water levels.

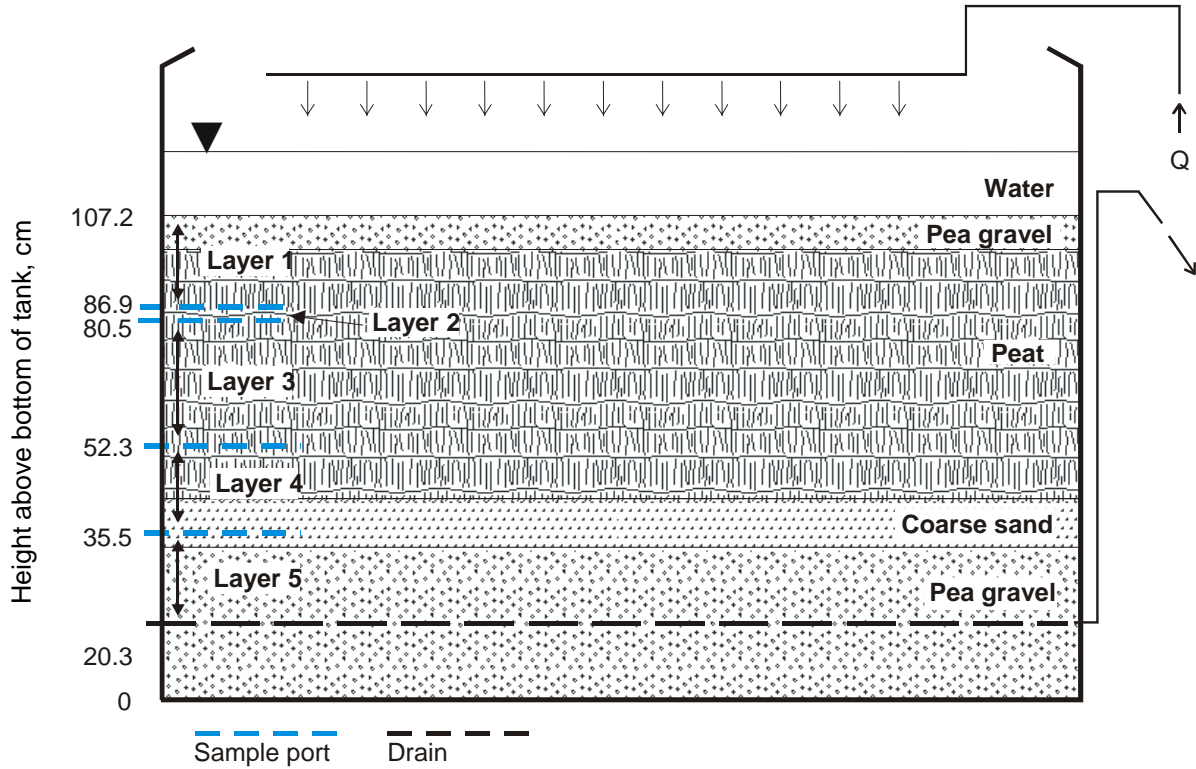
Figure 16. Monitoring points and material layers in Tank 1

A schematic showing the monitoring ports and material layers in Tank 1 is shown in Figure 16. A YSI® multiparameter water quality meter was used to measure the water quality indicators, pH, specific conductance, and dissolved oxygen, at different depths in the tank using the monitoring ports. Measurements were made in early June, shortly after Tank 1 began operating, and in September, after three months of operation. Results are shown in Figures 17 through 19. Initially, pH decreased within Tank 1; however, by September the pH was essentially unchanged with depth (Figure 17). This is the result of the depletion of H<sup>+</sup> ions initially sorbed onto the peat that were desorbed by water treated during the preceding portion of the pilot study. The specific conductivity profile for June (Figure 18) shows an increase with depth in the peat indicating that the water may have dissolved a slight amount of material in the peat. The specific conductivity is similar from top to bottom in the September profile suggesting the amount of dissolved material in the water is unchanged through the depth of the bed. Dissolved oxygen decreased with depth in both profiles due to the reducing environment that existed in the peat (Figure 19).

Hydraulic head was measured using the sample ports in Tank 1 (Figure 16). Using this data, the hydraulic conductivity of the peat-bed treatment system was calculated using Darcy's law for fluid flow in porous media. Darcy's law can be written as shown in equation 1 to calculate hydraulic conductivity. In this study the flow rate was measured using a flow meter on the inlet side of the peat-bed tank and hydraulic head was measured at several depths in the system.

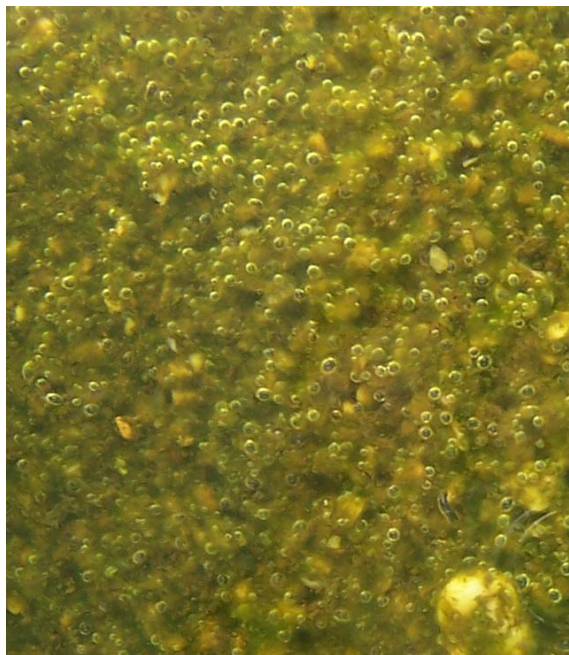
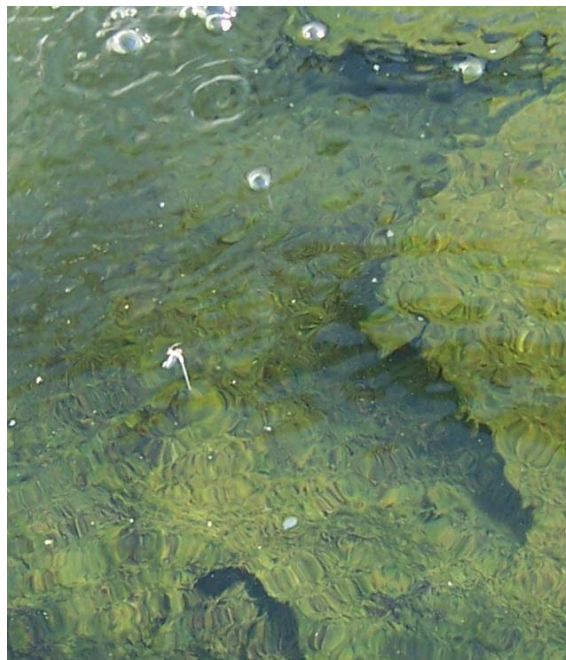
The algae growing in Tank 1 appeared to be different from that growing in Tank 2. The algae on the substrate of Tank 1 were green and covered with bubbles of the gas it generated (Figure 21). The algae floated to the surface if knocked loose from the gravel. The algae in Tank 2 did not appear as bright, and seemed to form a “crust” on the surface of the peat. Figure 22 shows the surface of the peat in Tank 2 in a location where a peat sample was collected, disturbing the “crust” of algae on top of the peat. Algae also were growing on the sides of both tanks and even on the surface of the LG Sonic SSS mounting structure, though not on the surface of the ultrasonic transducer, itself, indicating that the transducer was working to some degree.

Algae samples were collected on September 4 from both tanks. SRNL Environmental Biotechnology Section personnel evaluated the samples. In both tanks, the growth was a thick gelatinous biofilm containing a variety of organisms, including small rotifers, paramecium, green algae, cyanobacteria and many other bacteria typical of “pond scum” (Yeager 2007). There was an abundance of an as-yet unidentified green algae, as well as a Leptolyngbya-type species in the Oscillatoriales group of cyanobacteria. The Leptolyngbya-type algae might have been the major, but not only, generator of the biofilm, which provided a favorable habitat for growth of other microorganisms. Such a biofilm could clog the peat and hinder flow through the peat bed. The ultrasonic wave technology is not expected to kill Oscillatoria (Canadianpond.ca Products Limited 2007). The biofilm the Oscillatoria generates may also protect other algal species from the ultrasonic waves (Yeager 2007).

To prevent algae/bacteria problems in the full-scale peat bed, algae must be controlled in the various upstream retention basins that are exposed to sunlight, such as the 281-8H and 241-103H basins, in addition to the peat beds, themselves. Long-term operation of ultrasonic devices could be a part of the algae control solution, but some sort of ultraviolet light blocking mechanism on the peat beds is strongly recommended to prevent the bacterial growth that can clog the peat pores. A floating cover or a layer of small floating balls would reduce the ultraviolet light and minimize the algae and bacteria growth.
